3AM-IQA1626 Application for Amendment – Supporting Submission

Rev. 1 February 1, 2019

2 DETAILS OF AMENDMENT APPLICATION

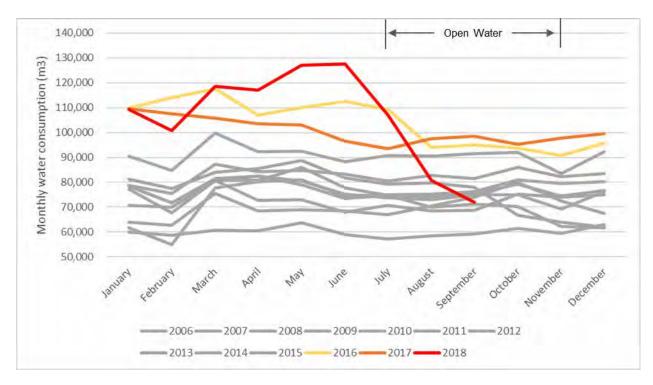
Figure 2-2: Iqaluit monthly water consumption 2006-2018

Lake Geraldine is estimated to contain approximately 1.8 million cubic metres of water at full capacity, with approximately 1.1 million cubic metres of this water available during winter months (November to June) (Nunami Stantec 2018). The remainder is unavailable during the winter months due to a portion being locked up as ice, and year-round due to the location of the water intake at depth. The City's water demands have been growing, and currently, approximately 73 to 78% of the available water in winter in Lake Geraldine is withdrawn to meet potable water demands (Figure 2-2). As recharge to the reservoir occurs only during open water months (July to October), the City's ability to supply water throughout the winter based on current demand, is based on having the full 1.1 million cubic metres of water in the Lake Geraldine Reservoir by the time of freeze-up.

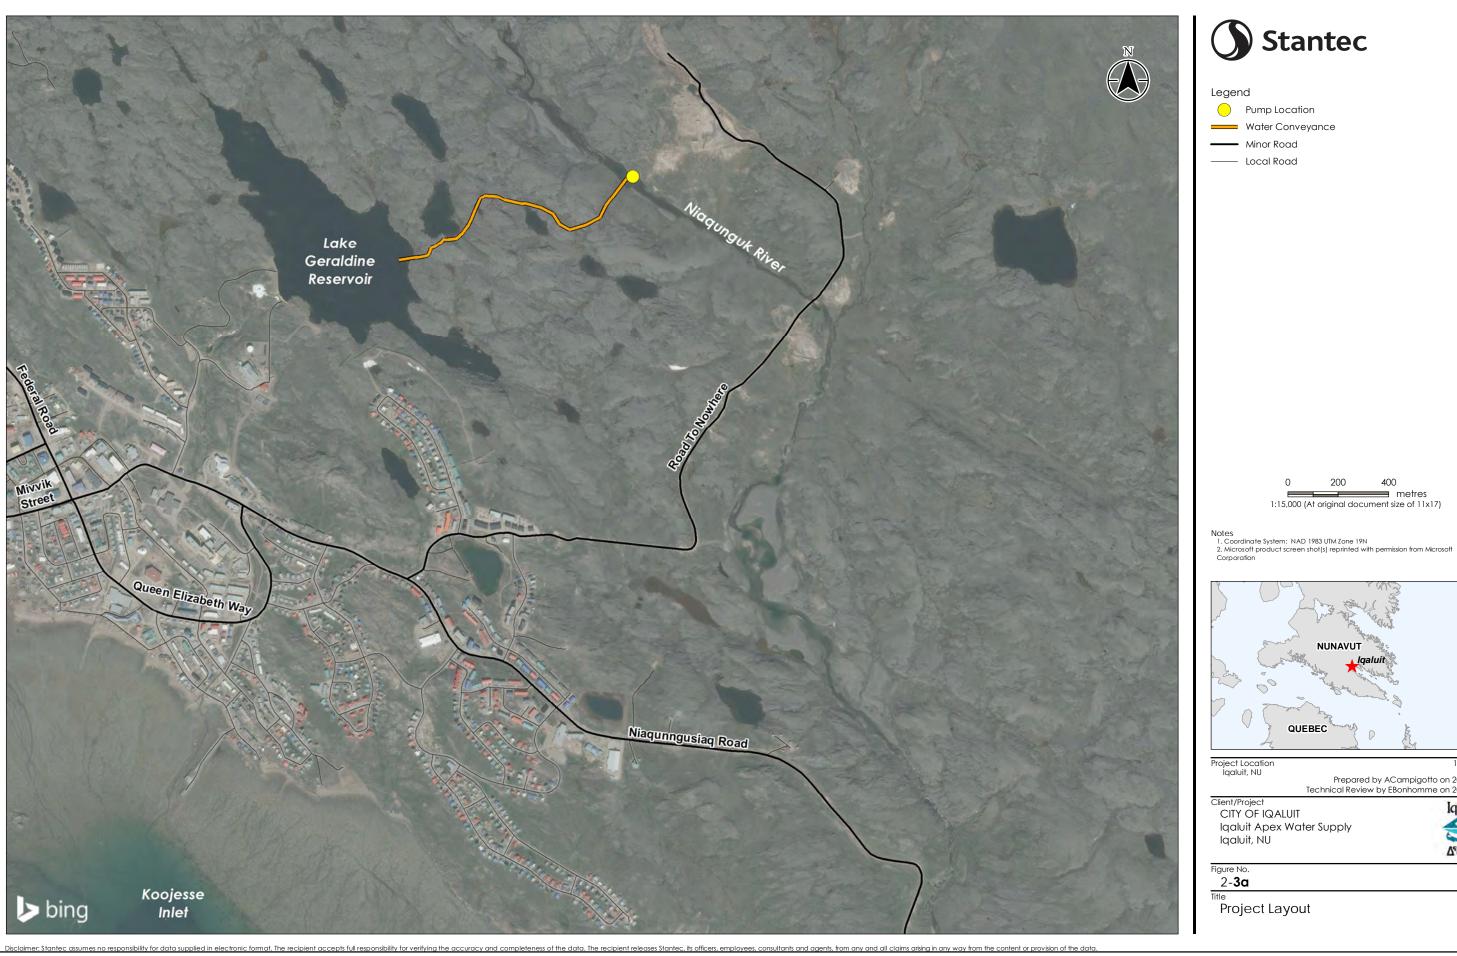
Figure 2-3: Site Plan

The City proposes to withdraw water annually from the Apex River, and to pump this water overland to the Lake Geraldine reservoir during open-water conditions, as needed until a permanent, long-term solution is implemented. Figure 2-3 shows the site plan for the proposed location of pumps within the Apex River and overland conveyance installation.

Water withdrawal from Apex River is proposed at up to 150 litres per second (L/s) (0.15 m³/s) or 11,000 m³/day over a 20 hour period, as flow conditions allow. Withdrawal may be ramped up or down so as to preferably not exceed 10% of the instantaneous flow of the Apex River when natural flow is above 30% of the mean annual discharge (MAD). Withdrawal within these parameters is accepted by DFO to have a low probability of impacts to fisheries (DFO 2013). Flows at the withdrawal site will be measured at a new hydrometric station to be installed upstream of the pump location, or can alternatively be calculated based on measured flows at Water Survey of Canada (WSC) Apex River at Apex hydrometric station (10UH002). MAD at the withdrawal location in 2017 was 0.717 m³s and 30% of MAD was 0.215 m³/s.

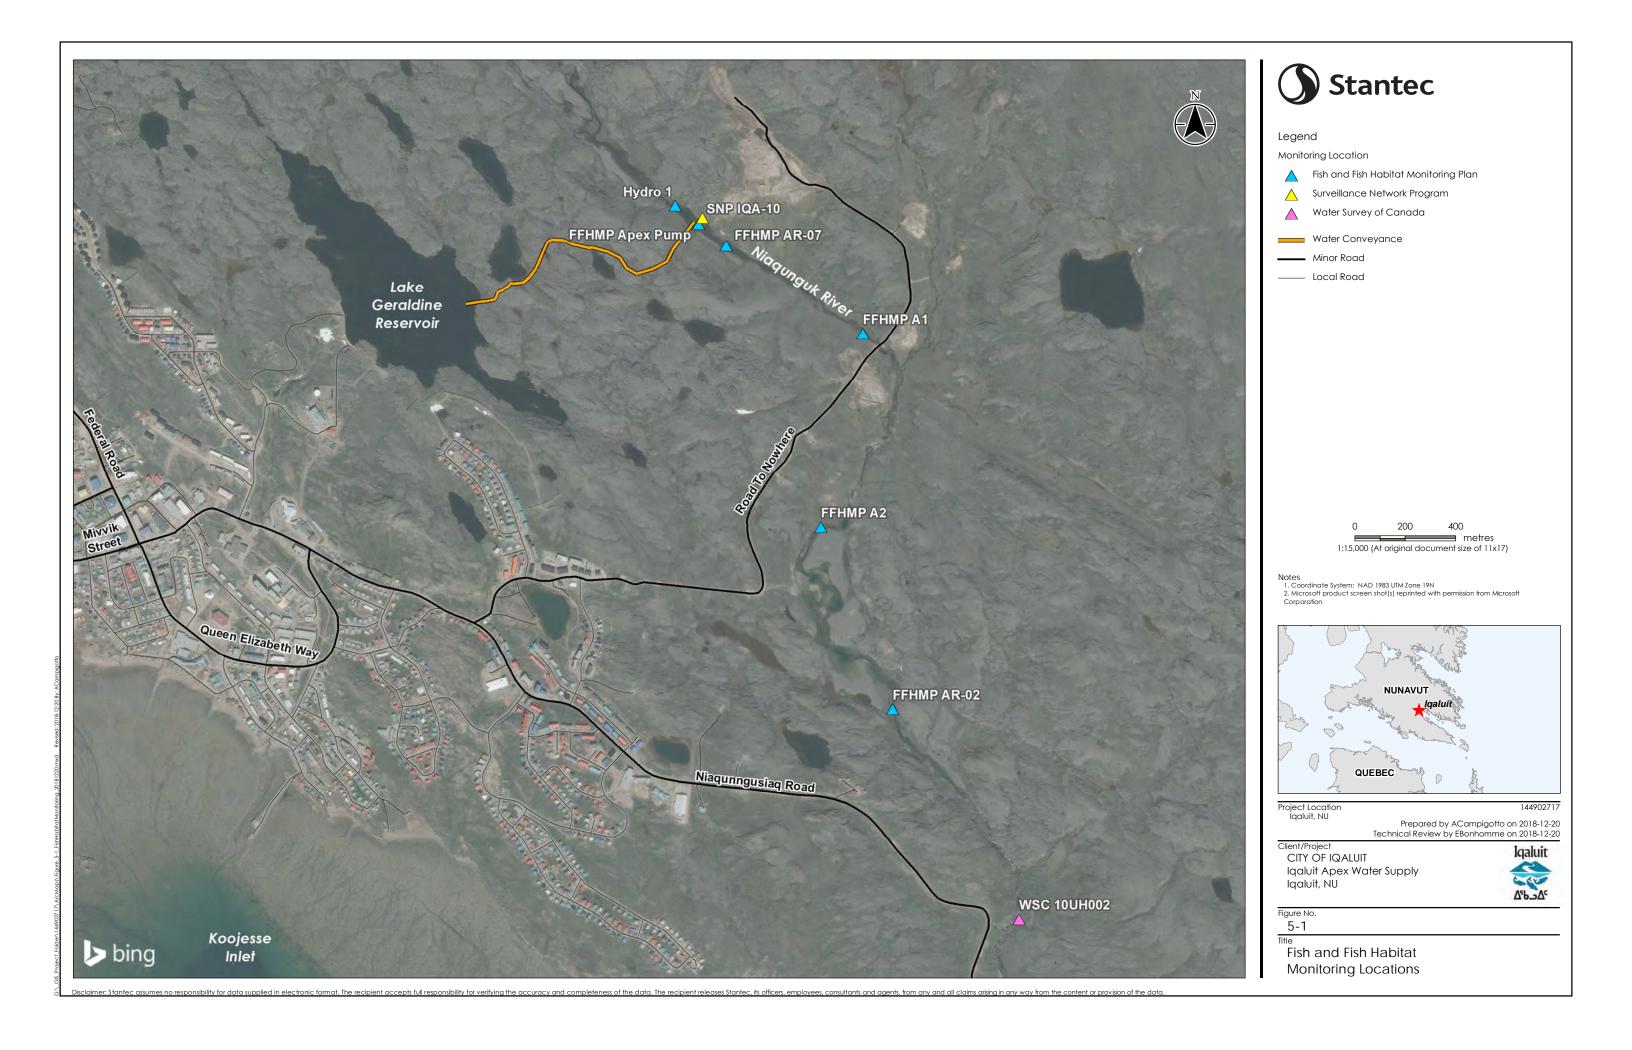
APEX – Fish and Fish Habitat Monitoring Plan				
ΔΡΡΕΝΠΙΥ ΕΕΗΜΡ.Δ.	MONITORING STATION LOCATIONS			
ALLENDIX LITIMIT -A.	WONTOKING STATION LOCATIONS

Station ID ¹	Station Description	UTM Coordinates		Monitoring	Monitoring	
		Easting	Northing	Parameters ^{3,4,5}	Frequency	Monitoring Rationale
AR-07	Immediately downstream (46 m) of pumping location	525850	7070428	Wetted width Water Level/Depth Habitat Conditions Fish Presence Fish Stranding Fish Mortality	Daily	Monitor fish habitat conditions and fish presence immediately downstream of pumping location
A1	Downstream of pumping location, upstream of Road to Nowhere Bridge	526497	7070003	Wetted width Water Level/Depth Habitat Conditions Fish Presence Fish Stranding Fish Mortality	Daily	Monitor fish habitat conditions and fish presence downstream of pumping location Continuity of monitoring location with 2016 fisheries program
A2	Downstream of pumping location, upstream of Swimming Lake	526299	7069247	Wetted width Water Level/Depth Habitat Conditions Fish Presence Fish Stranding Fish Mortality	Daily	Monitor fish habitat conditions and fish presence downstream of pumping location Continuity of monitoring location with 2016 fisheries program (fish previously captured here)

AR-02	Downstream of pumping location and downstream of Swimming Lake	526592	7068573	Wetted width Water Level/Depth Habitat Conditions Fish Presence Fish Stranding Fish Mortality	Daily	Monitor fish habitat conditions and fish presence downstream of pumping location and immediately downstream of Swimming Lake Continuity of monitoring location with 2016 fisheries program

Baseline channel and flow conditions at each of the above-noted stations were established in 2018. Measurements were completed as per the BC-MOE *Manual of British Columbia Hydrometric Standards* (2009), available here: https://www2.gov.bc.ca/assets/gov/environment/air-land-water/water/science-data/man_bc_hydrometric_stand_v10.pdf. Specifically, per monitoring station/transect, there was a minimum of 20 measurements and no one measurement would account for more than 10% of the discharge. The program used a Marsh-McBirney Flo-Mate 2000 electromagnetic flow meter.

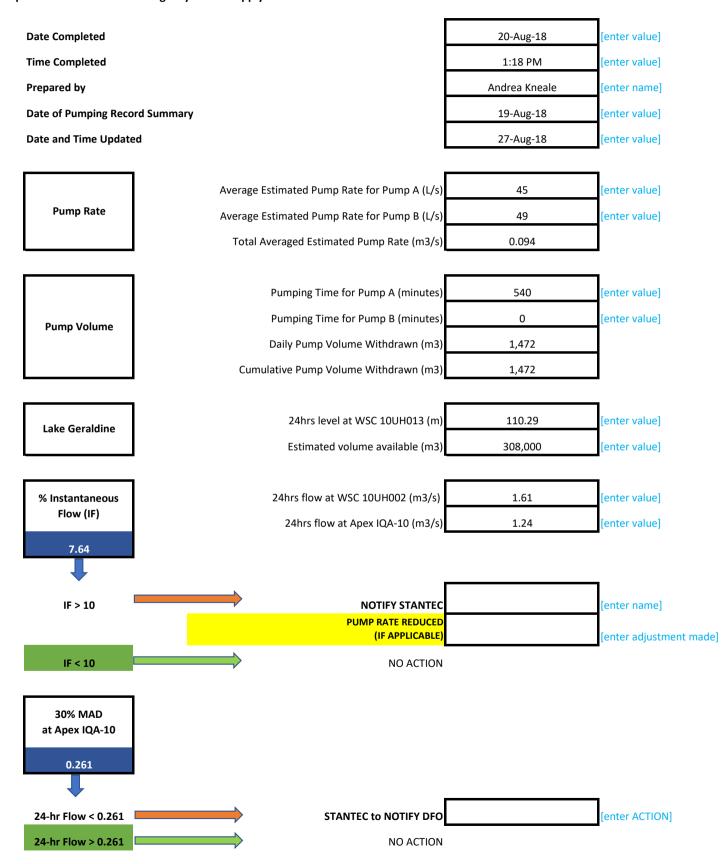
UPPER APEX IQA-10 - Daily Pumping Record City of Iqaluit - Lake Geraldine Emergency Water Supply

- **Cumulative Volume (m3) Withdrawn Before
- 19-Aug-18
- ,
- ** Daily Average Water Level measured from WSC 10UH013 (Lake Geraldine)
- ** Until spillway elevation (111.3 mASL) reached (using reservoir rating curve)
- ** Daily Average Flow measured from WSC 10UH002 (Apex River) station
- ** Daily Average Flow directly upstream of pumping location (not including effect from pumping rate), scaled from WSC 10UH002 (Apex River) station

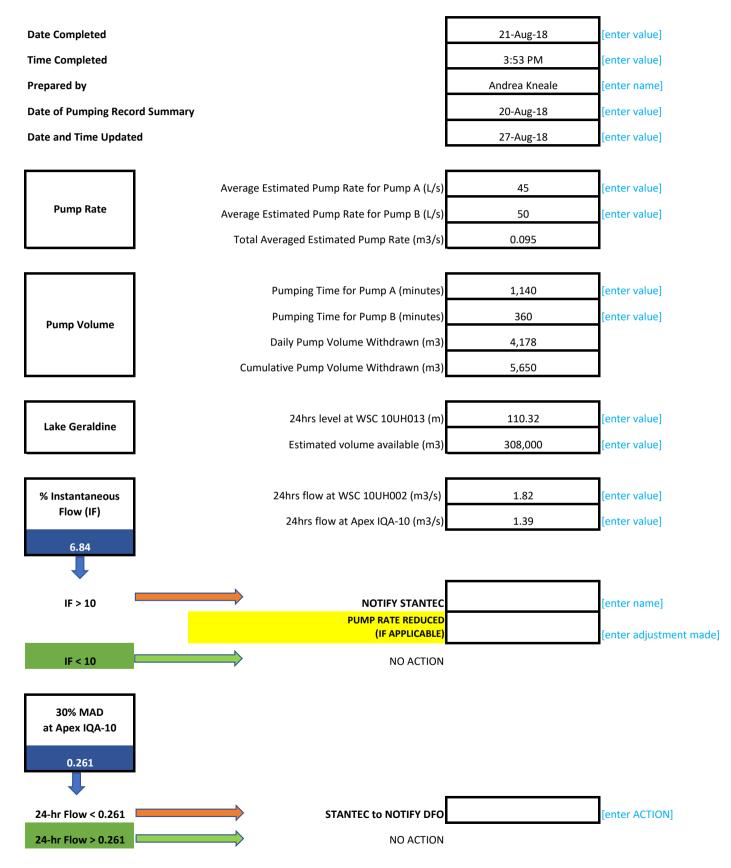
APEX RIVER - Daily Environmental Report City of Iqaluit - Lake Geraldine Emergency Water Supply

- **Cumulative Volume (m3) Withdrawn Before 20-Aug-18
- ** Daily Average Water Level measured from WSC 10UH013 (Lake Geraldine)

Date Completed	(UPDATE)		27-Aug-18										
Time Completed			3:53 PM										
Prepared by			Andrea Kneale										
Date of Pumping Record Summary			20-Aug-18										
% IF:	6.84	24-hr Flo	Ir Flow at IQA-10 (vs. 30% MAD): 1.39 Note: cell colours will change based on % IF and % MAD value										
Monitoring Compl		YES (with	drawal > 10% IF and/or Flow <	30% MA	AD)								
	✓	NO (with	drawal < 10% IF and > 30% MA	D)									
		NO, Other (provide reason):											
Meas./Obs.	Water Level (m)		Habitat Conditions (pool/riffle/run)		Fish Observations		Fish Salvage?		If Fish Salvage Completed, OR Dead Fish Obs., No. Fish Rescued & Species		Transfer Locn.		Photo Nos.
AR-05 RS	water Lever (III)	7	(росі) тіпе) типу		FISH Observations		rish Salvager	Γ	Obs., No. 11311 Nescueu & Species	Ī	Transfer Locil.	ſ	Filoto Nos.
u/s pump MID		1											
LS		1											
L3] 7] }				L -				L T	
PUMP RS		4											
at pump MID		4
