Granular Material Requirements and Local Sources Report

**Long Term Water Program – Supply and Storage
Iqaluit, Nunavut**

30192375 Iqaluit LTWP – Aggregate Assessment Report

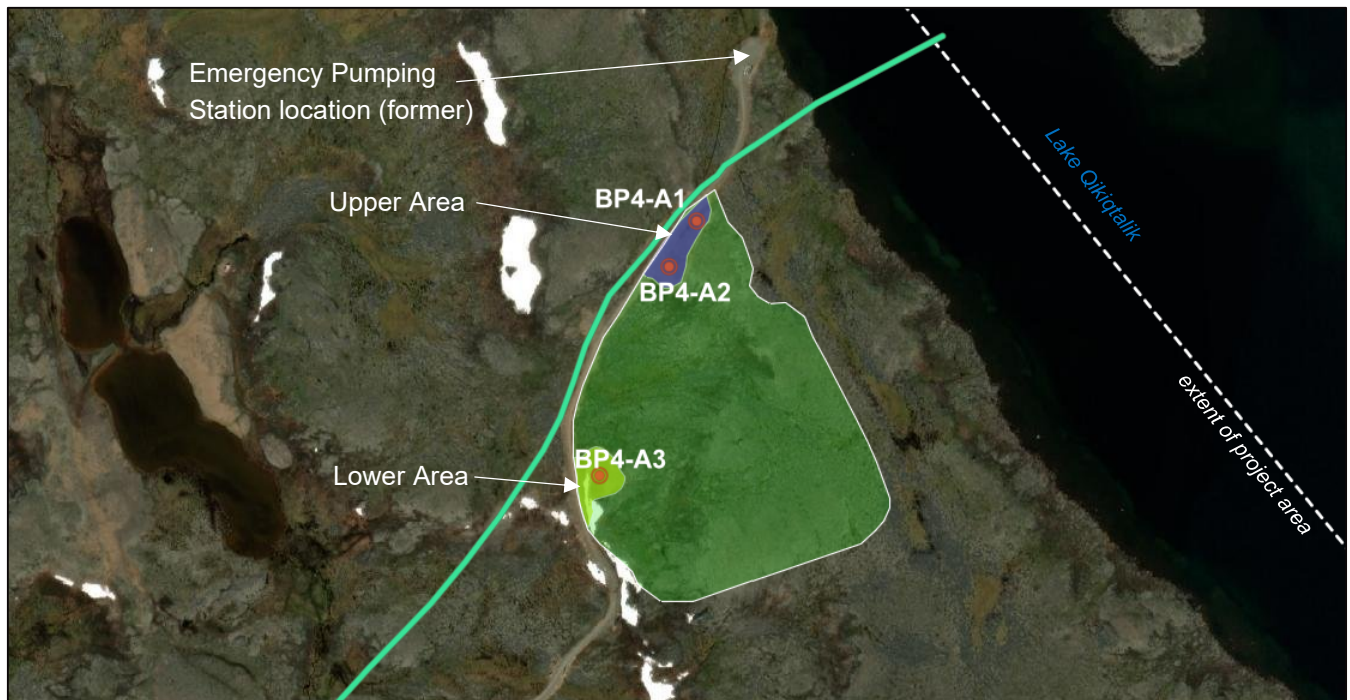
Figure 3-4: BP4 Qikiqtaalik Moraine

The total area of the feature is calculated at approximately 63,100m². At an average depth of 2m, an estimated volume of 126,200m³ would be present at this source. This is considered a conservative estimate, given that the feature is at least 20m high from the crest of the ridge to the base of the lower area.

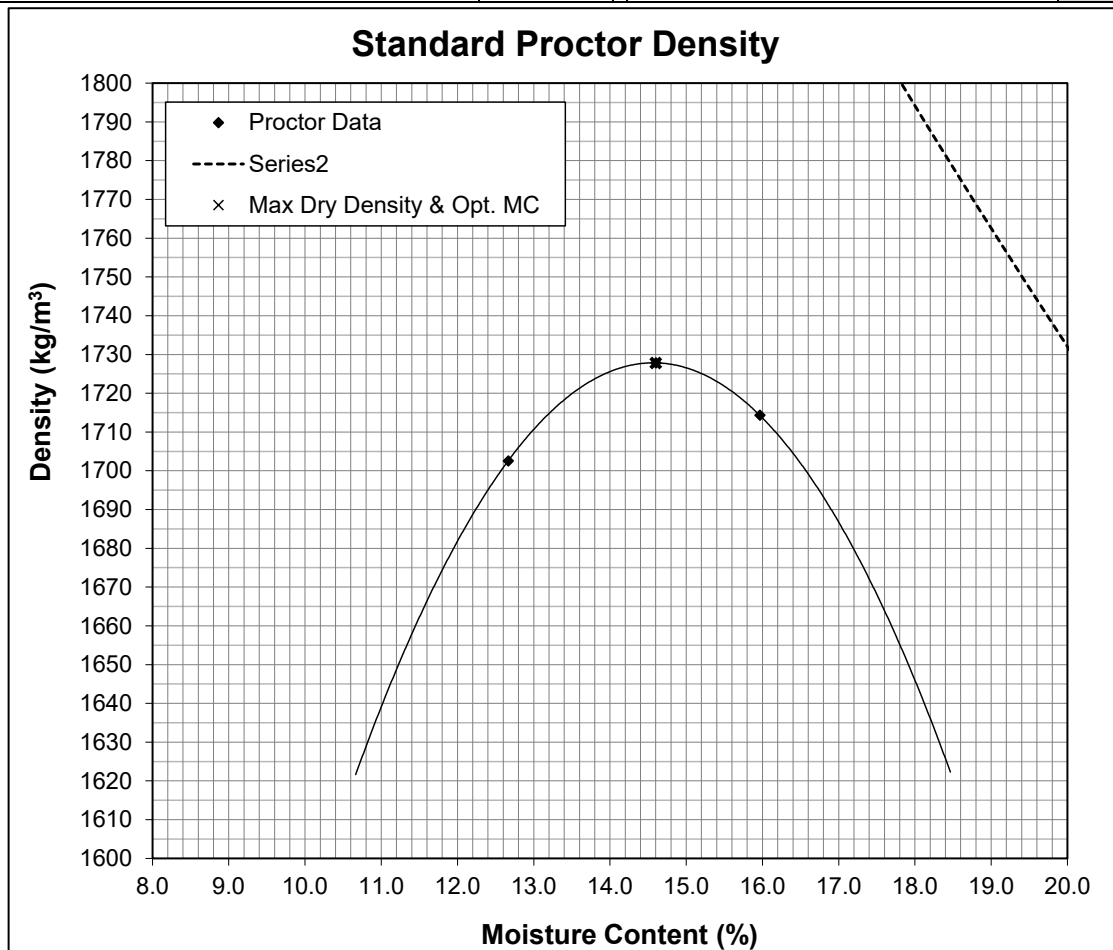
Test Results			
Corrected Maximum Dry Density (kg/m ³):	N/A	Maximum Wet Density (kg/m ³):	1980
Corrected Maximum Dry Density (g/cm ³):	N/A	Maximum Wet Density (g/cm ³):	1.980
Corrected Maximum Dry Unit Weight (kN/m ³):	N/A	Maximum Dry Density (kg/m ³):	1728
Corrected Optimum Moisture Content (%):	N/A	Optimum Moisture Content (%):	14.60

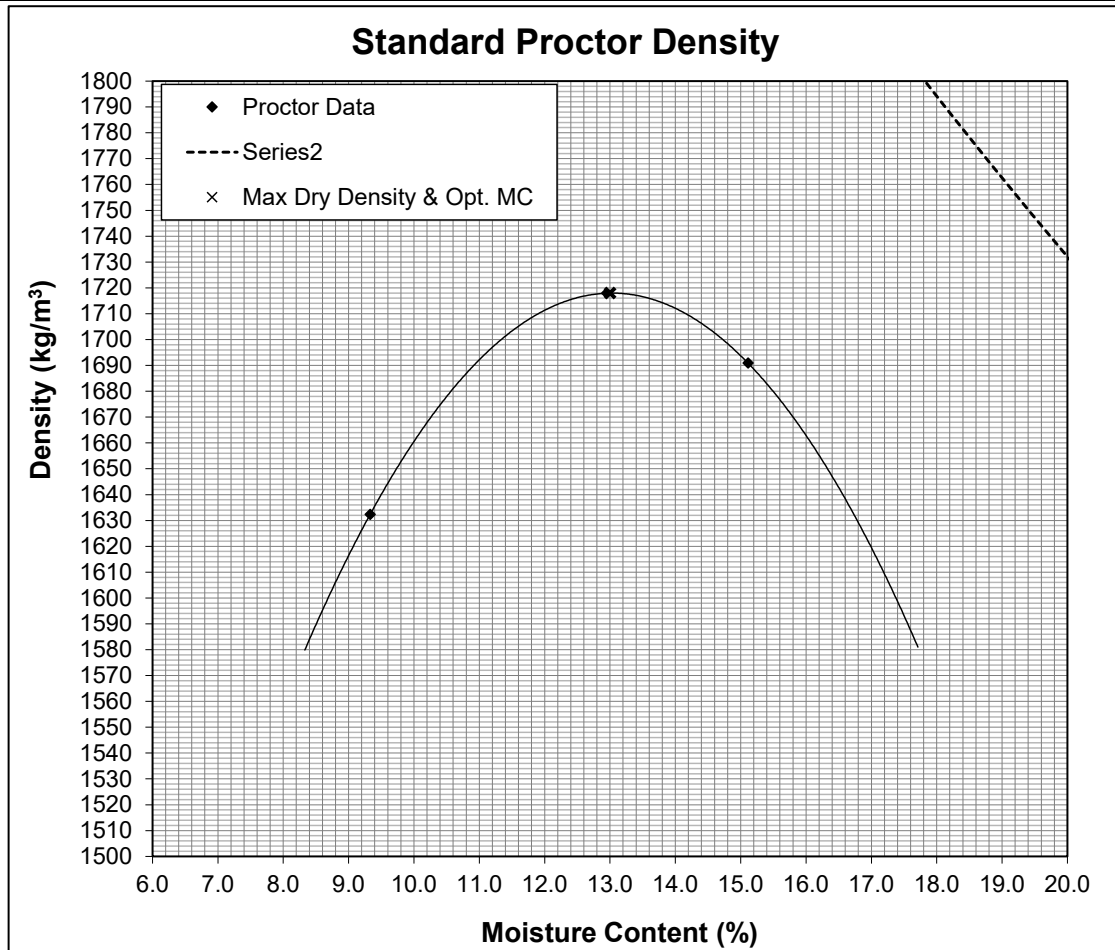
Test Results			
Corrected Maximum Dry Density (kg/m ³):	N/A	Maximum Wet Density (kg/m ³):	1941
Corrected Maximum Dry Density (g/cm ³):	N/A	Maximum Wet Density (g/cm ³):	1.941
Corrected Maximum Dry Unit Weight (kN/m ³):	N/A	Maximum Dry Density (kg/m ³):	1718
Corrected Optimum Moisture Content (%):	N/A	Optimum Moisture Content (%):	13.00
