**Project Summary Report:**  
**Iqaluit 2022 Lake Geraldine**  
**Resupply (Apex River**  
**Supplementary Pumping Program):**  
**Report of Activities 3AM-IQA1626**  
**and 22-HCAA-02043**

March 15, 2023

*Prepared for:*  
**City of Iqaluit**  
Iqaluit, Nunavut

*Prepared by:*  
**Nunami Stantec Limited**

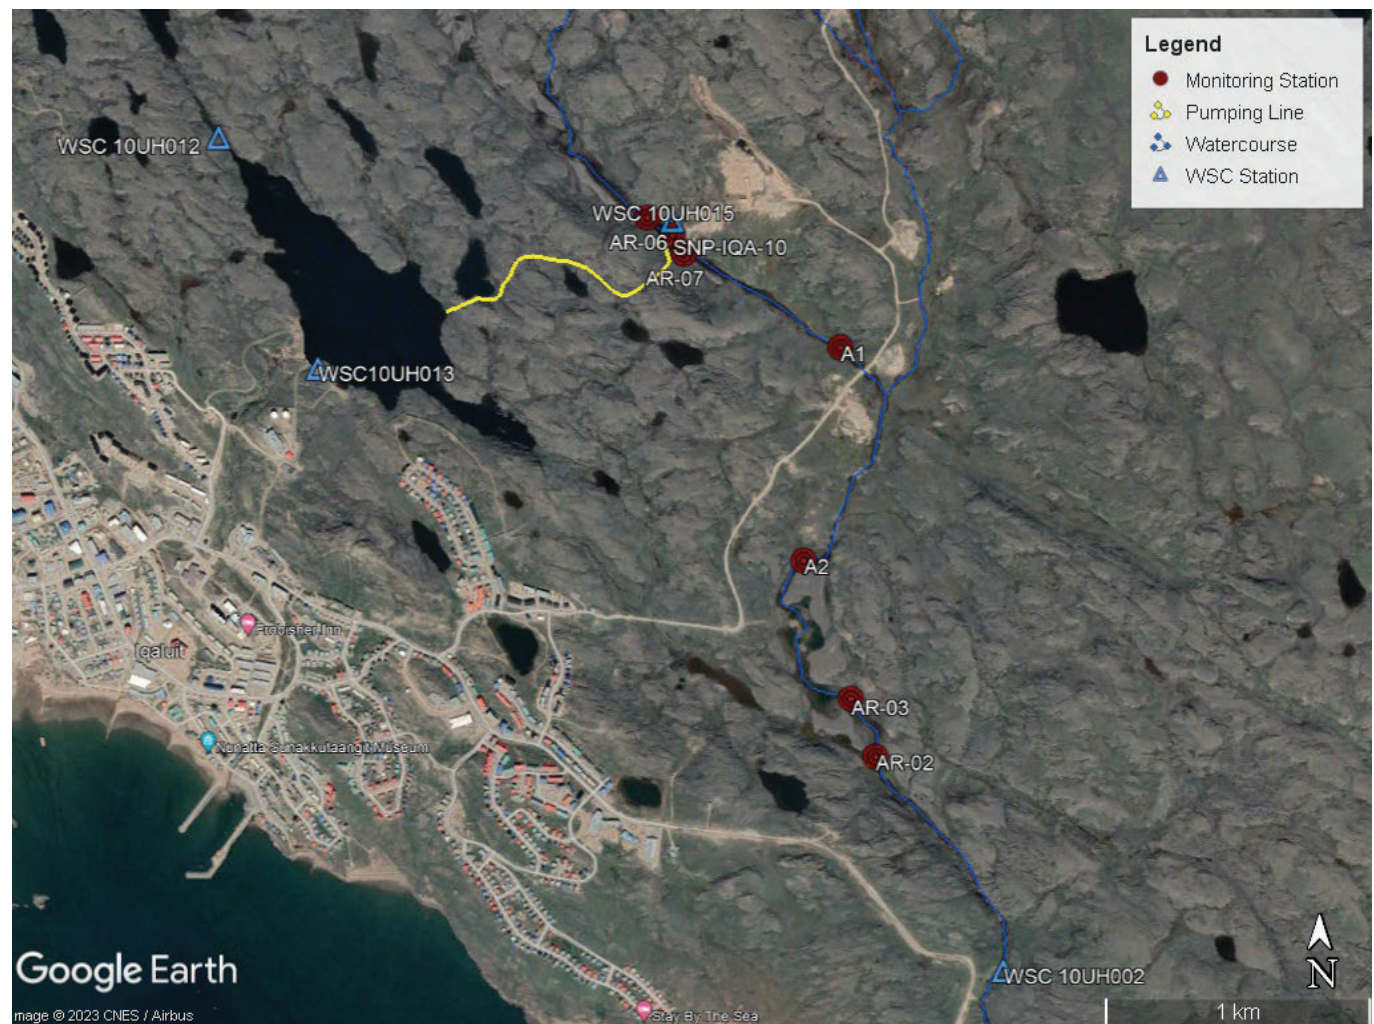
**Figure 3.1 Monitoring Locations for Pumping Period 1 and Pumping Period 2**

| Station ID | Station Description | UTM Coordinates (Zone 19V) | | Monitoring Parameters | Monitoring Rationale |
|---|---|---|---|---|---|
| AR-06 | Immediately upstream (125 m) of pump location | 525712 | 7070535 | Wetted width<br>Water level/depth<br>Habitat conditions<br>Fish presence | Monitor natural inflow conditions, immediately upstream of pumping location |
| SNP IQA-10 (Apex Pump Location) | At pumping location | 525820 | 7070467 | Wetted width<br>Water level/depth<br>Habitat conditions<br>Fish presence<br>Fish stranding<br>Fish mortality | Monitor fish habitat conditions and fish presence at pumping location |
| AR-07 | Immediately downstream (46 m) of pumping location | 525850 | 7070428 | Wetted width<br>Water level/depth<br>Habitat conditions<br>Fish presence<br>Fish stranding<br>Fish mortality | Monitor fish habitat conditions and fish presence immediately downstream of pumping location |
| A1 | Downstream of pumping location, upstream of Road to Nowhere Bridge | 526497 | 7070003 | Wetted width<br>Water level/depth<br>Habitat conditions<br>Fish presence<br>Fish stranding<br>Fish mortality | Monitor fish habitat conditions and fish presence downstream of pumping location<br>Continuity of monitoring location with 2016 fisheries program |
| A2 | Downstream of pumping location, upstream of Swimming Lake | 526299 | 7069247 | Wetted width<br>Water level/depth<br>Habitat conditions<br>Fish presence<br>Fish stranding<br>Fish mortality | Monitor fish habitat conditions and fish presence downstream of pumping location<br>Continuity of monitoring location with 2016 fisheries program (fish previously captured here) |
| AR-03 | Downstream of pumping location, at the downstream end of a pool within the Swimming Lake area | 526495 | 7068724 | Wetted width<br>Water level/depth<br>Habitat conditions<br>Fish presence<br>Fish stranding<br>Fish mortality | Observe fish habitat conditions and fish presence downstream of pumping location and within the Swimming Lake area |

| Station ID | Station Description | UTM Coordinates (Zone 19V) | | Monitoring Parameters | Monitoring Rationale |
|---|---|---|---|---|---|
| AR-02 | Downstream of pumping location and downstream of Swimming Lake | 526592 | 7068573 | Wetted width<br>Water level/depth<br>Habitat conditions<br>Fish presence<br>Fish stranding<br>Fish mortality | Monitor fish habitat conditions and fish presence downstream of pumping location and immediately downstream of Swimming Lake<br><br>Continuity of monitoring location with 2016 fisheries program |

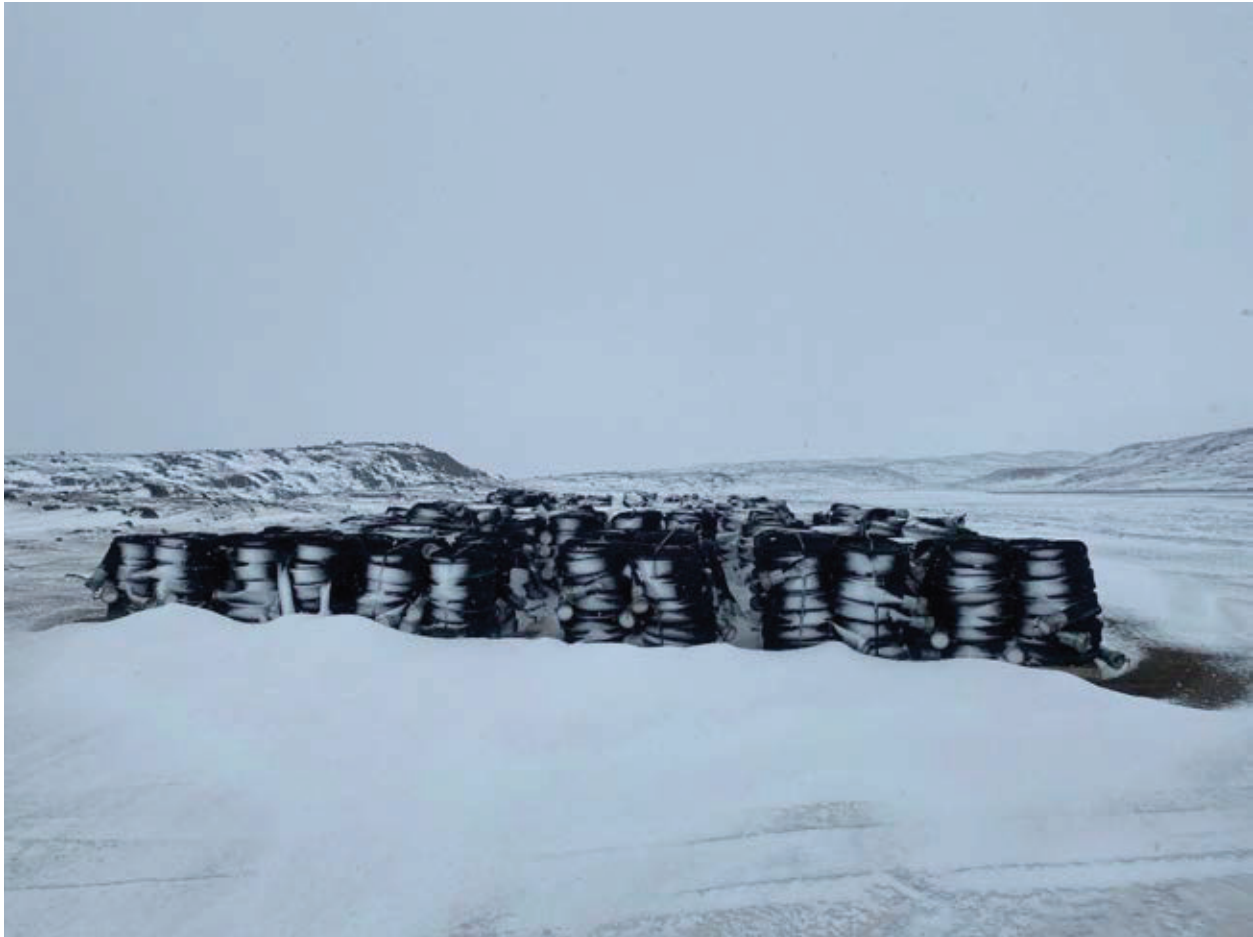
Fire rolled pads used to protect tiller area until it is

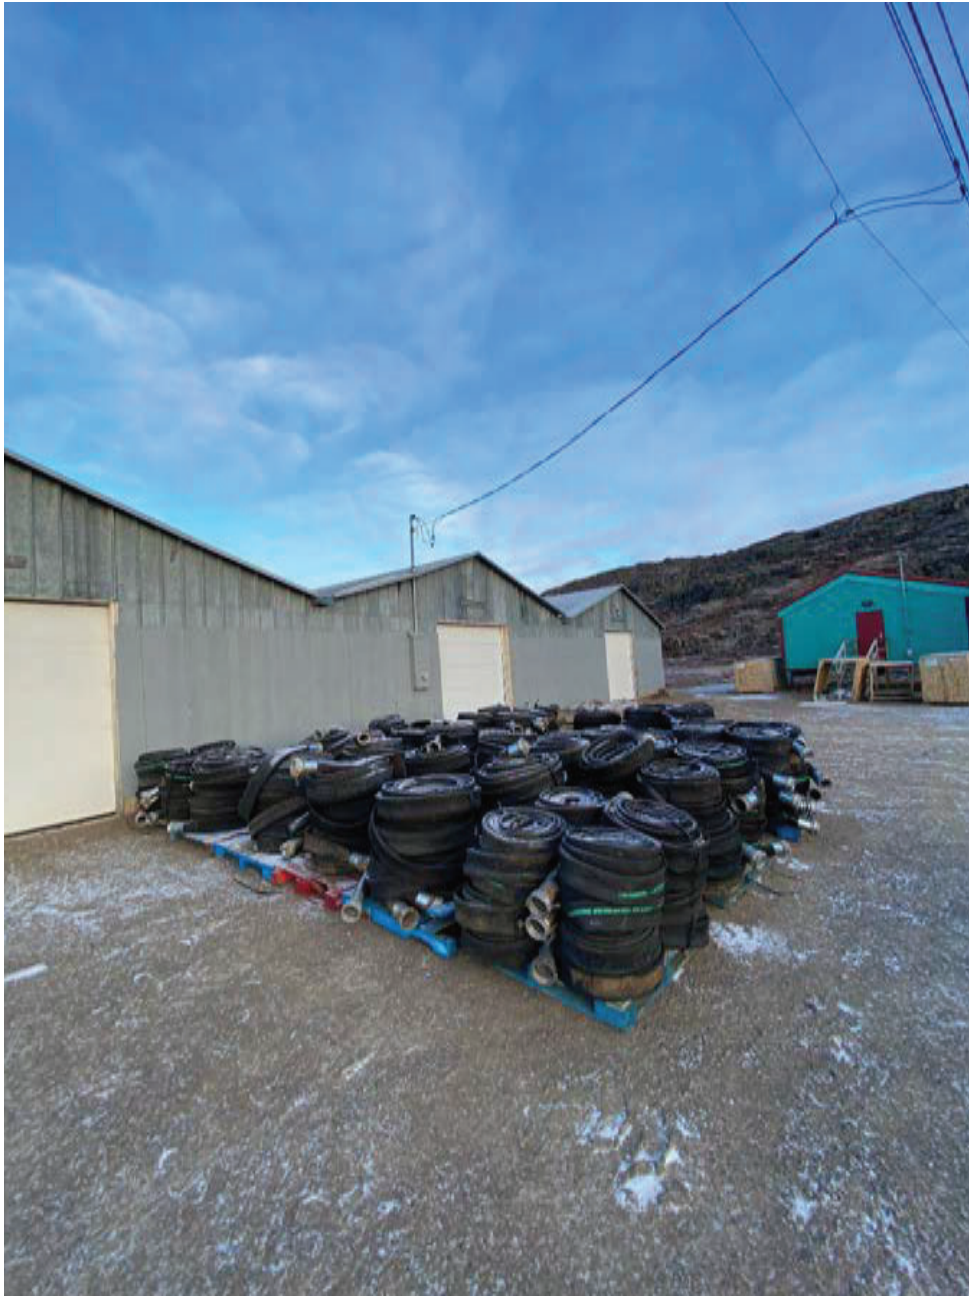
Fire hose placed at the site are on site

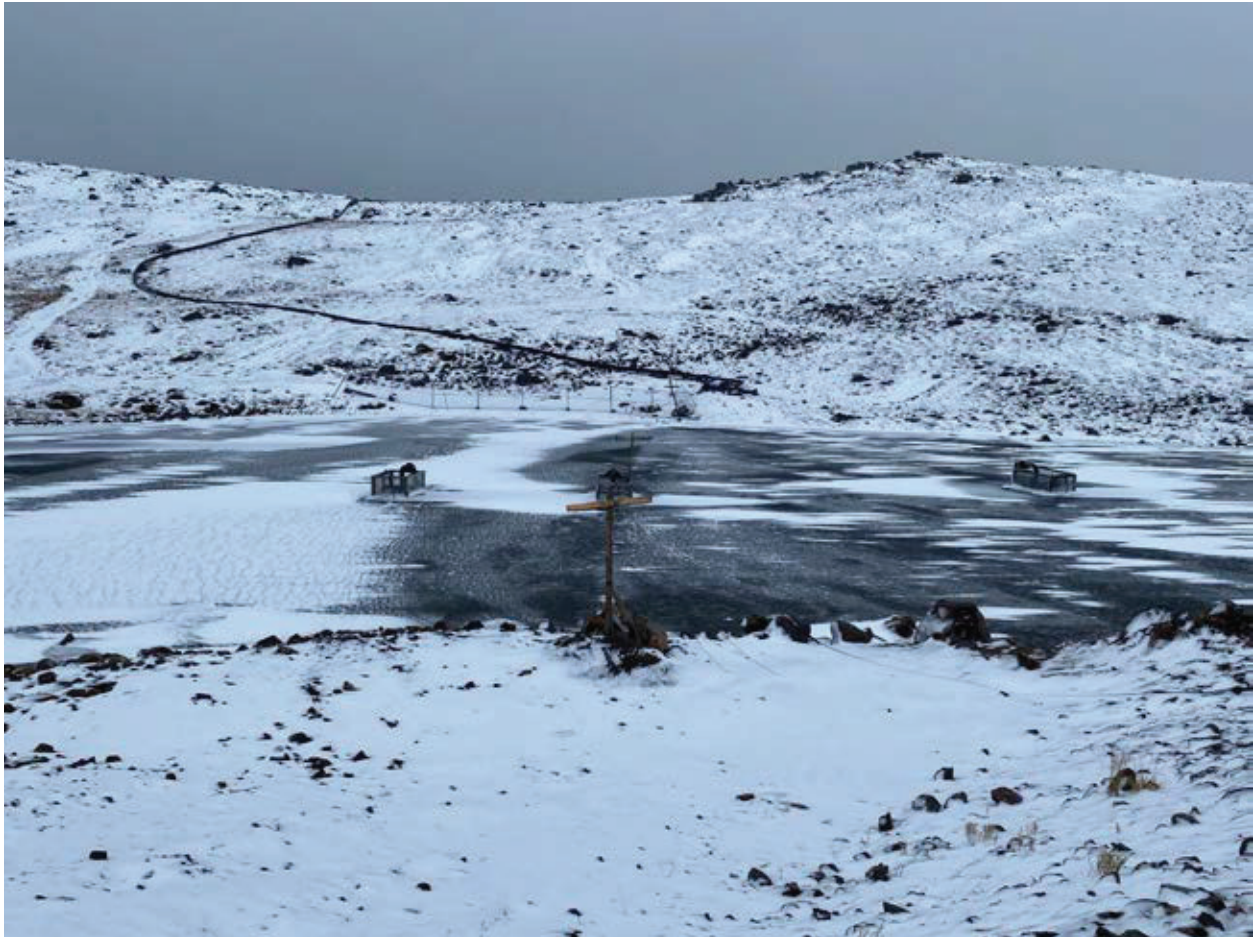
Fire perimeter to pit line area

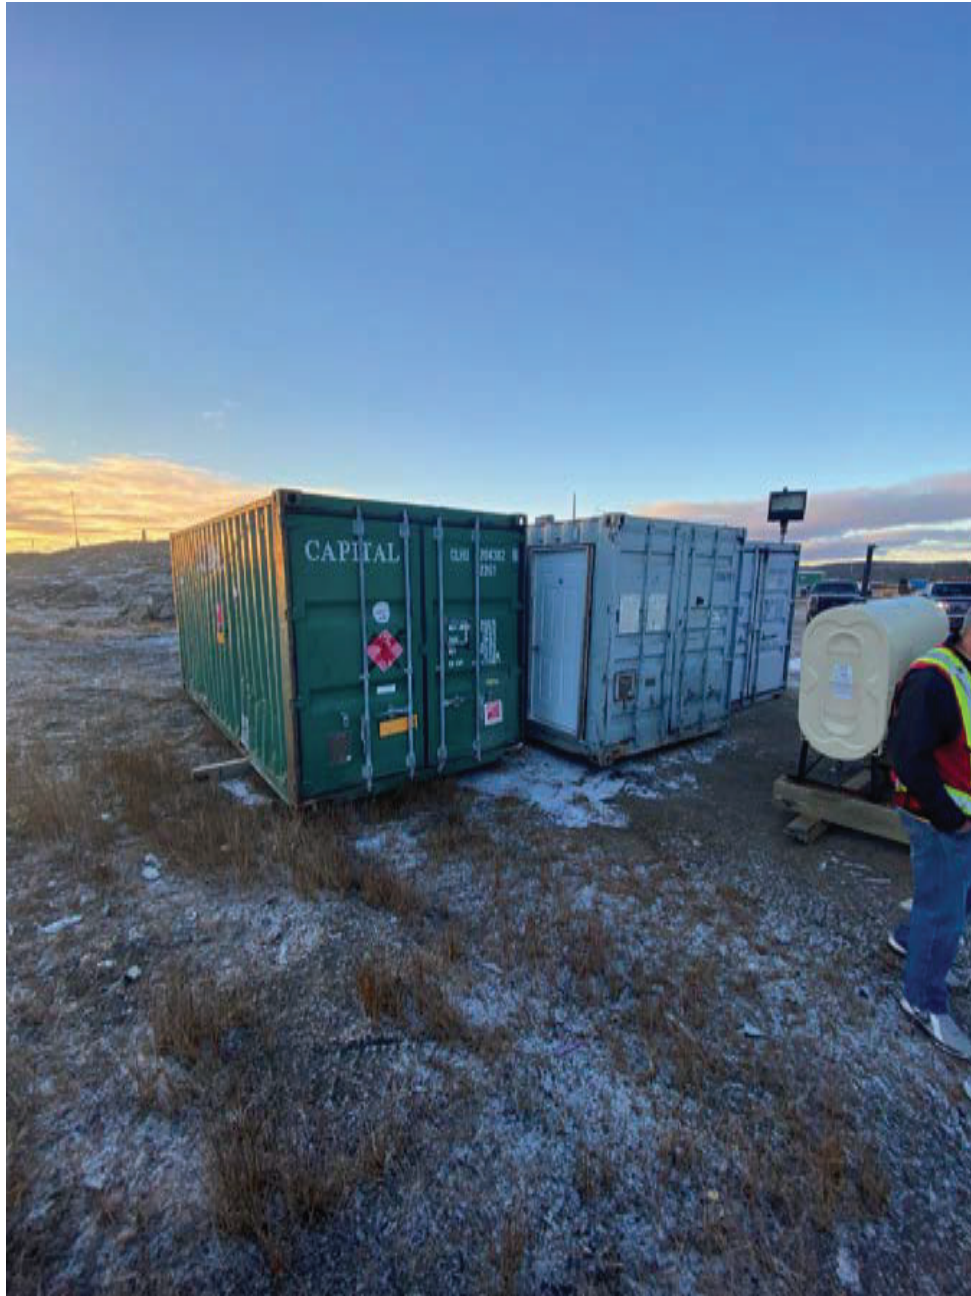
Fire perimeter area identified on site

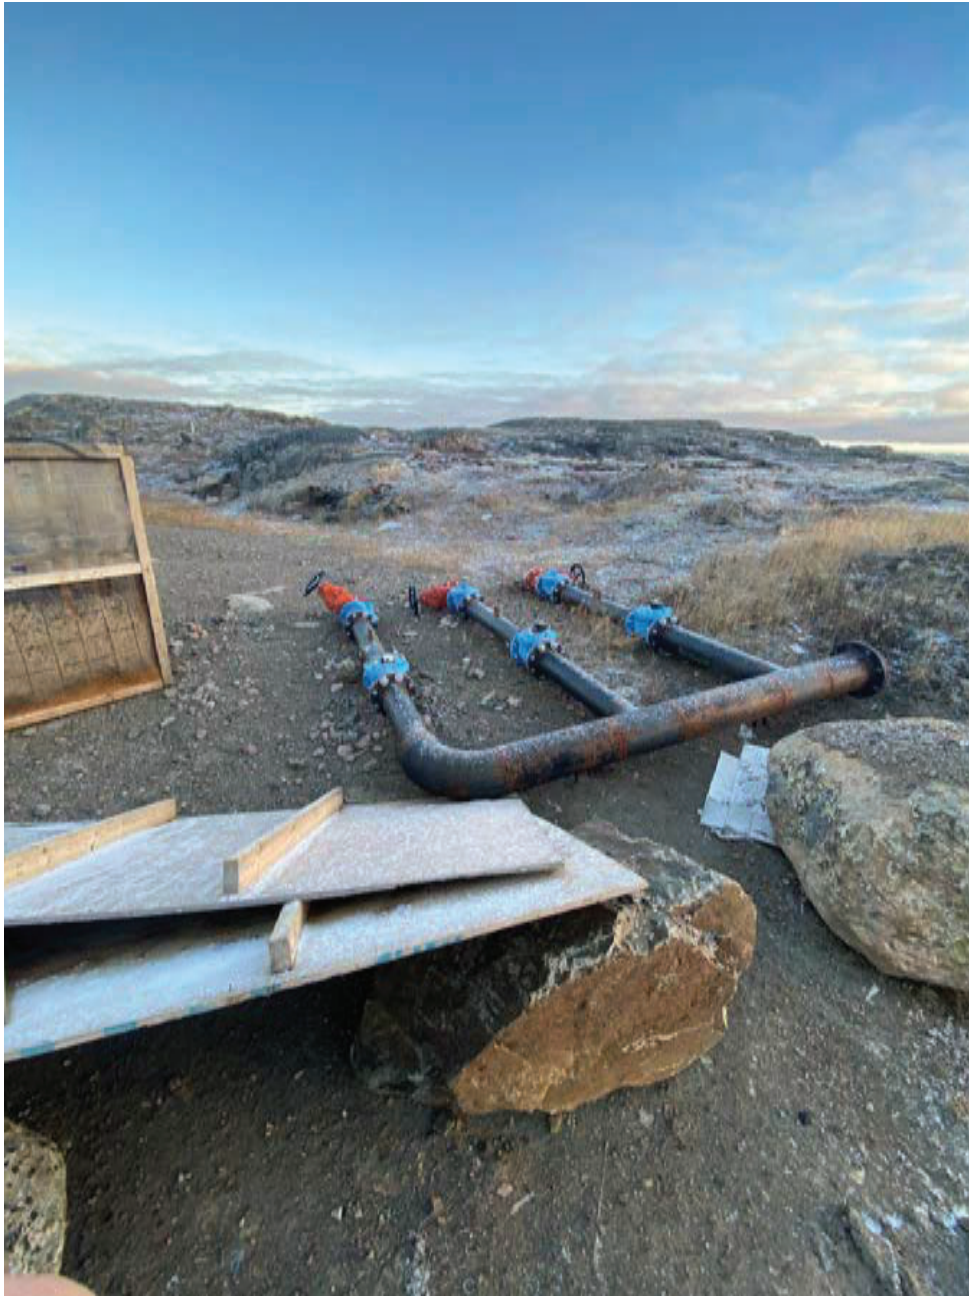
Fire perimeter pipe installation site

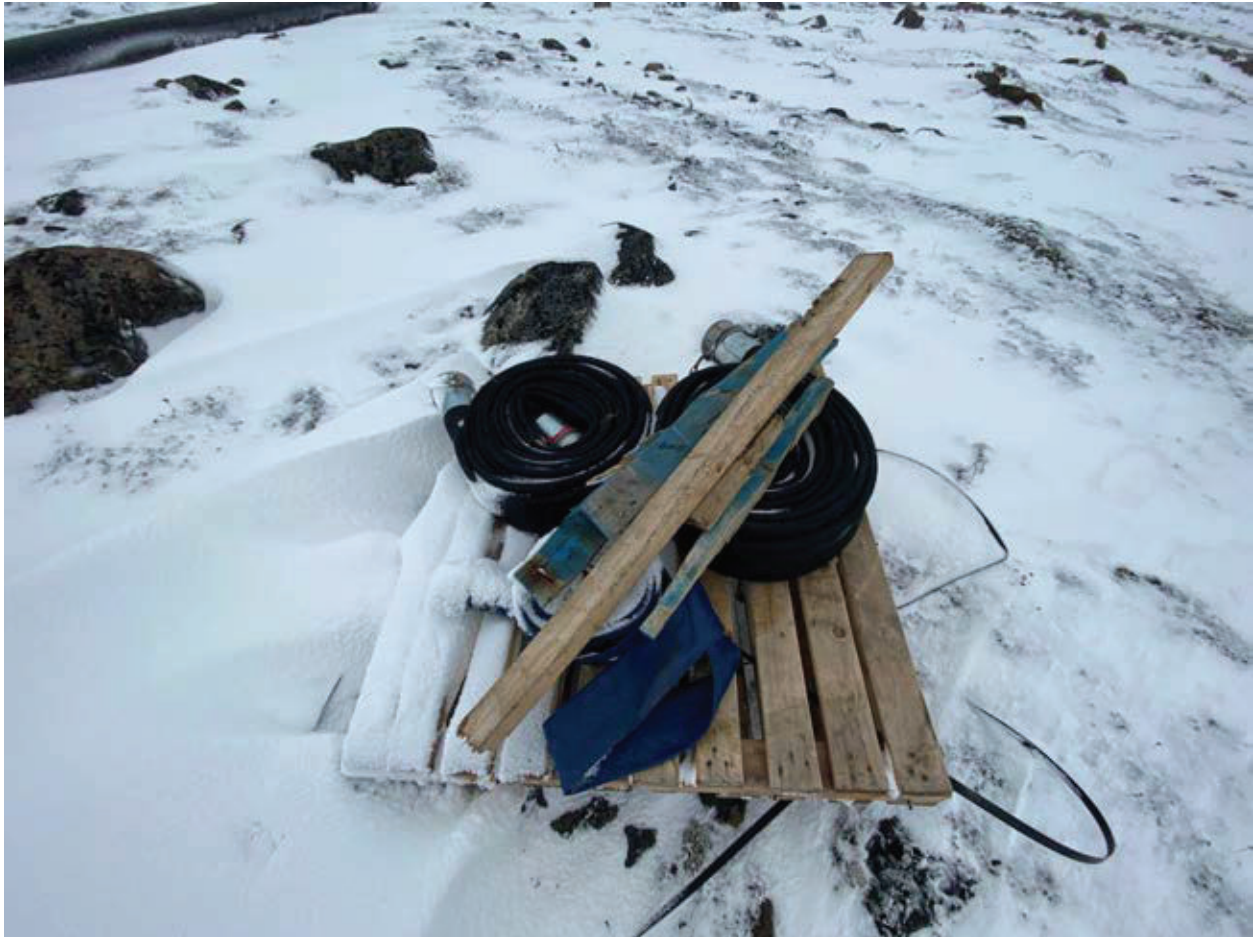
Figure 1: A pile of material (rope, tarp, planks) on a wooden pallet in a snowy, rocky landscape.
