# INSPECTION FORM

Licensee	Licensee Representative		
City of Iqaluit	NA .		
Licence No. / Expiry	Representative's Title		
3AM-IQA1626			
Land / Other Authorizations	Land / Other Authorizations		
Date of Inspection	Inspector		
June 18, 2019	Jonathan MESHER		
Activities Inspected			
☐ Camp ☐ Drilling ☐ Mining ☐ Roads/Hauling ☐ Other:	☐ Construction ☐ Reclamation ☐ Fuel Storage ☐ Other: Municipality

On June 18, 2019 an inspection was conducted of Carney Creek that flows through the City of Iqaluit's Municipal boundaries, by Water Resource Officer MESHER J.

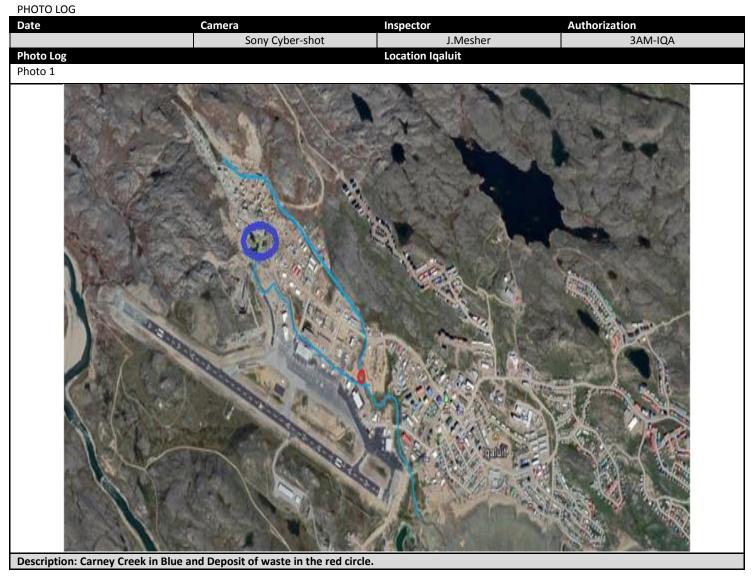
- 1. While inspecting Carney Creek to identify any deposits of waste or usages of water throughout this water body the following concerns were noted.
  - I. The following potentially hazardous and non-hazardous material within the creek; barrels, a housing oil tank, a snowmobile, significant plastics, wood and debris. See Photos 2-5 for the waste in Carney Creek.

# **Description: Waste in Carney Creek**

- a. The City is to remove all the waste from Carney Creek prior to the freeze up of this creek and provide a report with photos to the inspector once this is complete.
- b. The City of Iqaluit has been using water at location N63.764186 W68.549102. This activity is prohibited, as listed in Section 11 of the *Nunavut Waters and Nunavut Surface Rights Tribunal Act*

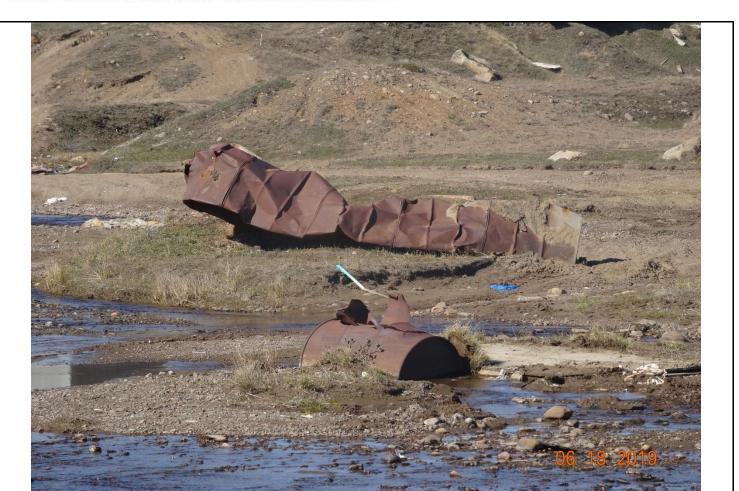
Date	Camera	Inspector	Authorization
	Sony Cyber-shot	J.Mesher	3AM-IQA
Photo Log		Location Iqaluit	
Photo 4

**Description: Waste in Carney Creek**

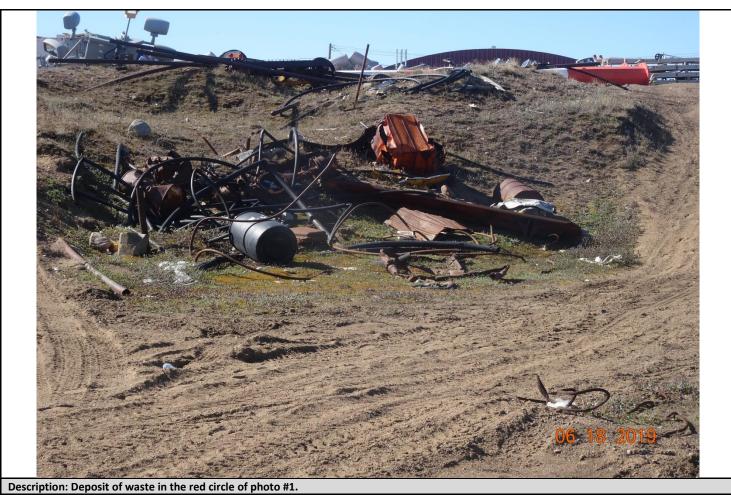
Photo Log Photo 5	Sony Cyber-shot	J.Mesher Location Iqaluit	3AM-IQA
		Location igaluit	
		·	
			06 18 2019
Description: Waste in Carney Cree			
Date	Camera Sany Cyber shot	Inspector	Authorization
Photo Log	Sony Cyber-shot	J.Mesher Location Iqaluit	3AM-IQA
Photo 6		Eocation Iqaidit

- II. It was also noted that there appears to be an unauthorized deposit of waste within 31 meters of this waterway, this deposit is identified with a red circle in Photo 1 and a closer picture is provided in photo 6.
