Reference: Iqaluit Wastewater Treatment System

Existing Sewage Lagoon Performance Review

SLUDGE SURVEY REPORT

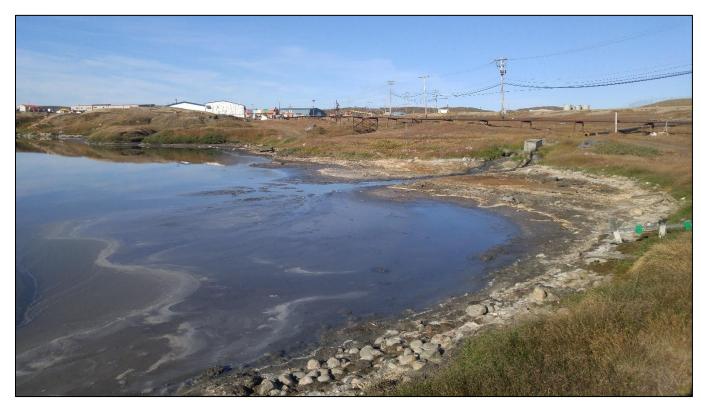
Figure 12 The north east corner of the Iqaluit Lagoon at the influent location was full of sludge. A portion of this area was not accessible by boat due to the extremely shallow beach that has formed. This influent area was in constant operation during the survey.

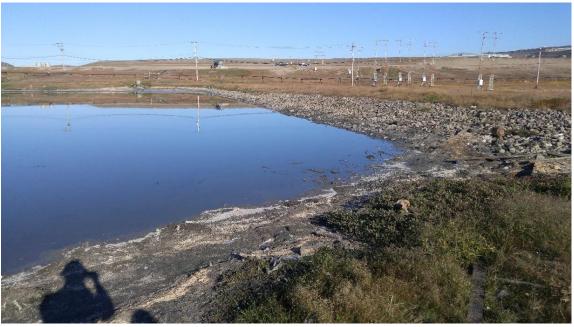
Figure 11 Exposed riprap and shoreline along the east dyke of the lagoon

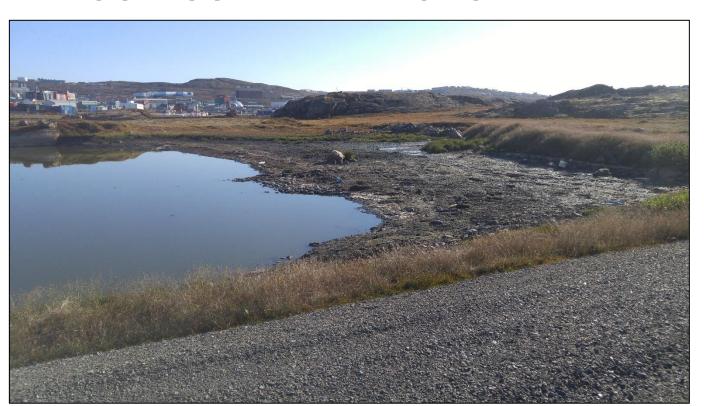
Figure 10 The low waterline exposed a large beach at the south west corner of the Iqaluit lagoon
