**July 16, 2001 Water Licence Inspection - Report**

## MUNICIPAL WATER USE INSPECTION FORM

Date: 2001/07/16 Licensee Rep. (Name/Title): Mosese Nowdlak / acting-Foreman  
Licensee: Hamlet of Pangnirtung Licence No.: N5L4-1447 (expired)

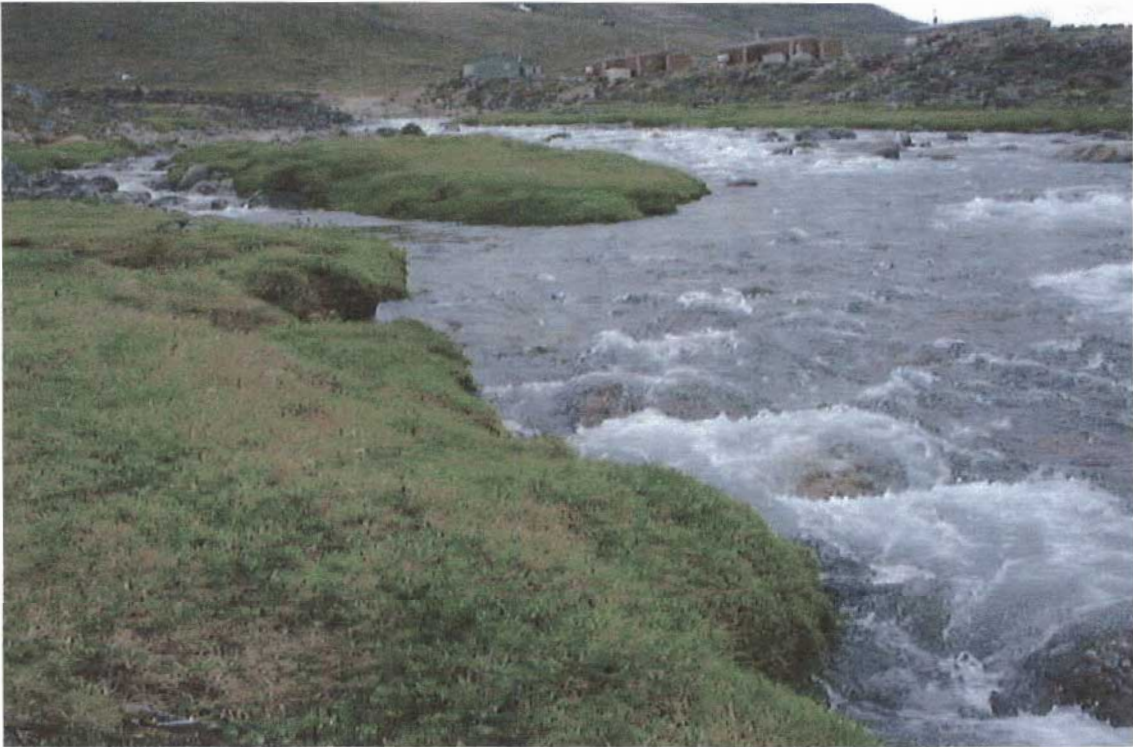
- **Water supply:** During the previous inspection, concern was raised over the proximity of new housing developments to the intake facility at the Duval River (figure 1), and its potential negative impact on the quality of the Hamlet's water supply. This being said, the attached analytical results relating to a sample collected at the intake facility indicate that the raw water meets the *Guidelines for Canadian Drinking Water Quality*, save for a slight exception: a field pH value of 8.9, which rests slightly above the 8.5 aesthetic objective.

**figure 1.** Duval River at water intake facility; 2001/07/16.

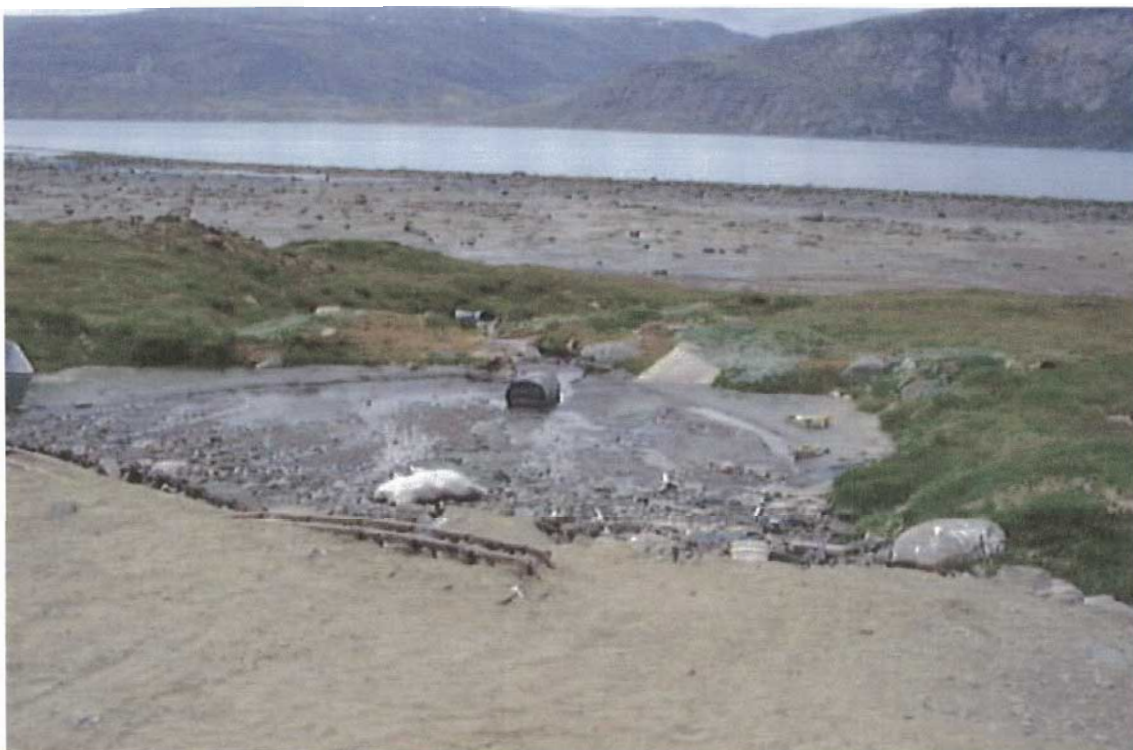
- **Sewage disposal:** The state of the sewage disposal facility represents an outstanding concern which needs to readily be addressed. Indeed, the facility is essentially nothing but a discharge point (figure 2), providing little in terms of retention time and treatment prior to the release of sewage effluent to receiving waters (figure 3). As such, the attached analytical results relating to a sample taken about 10 metres from the point of discharge reveal that the levels of faecal coliform (1.4 million CFU/100ml vs 1.0 million CFU/100ml), of the biological oxygen demand (387 mg/L vs 100mg/L), and of total suspended solids (254 mg/L vs 120 mg/L) breach the effluent quality standards set under the now expired Water licence N5L4-1447. In addition, concentrations of ammonia (161 mg/L vs 2.2 mg/L) and phenols (410 µg/L vs 4.0µg/L) substantially exceed the *Canadian Water Quality Guidelines for the Protection of Freshwater Aquatic Life*.

Moreover, the Microtox sample, which constitutes a reliable toxicity indicator ( $IC_{50}$ ), shows that half of light-producing bacteria were inhibited by a sample concentration of 2.8%, whereas 50% and over is considered non-toxic. Consequently, by copy of this letter to Community Government and Transportation (CG&T), the Inspector, once again, underlines the dire need of an effective and viable sewage treatment/disposal facility for the Hamlet.

**figure 2.** Sewage disposal facility; 2001/07/16.

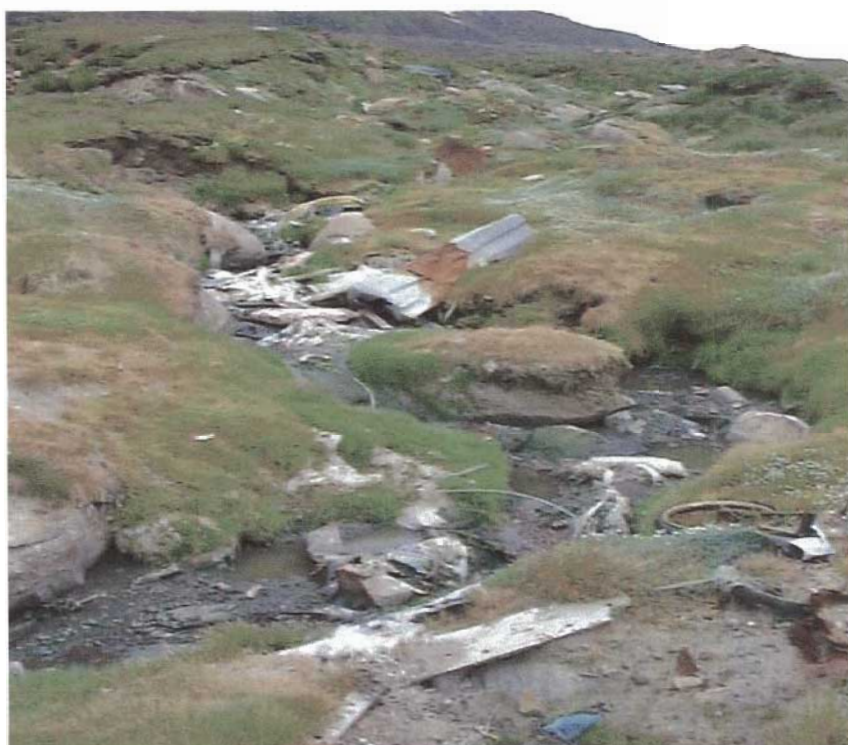
Comments: Considerable erosion and slumping in the vicinity of the sewage discharge area. Sewage disposal facility is practically dry; barely any retention time and/or effluent treatment provided. Perimeter fence of the solid wastes disposal facility is now almost totally dismantled; significant quantity of windblown garbage noted. Wastepile is relatively sprawled, and in need of compaction/coverage. No particular storage/disposal area for hazardous materials, but batteries are neutralized at the hamlet garage prior to disposal. Obvious signs of hydrocarbon contamination at the waste oil storage site. Overdue Operation and Maintenance (O&M) plan.

**figure 3.** Path of discharge from the sewage disposal facility; 2001/07/16.

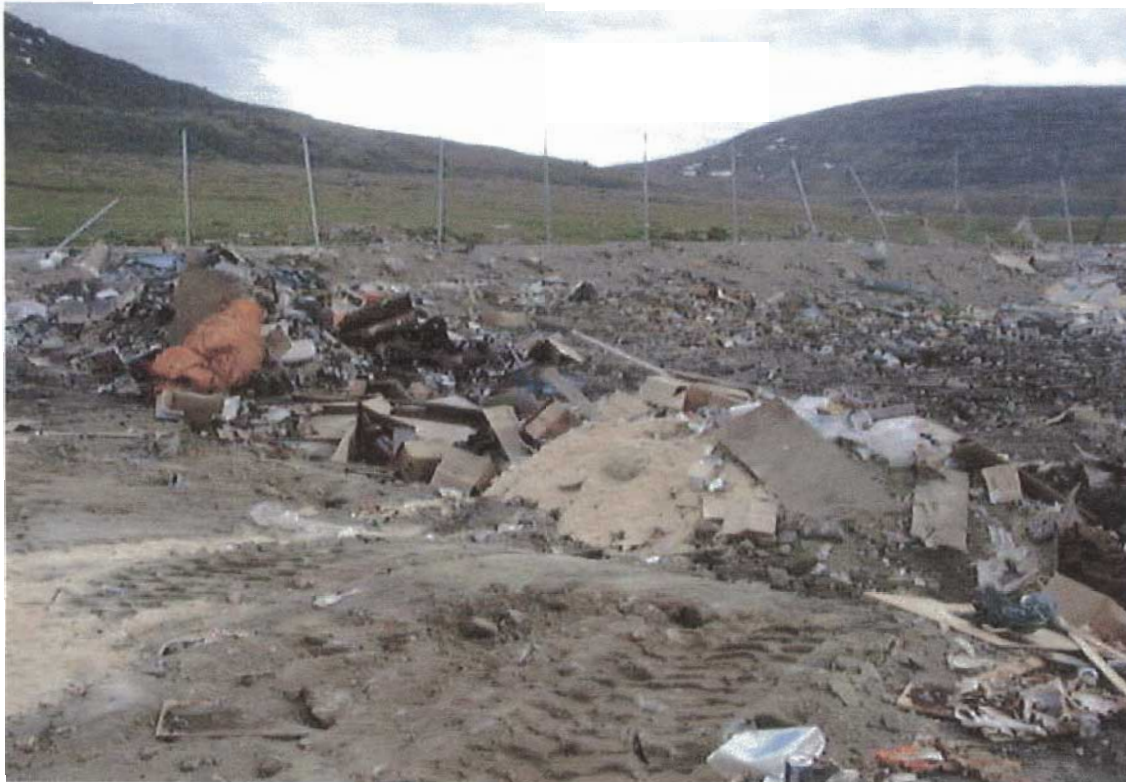
- **Solid wastes disposal:** Due to the almost totally dismantled perimeter fence, a considerable amount of windblown garbage, which may enter waters, was noted beyond the solid wastes disposal facility. However, it was mentioned during the inspection that fence replacement material was awaited on the summer's sealift. Although waste appears well segregated, the household wastepile spans a vast area (figure 4), and therefore would require some extent of compaction and fill material coverage. Furthermore, the attached analytical results relating to a sample taken from the discharge culvert (figure 5) reveal that levels of ammonia (170 mg/L), phenol (820 mg/L), arsenic ( $5.4 \mu\text{g/L}$  vs  $5.0 \mu\text{g/L}$ ), cadmium ( $1.3 \mu\text{g/L}$  vs  $0.017 \mu\text{g/L}$ ), copper ( $150 \mu\text{g/L}$  vs  $4.0 \mu\text{g/L}$ ), iron (142 mg/L vs 0.3 mg/L), and zinc ( $3.26 \text{ mg/L}$  vs 0.03 mg/L) exceed the *Canadian Water Quality Guidelines for the Protection of Freshwater Aquatic Life*. Likewise, the Microtox sample indicates high toxicity, with a  $IC_{50}$  of 17.1% versus the 50% non-toxic threshold. Accordingly, efforts should be taken to contain the leachate, or limit its extent.

**figure 4.** Solid wastes disposal facility; 2001/07/16.

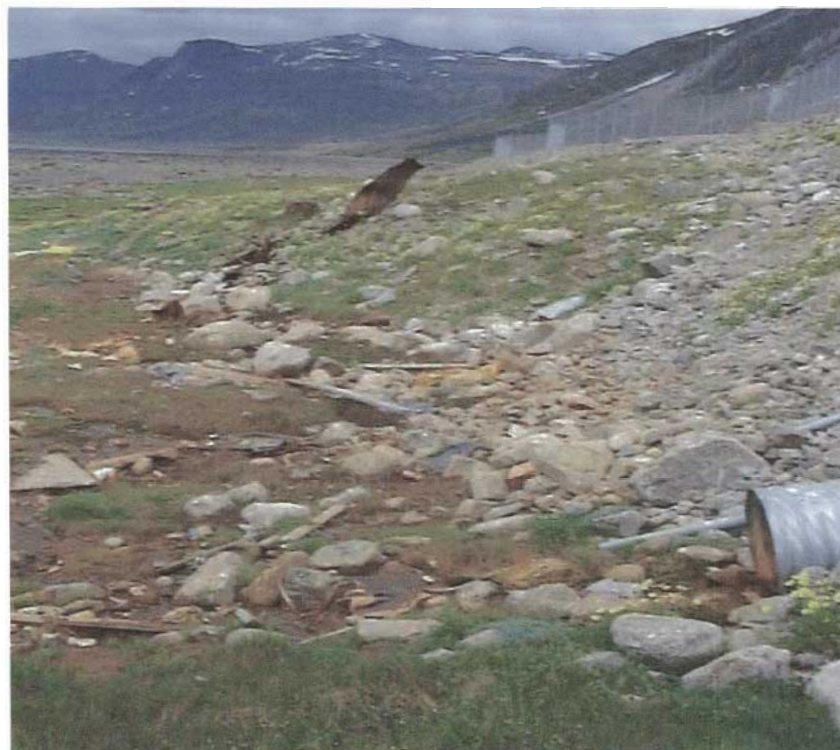
**figure 5.** Leachate from the solid wastes disposal facility; 2001/07/16.

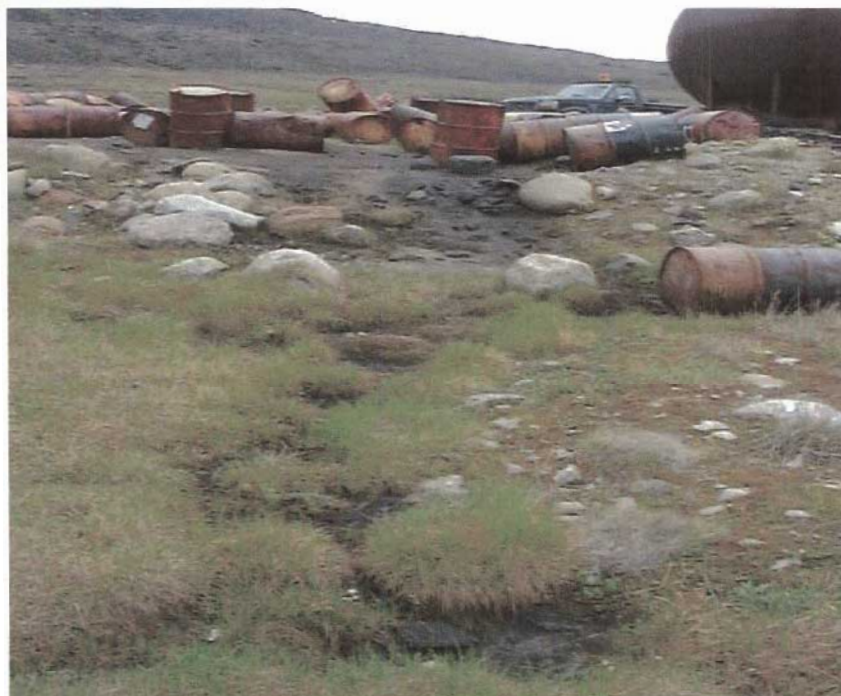
In parallel, the state of the waste oil storage site (figure 6) has not been improved upon since the previous inspection, nor has the spillage been acknowledged through the 24-hour spill report line as an unauthorized discharge of waste. Yet, since the hydrocarbon contamination can potentially migrate into waters, mitigation measures ought to be undertaken in a timely manner. In this regards, it was related during the inspection that the hamlet plans to ship out the accumulated waste oil in a bulk container, on this summer's sealift backhaul.

**figure 6.** Hydrocarbon contamination at the waste oil storage site; 2001/07/16.
