Drainage/Seepage Monitoring and Management Plan Hamlet of Pangnirtung, Pangnirtung, Nunavut

Water Licence Compliance - Hamlet of Pangnirtung

Drainage and Seepage Monitoring and Maintenance Plan

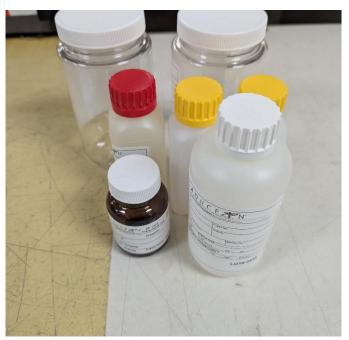
LEACHATE

Sample containers for drainage/seepage samples have their own set of containers. The following photographs indicate the containers for leachate sampling; specific sample bottle requirements are presented in Appendix D.

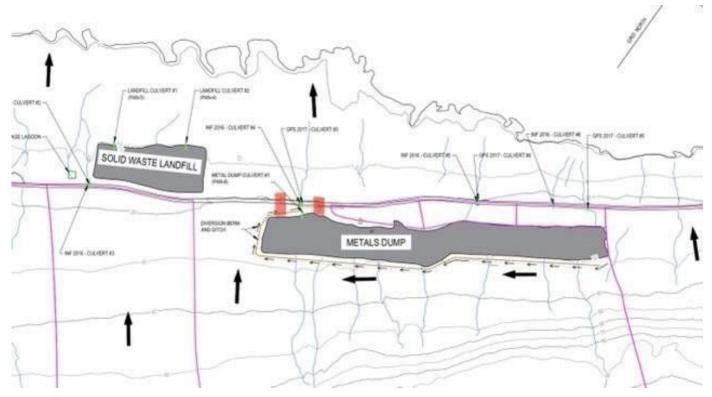
Photo 1: Existing Drainage Plan

EXP was on site to document the current conditions at drainage/seepage monitoring locations PAN 4, 5 and 6, as well as the culverts bridging both sides of the roadway on September 26, 2024. The existing drainage plan is attached for reference. Photographs of the drainage/ seepage monitoring stations and signage are also attached.

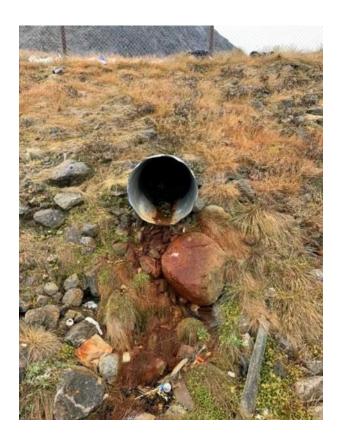
Photo 2: PAN-4 Outlet

PAN-4 was located on the northeast side of the solid waste landfill, as per the signage on site. The culvert outlet was in good condition. It is assumed that the inlet of the pipe was also buried in the landfill. The outlet was observed to be dry with some garbage downstream.

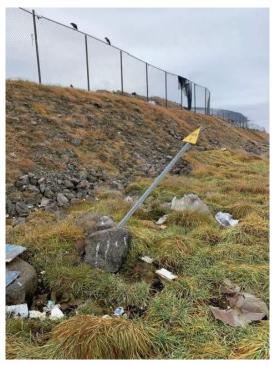
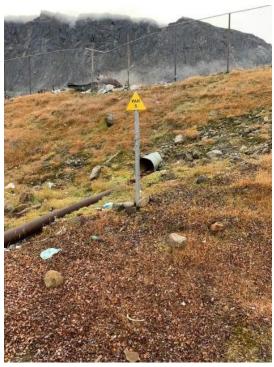
PAN-4 Sign PAN-5 Sign

- d) Repair/reinstate, as necessary, the sample location ID signs (PAN-4, PAN5, and PAN-6) to assist in ensuring that samples are collected and labelled accordingly in the field. At the time of the 2024 Site Visit, signs were located at each station (see photos attached).

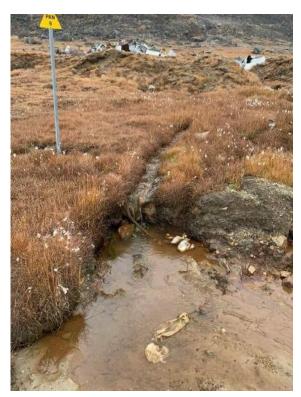
PAN-6 Sign

The PAN-6 culvert signage was located on the northwest side of the metals dump. EXP noted that there was no culvert at this location, only a swale in the berm of the metals dump. Significant flow was coming directly from the metals dump using the swale, then through a culvert under the roadway west of PAN-6, and downhill into the Fjord. Little amounts of garbage were observed downstream.

- c) PAN-6: the 2024 Site Visit observations indicated that there was no culvert observable near this location, only a drainage swale exiting the containment berm. Notable and steady flow was observed coming directly from the point where the swale exited the berm, then through a culvert under the roadway. Along its drainage course before the roadway, there is an elevation drop at PAN-6 (see PAN-6 sign location photo, Appendix C). At the PAN-6 monitoring location it is expected that monitoring and sampling requirements can be met (e.g., as practical capture and time sample collection using a pail/ bucket);
