Phase I Environmental Site Assessment - Resolute Bay Wastewater Treatment Facility Site Selection, Resolute Bay, Nunavut

*Government of Nunavut
Department of Community and Government Services
PO Box 1000, Stn. 700
Iqaluit, NU
X0A 0H0*

FRE-00255934-A0

2020-February-7

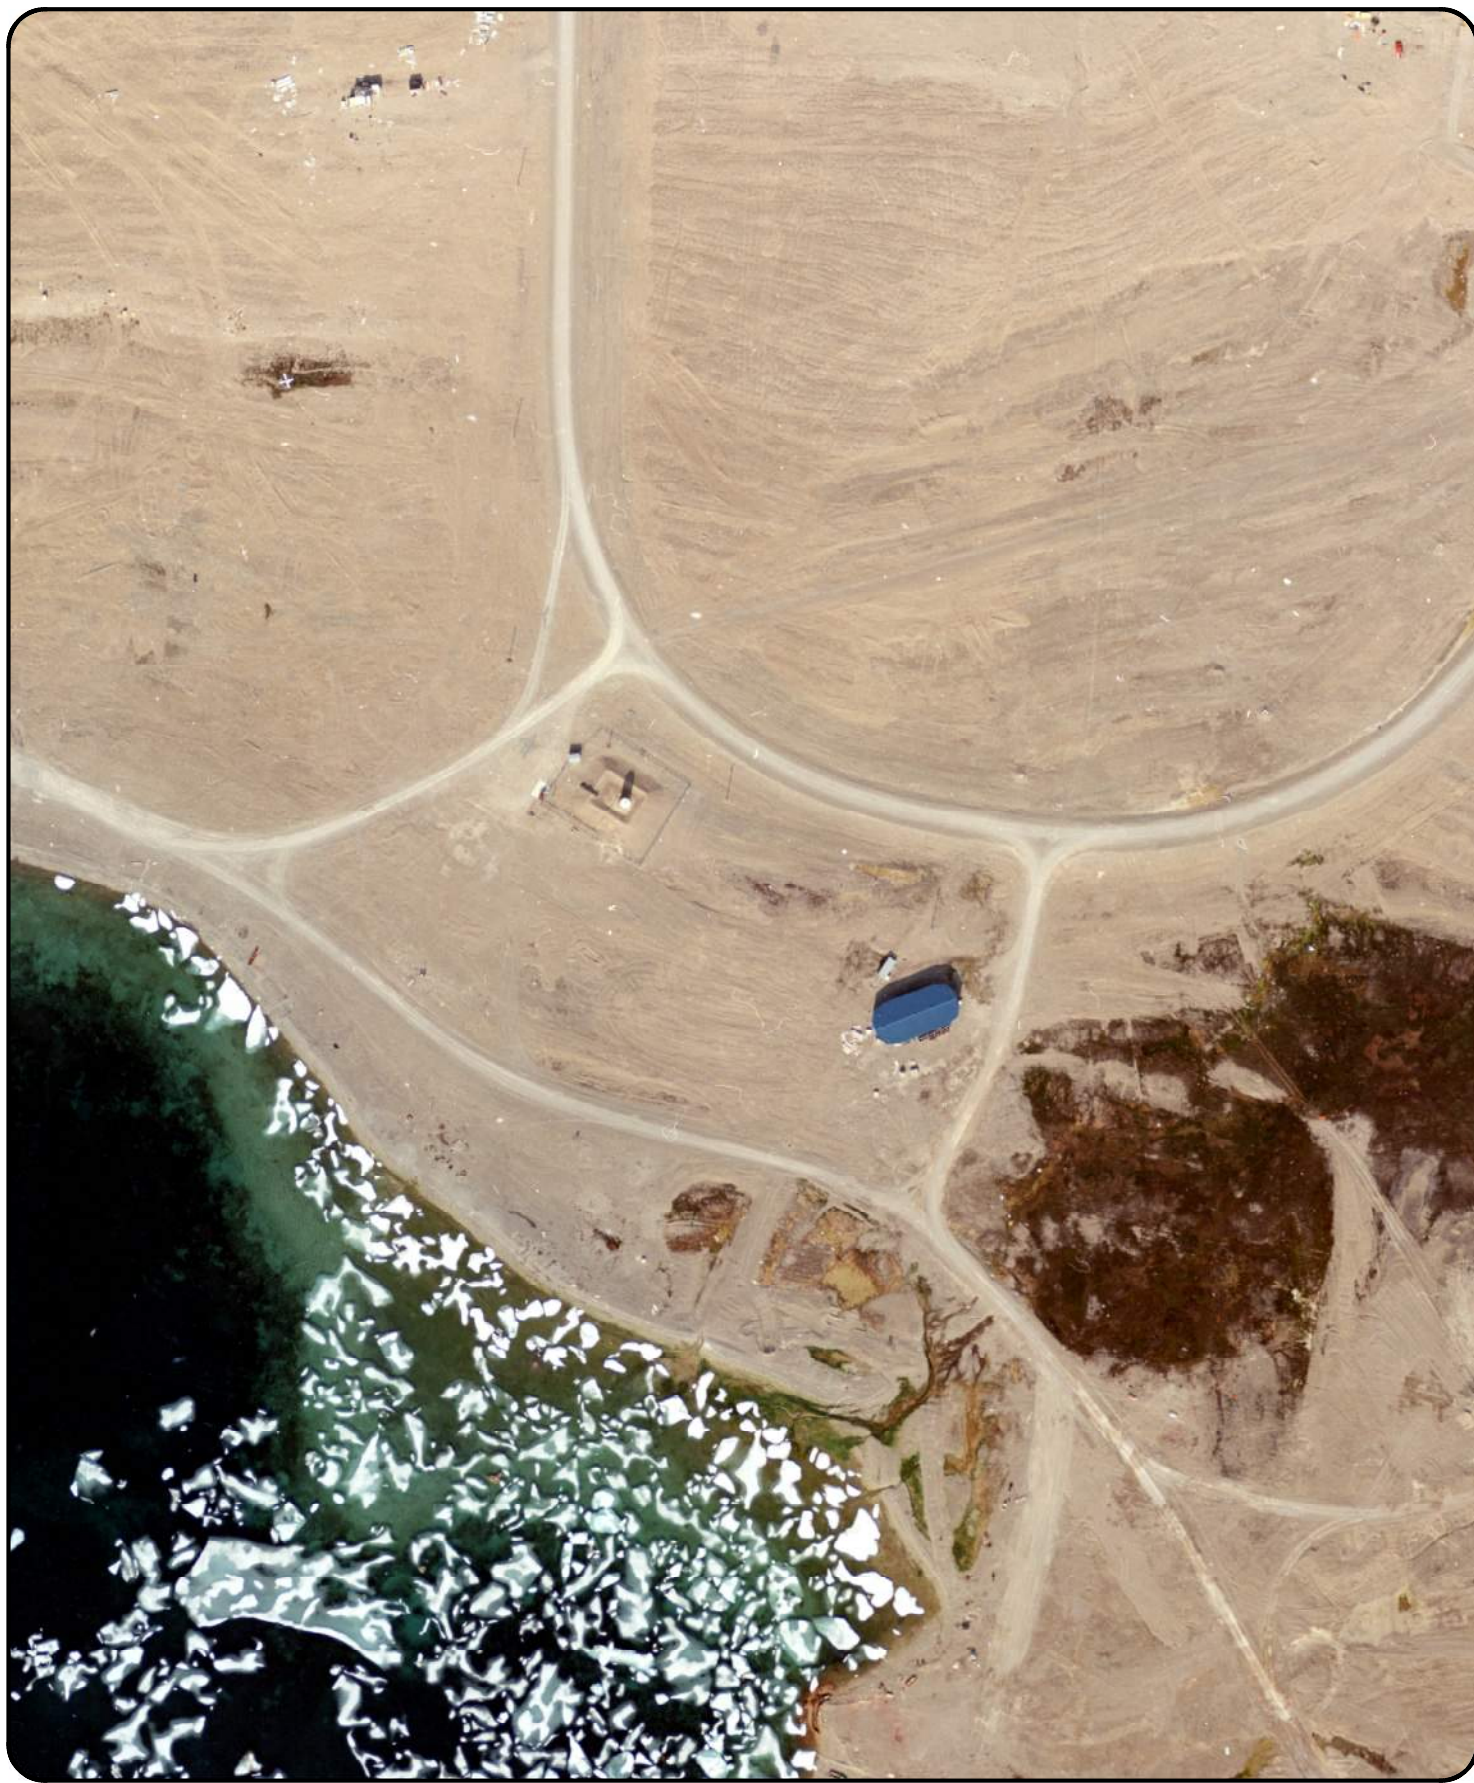
Year: 1995
Source: NAPL
Map Scale: 1: 10000
Comments:

1995	First reasonable quality image. Presence of above ground petroleum storage tank (understood to have been gasoline and non-operational since 2010) with perimeter containment berm – this infrastructure is located approximately 70 m west northwest of the subject site. In general, no other significant infrastructure other than the non operational wastewater treatment plant building noted in the 1987 image, and the small Macerator Building located immediately adjacent (west side) of the non-operational WWTP building. Existing (2019) roadway pattern essentially in place.
2000	Not available.
2019 (Google Earth)	The subject site and surrounding areas remain essentially unchanged.

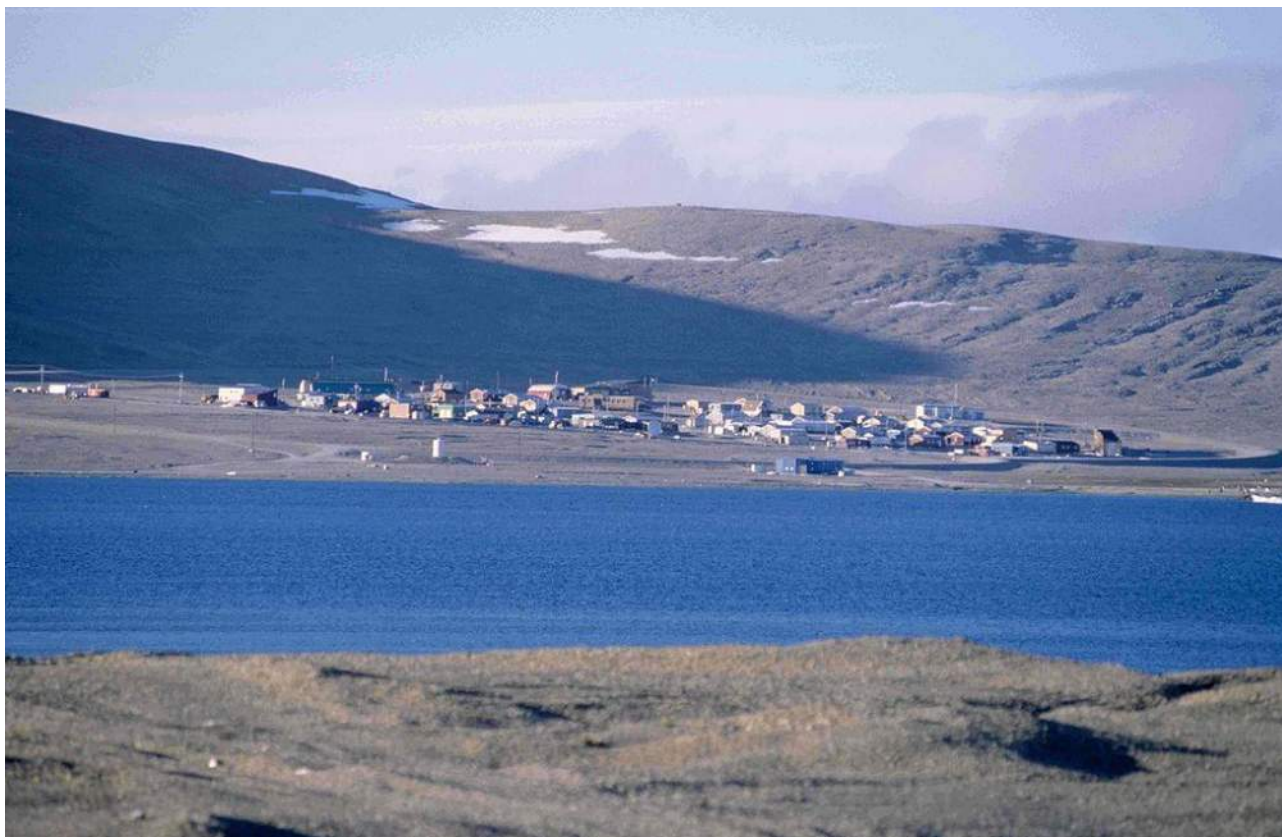
Photograph No. 1

A view of site looking north across bay – note in foreground non-operational former gasoline storage tank to west of subject site and abandoned former WWTP building to east (blue building), and community in background.

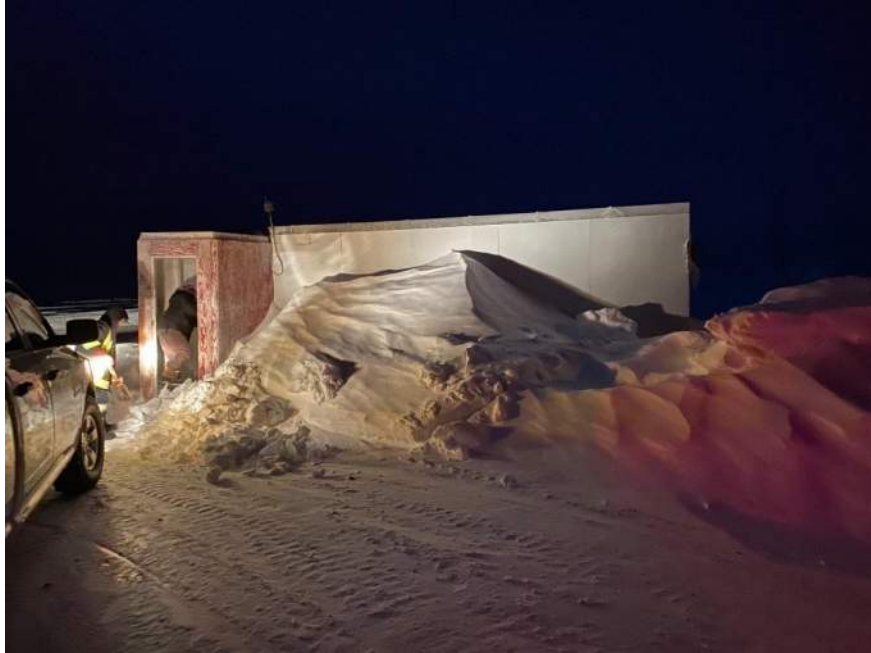
Photograph No. 2

Macerator Building located immediately east of subject site (Dec 3, 2019, EXP).

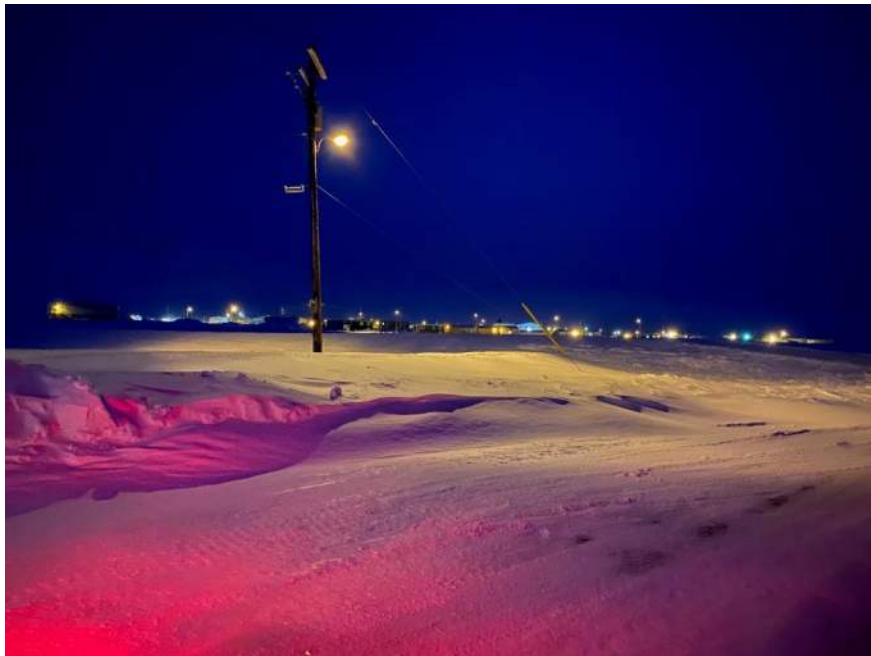
Photograph No. 3

View from subject site looking north toward the community (Dec 3, 2019, EXP).

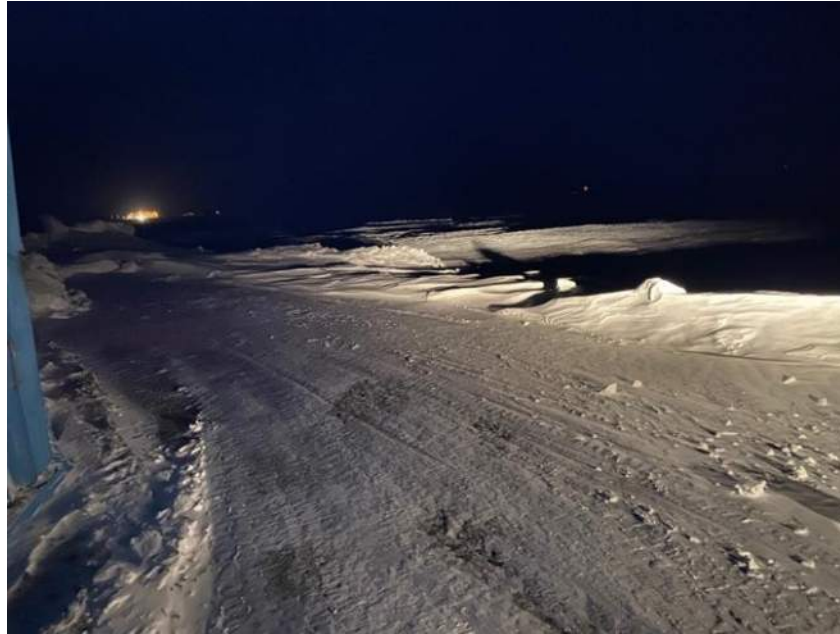
Photograph No. 4

Existing WWTP outfall to the left (Dec 3, 2019, EXP).

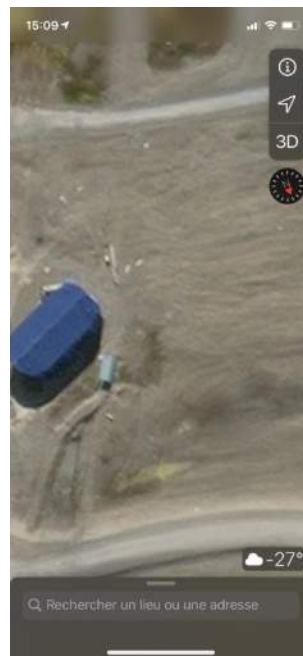
Photograph No. 5

Existing WWTP (abandoned – blue building) and small Macerator Building located east of subject site (Google Image).

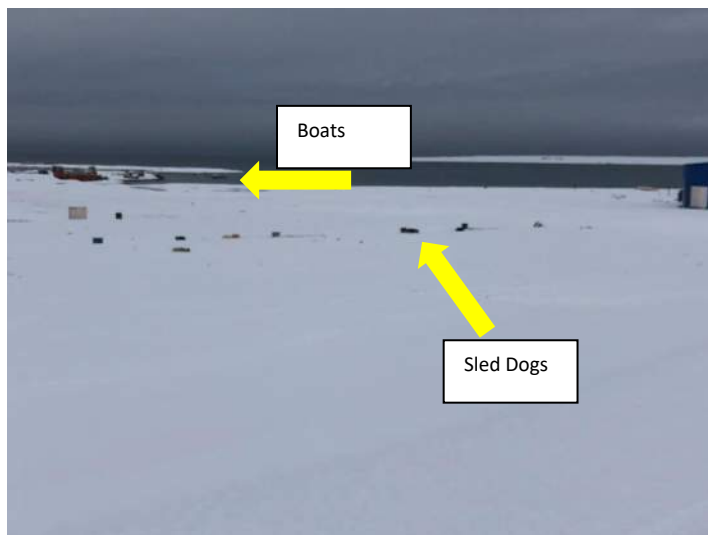
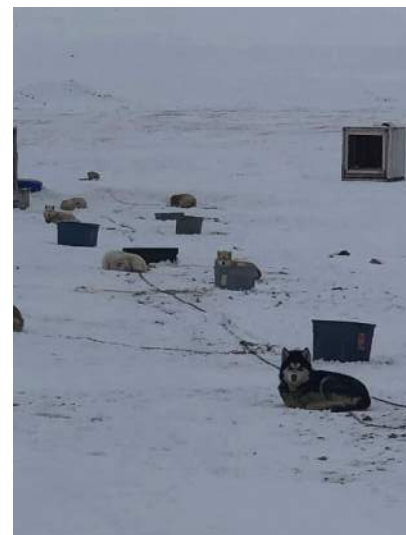
The area to the left of the blue building is less suitable because of a lower elevation susceptible to flooding plus significant activity in the area (lots of small boats and sled dogs). See photos below.

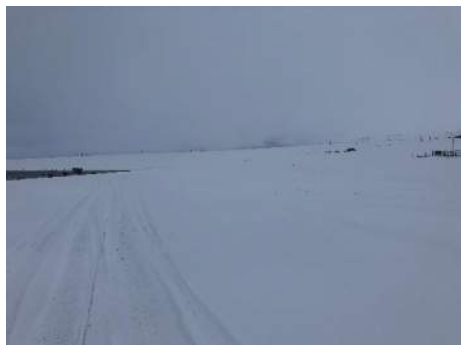
The area to the right of the blue building would be better because of a slightly higher elevation and less observed activity as seen in the photo below.

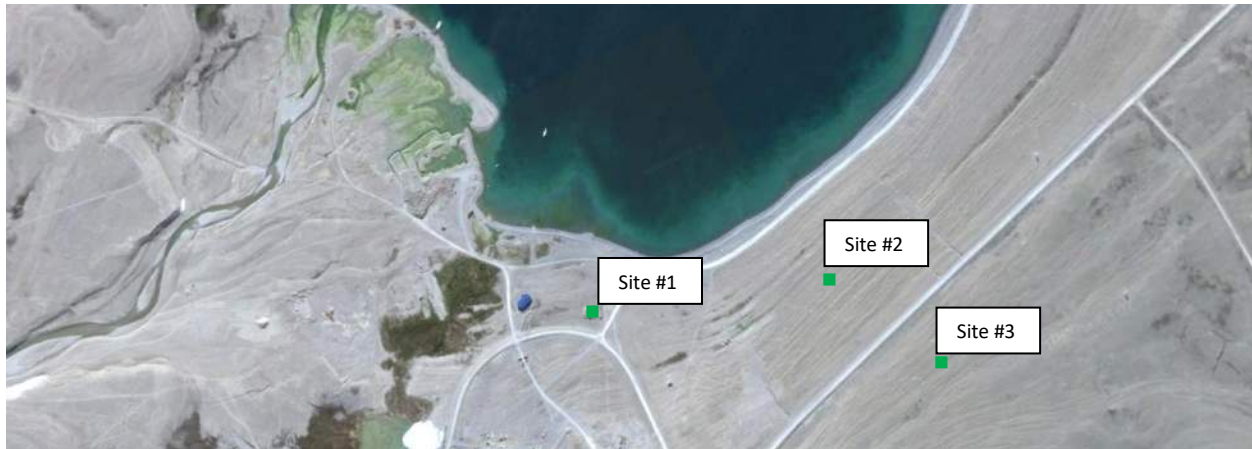
I have arbitrarily selected 3 potential locations, all to the right of the blue building as indicated in the attached map below. Each green square is approximately 20m x 30m which is roughly the size of the building required to house the wastewater treatment facility based on the 2012 design brief.
