## WATER LICENCE INSPECTION FORM

-ор кероп	
Licensee	nsee Licensee Representative						
			Bhabe	sh Roy			
Government a	Government and Services						
Government of	of Nunavut						
Licence No. / Expiry			-	ative's Title			
3BM-RUT1520			-	nal Engin			
Land / Other Authorization	ons		Land / Oth	er Authorizati	ons		
Date of Inspection			Inspector				
June 23,2017			Jonath	nan Mesl	her		
Activities Inspected	Duilling.	□ N dimin m			□ Deelewekien	□ Fuel Sterese	
Camp Roads/Hauling	☐ Drilling ☐ Other: Water Di	☐ Mining scharge	_	nstruction ner: Municipal	Reclamation	☐ Fuel Storage	
Conditions: A	- Acceptable	C - Concern	U - Unaccep	table	NA – Not Applicable	NI – Not Insp	ected
Water Use	Condition Comr		о опассор		omment Haz/Mat Manage	-	Comment
Intake/Screen	NI	Water Managemer	nt Structures	NA	Storage	NA	
Flow Measure. Device	ce A	Culverts / Bridges	S	NA	Spills	NI	
Source: Char Lake	Α	Drainage		NA	Spill Plan	Α	
Water Use:	С	Erosion / Sedime		NA

## Effluent Discharge to the Arctic Ocean

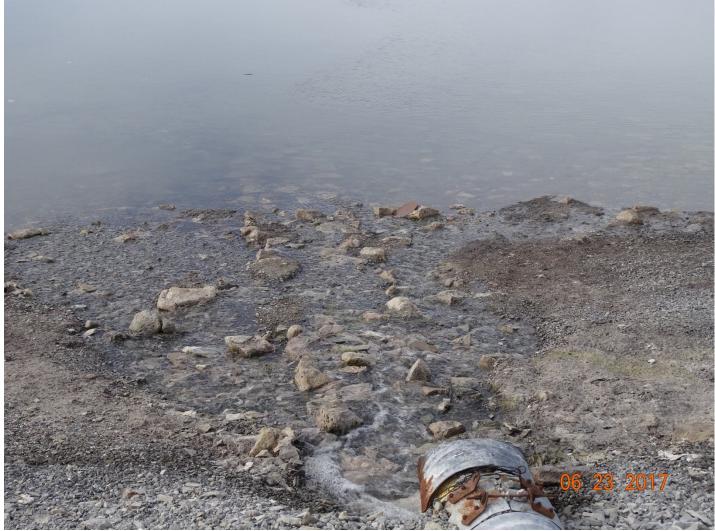
Figure 1: Ocean discharge

- 1. Discharge point was identified by signage.
- 2. This is a discharge to the Arctic Ocean and does not appear to the inspector to effect inland waters. Figure 1 shows the effluent pipe leading directly to the Ocean

With this information in mind, during subsequent inspections, the inspector will be addressing this discharge to the marine environment under the Arctic Waters Pollution Prevention Act.
