WATER LICENCE INSPECTION FORM

Licensee	Licensee Representative
Hamlet of Resolute Bay	Bhabesh Roy, Angela Idlout
Licence No. / Expiry	Representative's Title
3BM-RUT1520	Municipal Engineer, Senior Administrative Officer
Land / Other Authorizations	Land / Other Authorizations
Date of Inspection	Inspector
July 13, 2019	Joseph Monteith, & Jeremy Fraser
Activities Inspected	
<input type="checkbox"/> Camp	<input type="checkbox"/> Drilling
<input type="checkbox"/> Roads/Hauling	<input type="checkbox"/> Mining
	<input type="checkbox"/> Construction
	<input checked="" type="checkbox"/> Other: Water Treatment Facility, Waste Water Utilidor Hazardous Waste Facility
	<input type="checkbox"/> Reclamation
	<input type="checkbox"/> Fuel Storage
	<input type="checkbox"/> Other:

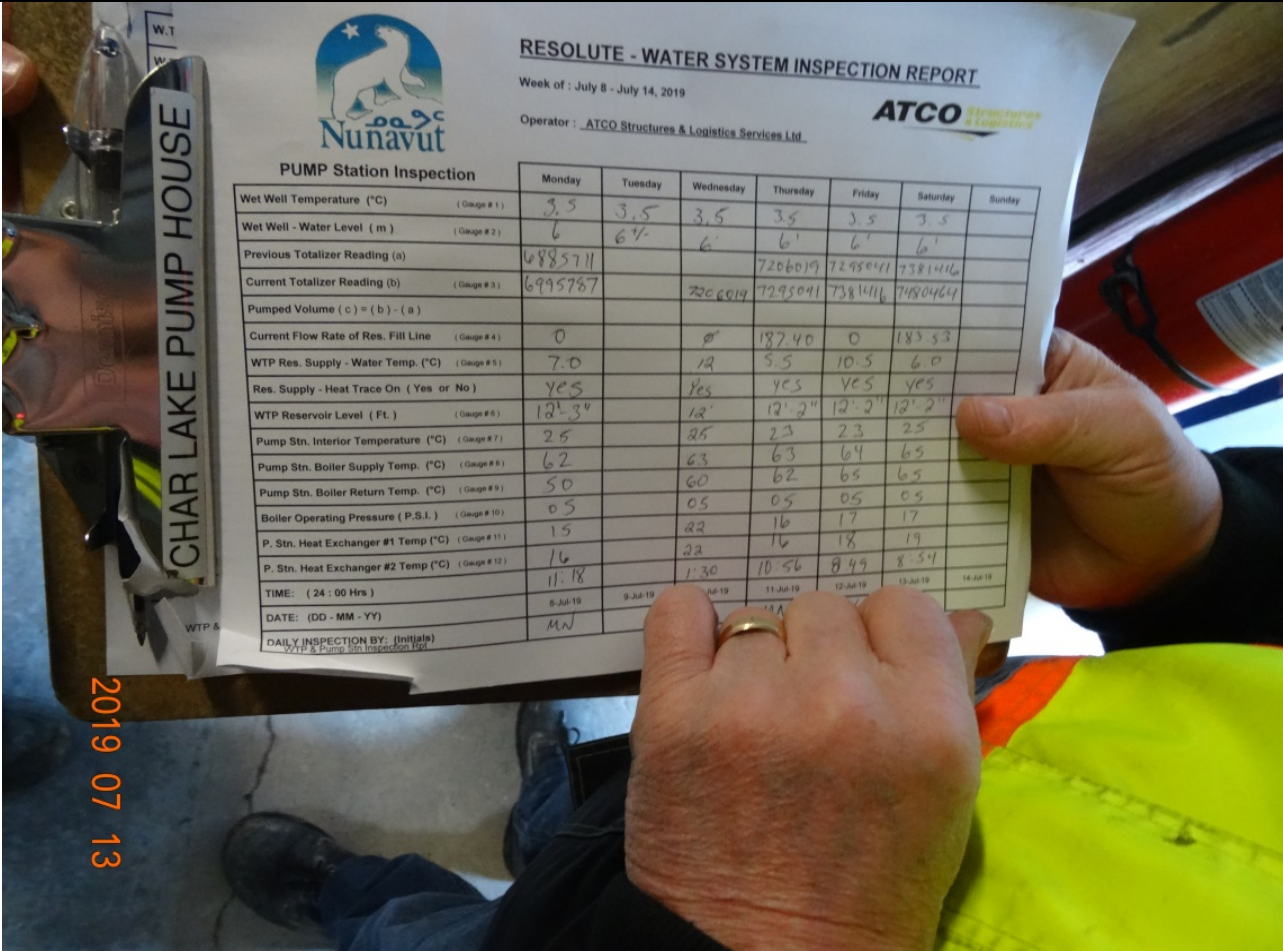
Photo 3

Description: ATCO –Resolute – Water System Inspection Report week of July 8-July 14, 2019. July 13, 2019 Gauge # 3 Current Totalizer Reading (b) reads 7480464. Does not indicate measurement. Gauge # 3 reads in Gallons.

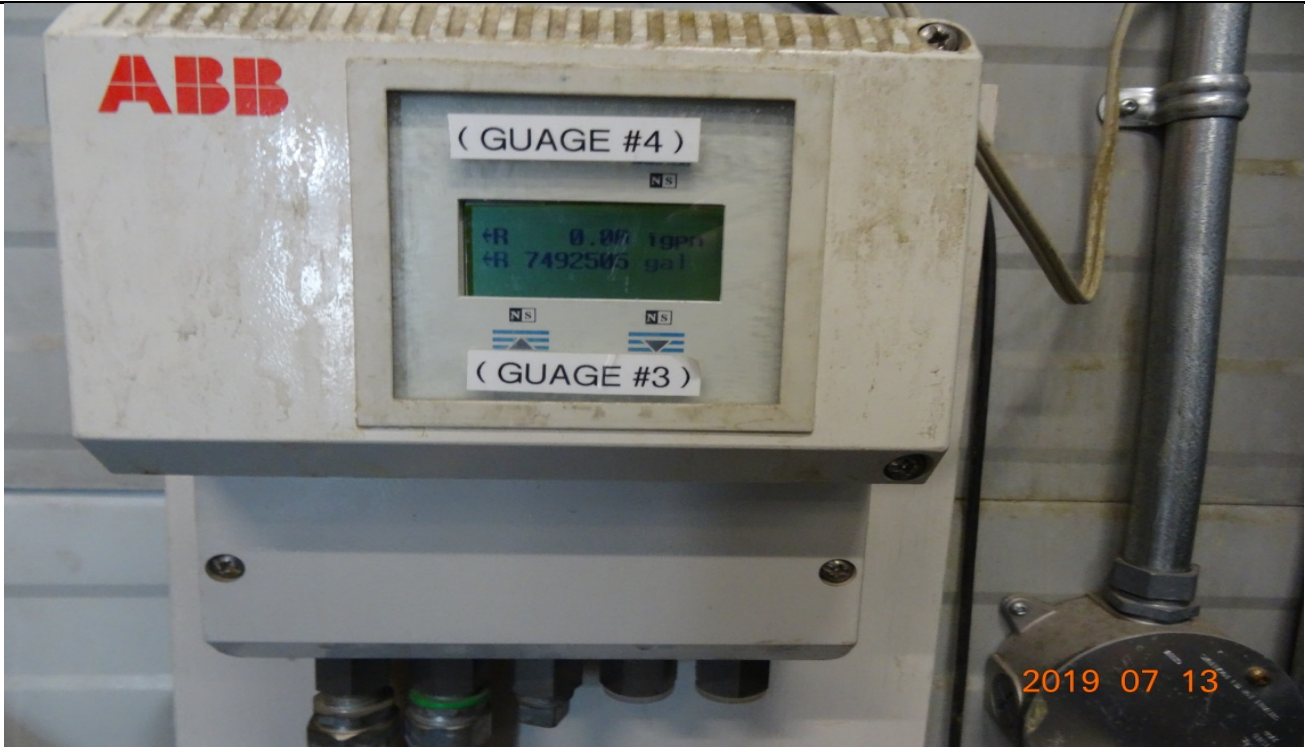
Photo 4

- The Water Treatment Plant contains sump pits, pumps, a chlorine mix pot, 12,300 cubic metre water storage tank, and pipes the treated water to the residents by gravity using underground pipes.
- Appeared to be not operating as intended. Some signs of spill from chlorine Mixing station. A unreported spill occurred within the water treatment facility due to the a flange damage to a filter box(photo 6, 7, and 8).
- Water storage tank gauge reads 12 feet.
- Water Usage Logs (photo 3). Gauge # 3 reads 7492505 Gallons.

Description: Gauge # 3 reads 7492505 Gallons.

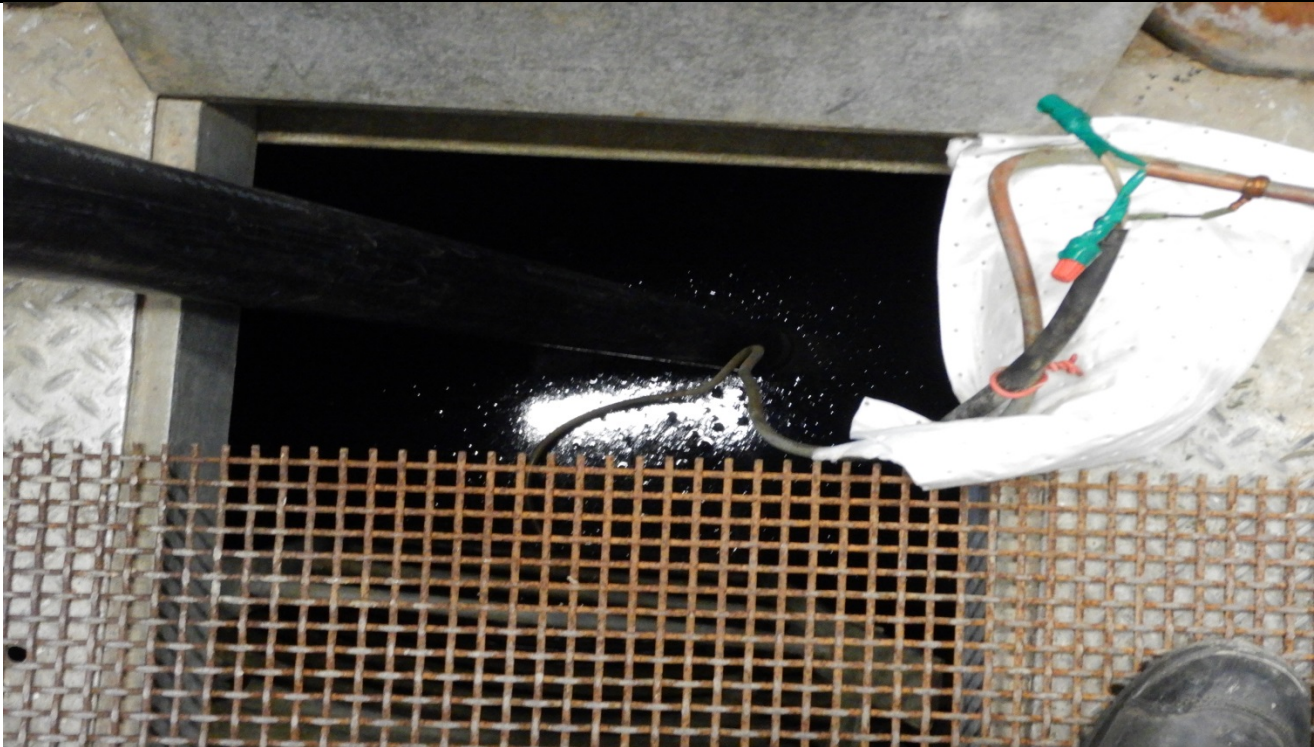
Photo 5

Description: Pump house. Water well. PVC hoses used to withdrawal water.

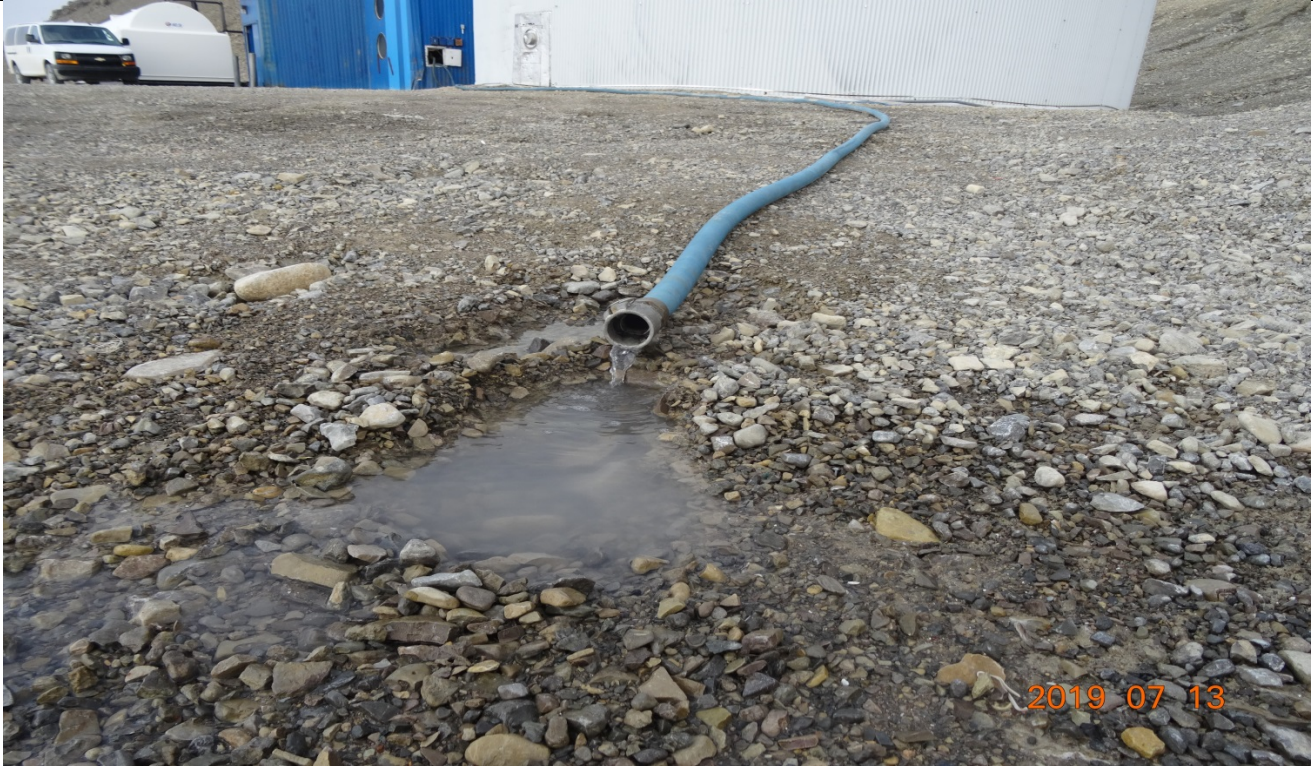
Photo 6

Description: Water Treatment Plant – Water Storage Reservoir – Capacity 12,500 Cubic Metres . Discharging water from Water Treatment Plant.

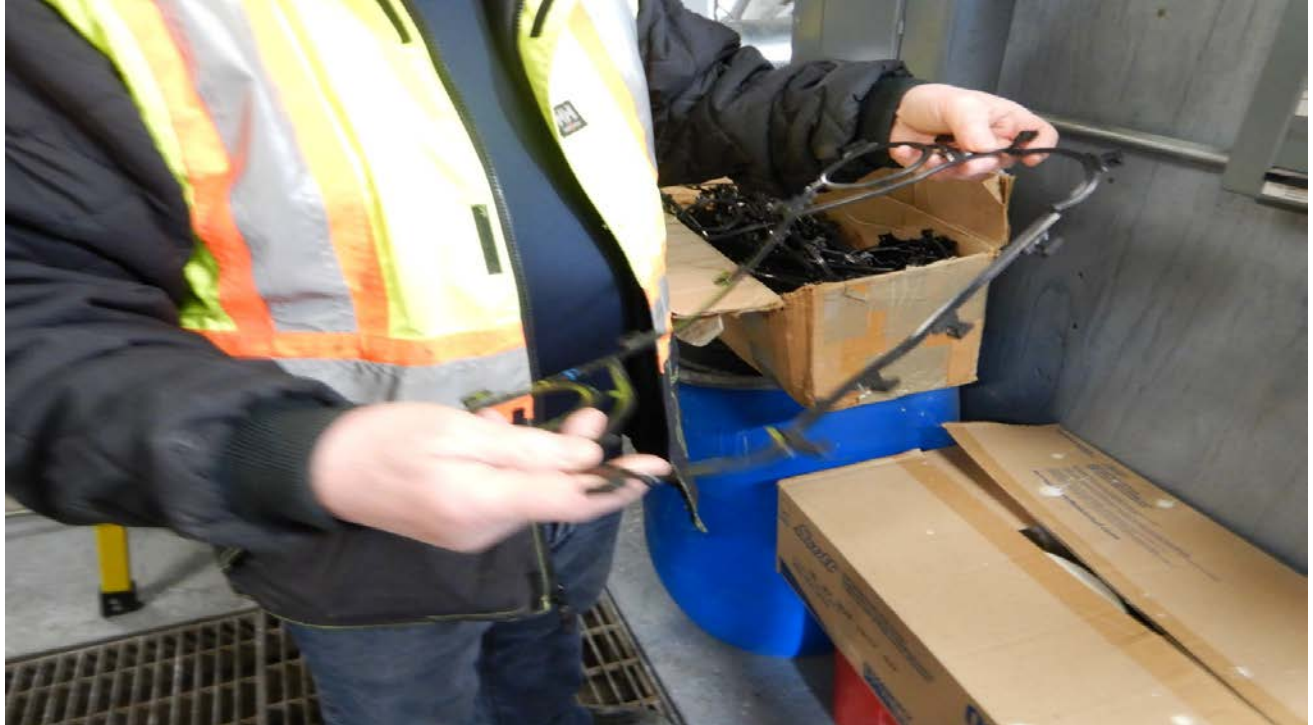
Photo 7

Description: Damaged Flange

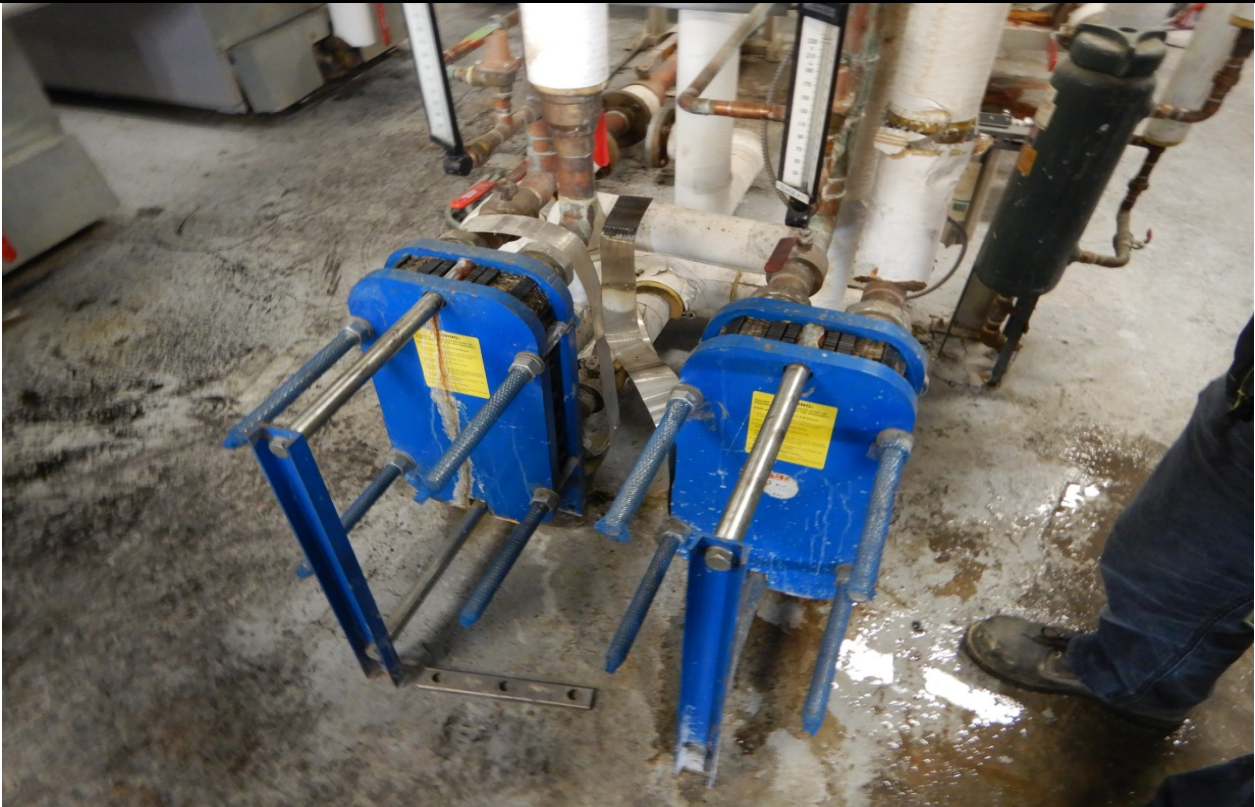
Photo 8

Description: flange broke in this filter press. Spilling treated water within the facility. Product settled in a sump pit.

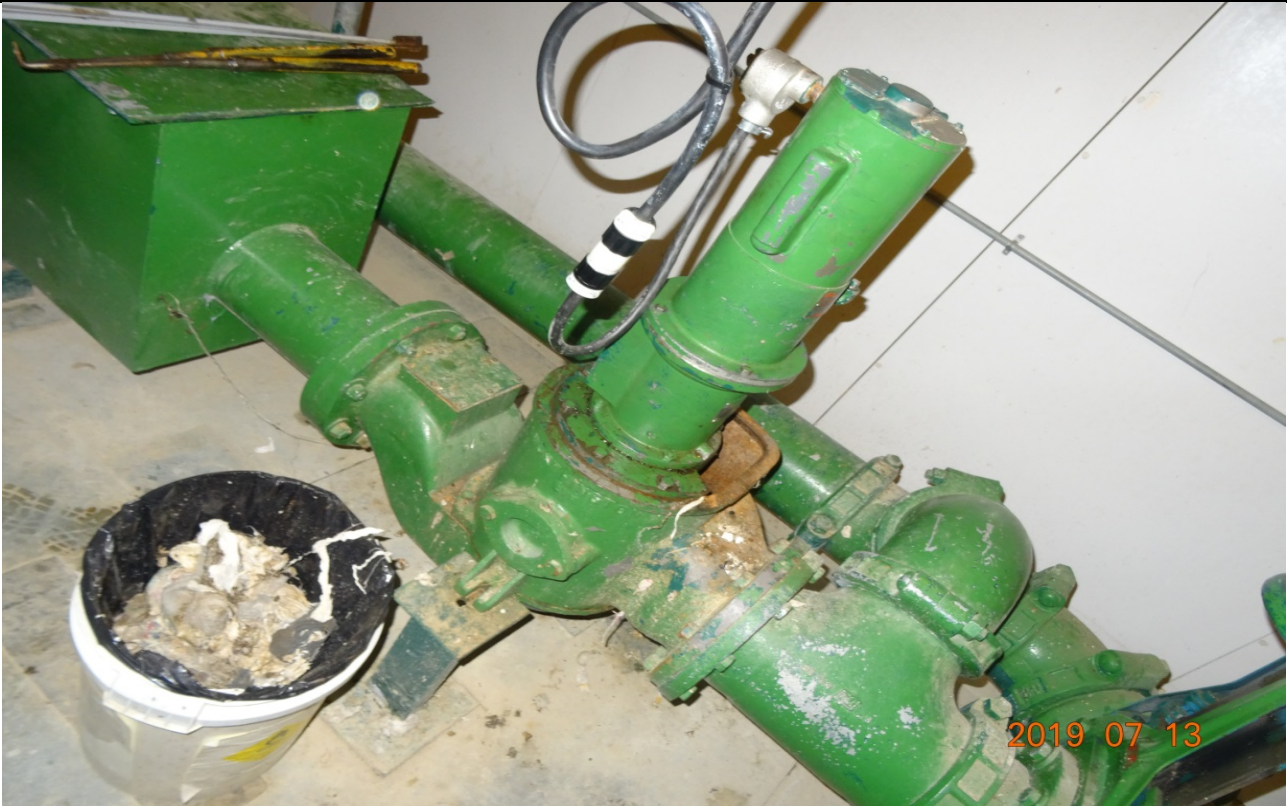
Photo 9

- An old Trailer Building contains a macerator, which takes any solids such toilet paper, and traps it from being discharged with the waste water. (See photo 6)

Description: Macerator in Old Trailer Building – Solids extracted from Macerator, and deposited into waste bin.
