WATER LICENCE INSPECTION FORM

| Hamlet of Resolute Bay | Megan Lusty |
| 3BM-RES2025 | Regional Engineer |
| July 10, 2024 | Joseph Monteith |

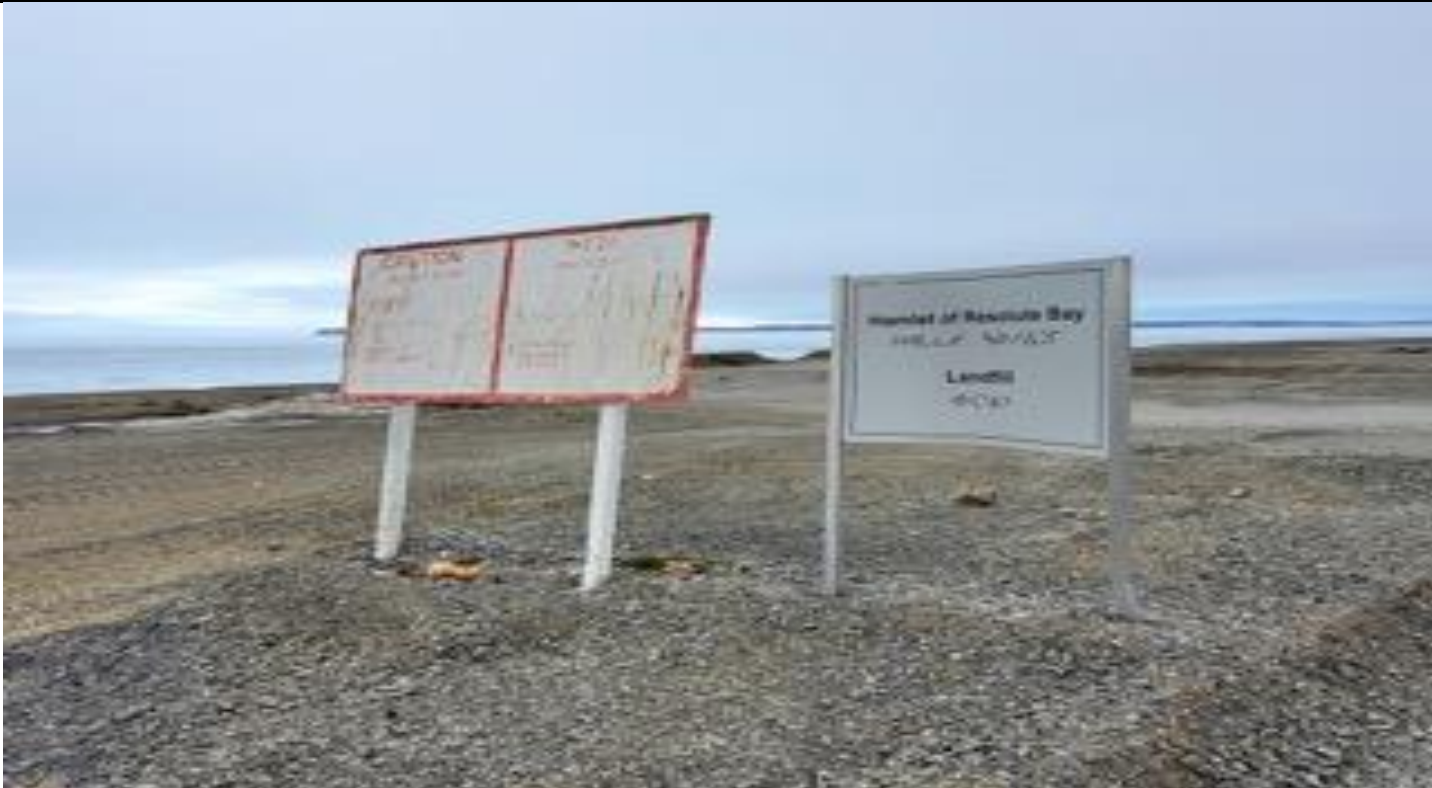
| Date | Camera | Inspector | |
|---|---|---|--|
| Photo 1 | Burn and Cap, Resolute Bay, NU | | |

- lined, no signs of water flowing in and out of the facility. This site was active at the time of inspection (photo 2).
2. No minimum 10 day notice has been given to the inspector since April 2018 for open pit burning.
  3. A caution sign was observed cautioning the public from dumping Hazardous Material, Metals, and Rubber Tires, and Tracks. Both signs in English and in Inuktitut m(photo 1).
  4. No signs of water entering the facility, the site is on a sloped rocky beach (photo 2).
  5. No signs of leachate leaving the facility. Slope downgrade of burn and cap steepens. Signs of past deposits capped.

| Date | Camera | Inspector | |
|---|---|---|--|
| Description: Burn and Cap site active at the time of inspection. | | | |

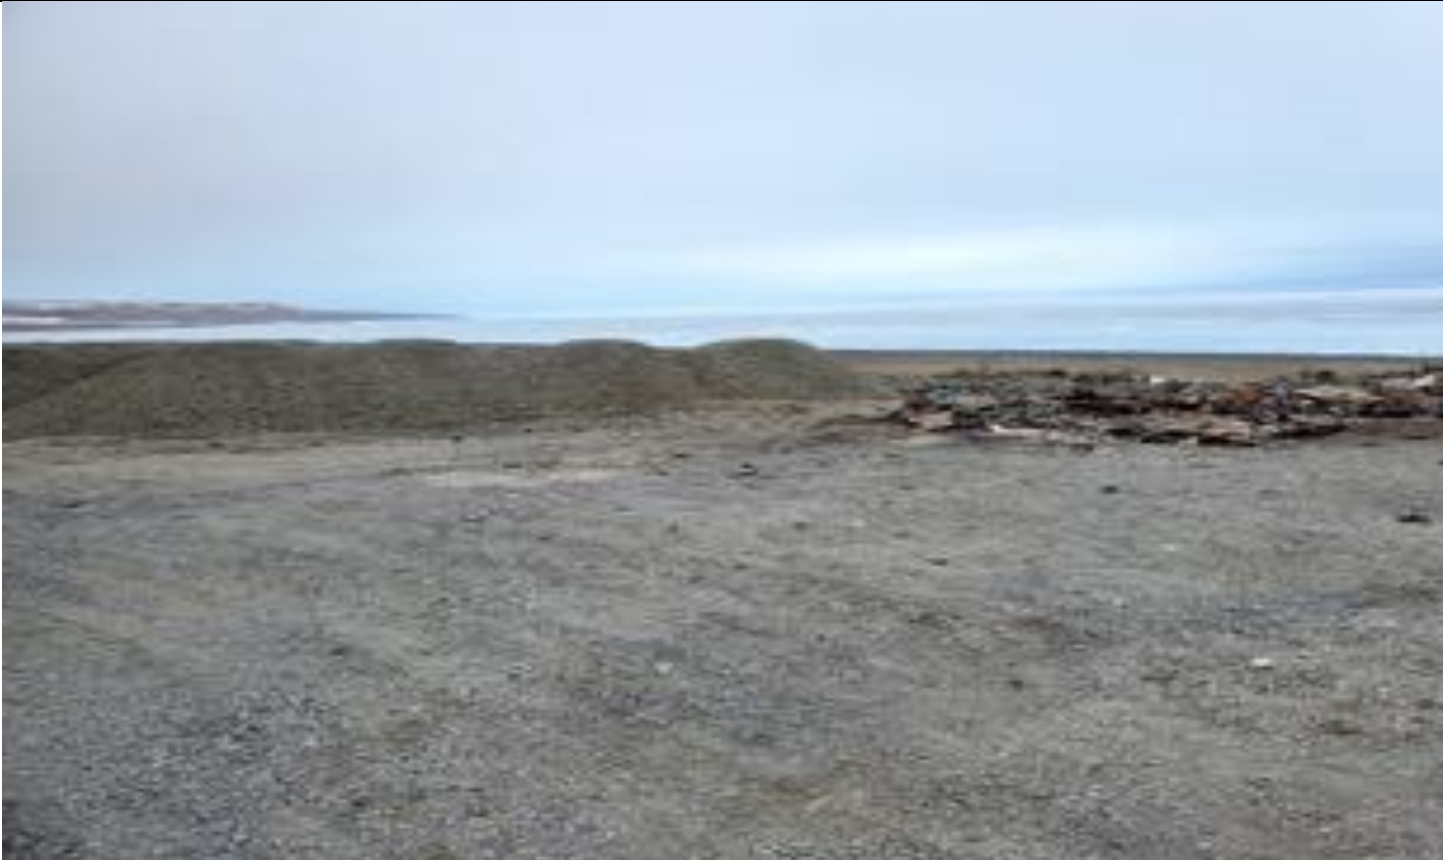
| Photo Log | Location |
|---|---|
| Photo 2 | Bulk Metal Solid Waste Facility, Resolute Bay, NU |

6. The Metal Dump facility located with the community of Resolute Bay has a mixture of white waste such as water heaters, washers, dryers, fridges, and freezers. Bulk Metal such as abandoned vehicles such as trucks and snowmobiles, pipes, and storage tanks. (See Photo 2).
7. Water enters the site coming out from underground and migrating through the facility (photo 2).

| Photo Log | Location |
|---|---|
| Description: Burn and Cap smoldering with domestic waste, and bulk wood. Gravel used for capping is stored next to the open pit for use. | |

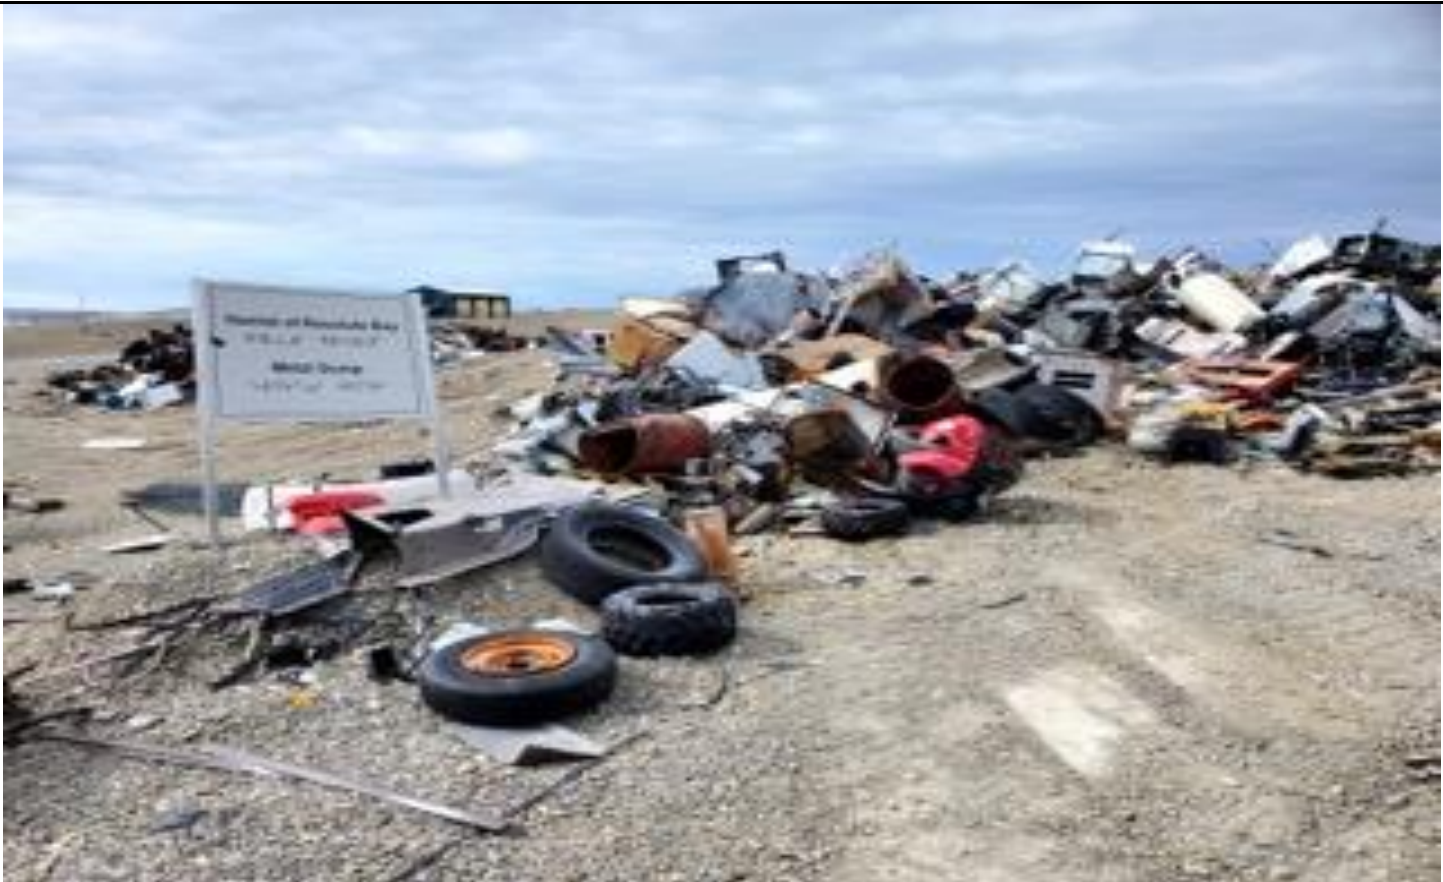
| Photo Log | Location |
|---|---|
| Photo 3 | Bulk Metal Solid Waste Facility, Resolute Bay, NU |

| Photo Log | Location |
|---|---|
| Description: Sign reads “Metal Dump” | |

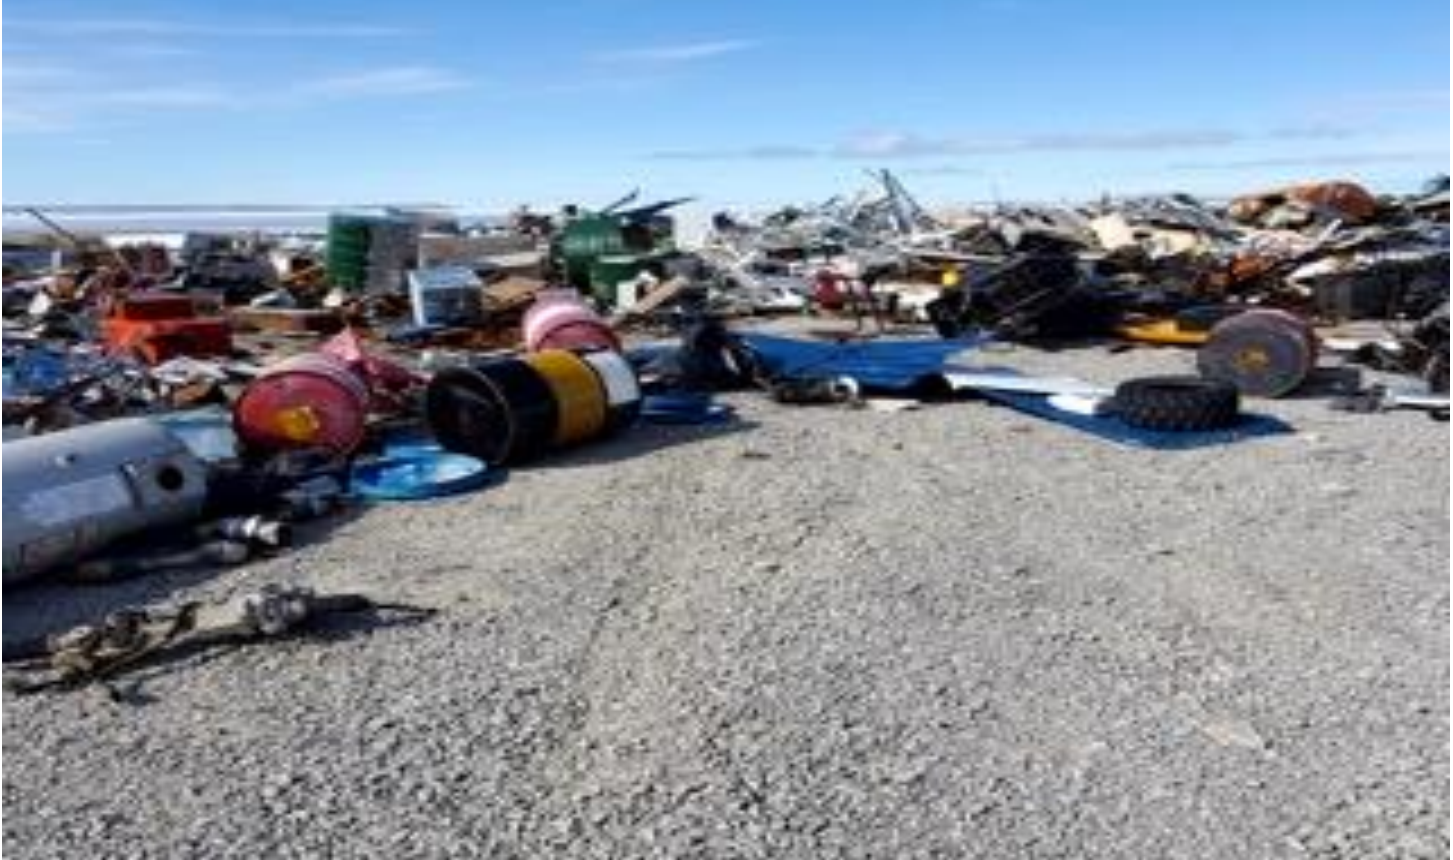
| Photo Log | Location |
|---|---|
| Photo 5 | Bulk Metal Solid Waste Facility, Resolute Bay, NU |

10. Inside the new bulk metal Solid Waste Facility west of Resolute Bay (photo 3 & 4).
11. Battery, waste oil can observed exposed to the outside elements within the fenced area of the domestic waste facility.

| Photo Log | Location |
|---|---|
| Description: Bulk Metals Facility outside the community. Battery observed. | |

- The items listed below are the action’s required as summarized from above to ensure compliance:
- Consolidate all hazardous waste such as paint cans and oil cans in the Bulk Metal Solid Waste Facility and Domestic Solid Waste Facility, and store in the hazardous waste section of the Solid Waste Facility to be compliant with Part D: Item 4
  - Notify the inspector 10 days ahead of a planned open pit burn by emailing Water Resource Officer Joseph Monteith at: [joseph.monteith@rcaanc-cirnac.gc.ca](mailto:joseph.monteith@rcaanc-cirnac.gc.ca). To be compliant with Part D:Item 3
  - Consult with neighbouring land owners on an agreement to mitigate the interaction of water on access to the new bulk metal solid waste facility, to be compliant with Part C:Item 2
  - The Licensee is reminded to remain diligent to prevent wastes from entering water, and the environment.

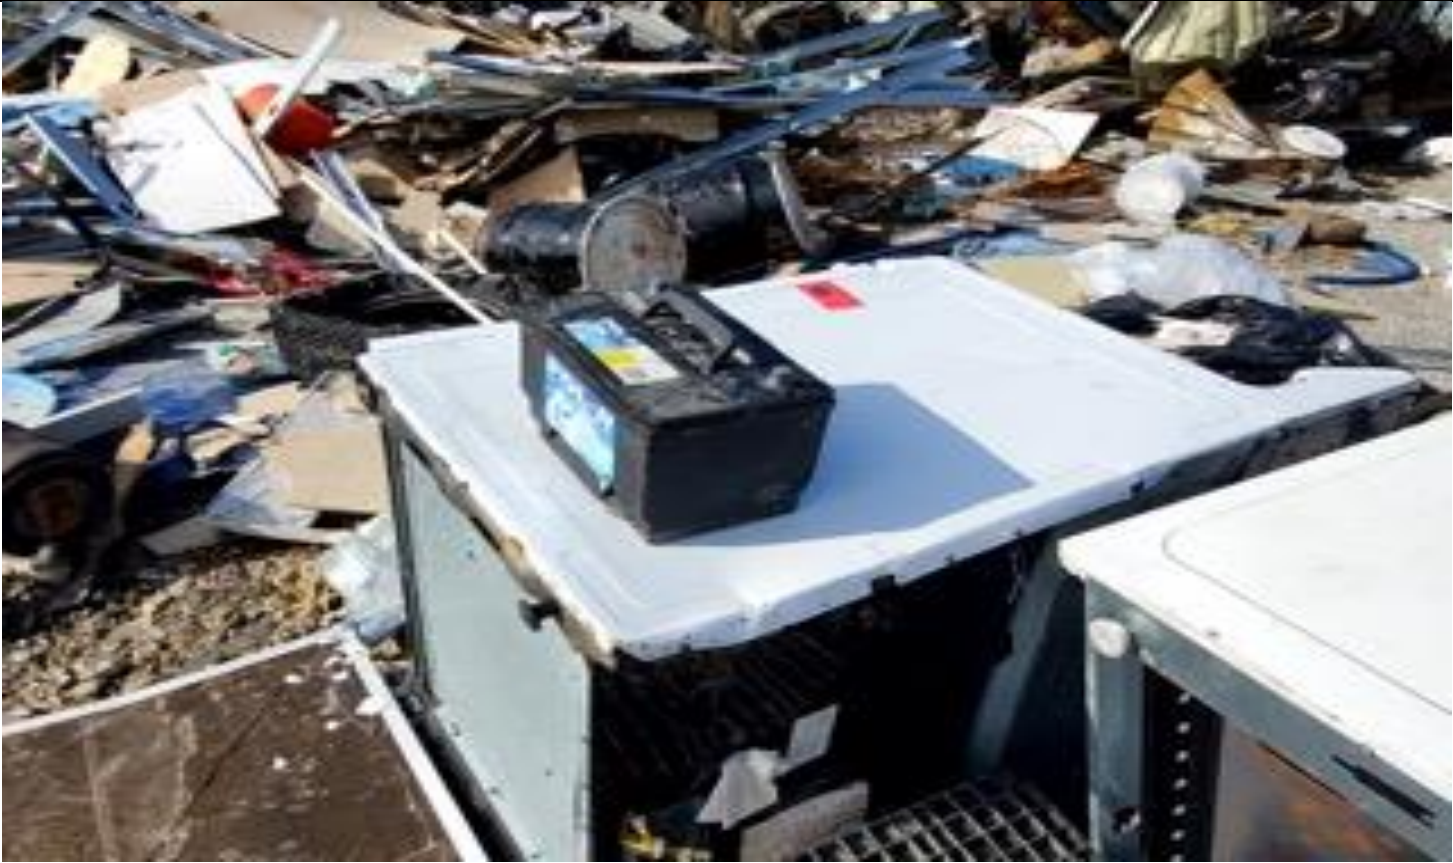
Photo 6

Description: Bulk Metals Facility outside the community. Battery observed.

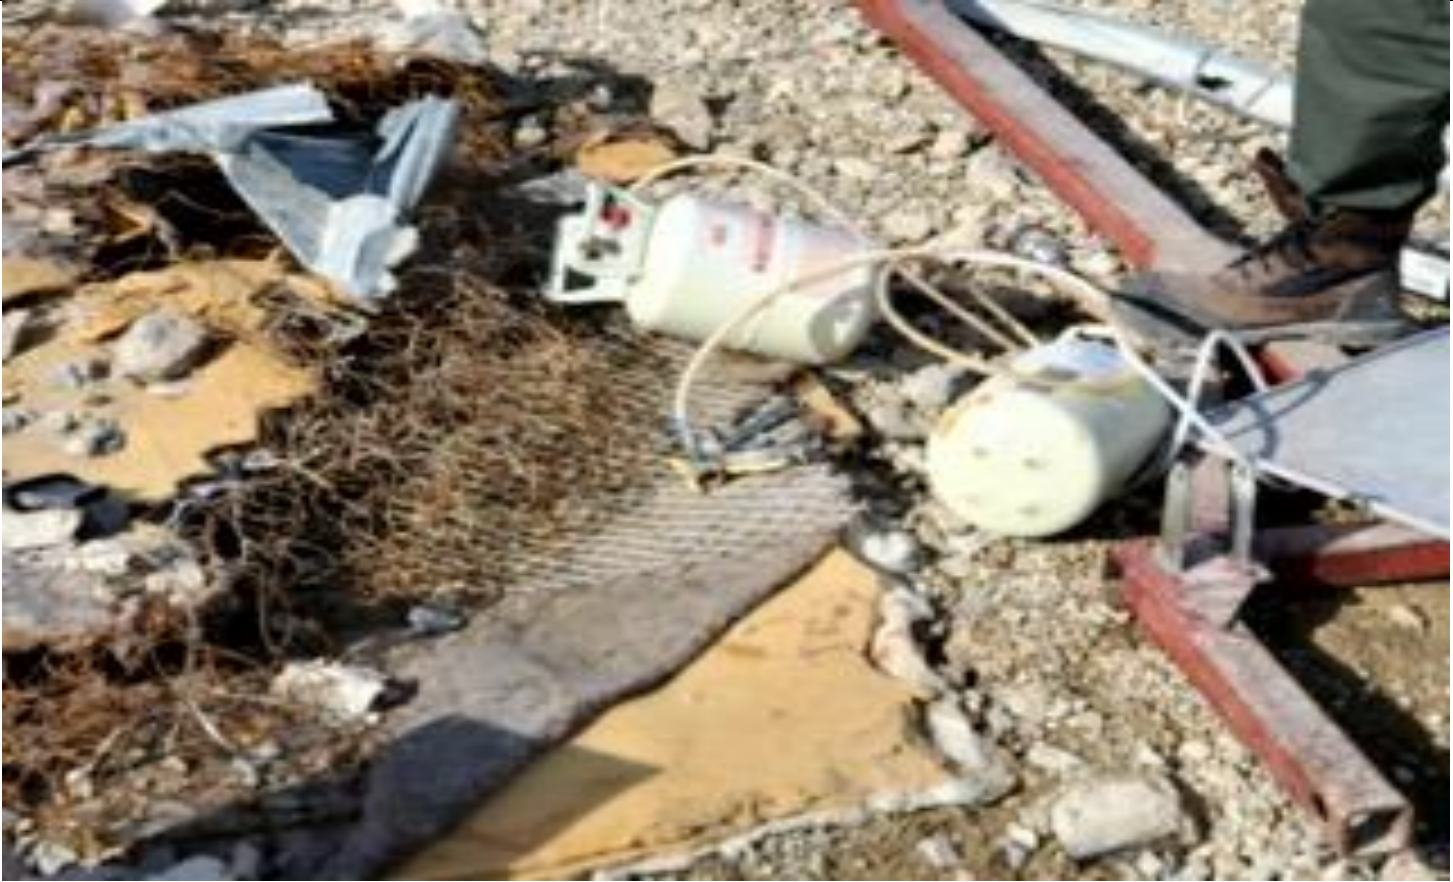
Photo 7

Description: Bulk Metal Facility outside the community. 2 empty cannisters for compressed gas.

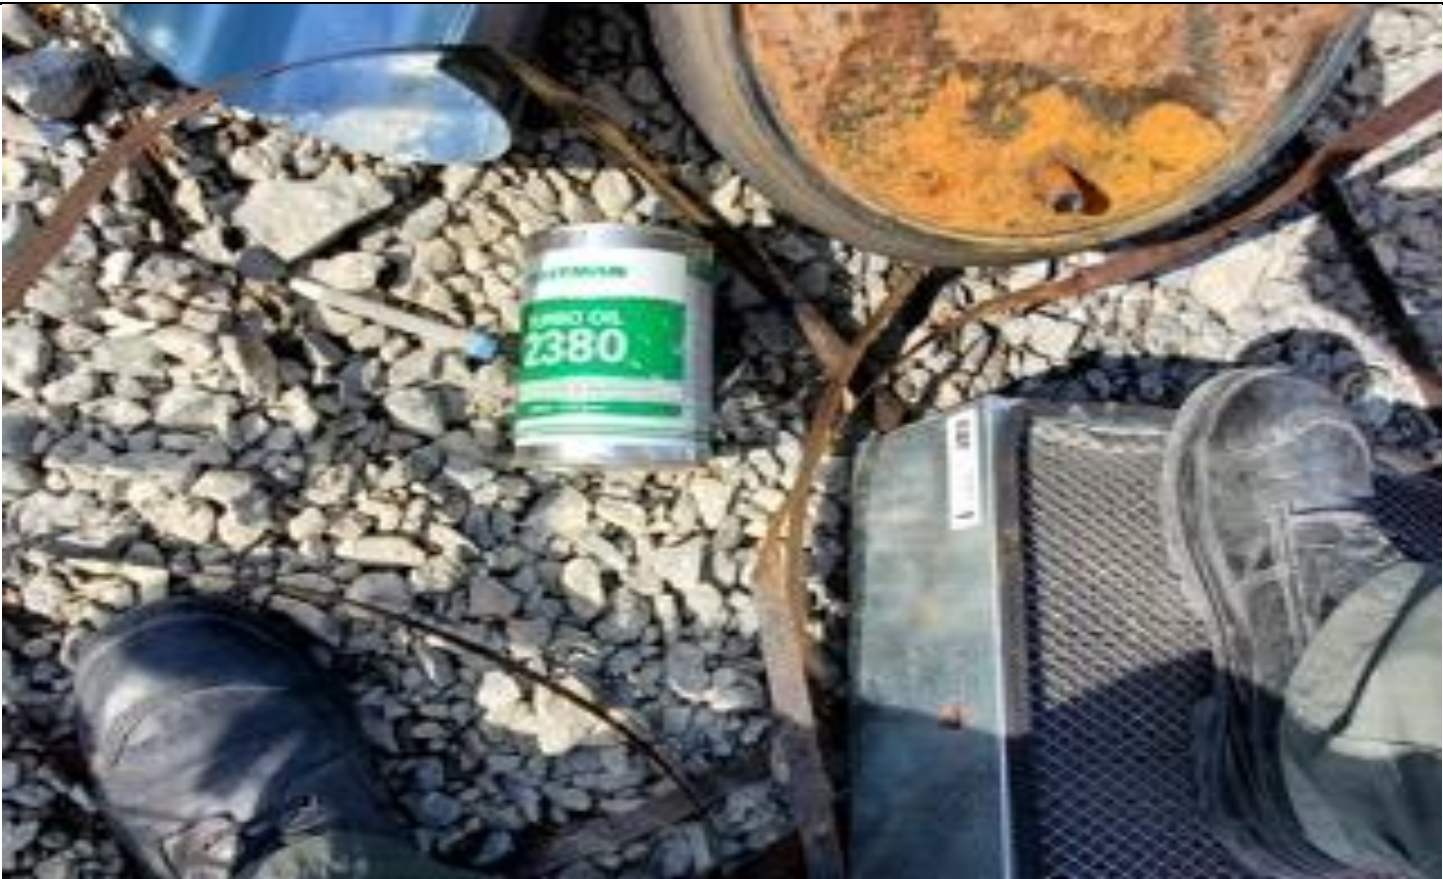
Photo 8

Description: Bulk Metal Facility outside the community. Hazardous Waste Oil cans

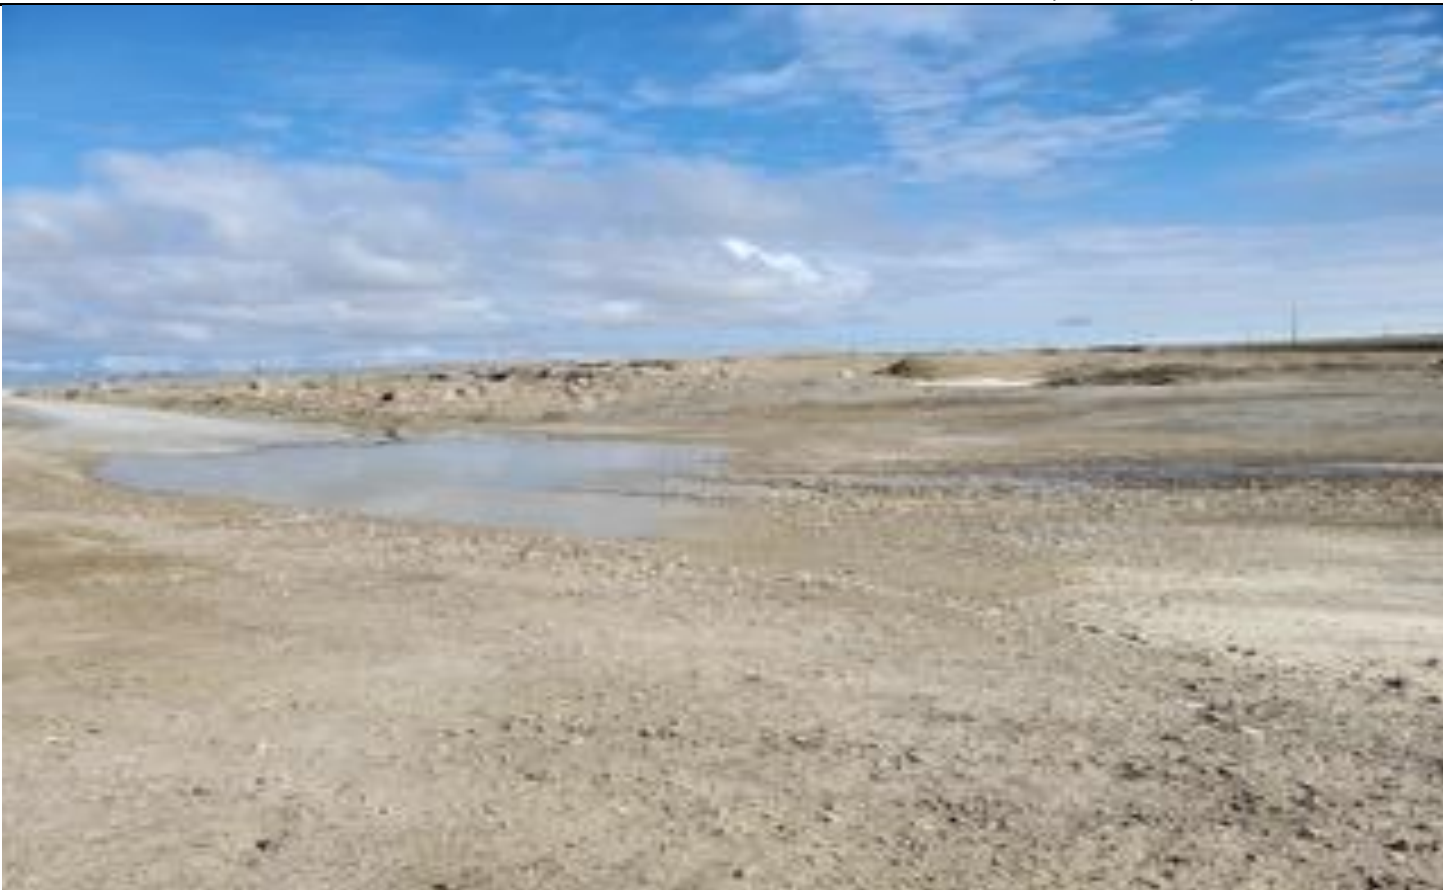
Photo 9

Description: A pool of surface water at the entrance to the Bulk Metal Facility outside the community and Sewage Lagoon.

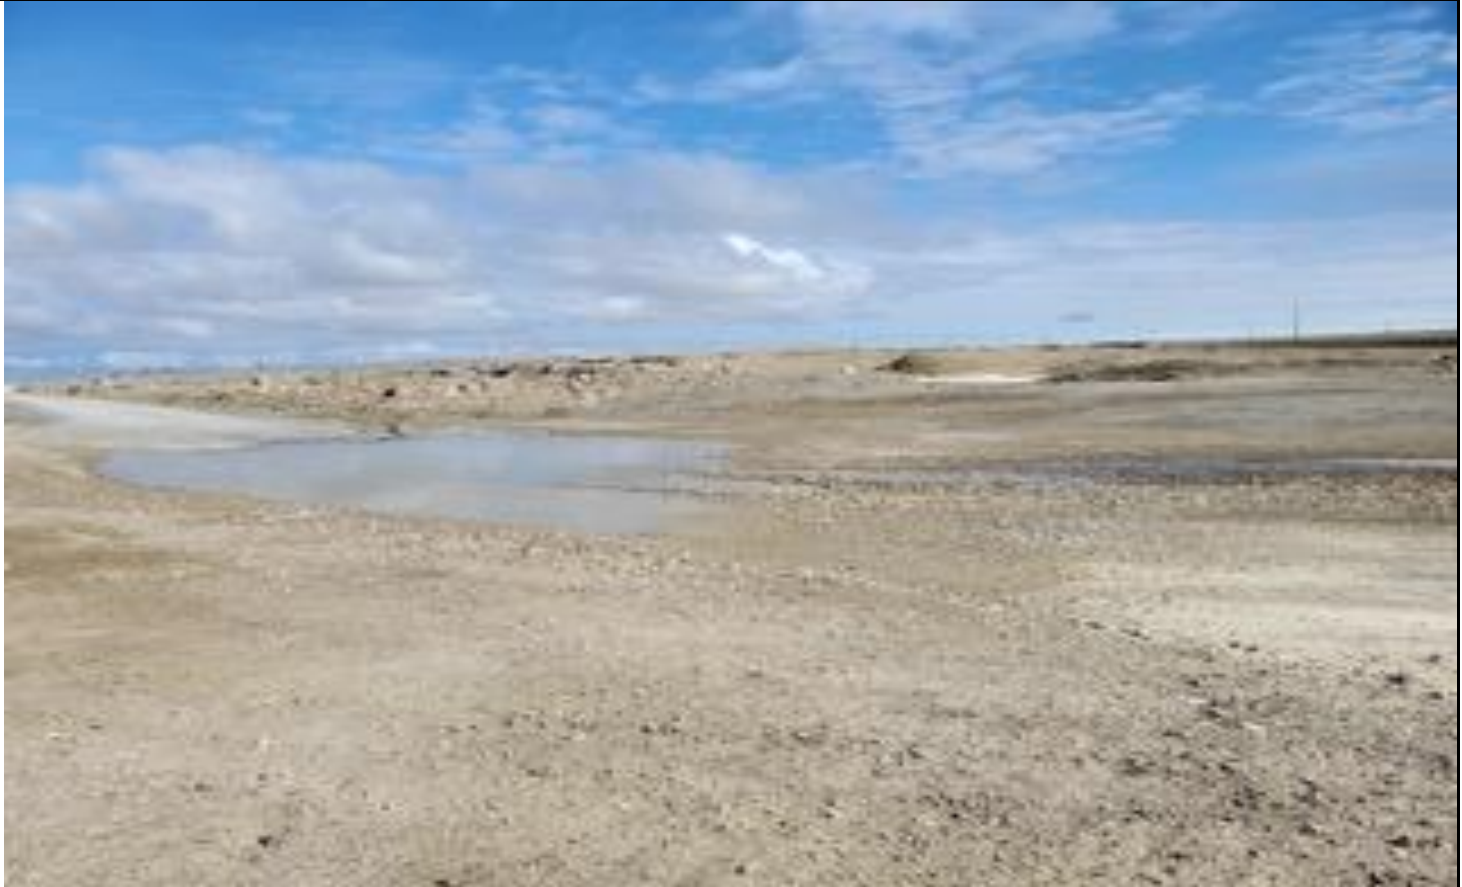
| Photo Log | Location |
|---|---|
| Photo 9 | New Bulk Metal Solid Waste Facility, Resolute Bay, NU |

| Photo Log | Location |
|---|---|
| Description: A pool of surface water at the entrance to the Bulk Metal Facility outside the community and Sewage Lagoon. | |
