## **SITE CHARACTERIZATION, *EX SITU* BIOPILES AND *IN SITU* PILOT SCALE BIOREMEDIATION STUDIES AT CFS-ALERT, NUNAVUT**

**Final Report 2008-2009**

March 31, 2009

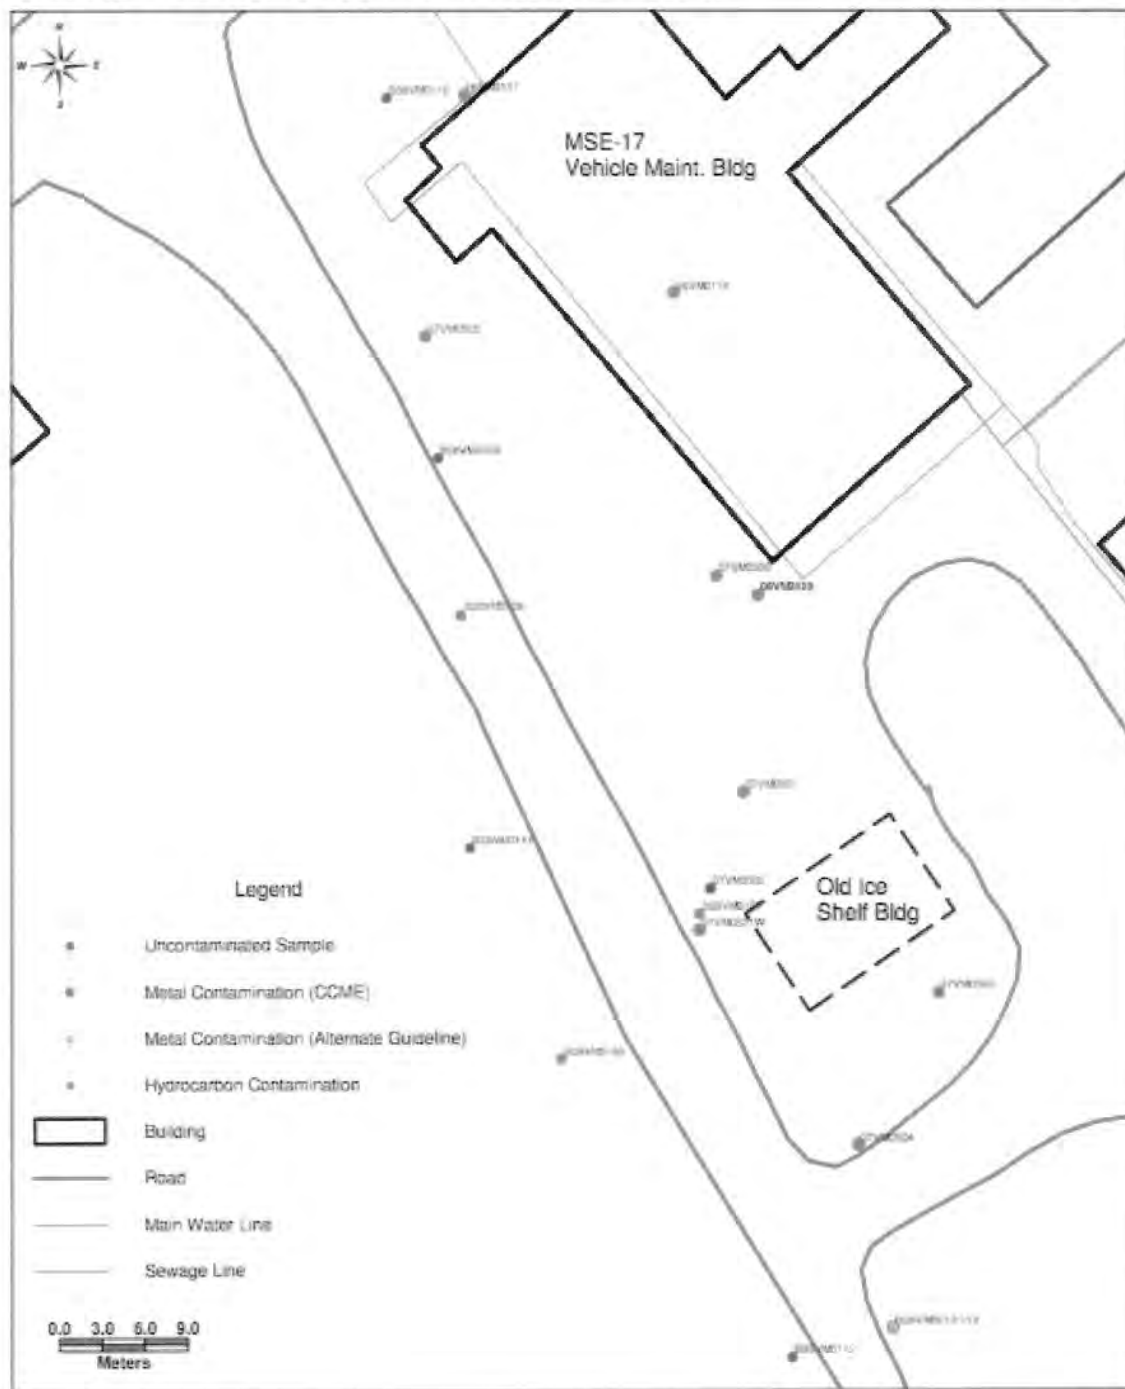
Figure 7. S-10195 MSE-17 Vehicle Maintenance Building map.

CHARACTERIZATION OF CONTAMINATED SITE / 2006-09

During the 2006 and 2007 field seasons, sampling focused on the area behind the MSE-17 Vehicle Maintenance building and the down slope area between the building and Herc drive (Figure 7). Hydrocarbon contamination (F1-F4) was found exceeding guidelines in samples collected from either the surface (approximately 20 cm depth) or suprapermafrost

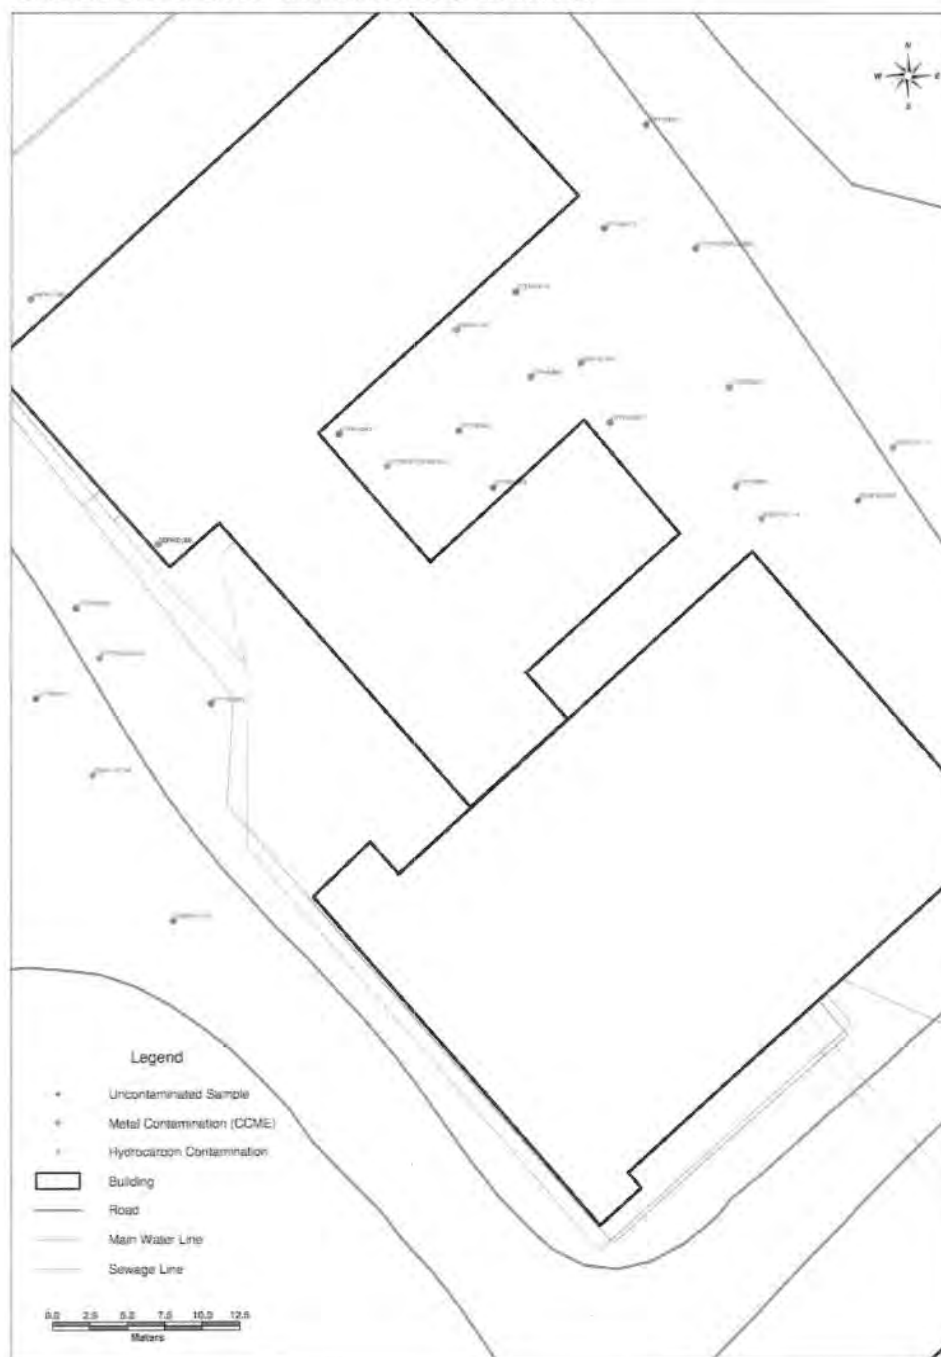
Figure 9. S-10199 CE-140 MCE Building Fire Hall map.

**CE-140 MCE BUILDING FIRE HALL (S-10199)**  
CHARACTERIZATION OF CONTAMINATED SITE / 2006-09

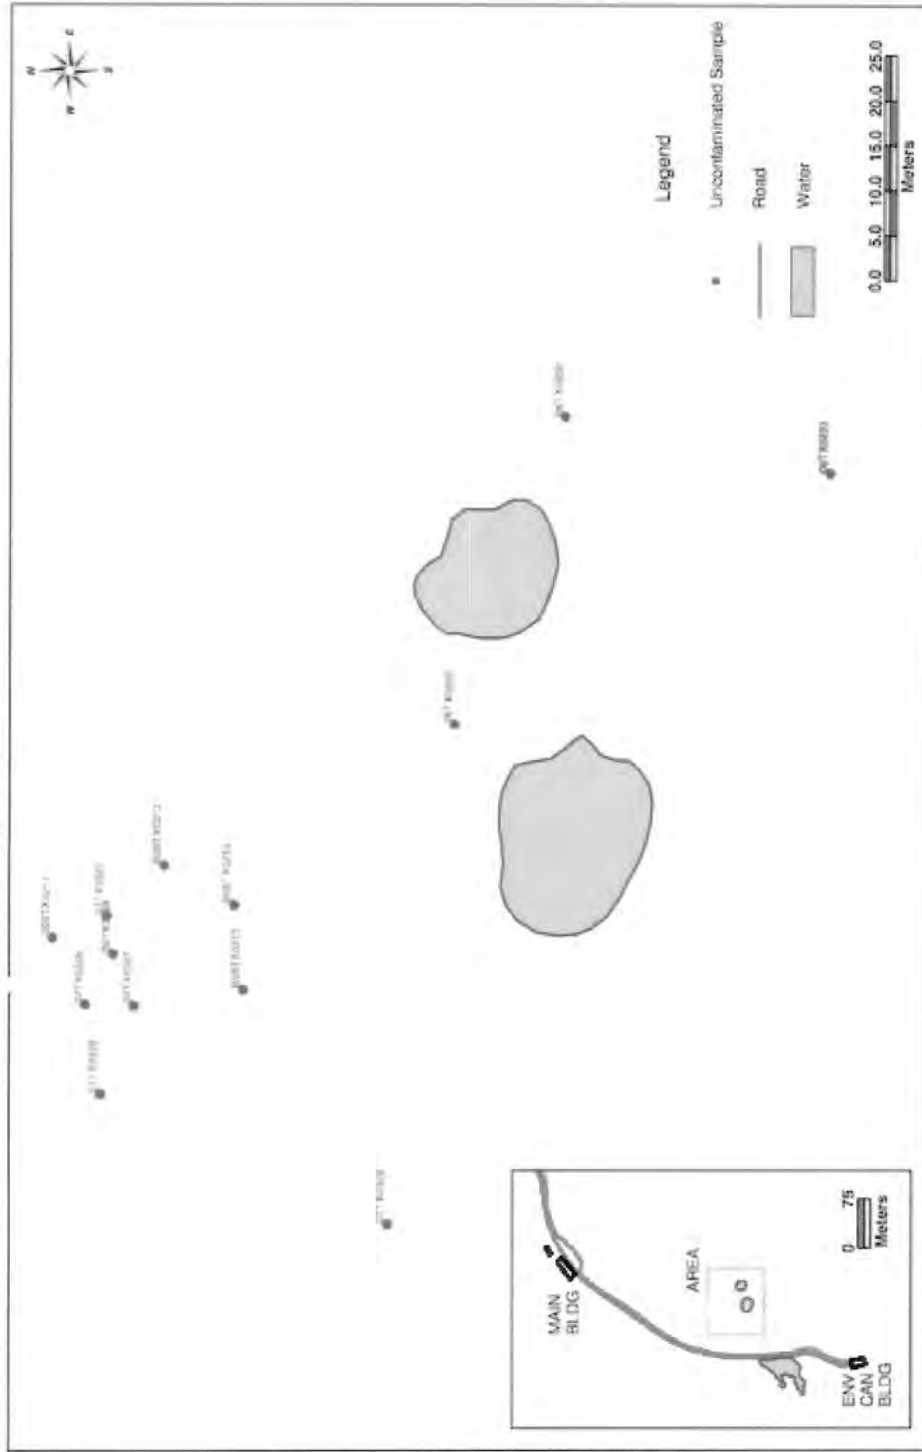
Figure 11. S-10206 TX Site map 2.

**TX SITE, REMAINS BLDG AREA (S-10206) (2)**  
 CHARACTERIZATION OF CONTAMINATED SITE / 2006-09

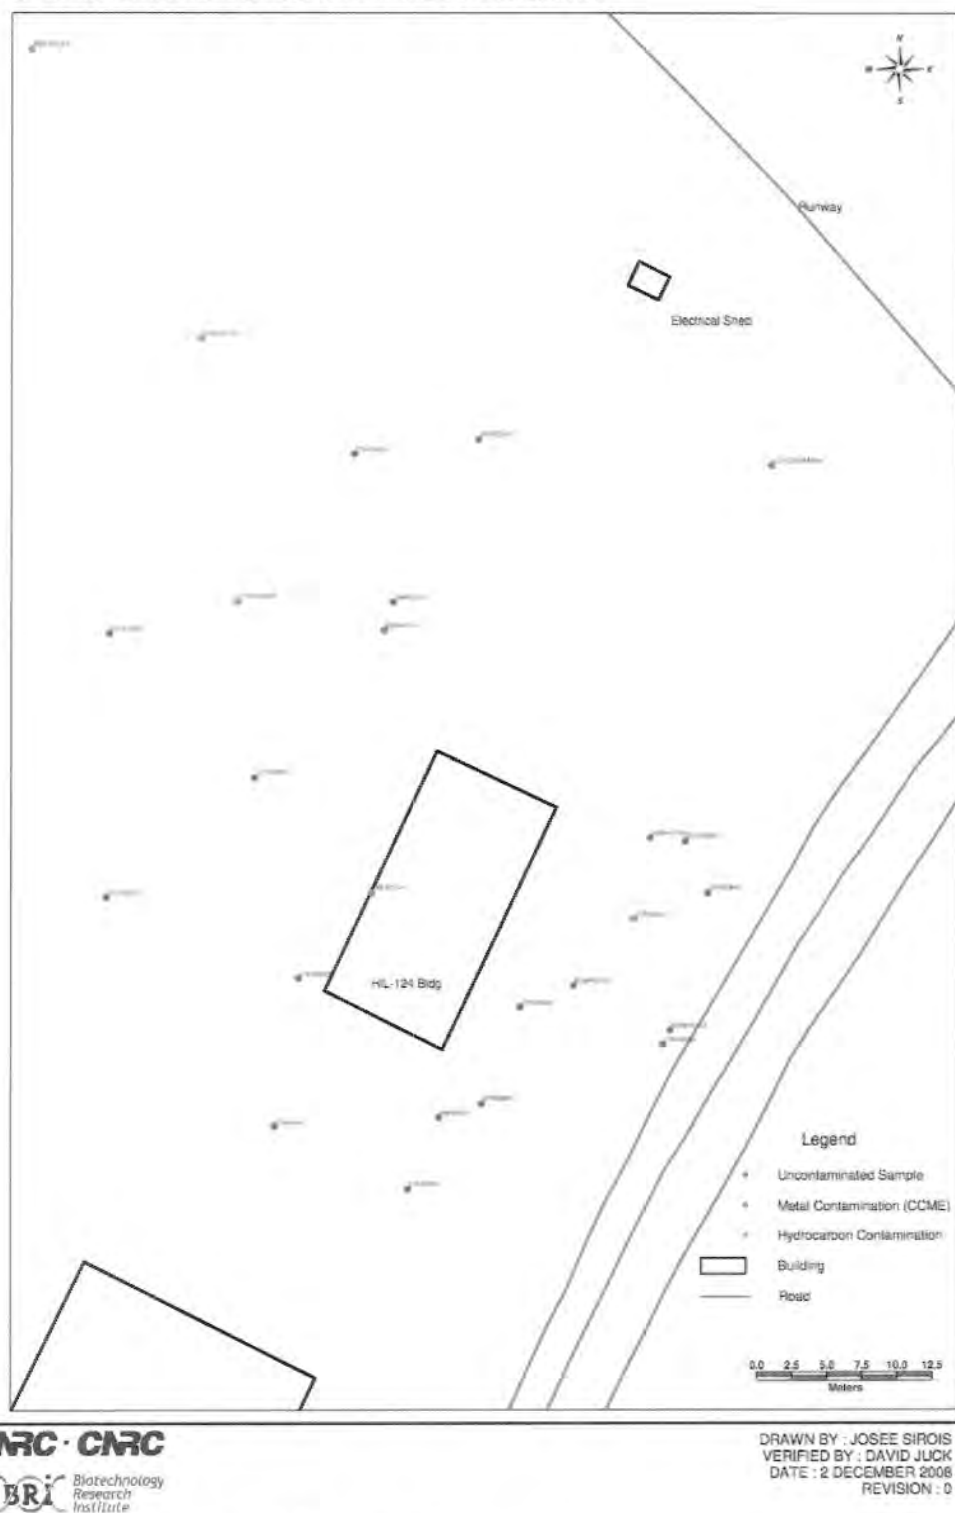
Figure 12. S-10207 Airstrip Building HIL-124 map.

**AIRSTRIP BUILDING HIL-124 (S-10207)**  
CHARACTERIZATION OF CONTAMINATED SITE / 2006-09

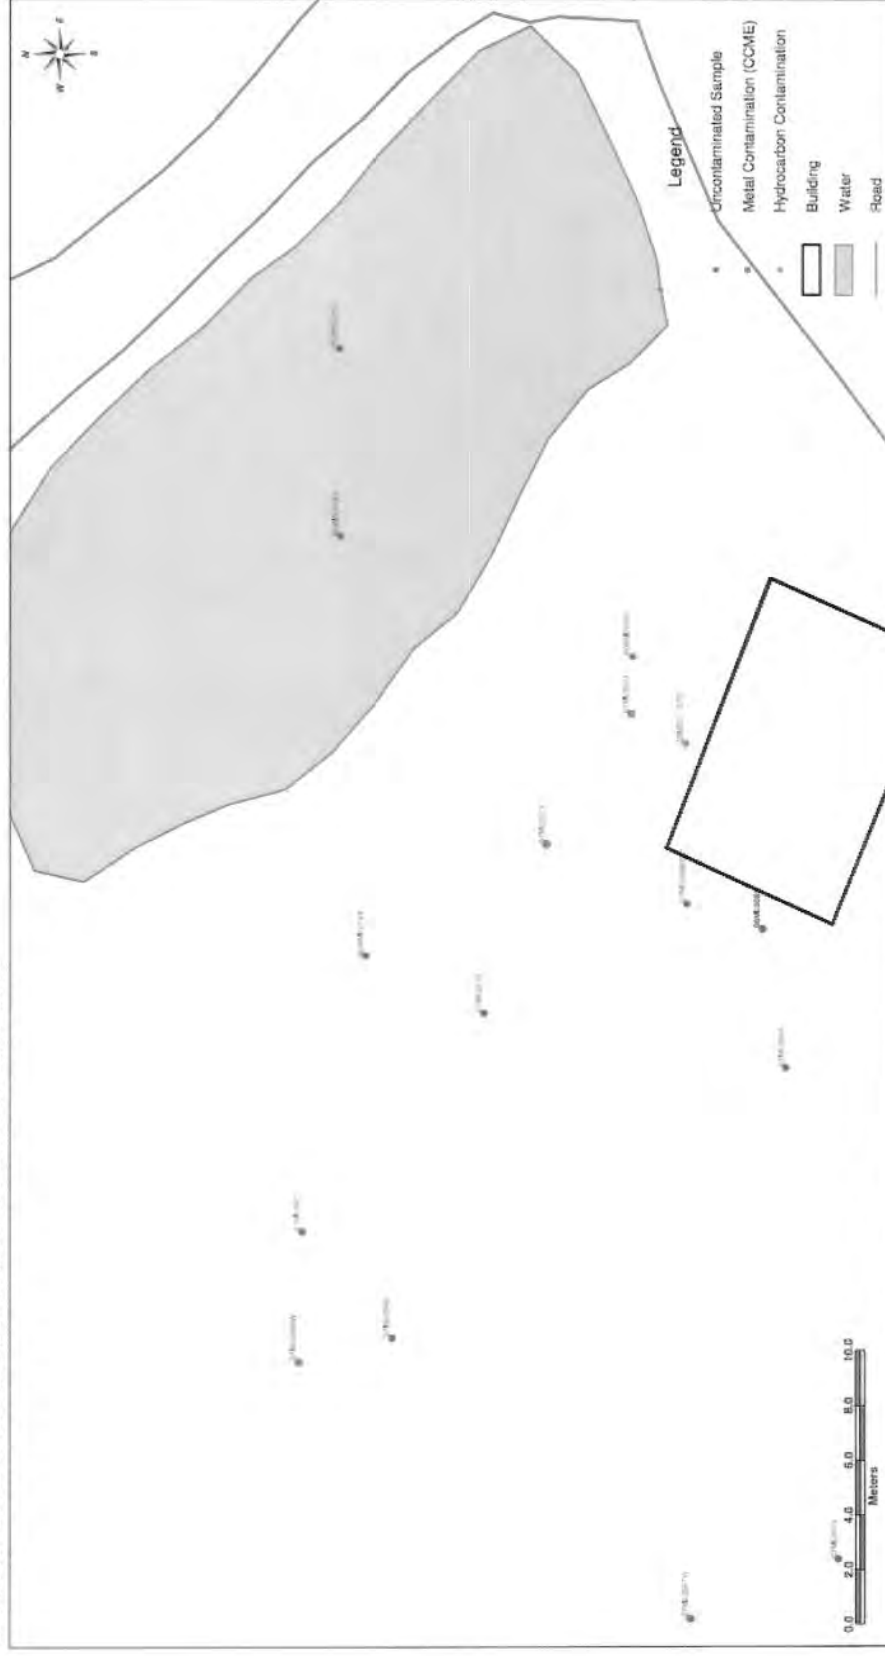
Figure 14. S-10212 Airstrip Met Shack map.

**AIRSTRIP MET SHACK (S-10212)**  
 CHARACTERIZATION OF CONTAMINATED SITE / 2006-2008

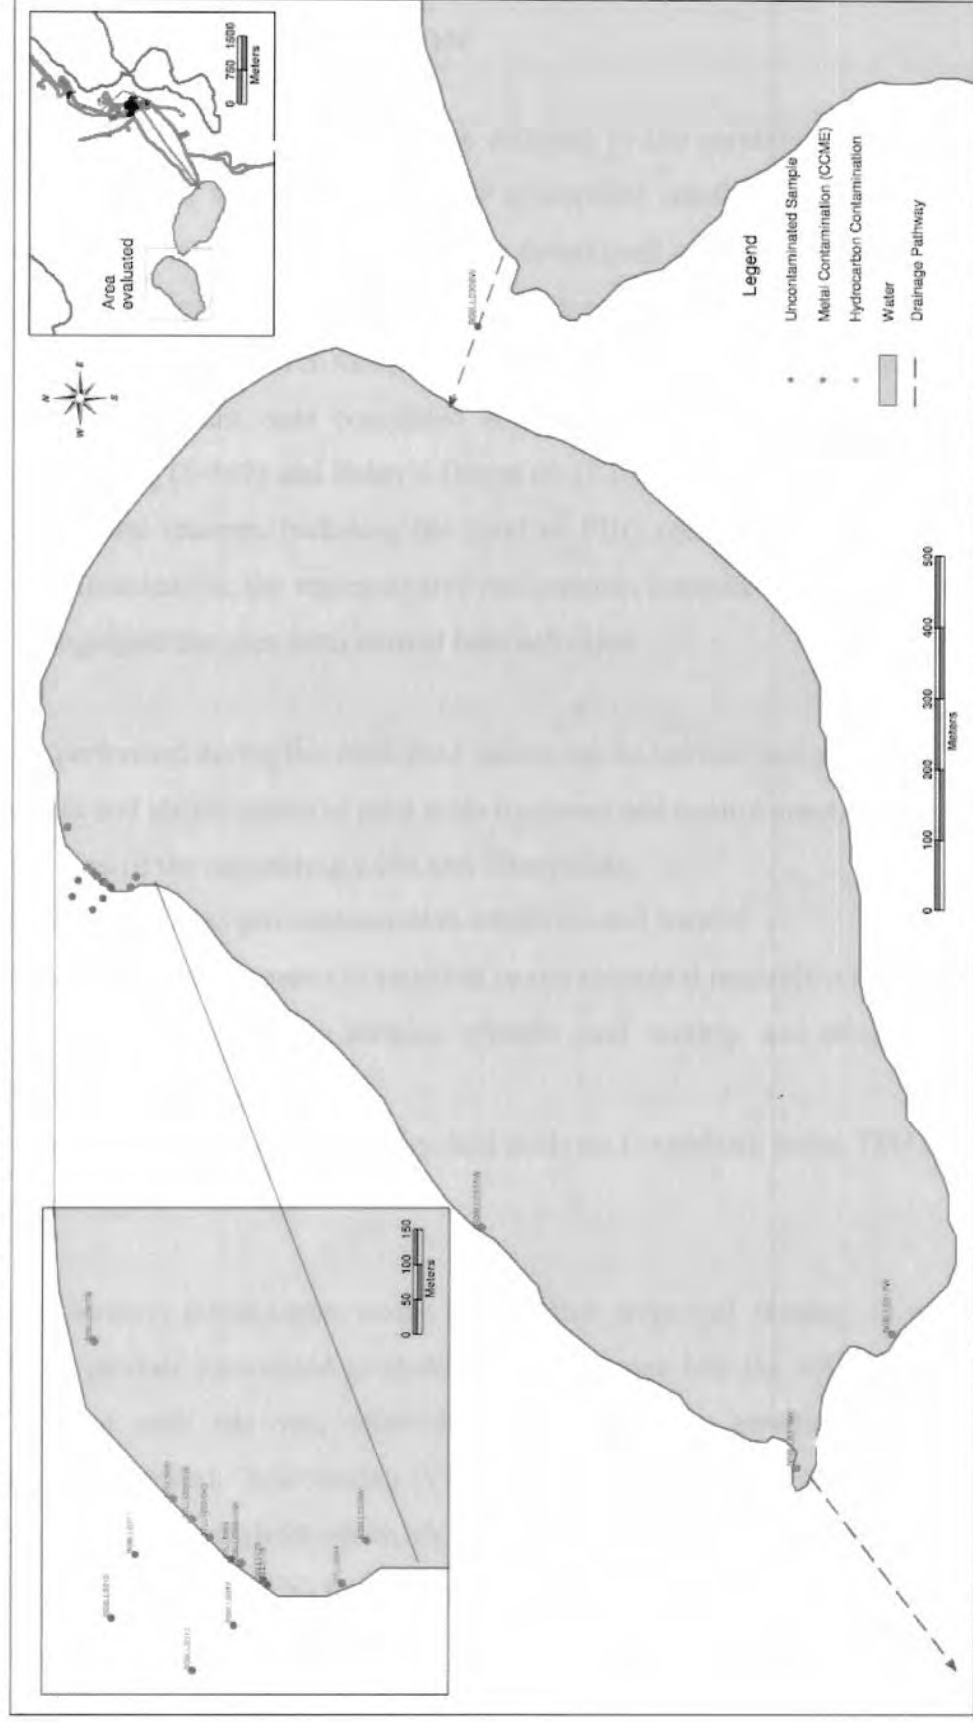
Figure 22. S-10529 Lower Dumbell Lake map.

**LOWER DUMBELL LAKE (S-10529)**  
 CHARACTERIZATION OF CONTAMINATED SITE / 2007-09
