July 24, 2001 Municipal Water Use Inspection - Report

MUNICIPAL WATER USE INSPECTION FORM

Date: 2001/07/24 Licensee Rep. (Name/Title): Sam Willie / Foreman
Licensee: Municipality of Arctic Bay Licence No.: unlicensed

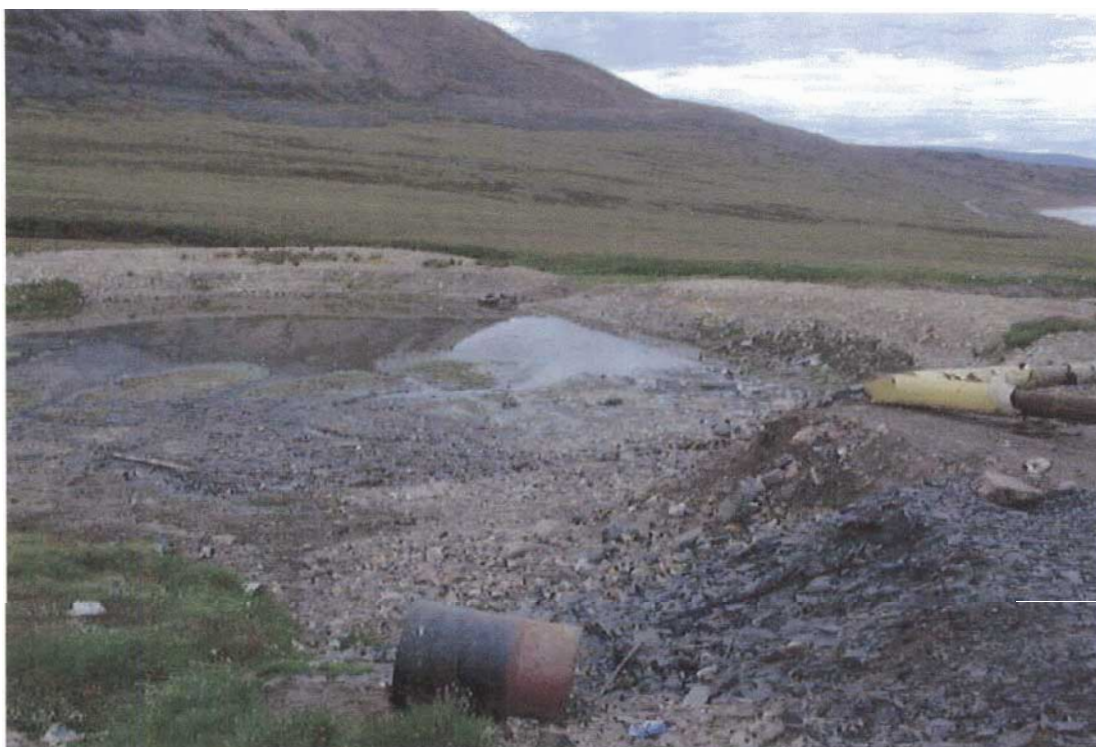
- **Sewage disposal:** At the time of the inspection, the sewage disposal facility was almost entirely emptied of its contents (figure 1). In fact, due to the severe erosion of the facility's decant structure (figure 2), the discharge of effluent is essentially unhindered. Moreover, although abundant vegetation growth is noticeable along the path of discharge, the lack of retention and treatment time provided by the sewage disposal facility likely impacts negatively on the overall treatment efficiency. Accordingly, the attached analytical results relating to a sample taken five metres below the decant structure (figure 3), while revealing elevated levels of suspended solids (223 mg/L), indicate that both ammonia (91.2 mg/L vs 2.2 mg/L) and phenols (300 µg/L vs 4 µg/L) significantly exceed the *Canadian Water Quality Guidelines for the Protection of Freshwater Aquatic Life*. Regardless, the Microtox sample, which constitutes a reliable toxicity indicator (IC₅₀), did not attribute toxicity to the sewage effluent discharge. Again, bacteriological parameters could not be analysed. In light of this, the Inspector is glad to hear that third party assistance on the matter was slated for the summer.

figure 1. Sewage disposal facility; 2001/07/24.

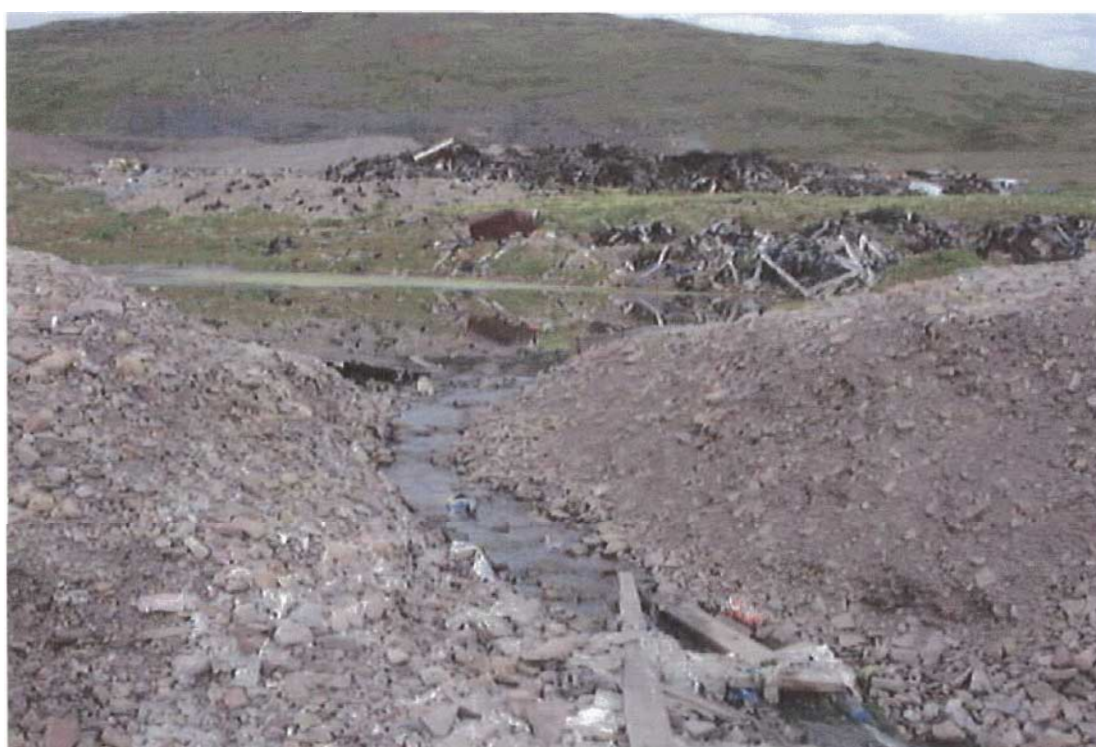
Comments: Sewage disposal facility's decant structure severely eroded; discharge of sewage effluent is essentially unhindered. Facility reportedly once again overflowed during springtime; third party assistance scheduled for the summer. Minor erosion also noted at the truck dumping point. Considerable vegetation noted growing along the path of discharge from the facility. Combustible wastes well managed at the unfenced solid waste disposal facility; wastepile adequately compacted and covered. Work on bulky metal wastes site nearing completion; only finishing and covering efforts remain. Batteries stored in sealift container until proper disposal; awaiting plastic drums from a third party in order to undertake neutralization. Waste oil storage and disposal properly handled. Trickling leachate flow noticeable along the toe of the wastepile. Runoff from the bulky metal wastes disposal site is channeled alongside the access road.

figure 2. Decanting area of the sewage disposal facility; 2001/07/24.

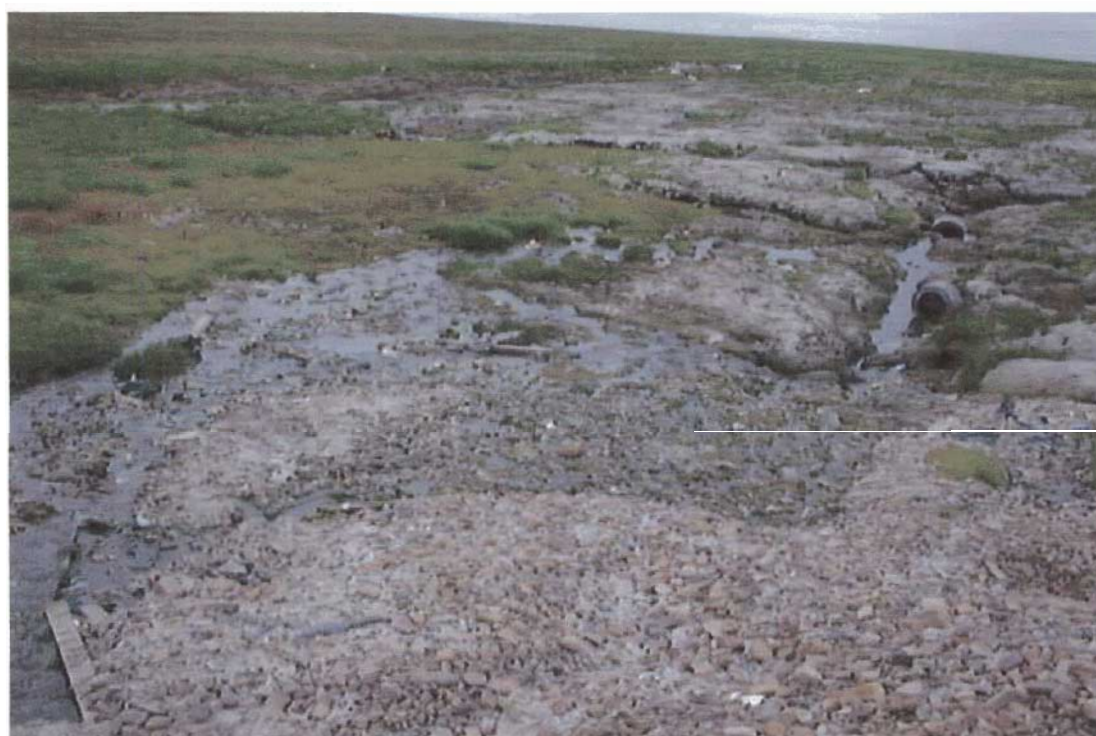
figure 3. Path of effluent discharge from the sewage disposal facility; 2001/07/24.

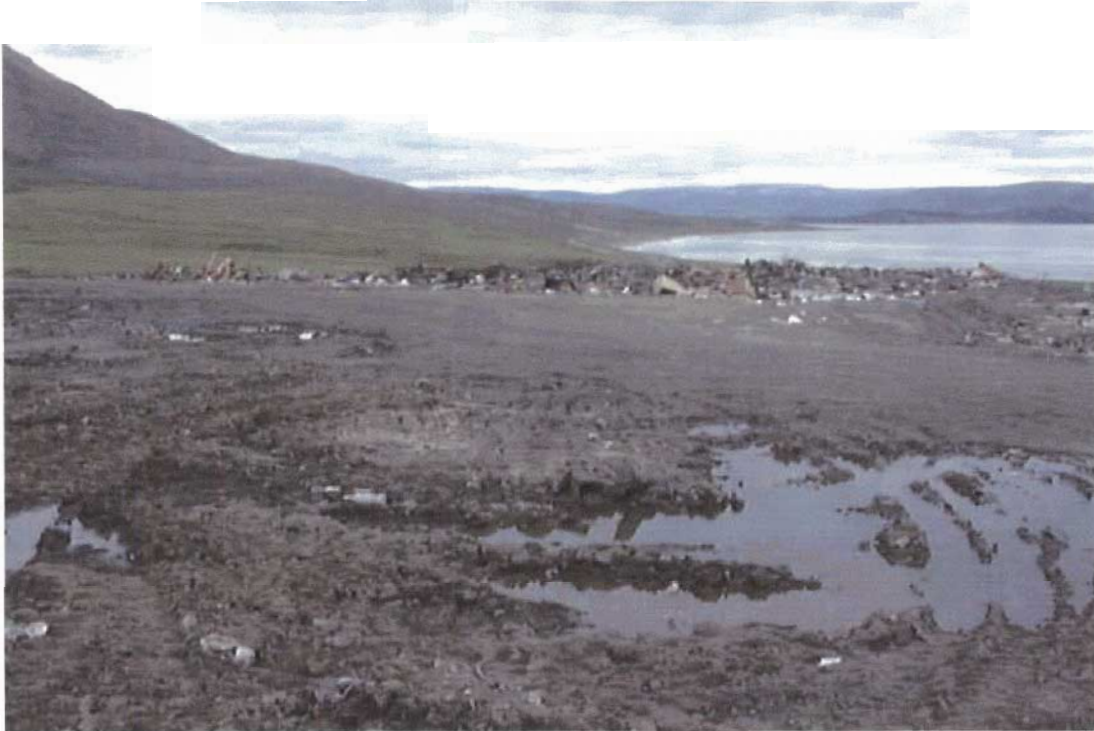
- **Solid waste disposal:** Adequate compaction and coverage of combustible wastes are maintained at the solid waste disposal facility (figure 4). Nevertheless, a trickling flow of leachate was noticeable along the toe of the wastepile (figure 5). However, the associated Microtox sample did not denote toxicity. In regards to the bulky metal wastes disposal site, the inspector acknowledges that considerable improvements have been made and that only the finishing touches to the consolidation and burial work remain to be undertaken. In spite of this, the attached analytical results relating to a runoff sample collected along the roadside downslope of the site (figure 6) reveal that the concentrations of copper ($7 \mu\text{g/L}$ vs $4 \mu\text{g/L}$) and zinc ($123 \mu\text{g/L}$ vs $30 \mu\text{g/L}$) slightly exceed the *Canadian Water Quality Guidelines for the Protection of Freshwater Aquatic Life*. On a side note, it was mentioned during the inspection that the Municipality intends to install a perimeter fence around the waste disposal facilities once the ongoing/pending work at the bulky metal wastes disposal site and at the sewage disposal facility are completed.

figure 4. Solid waste disposal facility; 2001/07/24.

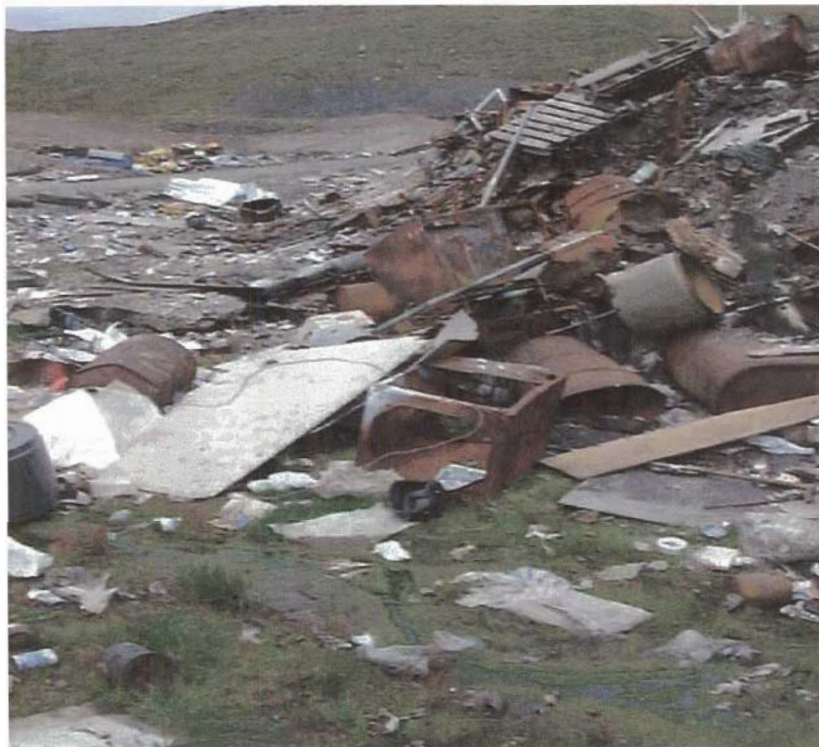
figure 5. Leachate flowing from the toe of the solid waste disposal facility; 2001/07/24.

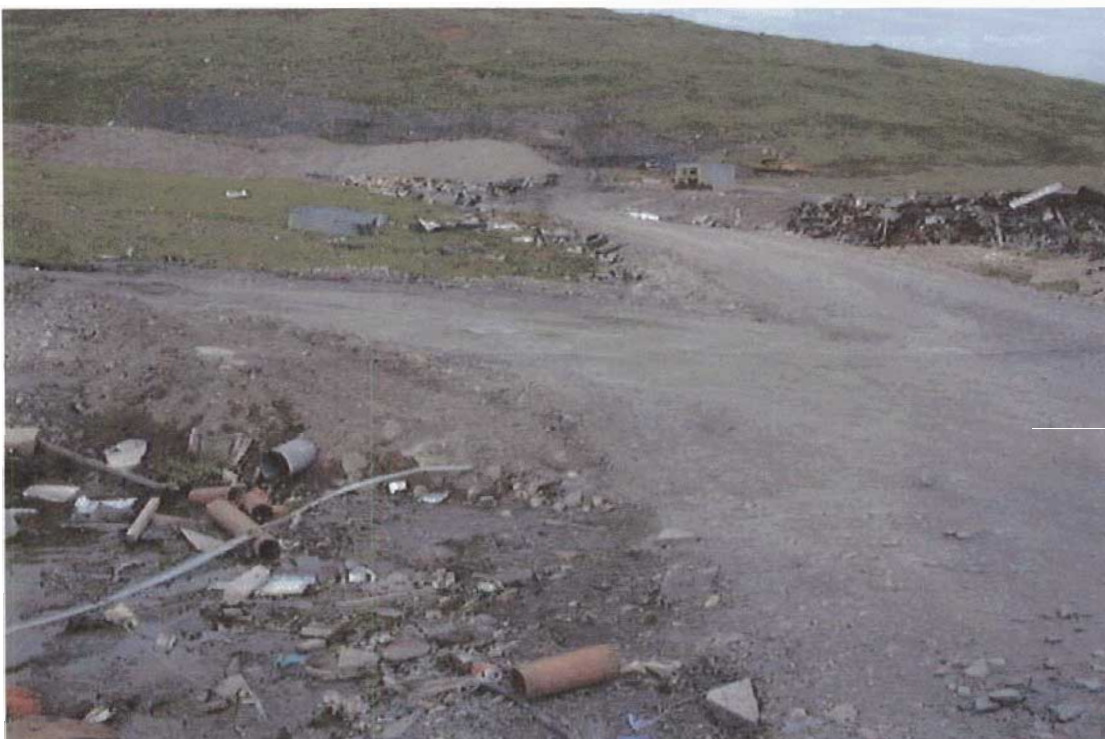
figure 6. Bulky metal disposal site runoff channelled along the roadside; 2001/07/24.
