**August 29, 2000 Municipal Water Use Inspection - Report**

## MUNICIPAL WATER USE INSPECTION FORM

Date: 2000/08/29 Licensee Rep. (Name/Title): Mike Gibbons / Foreman  
Licensee: Hamlet of Arviat Licence No.: unlicenced

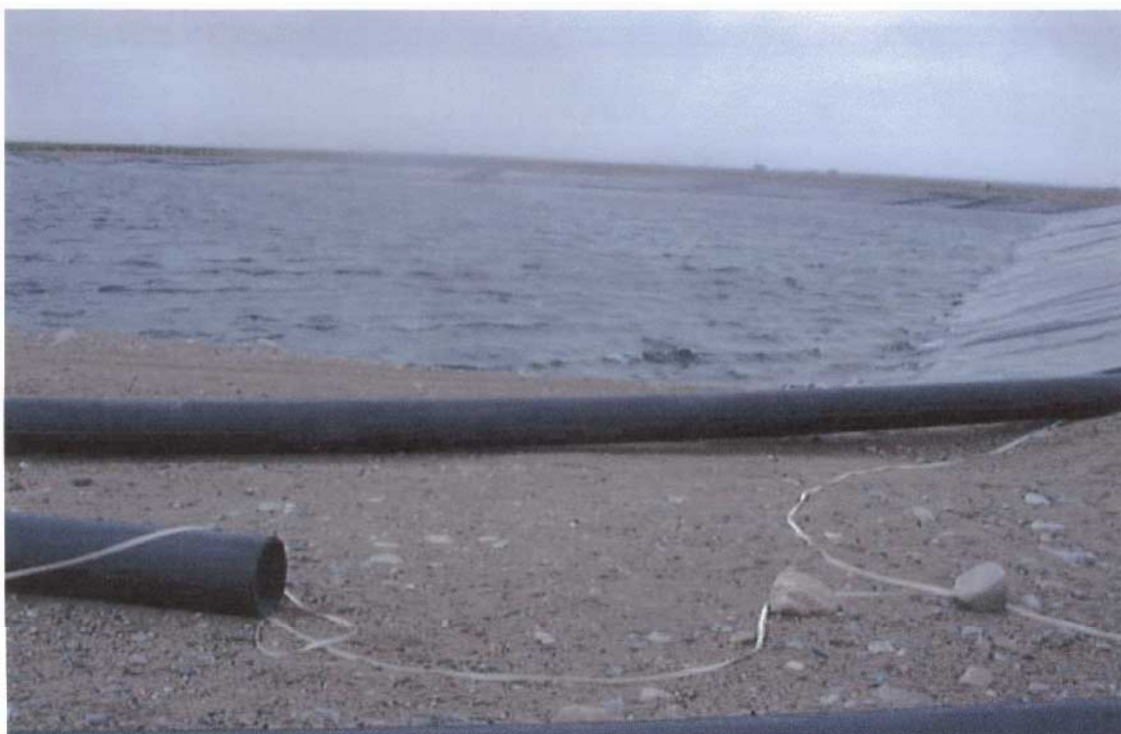
- **Water supply:** At the time of the inspection, the expansion work on the smallest of the water reservoir's holding cells was practically completed (figure 1). However, the older holding cell, which was previously drained and cleaned, had yet to be refilled (figure 2).

**figure 1.** Recently expended holding cell, water reservoir; 2000/08/29.

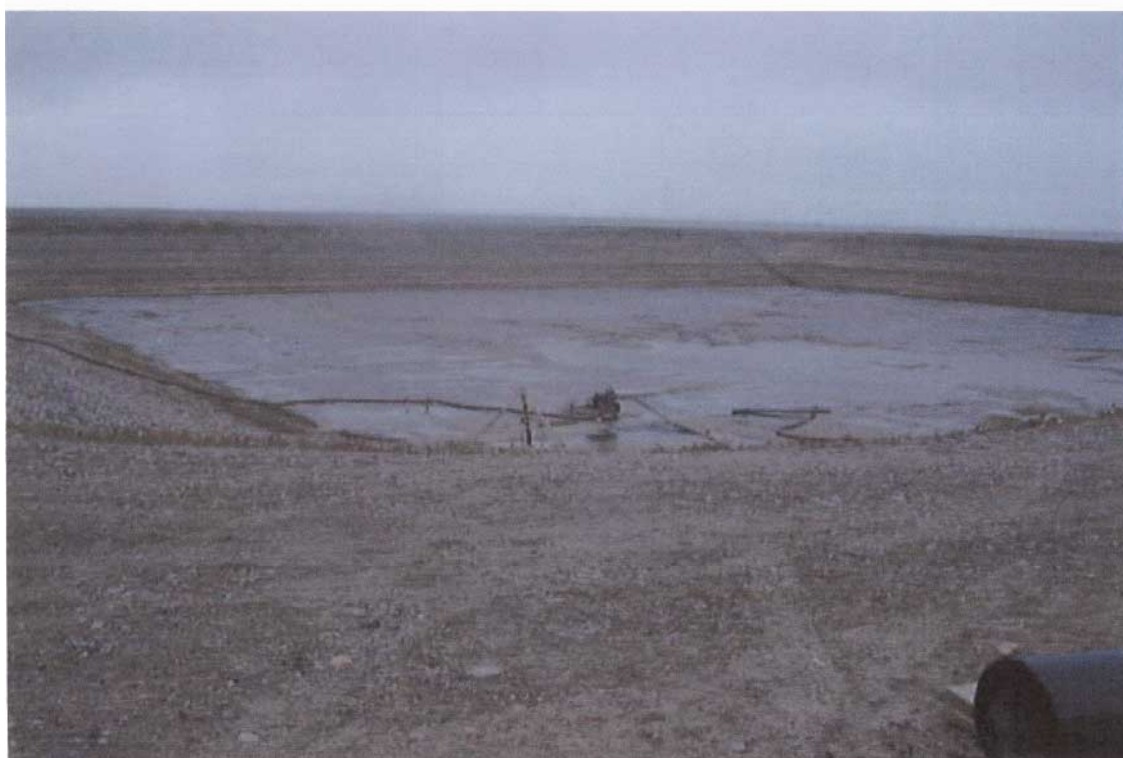
**figure 2.** Older holding cell, water reservoir; 2000/08/29.

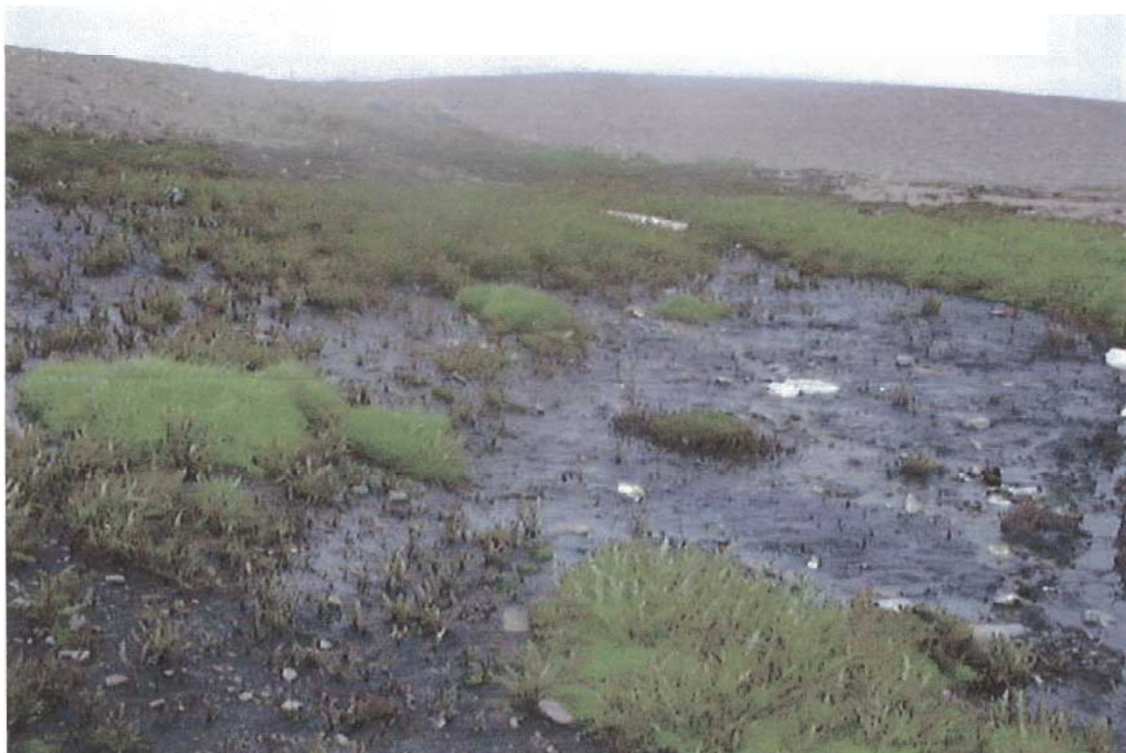
- **Sewage waste disposal:** Seepage from the permeable berm of the sewage lagoon (figure 3) flows down through abundant vegetation along the discharge path (figure 4), thus likely enhancing the treatment of the effluent. As such, the attached analytical results relating to the discharge from the sewage disposal facility reveal acceptable concentrations of most tested parameters. However, the recorded ammonia level exceeds recommended guidelines for the protection of both freshwater and marine aquatic life. As a side note, the green tinge of the sewage lagoon's contents (figure 5) can reportedly be attributed to a seasonal algal bloom.

**figure 3.** Seepage from the sewage lagoon; 2000/08/29.

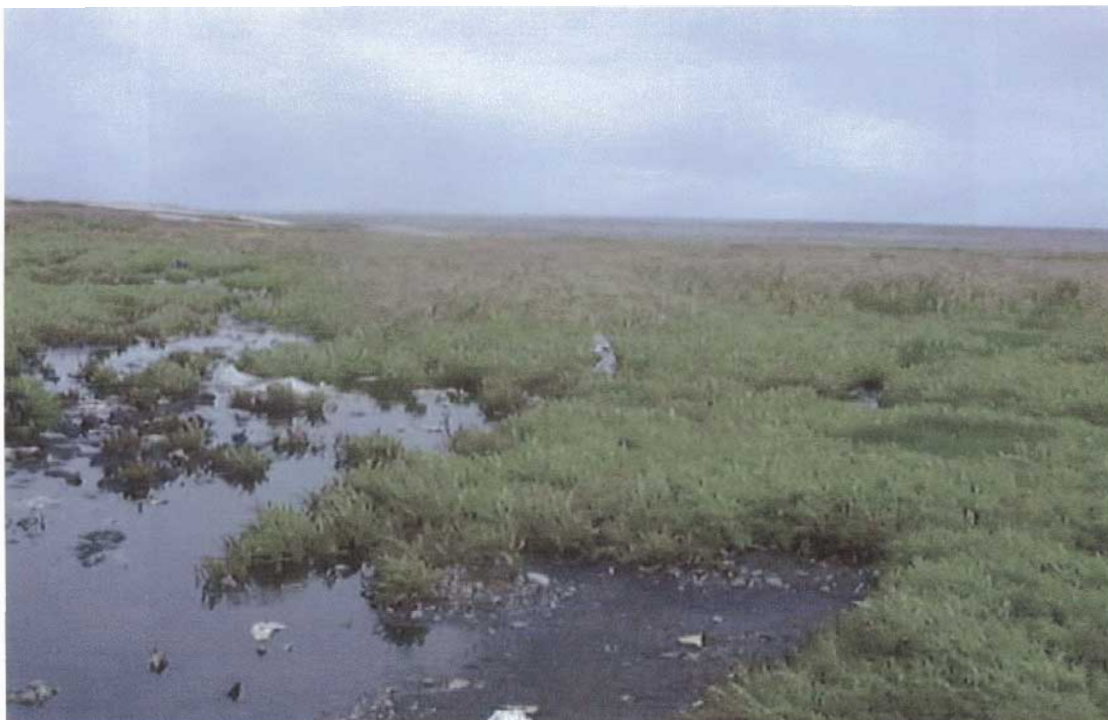
**figure 4.** Path of discharge from the sewage lagoon; 2000/08/29.

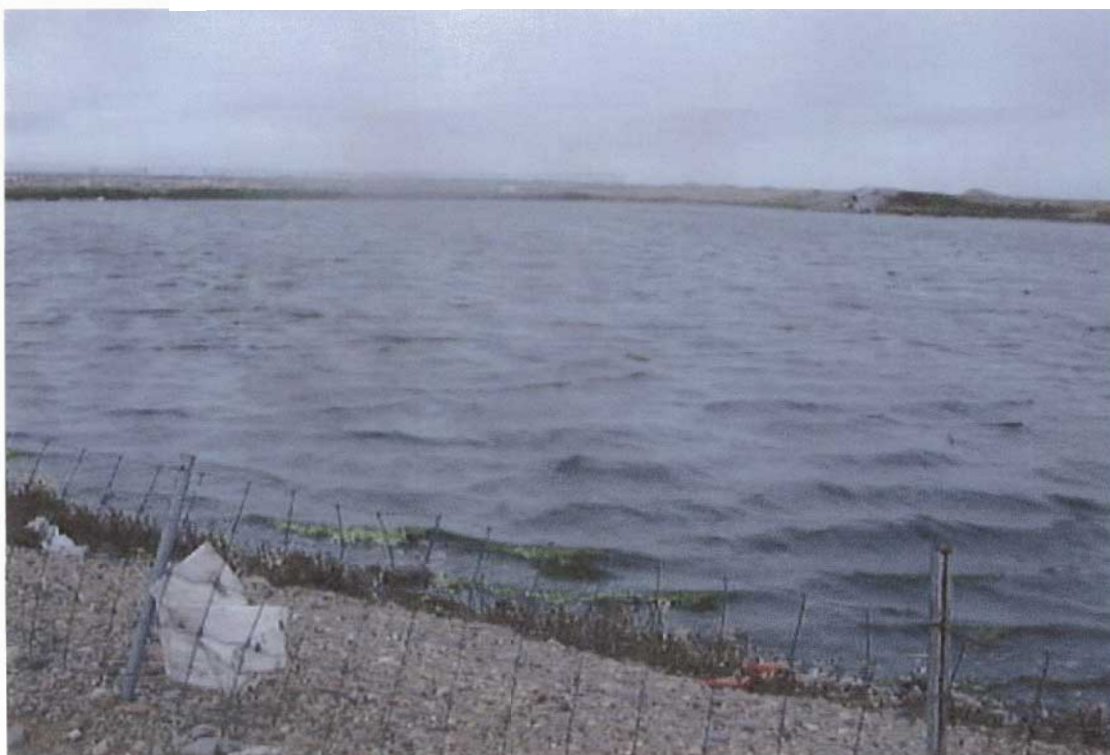
**figure 5.** Sewage lagoon; 2000/08/29.

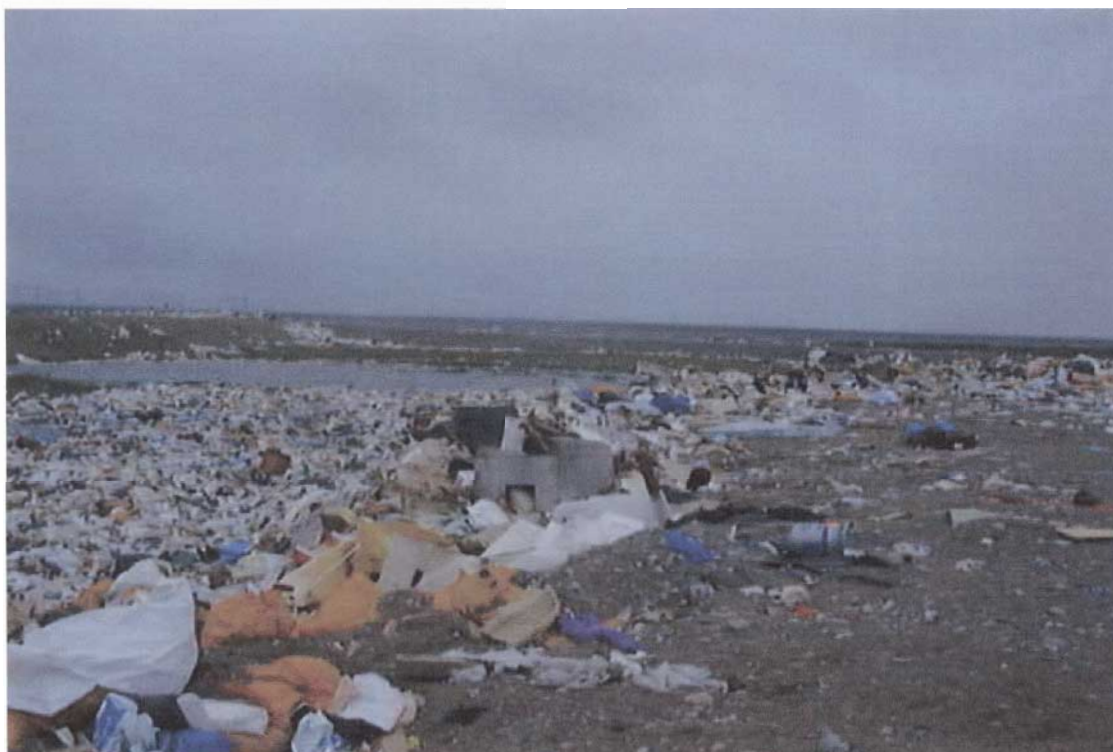
- **Solid waste disposal:** A substantial amount of waste has accumulated at the solid waste disposal facility (figure 6). Although the Inspector acknowledges that the Hamlet intends to burn/compact and cover the waste as soon as prevailing winds become favourable, such a quantity of scattered waste is nonetheless far from ideal. Indeed, as the perimeter fence is partly dismantled and as the wastepile is encroaching upon a marshy area, concerns relating to windblown material and leachate respectively arise. In this regards, while pooled water was observed at the toe of the solid waste disposal facility (figures 7-8), no leachate was noted actively flowing from the site.

**figure 6.** Solid waste disposal facility; 2000/08/29.

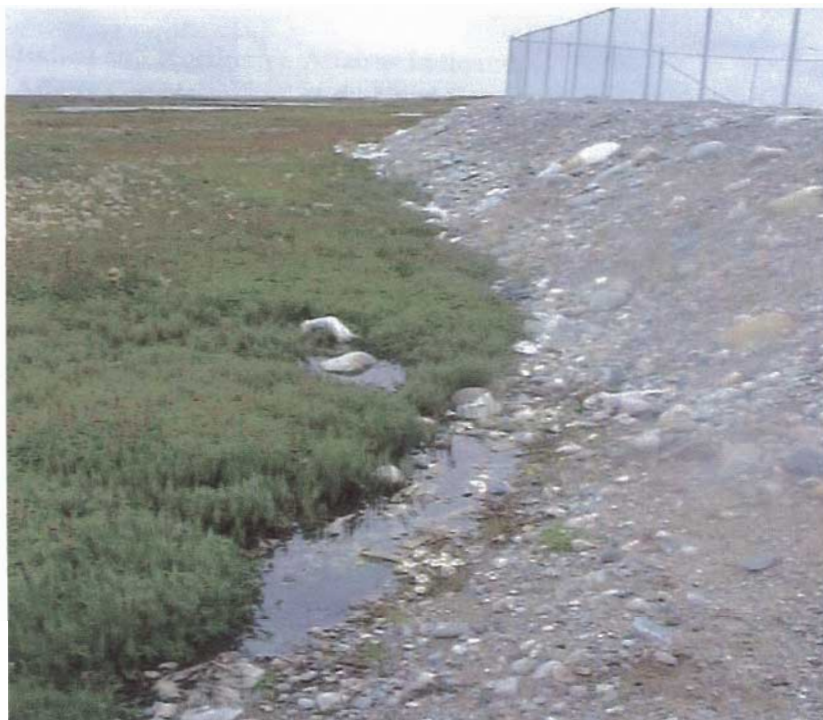
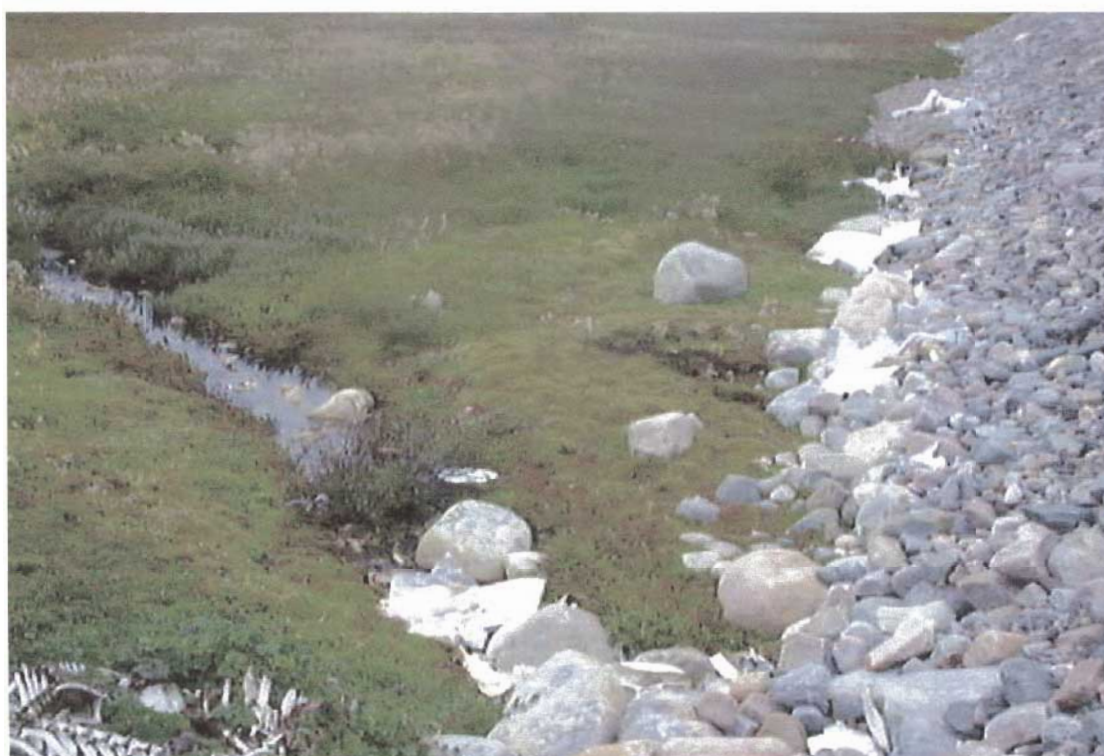
**figure 7.** Pooled water at the toe of the solid waste disposal facility; 2000/08/29.

**figure 8.** Pooled water at the toe of the solid waste disposal facility; 2000/08/29.

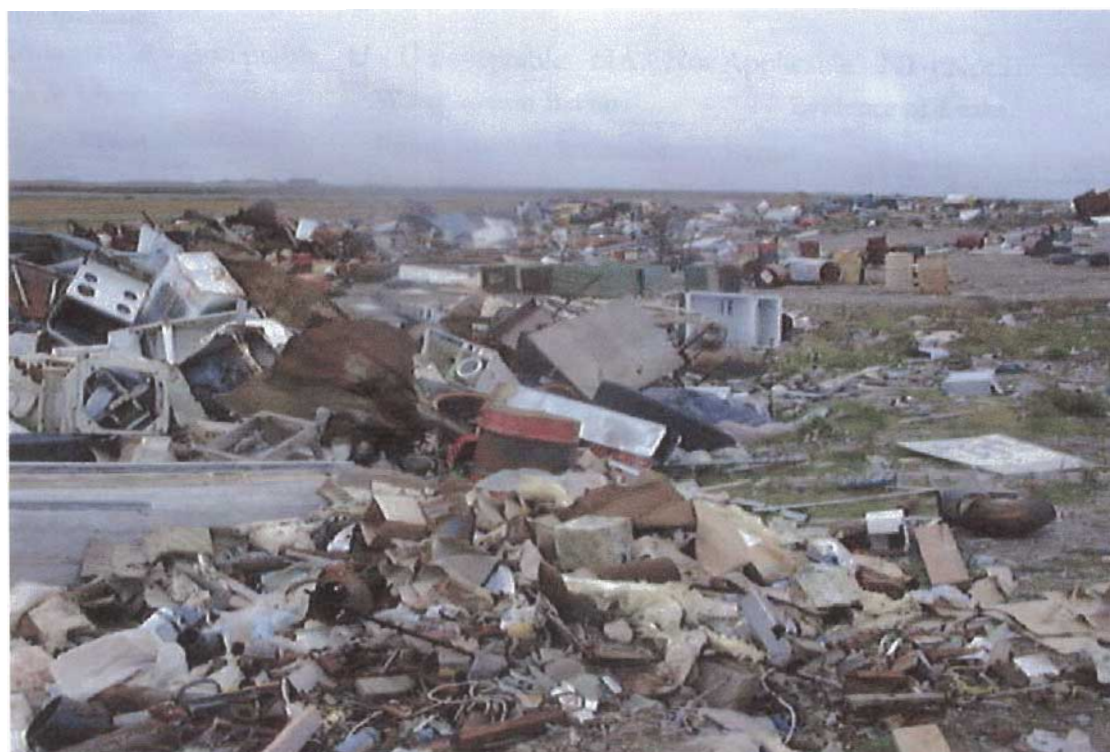
In parallel, the bulky metal wastes disposal site also covers an extensive area (figure 9). Accordingly, the Hamlet was planning to bulldoze the waste into a more compact and confined site. In addition, the Hamlet was planning to install a form of containment for hazardous material at the solid waste disposal facility, and was considering to acquire an incinerator in order to manage the waste oil presently handled by a contractor.

**figure 9.** Bulky metal wastes disposal site; 2000/08/29.
