**Site Investigations Report for the Sewage Disposal System
In the Hamlet of Baker Lake, NU**

Department of Community & Government Services

The Government of Nunavut

September, 2005

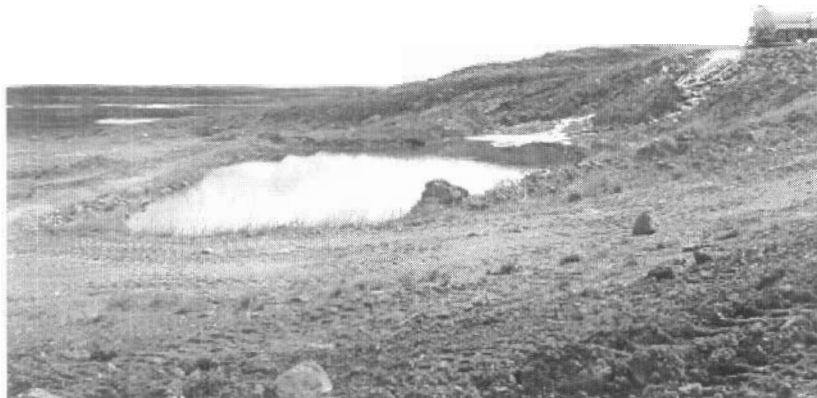
The truck-collected sewage was dumped to the bermed pond on the road side (Figure-1). The sewage was found to seep from this bermed pond. This bermed pond may partially be regarded as a primary treatment, for large particles in the sewage may settle or be screened.

Figure-1 Sewage dumping pond

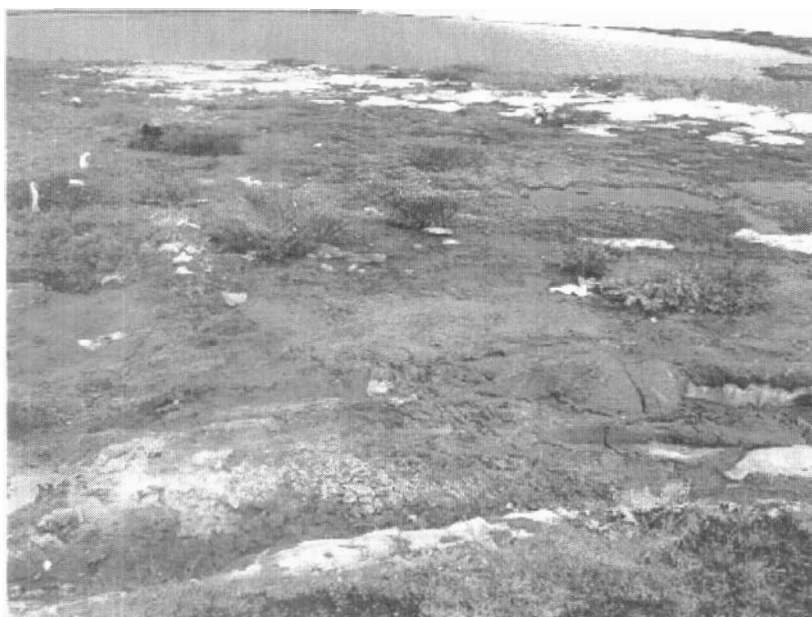
The effluent from the dumping pond flowed over the slope area and down to the first pond (P1). The slope area between the dumping pond and P1 was covered by a thick layer of slime (Figure-3).

Figure-2 Slime layers on the slope after the dumping pond

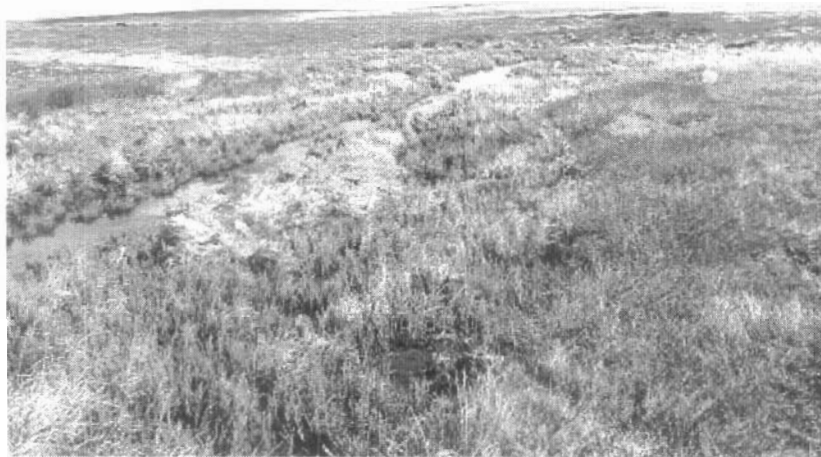
Effluent from the first pond flowed through a defined channel to the second pond while the effluent from the second pond proceeded over a large area of wetland with abundant vegetation plants to the third pond, P3 or Landing Lake, as was locally called (Figure-3, 4). The effluent from the P3 flowed by gravity through a defined sloping gravel ditch, and finally was discharged at Baker Lake (Figure-5, 6).

Figure-3 Defined channel from pond1 to pond 2

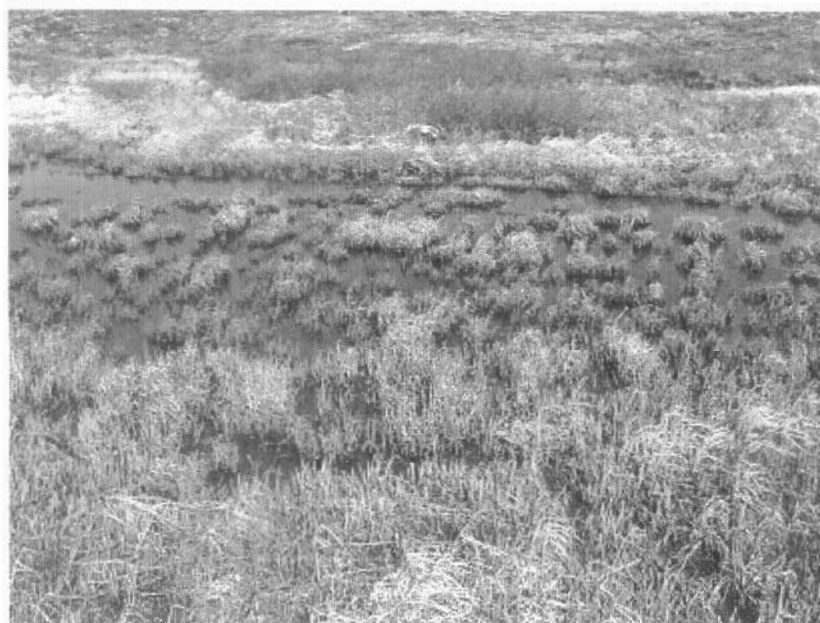
In the wetland area, abundant and thick vegetation was observed. In the relatively dry area, mosses and lichens were dominated, while in the swampy areas, sedge marshes and grasses were dominated (Figure-3, 4, 5, 8).

Figure-4 Shallow water area with species of sedges between pond 2 and pond 3

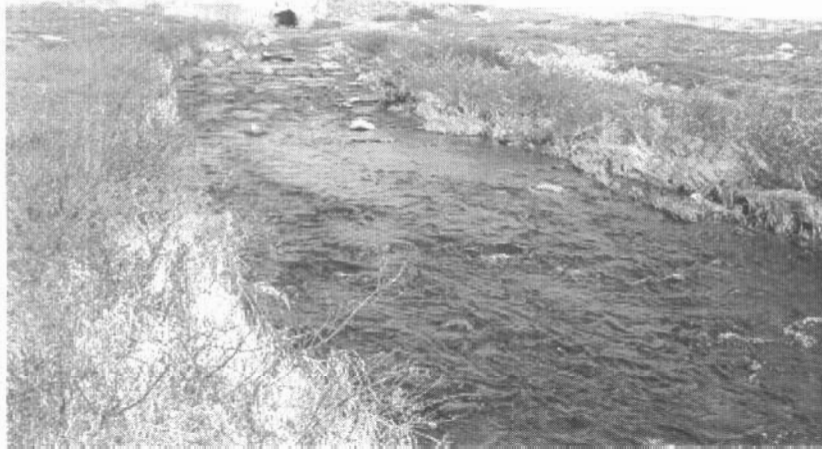
Figure-5 Confined gravel ditch for effluent to Baker Lake

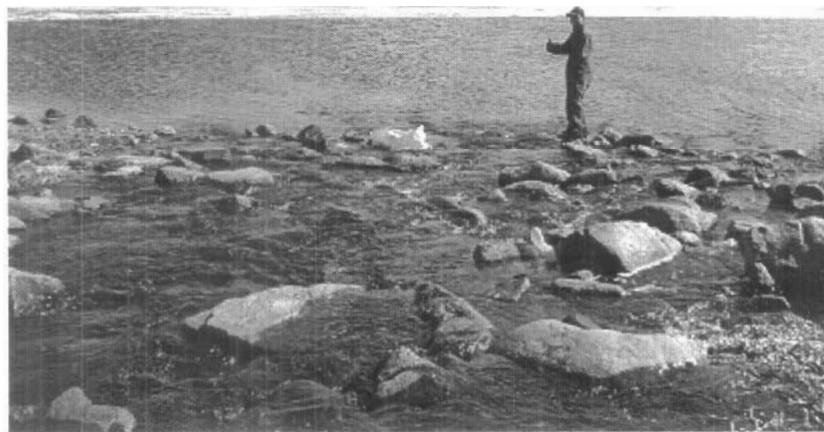
Figure-6 Final discharge point to Baker Lake

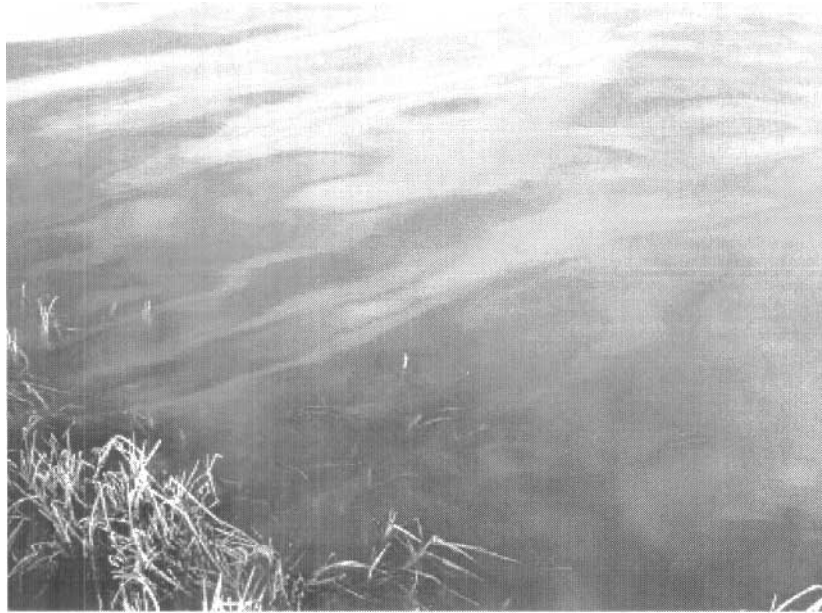
From visual inspection, the water in P1 and P2 appeared to be turbid and green in color due to algae boom (Figure-7). This was probably due to the combined functions of the rich organics and nutrients (nitrogen, phosphorous, etc.) in the water as well as the long daylight in the summer. However, the effluent from P2, after flowing over the area of

Figure-7 Algae boom in P2

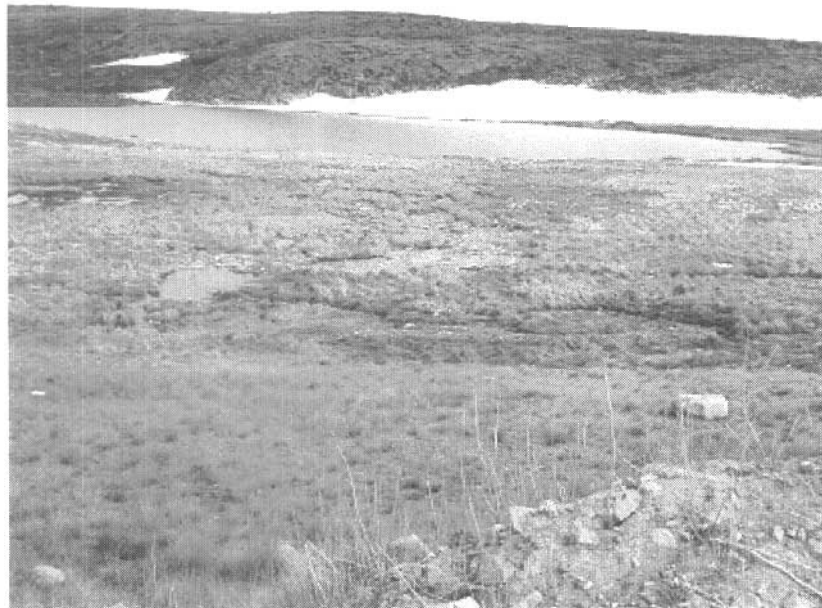
Figure-8a The vegetation plants around the P1
