August 31, 2001 Water Licence Inspection - Report

MUNICIPAL WATER USE INSPECTION FORM

Date: 2001/08/31 Licensee Rep. (Name/Title): Jeremy Singahti / Municipal Public Works Maintainer
Licensee: Hamlet of Baker Lake Licence No.: NWB3BAK9904

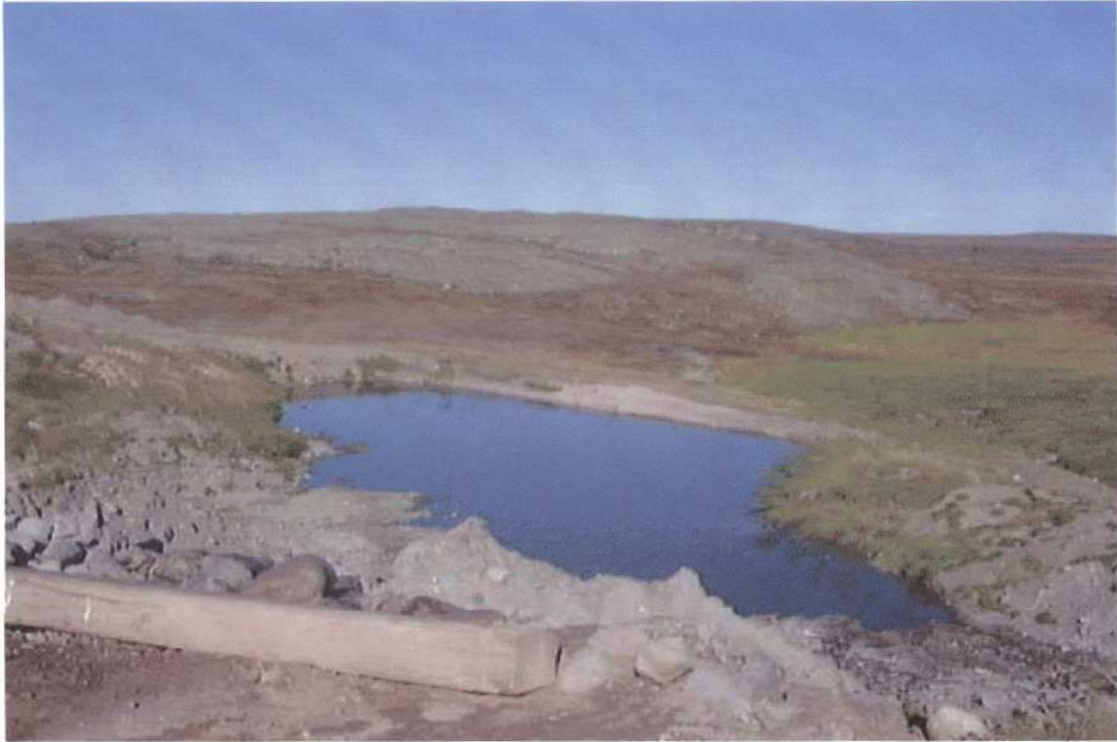
- **Sewage disposal:** Early signs of erosion were observed along the sewage disposal facility's initial holding cell (figure 1). As such, especially since effluent reportedly overtops the retention berm during winter and/or spring, the Licensee may wish to undertake preventive erosion control measures before the matter becomes problematic.

figure 1. Sewage disposal facility from the truck dumping point; 2001/08/31.

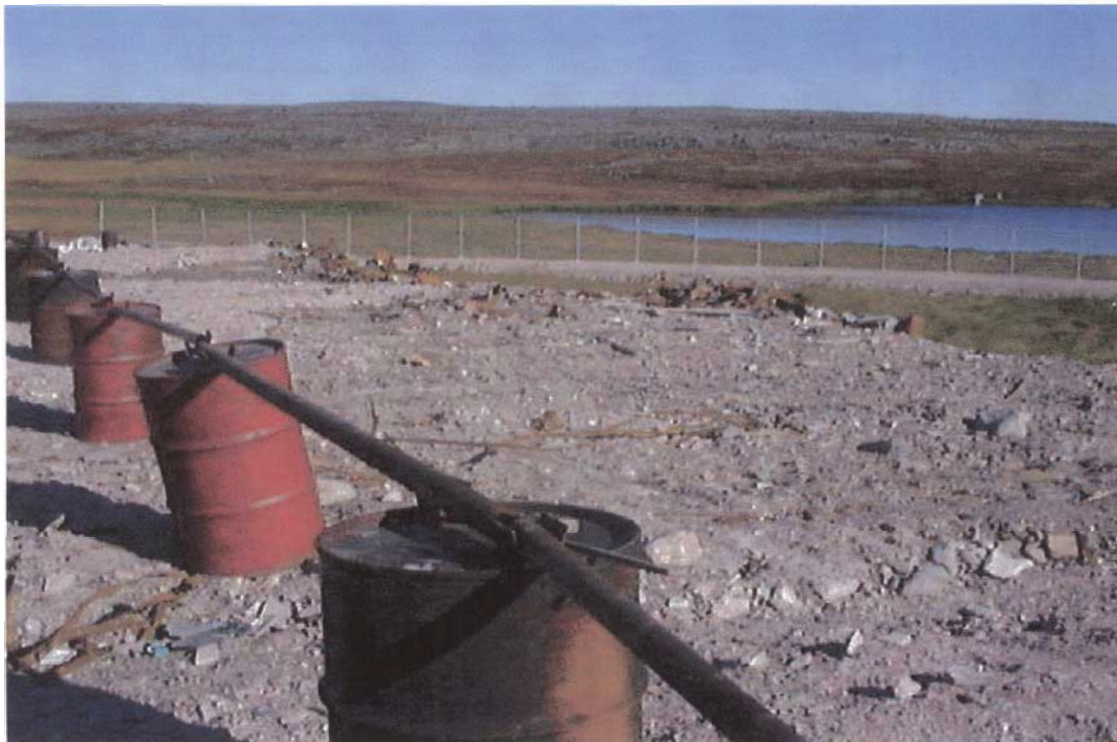
- **Solid waste disposal:** The solid waste disposal facility is quite efficiently managed, as the wastepile is well compacted and covered (figure 2). Furthermore, while pooled water was noted along the exposed toe of the wastepile (figure 3), no flow from the facility's discharge culvert was noticeable at the time of the inspection. In addition, bulky metal wastes, tires, hazardous materials, and waste oil/antifreeze are further segregated on-site. In this regards, since no form of containment is at the moment provided for accumulated batteries and other hazardous materials, it was mentioned during the inspection that two sealift containers will shortly be dedicated to that purpose.

figure 2. Solid waste disposal facility; 2001/08/31.

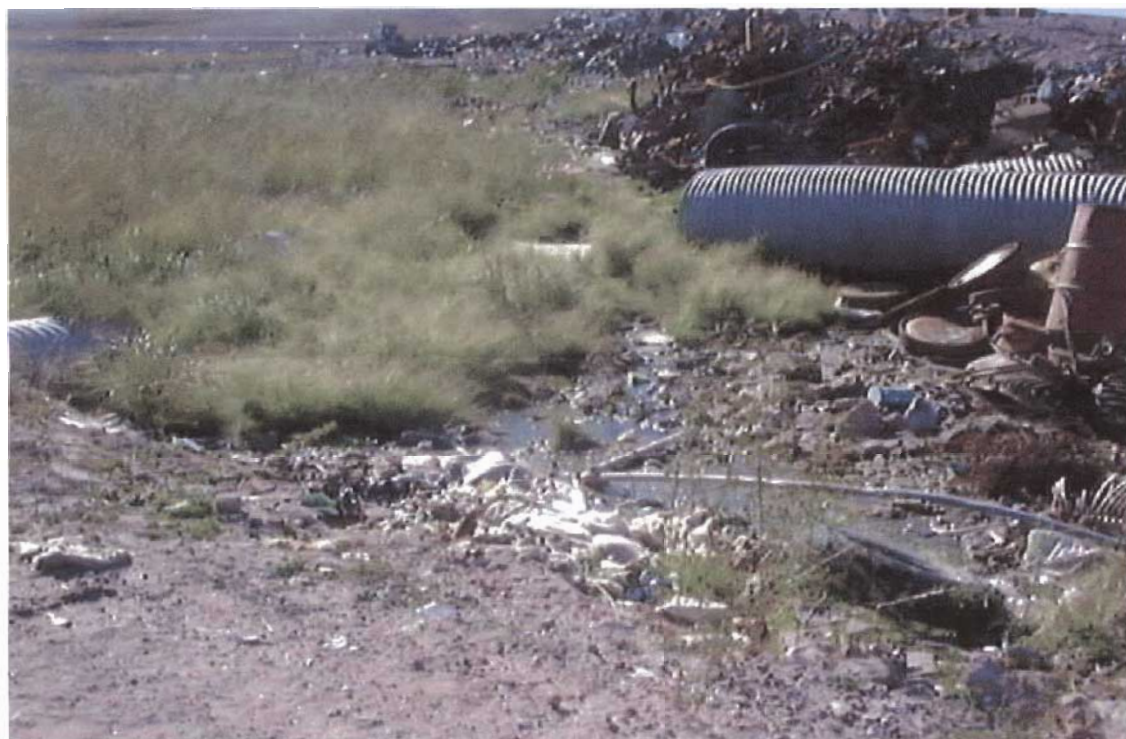
figure 3. Pooled water along the toe of the solid waste disposal facility; 2001/08/31.

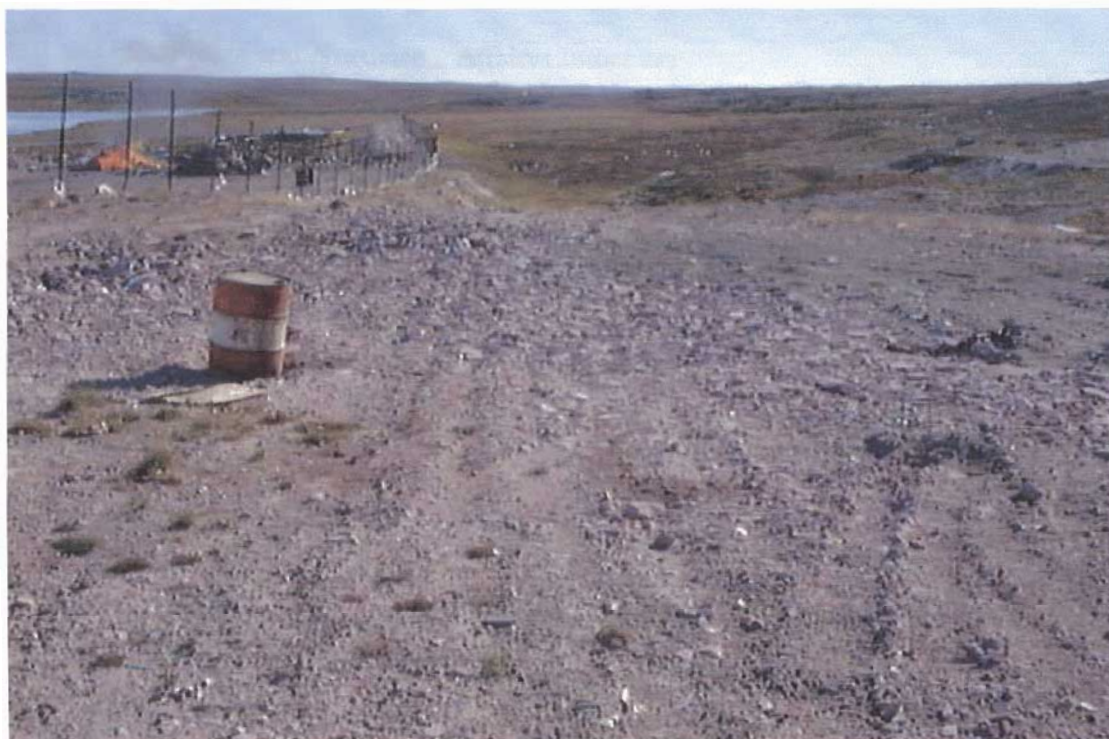
Concerning waste oil management, the Inspector acknowledges the reclamation of the old pit and the recent acquisition of a furnace at which numerous drums have been disposed since the last inspection. However, no Abandonment and Restoration (A&R) information relating to the work was provided to the Nunavut Water Board (NWB). Additionally, at the time of the inspection no confirmation could be given to the effect that hydrocarbon-contaminated soil had been removed from the area prior to the backfilling of the site (figure 4), thus guaranteeing that runoff flowing over the reclaimed pit would not imply further contamination. In parallel, while it is recognized that the Licensee intends to dispose of the remaining waste oil drums during the coming winter, the Inspector nevertheless underlines that the Licensee must ensure that the temporary storage does not bring about the deposit of waste into waters (figures 5-6). Thus, should any such unauthorized discharges of waste occur, due contingency measures ought to be taken as per licenced conditions (part H, item 3).

figure 4. Location of the recently backfilled old waste oil disposal pit; 2001/08/31.

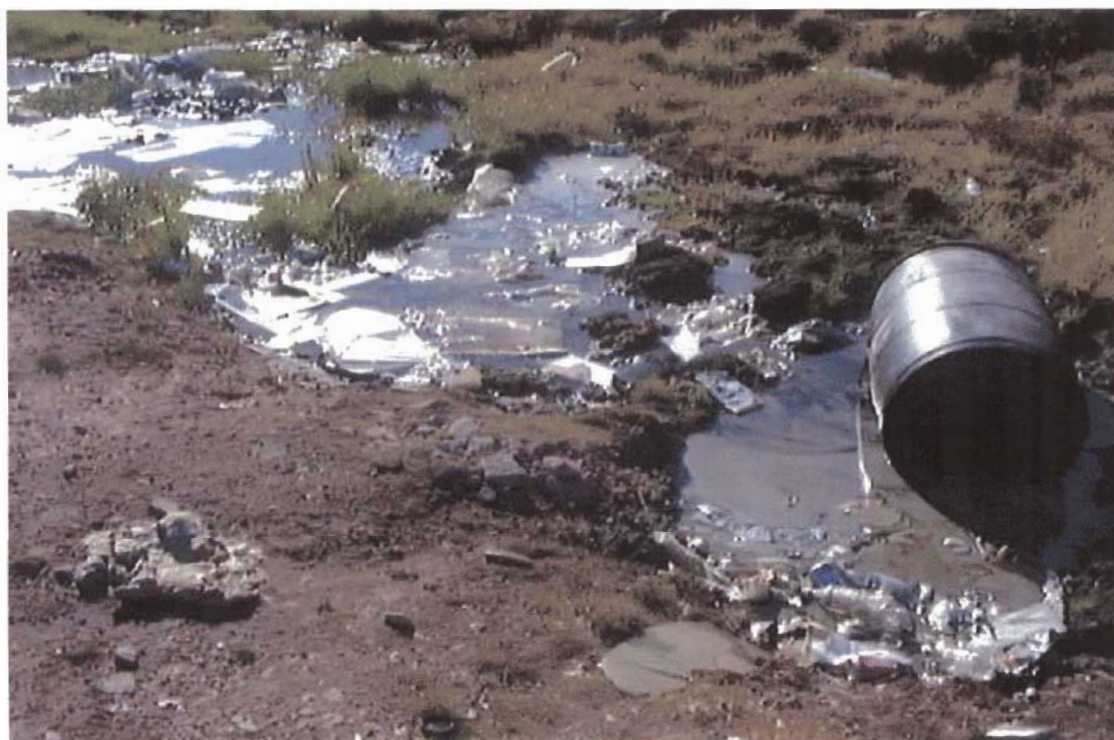
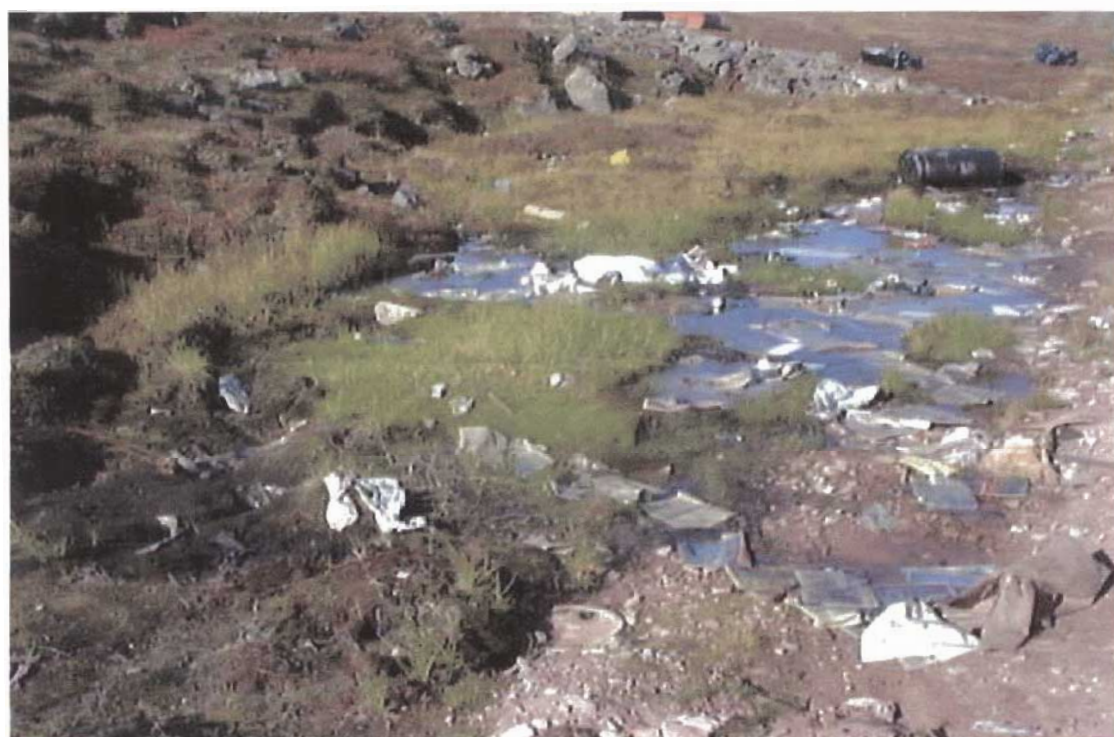
figure 5. Hydrocarbon contamination at the waste oil storage site; 2001/08/31.

figure 6. Hydrocarbon contamination at the waste oil storage site; 2001/08/31.
