RE: August 21, 2002 Municipal Water Use Inspection - Report

MUNICIPAL WATER USE INSPECTION REPORT

Date: August 21, 2002 Licensee Rep. (Name/Title): Elwood Johnson/ SAO
Licensee: Hamlet of Cambridge Bay Licence No.: NWB3-CAM0207

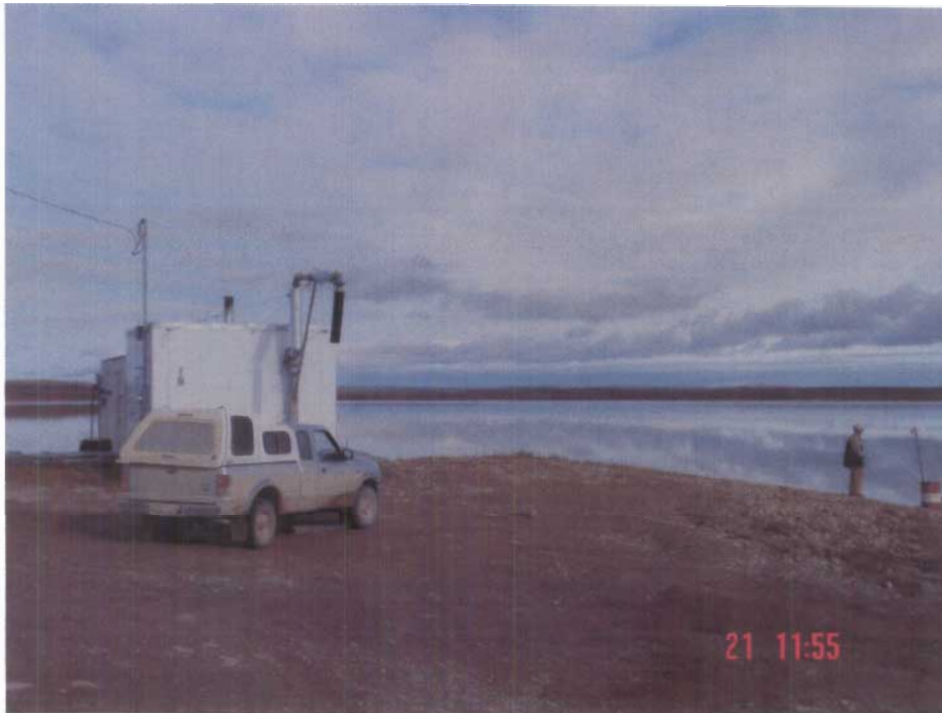
- ☐ **Water Supply:** The Water Intake Facility located on Water Lake is operating properly although it appeared rather cluttered and unclean (Photo 1 & 2). The generator room was very hot during the inspection this may be due to poor ventilation. The soil around the fuel oil over flow drums, located on the exterior of the Water Lake Intake Facility is stained with spilled fuel. It is recommended that the contaminated soil be removed to the Land Farm. It is recommended that spill equipment be made available at the Water Intake Facility. The Water Treatment Plant/ Reservoir located in town is clean. Enclosed chemical analysis of Water Lake at (SNP) CAM-1 indicate that Nitrate + Nitrite (<0.008 mg/L vs 3.2 mg/L), Colour (10 TCU vs 15 TCU) and pH (7.91 vs 6.5-8.5) are within the *Municipal Wastewater Effluent Quality Guidelines*.

Comments: Water Supply Facilities located on Water Lake although in good operational condition was unclear. Intake Facility fuel oil over flow containment drums show signs of spillage. Maintenance required to correct condition of Intake Facility generator room excessive heat. Chlorination system functioning at Water Intake Facility.

Photo # 1 Water Intake Facility at Water Lake.

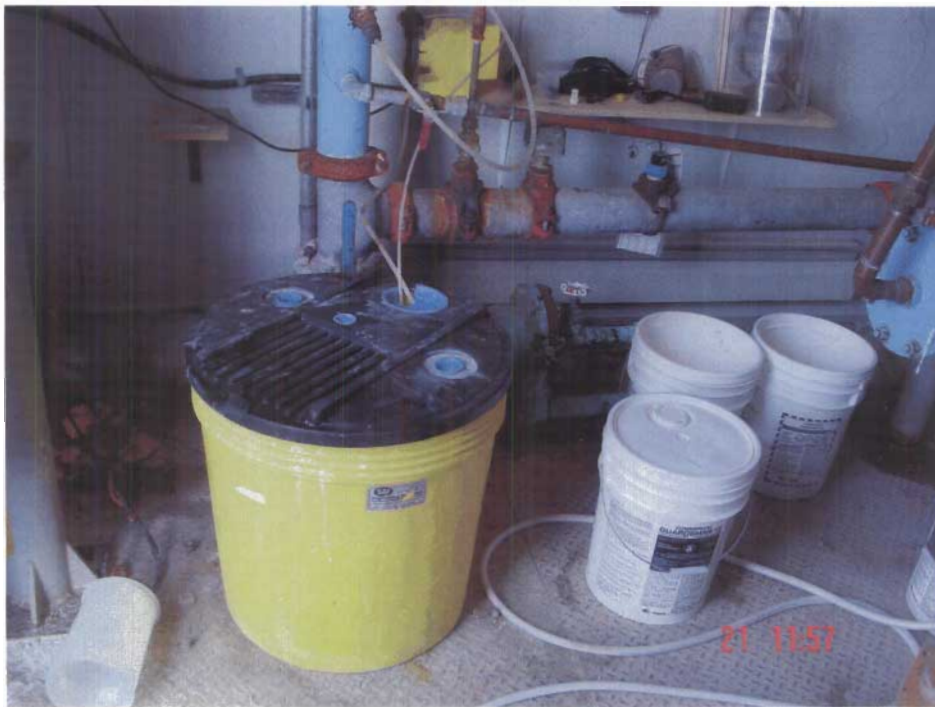
Photo # 2 Chlorination system at Water Intake Facility.

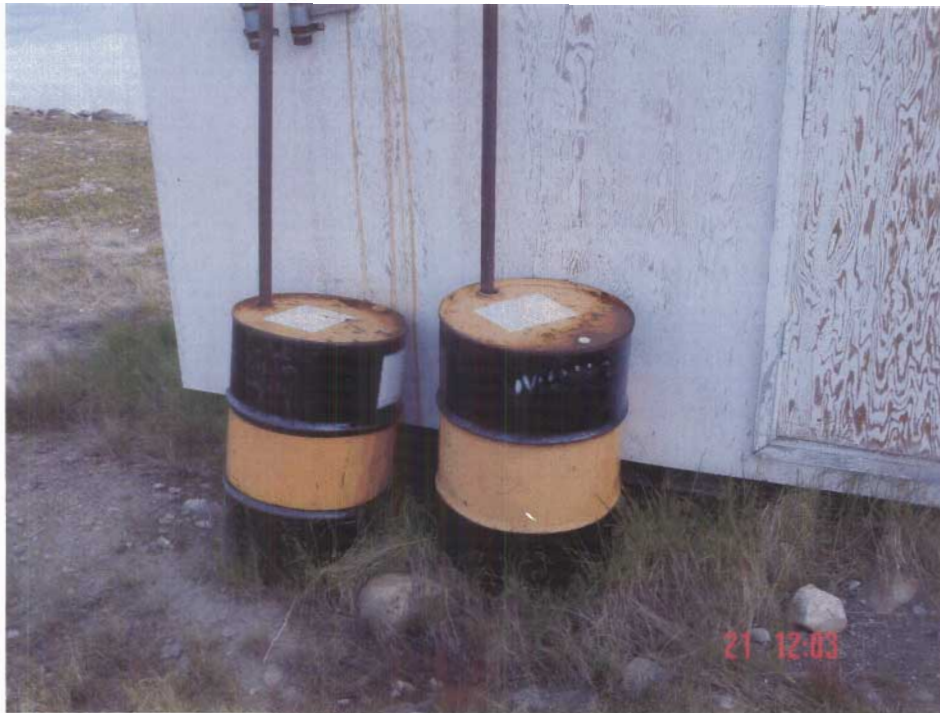
Photo # 3 Over flow for fuel oil at Water Intake Facility, staining of fuel noted around drums.

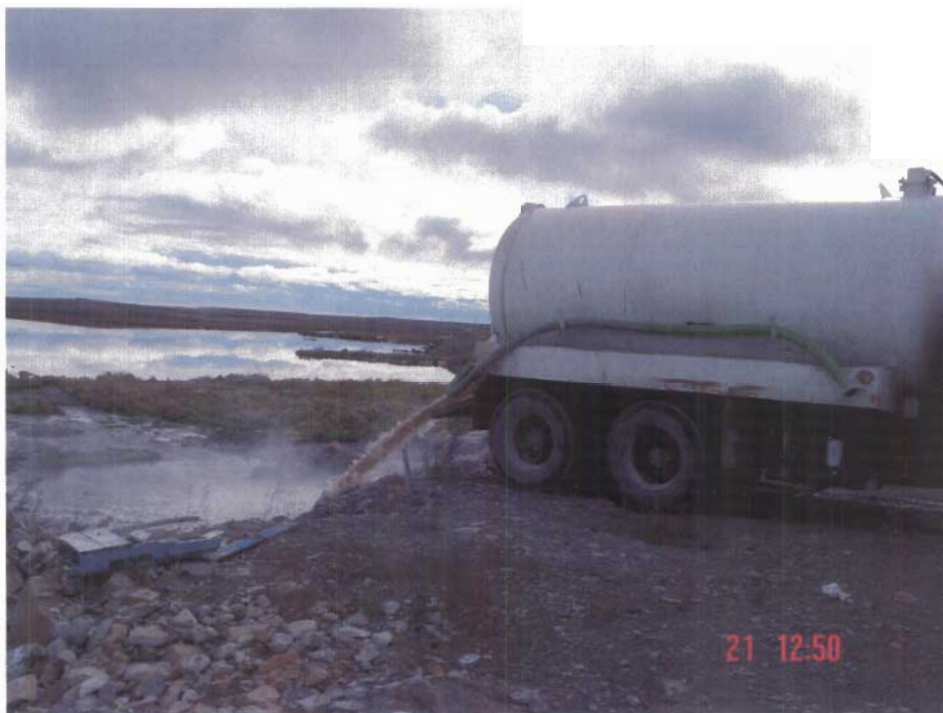
- ☐ **Sewage Disposal:** The Sewage Lagoon has sufficient freeboard (Photo 4). The Sewage Truck Discharge structure worked well at reducing erosion during truck discharges at the Sewage Lagoon. Sewage lagoon effluent enters a wetland that flows around the Solid Waste Disposal Facility. The effluent then flows through the toe of the Bulky Metal Waste Dump prior to entering the ocean (Photo 5).

Photo # 4 Truck at sewage truck discharge structure component of Sewage Lagoon.

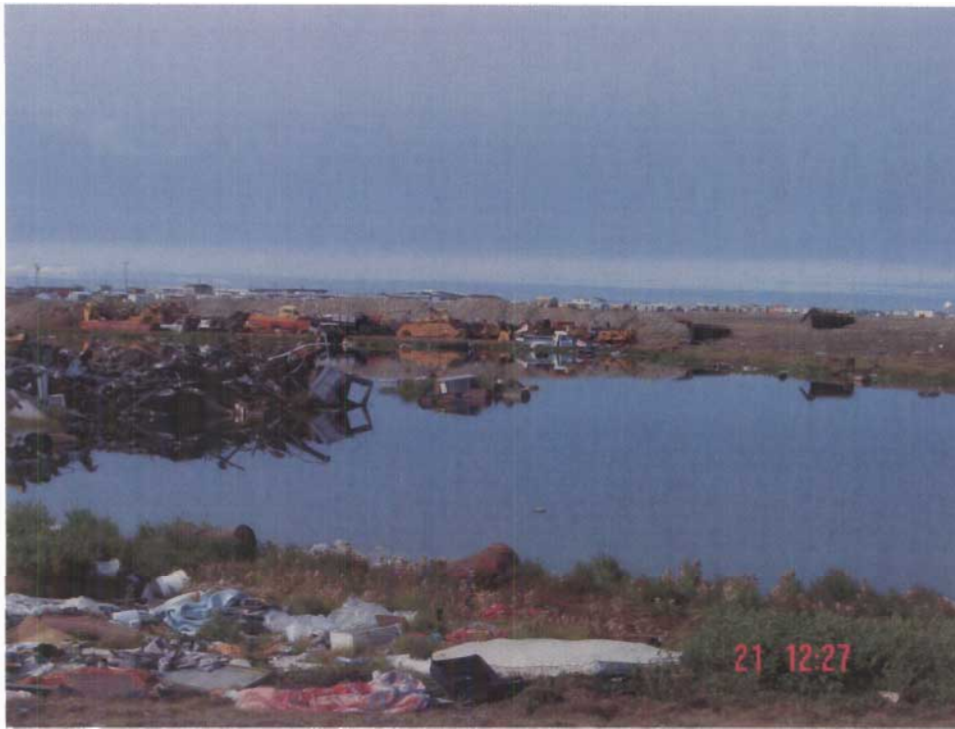
- ☐ **Bulky Metal Waste Disposal Site:** The Bulky Metal Dump has effluent from the Sewage Lagoon flowing through the area (Photo 5). There was little segregation of wastes at the metal dump with bulky metal and construction waste mixed (Photo 8). The only noted segregation of waste was that of waste oil, that was placed on pallets. No waste battery storage area was observed. Some form of spill protection should be provided to assist in reducing contamination from spilled oil and battery acid (Photo 6).

Comments: Sewage Lagoon effluent passes through a wetland that flows through the bulky metal disposal area prior to discharging to the ocean. Some concern with effluent flowing through the metal dump. Soil Waste Disposal Facility well kept despite no fencing. No effluent seepage was observed emitting from the Solid Waste Disposal Facility. Waste at the bulky metal dump not well segregated.

Photo # 5 Bulky metal waste containment area. Note that there is sewage effluent flowing through bulky metal materials.

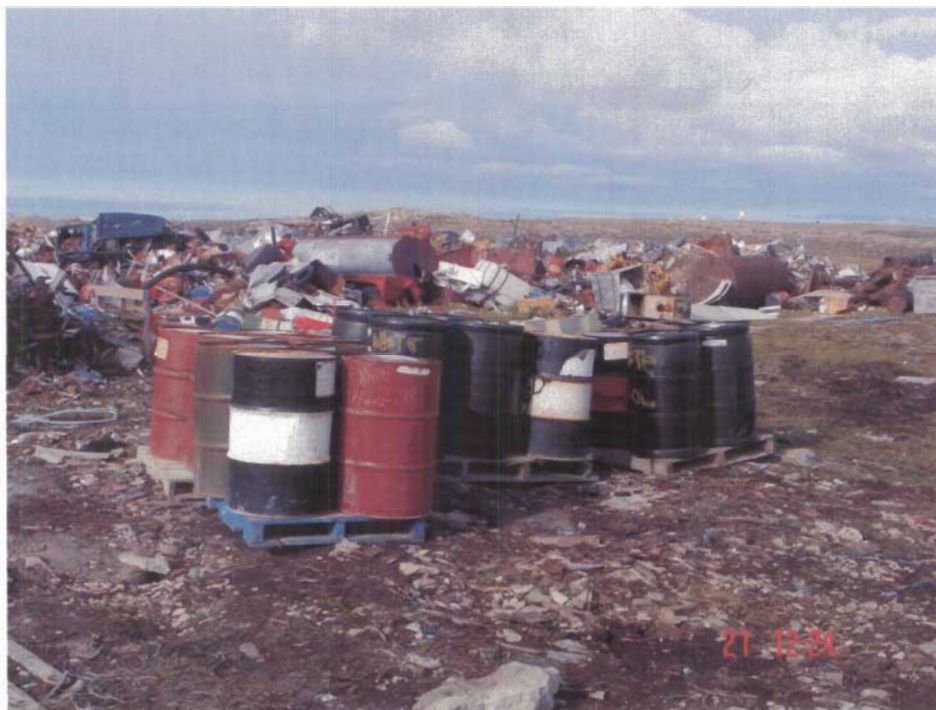
Photo # 6 Waste oil drums at bulky metal dump.

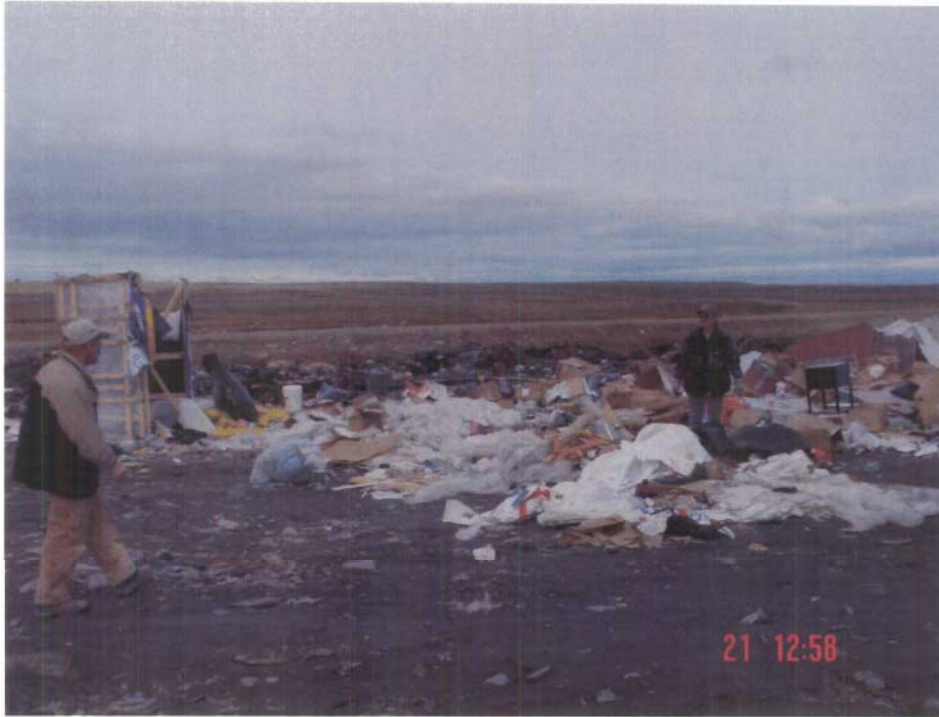
- ☐ **Solid Waste Disposal:** The tipping face at the dump is kept to a minimum . The Solid Waste Disposal Facility is not fenced, yet little wind blown refuse is located around the facility. Burning and burial of refuse appeared to be commonly practiced at the dump (Photo 7). No leachate effluent was seen omitting from the toe of the Solid Waste Disposal Facility.

Photo # 7 Tipping face at Solid Waste Disposal Facility. Note burning of refuse occurs on a frequent basis reducing wind blown refuse despite lack of fencing.

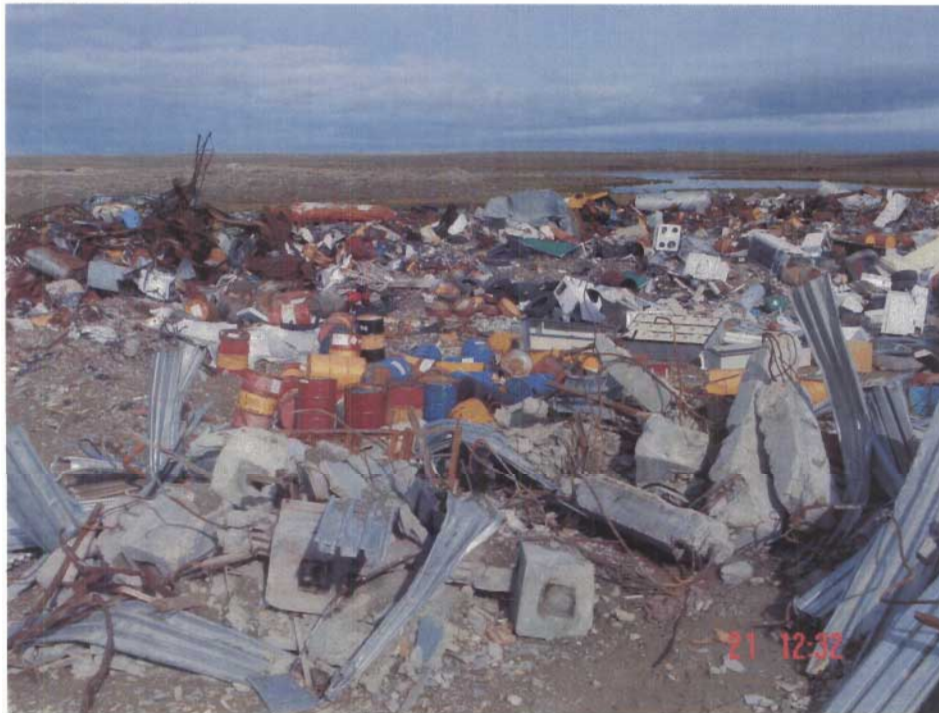
Photo # 8 Bulky metal waste with hazardous materials not segregated.
