2006 Cambridge Bay Annual Water Licence Report

Nunavut Water Board
P.O. Box 119
Gjoa Haven, NU X0B 1J0

Earth Tech (Canada) Inc.
17203-103rd Avenue
Edmonton, AB T5S 1J4

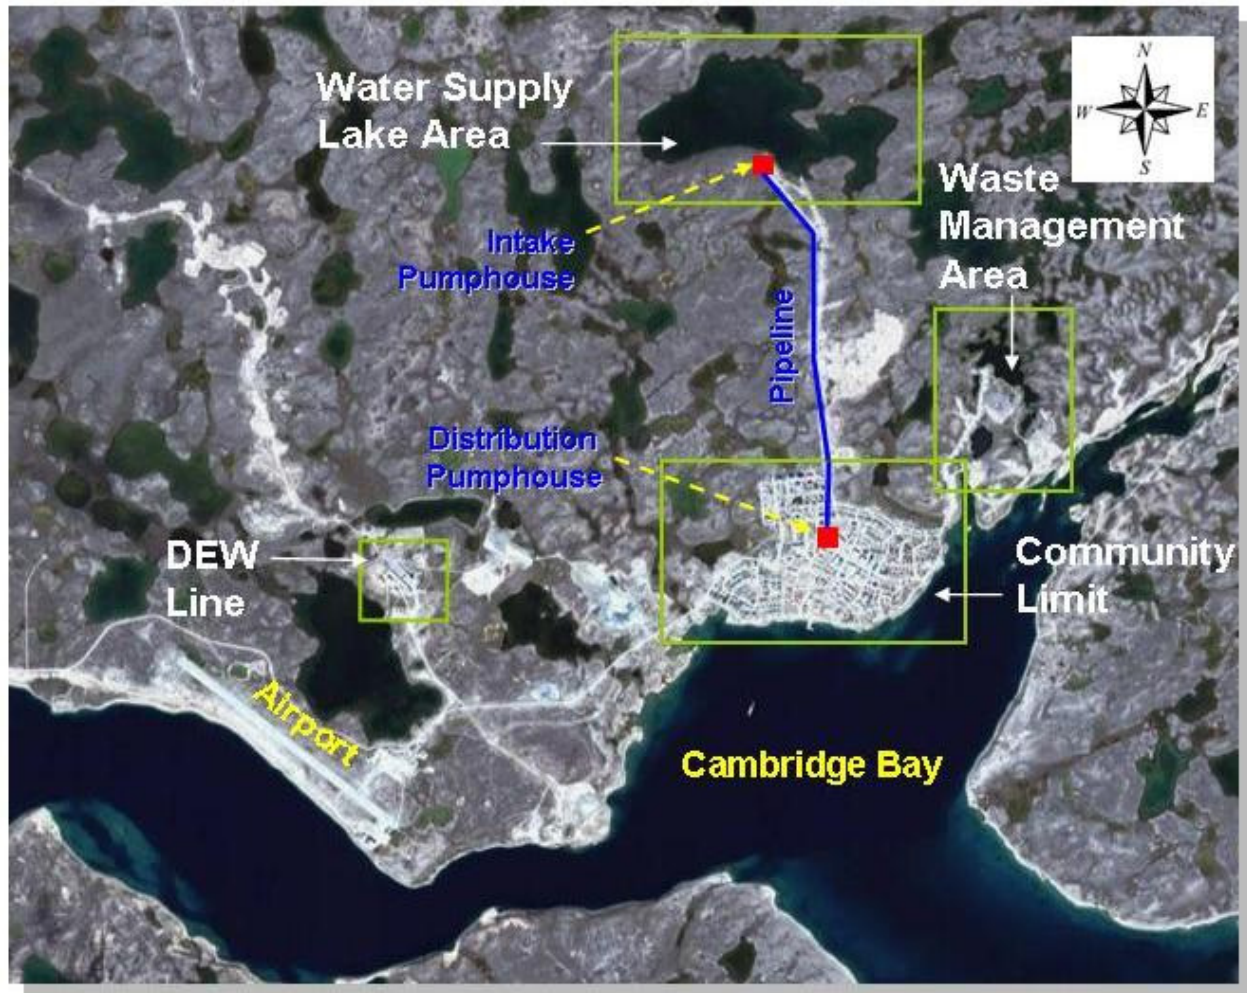
Figure 3

**Hamlet of Cambridge Bay
Annual Report
Water Pumphouse and Pipeline
Locations**

The intake facilities extend 20 meters into Water Supply Lake to a depth of approximately 4 meters below the surface. The intake pump discharge line consists of a 100 mm diameter HDPE pipe. This pipeline is coupled to submersible pump at the intake pumphouse and rests with a HDPE intake shaft or casing pipe. The water is chlorinated at the intake pumphouse prior to pumping to the distribution pumphouse.

A 2,900 meters water supply pipeline runs from the intake facilities to the distribution pumphouse at the centre of community. The 150 mm waterline is freeze protected with insulation and a 50 mm recirculation waterline.

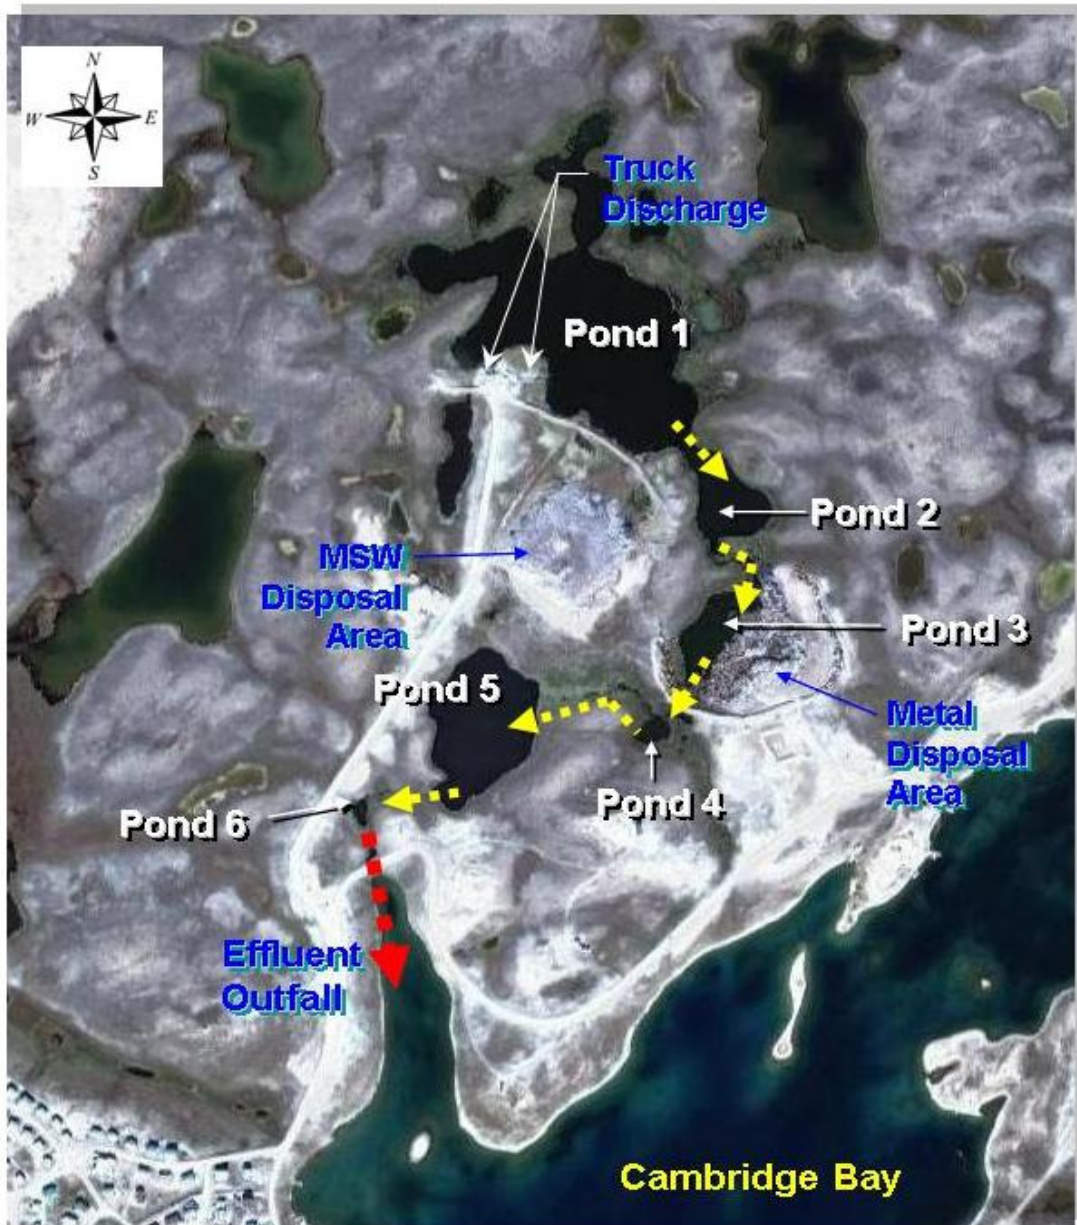
Figure 4

**Hamlet of Cambridge Bay
Annual Report
Sewage Lagoon Pond Locations**

Sewage enters into Pond 1 at the truck discharge site. Sewage travels through the six lagoon ponds identified in Figure 4. The wastewater will enter a series of natural lakes and wetlands before ultimately discharging into Cambridge Bay approximately 450 metres east of the community. Effluent from the sewage lagoon discharges during spring, summer and fall. Effluent does not discharge during winter due to freezing.

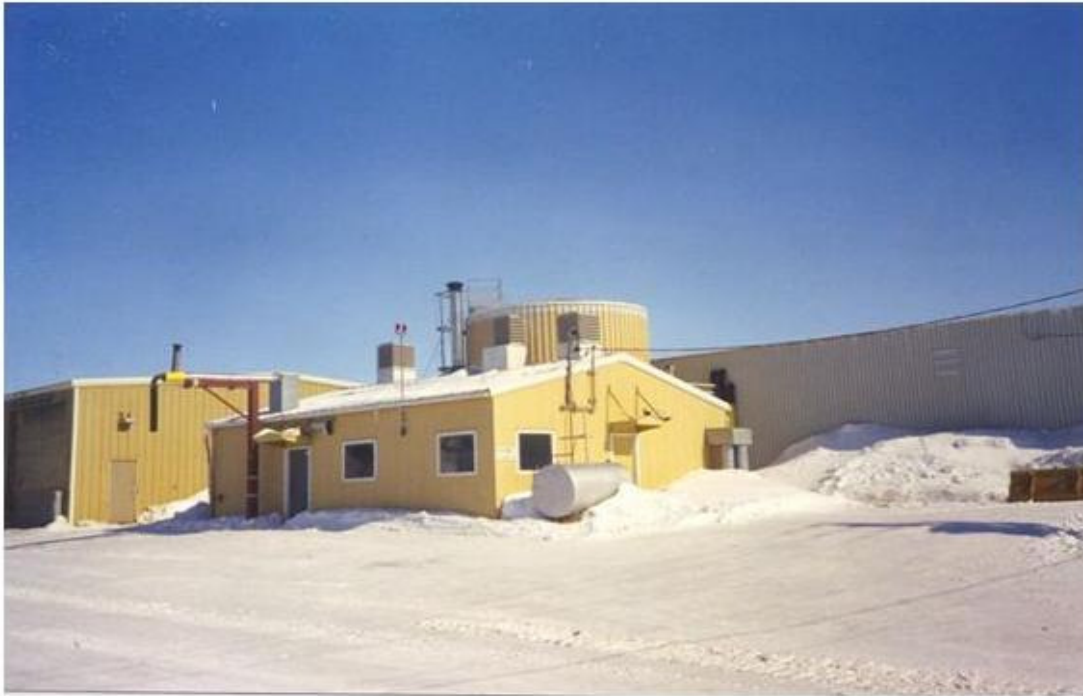
Figure 5

Figure 3 Water Distribution Pumphouse

**Hamlet of Cambridge Bay
Annual Report
Water Distribution Pumphouse**

Water is then distributed by water trucks from the truckfill station in the community center to the water tanks within each residence in the community. Water delivery is provided to the residents by the Hamlet using 12,000 litre water trucks. There is a 260 m³ storage tank located beside the distribution pumphouse. **Figure 3** shows the location of the intake area, pipeline, and distribution pumphouse. **Figure 4** shows the water distribution pumphouse.

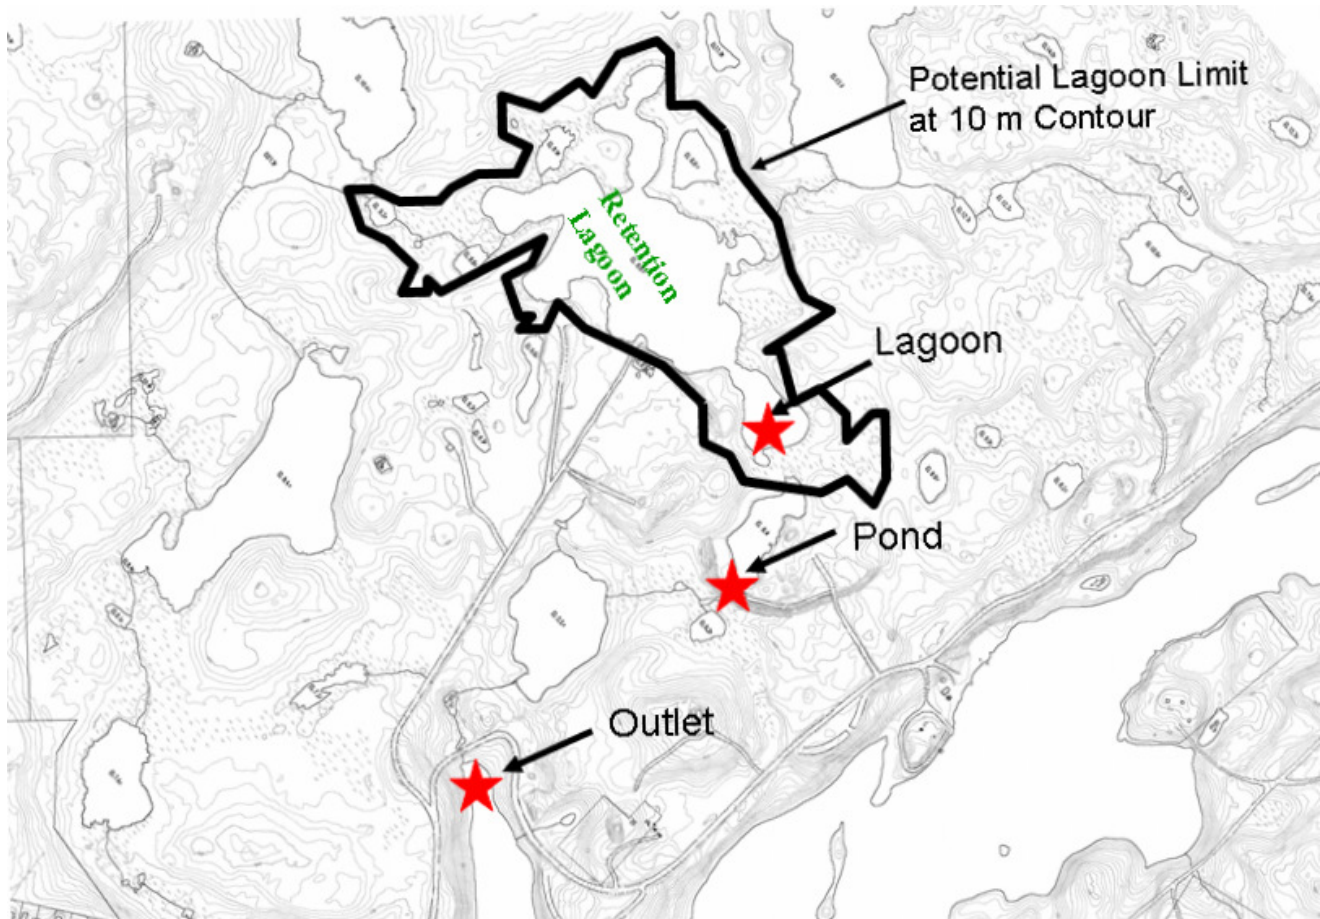
Figure 6

**Hamlet of Cambridge Bay
Annual Report
Sewage Lagoon Sampling Locations**

A sampling of Cambridge Bay's wastewater system was undertaken on June 21, 2006 at the sewage lagoon pond "lagoon", the outlet of the pond adjacent to the metal disposal site "pond", and the ocean discharge point "outlet". The locations are presented in **Figure 6**. Sample results are detailed below. Previous sampling data, where available, is included. The laboratory report is included in **Appendix A**.
