Annual Report -2016

Water Licence: 3BM-CAM 1520

Hamlet of Cambridge Bay, NU

AANDC Report 2016

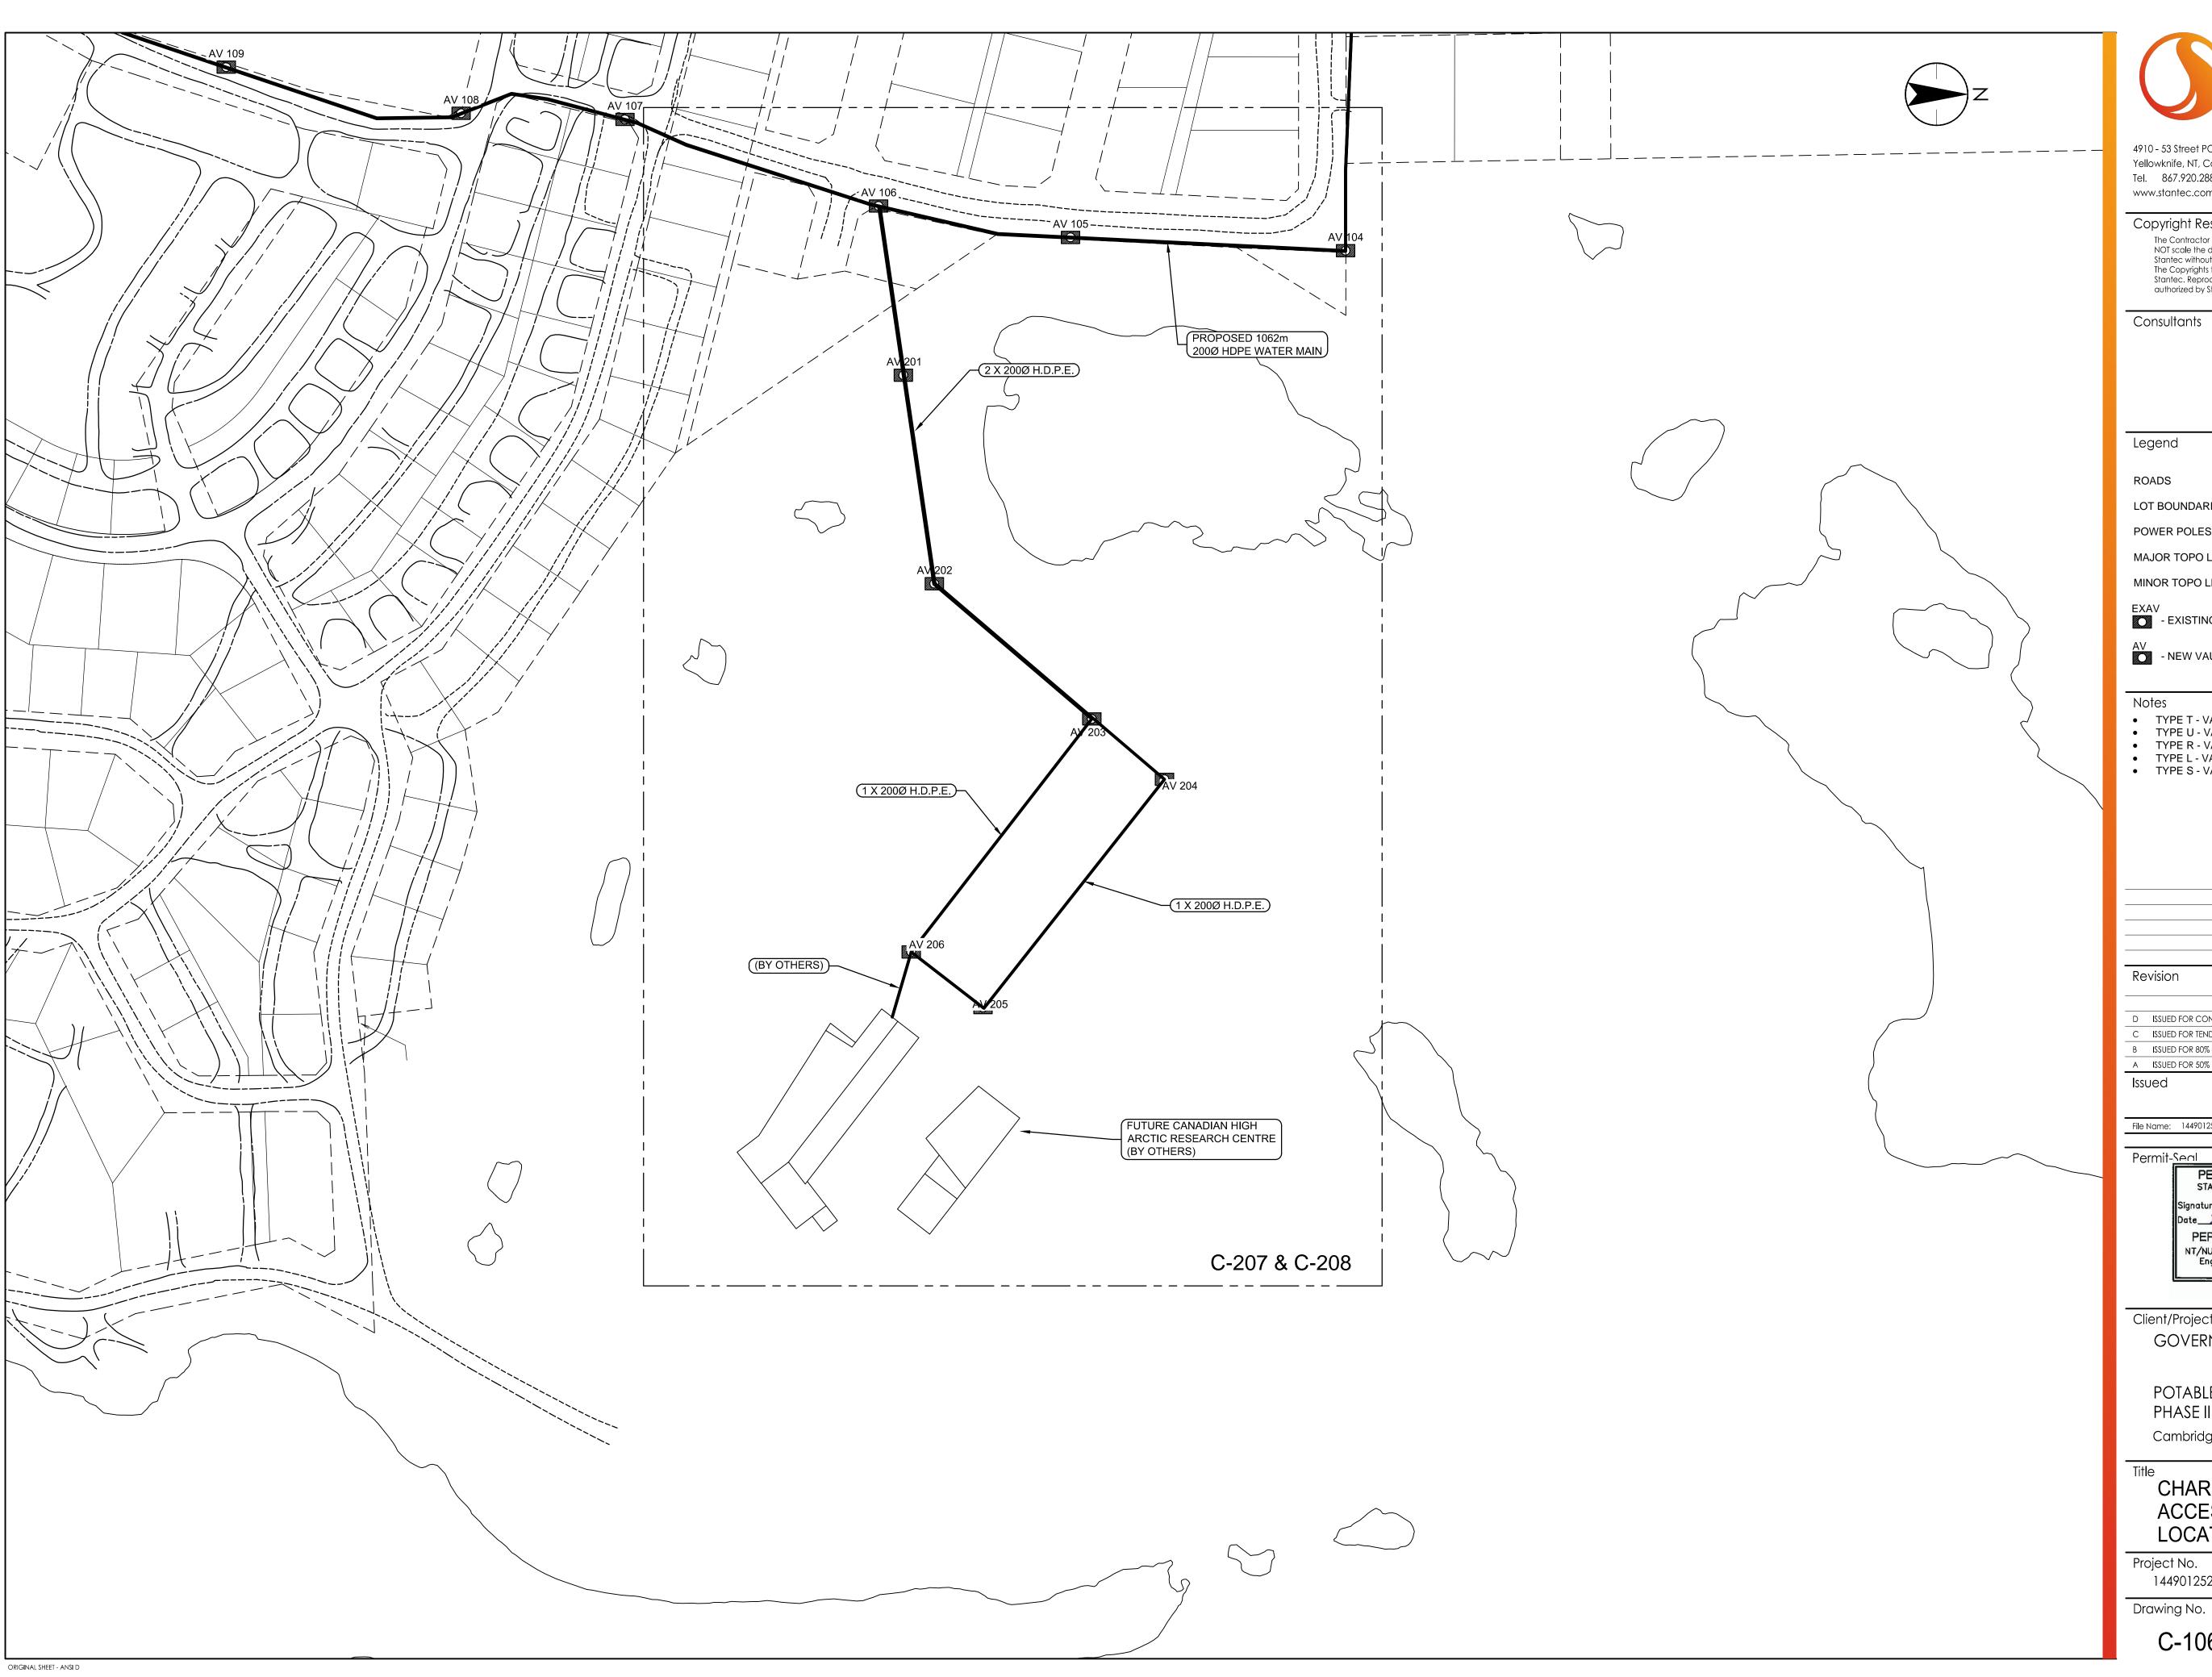
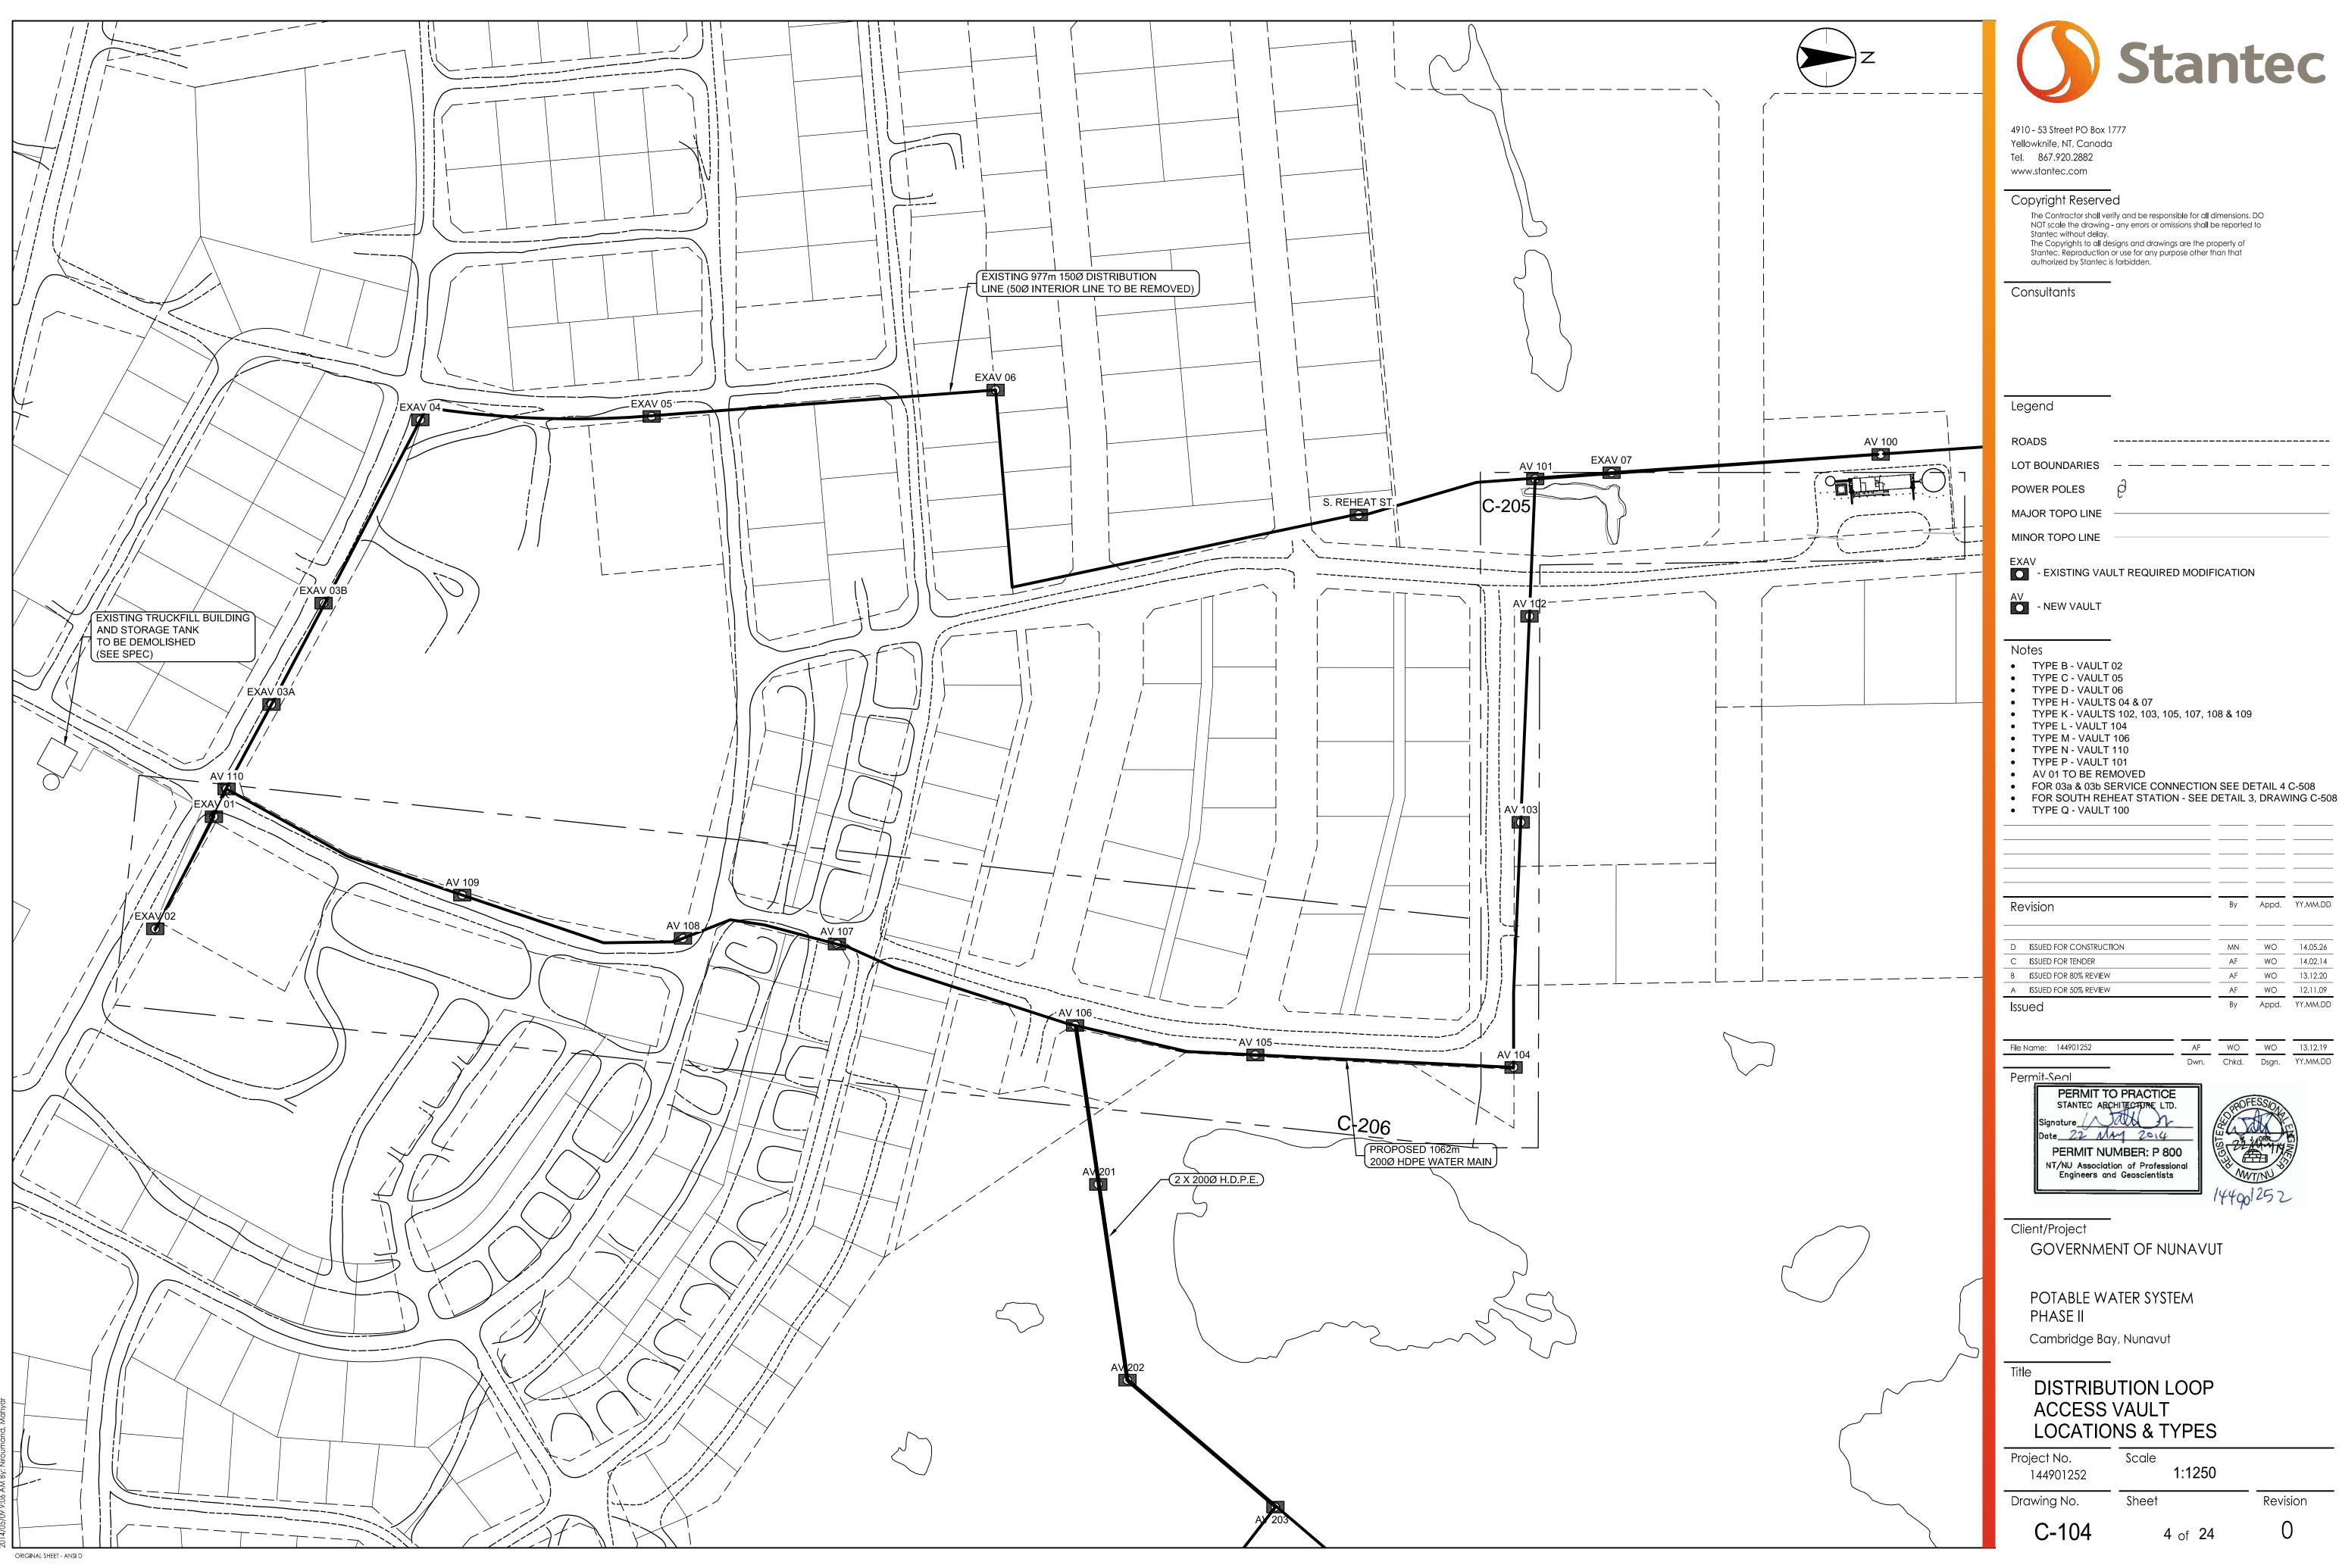
CHARS LOOP **ACCESS VAULT**

TYPE T - VAULTS 201
 TYPE U - VAULT 202
 TYPE R - VAULT 203
 TYPE L - VAULTS 204, 205,
 TYPE S - VAULT 206

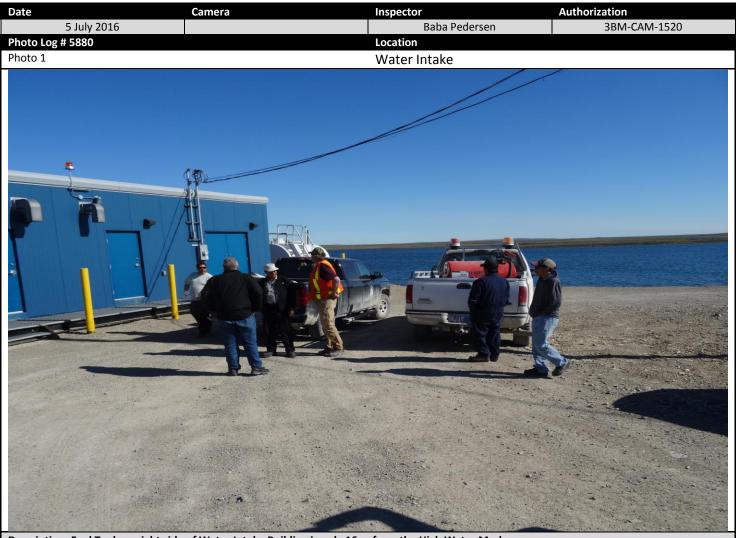
1. The Fuel Tank outside the Water Intake Building (photo 1) is only 16 m from the High Water Mark. This should have been noticed and rectified during the Design/Build Process. 2. The Main Dump (photo 2) was well organized and is Fenced and Gated with Staff controlling intake. 3. The Sewage Lagoon (photos 3 and 4) is very large, allowing for ample future expansion when required. It was mentioned that they are still using the old Dumping Station (photo 5) because of Liner Damage (photo 6) at the New Dumping Station. 4. The Metal Dump is very nicely sorted with good Signage directing what items should be placed where. 5. The Lined Berm area within the Metal Dump Site (photos 7, 8 and 9) contains many various containers of a variety of Oils and Lubricants, lots of Mega Bags of Contaminated Soil and Paint and other Containers both Open and Closed. There is approximately 12 inches of water throughout the entire Berm Area, fully or partially submerging everything inside and there are visible Sheens on the surface in a few spots. 6. The Daily, Weekly, Monthly and Annual Water Use Consumption Data is done electronically which made it very difficult for the staff to show me any actual Consumption Amounts (photo 10) as is required in the Water Licence. Staff must be able to show the Inspector Consumption Figures on request. Inspector's Name Baba Pedersen Signature	Soil/Misc Products B	erm and the	Hamlet (Office for Computerized	d Water (Consump	tion Doc	cuments.

The fuel tank outside the water IPH building is only 16 m from High Water Mark, which should be considered in the Design/Build process of the IPH.

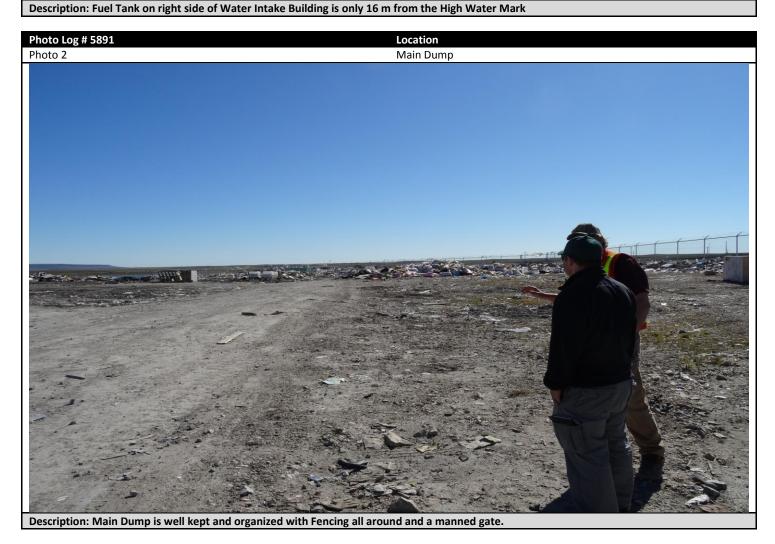
noticed and rectified during the Design/Build Process. 2. The Main Dump (photo 2) was well organized and is Fenced and Gated with Staff controlling intake. 3. The Sewage Lagoon (photos 3 and 4) is very large, allowing for ample future expansion when required. It was mentioned that they are still using the old Dumping Station (photo 5) because of Liner Damage (photo 6) at the New Dumping Station. 4. The Metal Dump is very nicely sorted with good Signage directing what items should be placed where. 5. The Lined Berm area within the Metal Dump Site (photos 7, 8 and 9) contains many various containers of a variety of Oils and Lubricants, lots of Mega Bags of Contaminated Soil and Paint and other Containers both Open and Closed. There is approximately 12 inches of water throughout the entire Berm Area, fully or partially submerging everything inside and there are visible Sheens on the surface in a few spots. 6. The Daily, Weekly, Monthly and Annual Water Use Consumption Data is done electronically which made it very difficult for the staff to show me any actual Consumption Amounts (photo 10) as is required in the Water Licence. Staff must be able to show the Inspector Consumption Figures on request. Licensee or Representative Licensee or Representative Inspector's Name Baba Pedersen Signature Signature Signature Signature Signature Signature Date	SECTION 3	Comme	ents	Non-Comp	liance w	ith Act o	r Licence		Action Re	quired

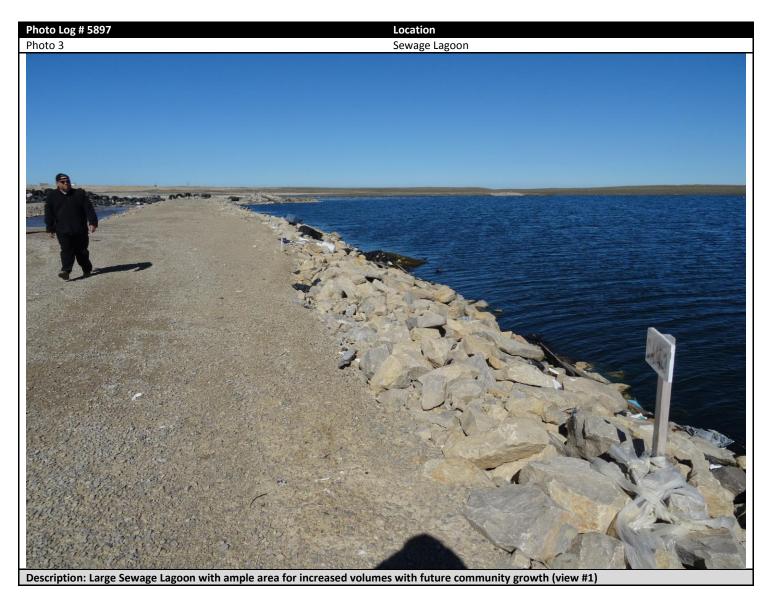
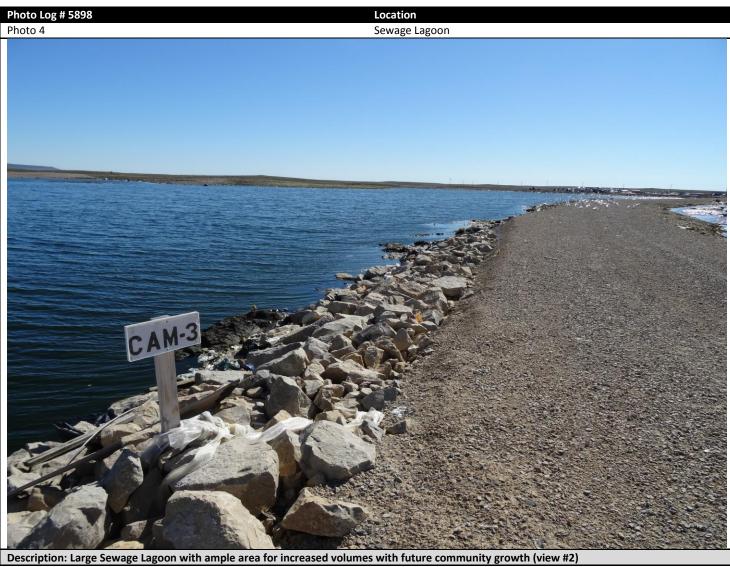
Gated with Staff controlling intake. 3. The Sewage Lagoon (photos 3 and 4) is very large, allowing for ample future expansion when required. It was mentioned that they are still using the old Dumping Station (photo 5) because of Liner Damage (photo 6) at the New Dumping Station. 4. The Metal Dump is very nicely sorted with good Signage directing what items should be placed where. 5. The Lined Berm area within the Metal Dump Site (photos 7, 8 and 9) contains many various containers of a variety of Oils and Lubricants, lots of Mega Bags of Contaminated Soil and Paint and other Containers both Open and Closed. There is approximately 12 inches of water throughout the entire Berm Area, fully or partially submerging everything inside and there are visible Sheens on the surface in a few spots. 6. The Daily, Weekly, Monthly and Annual Water Use Consumption Data is done electronically which made it very difficult for the staff to show me any actual Consumption Amounts (photo 10) as is required in the Water Licence. Staff must be able to show the Inspector Consumption Figures on request. Licensee or Representative Licensee or Representative Inspector's Name Baba Pedersen Signature Signature Signature Signature Signature Date	1. The Fuel Ta	nk outside t	he Water	Intake Building (photo	1) is only	16 m fro	om the F	ligh Water Ma	ark. This shou	ıld have	been

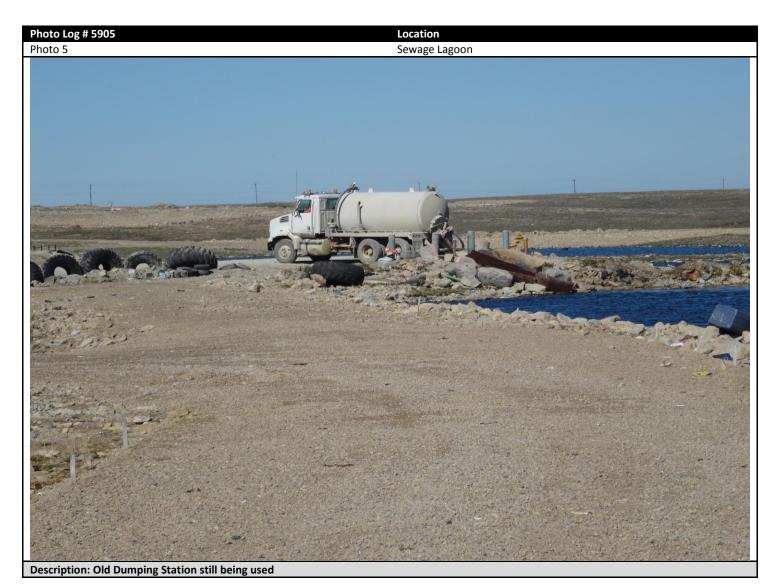
expansion when required. It was mentioned that they are still using the old Dumping Station (photo 5) because of Liner Damage (photo 6) at the New Dumping Station. 4. The Metal Dump is very nicely sorted with good Signage directing what items should be placed where. 5. The Lined Berm area within the Metal Dump Site (photos 7, 8 and 9) contains many various containers of a variety of Oils and Lubricants, lots of Mega Bags of Contaminated Soil and Paint and other Containers both Open and Closed. There is approximately 12 inches of water throughout the entire Berm Area, fully or partially submerging everything inside and there are visible Sheens on the surface in a few spots. 6. The Daily, Weekly, Monthly and Annual Water Use Consumption Data is done electronically which made it very difficult for the staff to show me any actual Consumption Amounts (photo 10) as is required in the Water Licence. Staff must be able to show the Inspector Consumption Figures on request. Licensee or Representative Inspector's Name Baba Pedersen Signature Signature Signature Signature Date	noticed and	d rectified du	iring the I	Design/Build Process. 2	2. The Ma	in Dump	(photo	2) was well oi	ganized and i	is Fenced	d and

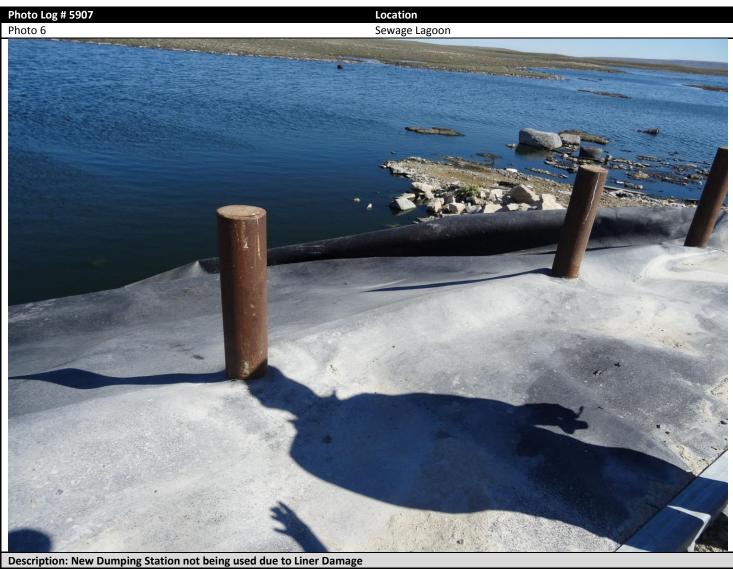
Damage (photo 6) at the New Dumping Station. 4. The Metal Dump is very nicely sorted with good Signage directing what items should be placed where. 5. The Lined Berm area within the Metal Dump Site (photos 7, 8 and 9) contains many various containers of a variety of Oils and Lubricants, lots of Mega Bags of Contaminated Soil and Paint and other Containers both Open and Closed. There is approximately 12 inches of water throughout the entire Berm Area, fully or partially submerging everything inside and there are visible Sheens on the surface in a few spots. 6. The Daily, Weekly, Monthly and Annual Water Use Consumption Data is done electronically which made it very difficult for the staff to show me any actual Consumption Amounts (photo 10) as is required in the Water Licence. Staff must be able to show the Inspector Consumption Figures on request. Licensee or Representative Inspector's Name Baba Pedersen Signature Signature Signature Date	Gated with	Staff contro	lling intak	ke. 3. The Sewage Lago	on (phot	os 3 and	4) is ver	y large, allowi	ing for ample	future

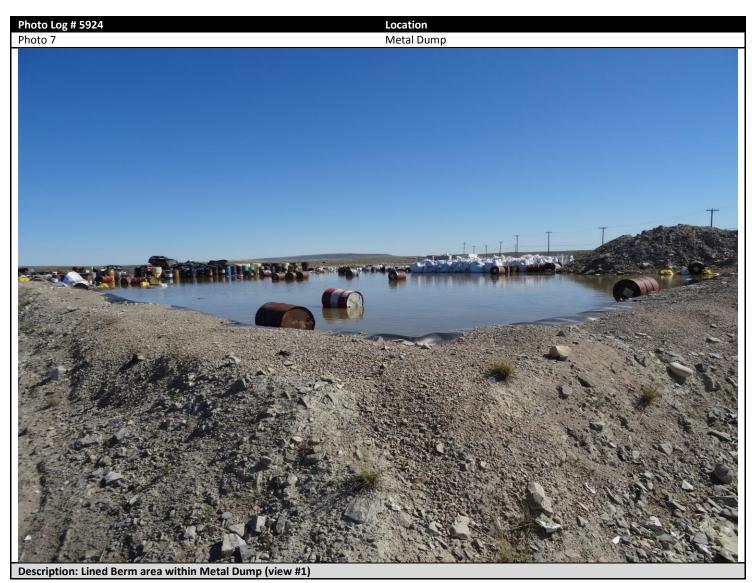
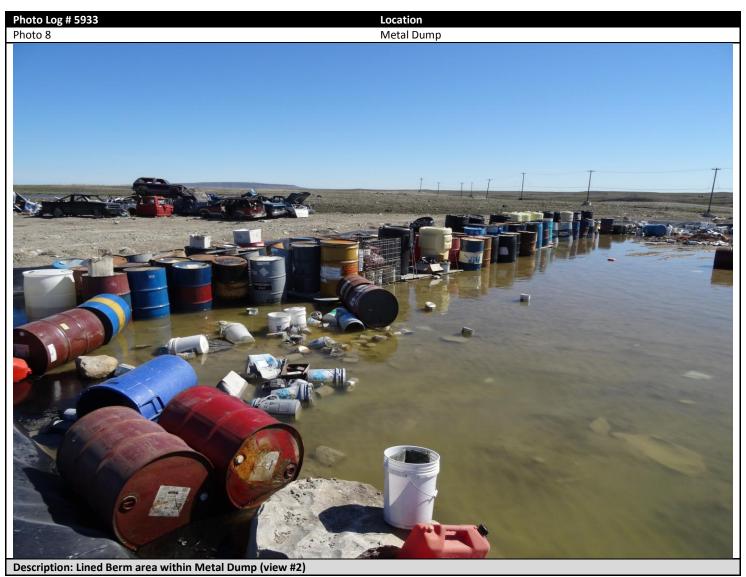
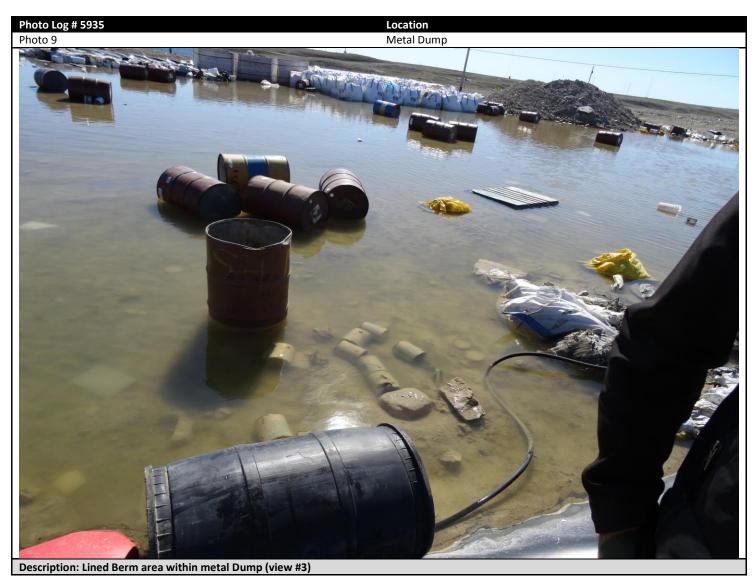
items should be placed where. 5. The Lined Berm area within the Metal Dump Site (photos 7, 8 and 9) contains many various containers of a variety of Oils and Lubricants, lots of Mega Bags of Contaminated Soil and Paint and other Containers both Open and Closed. There is approximately 12 inches of water throughout the entire Berm Area, fully or partially submerging everything inside and there are visible Sheens on the surface in a few spots. 6. The Daily, Weekly, Monthly and Annual Water Use Consumption Data is done electronically which made it very difficult for the staff to show me any actual Consumption Amounts (photo 10) as is required in the Water Licence. Staff must be able to show the Inspector Consumption Figures on request. Licensee or Representative Inspector's Name Baba Pedersen Signature Signature Signed Original on File Date	expansion v	when require	ed. It was	mentioned that they a	re still us	sing the o	old Dum _l	oing Station (photo 5) beca	use of Li	ner

various containers of a variety of Oils and Lubricants, lots of Mega Bags of Contaminated Soil and Paint and other Containers both Open and Closed. There is approximately 12 inches of water throughout the entire Berm Area, fully or partially submerging everything inside and there are visible Sheens on the surface in a few spots. 6. The Daily, Weekly, Monthly and Annual Water Use Consumption Data is done electronically which made it very difficult for the staff to show me any actual Consumption Amounts (photo 10) as is required in the Water Licence. Staff must be able to show the Inspector Consumption Figures on request. Licensee or Representative Inspector's Name Baba Pedersen Signature Signature Signature Date	Damage (pl	noto 6) at th	e New Du	ımping Station. 4. The I	Metal Du	mp is ve	ry nicely	sorted with g	ood Signage	directing	what
Containers both Open and Closed. There is approximately 12 inches of water throughout the entire Berm Area, fully or partially submerging everything inside and there are visible Sheens on the surface in a few spots. 6. The Daily, Weekly, Monthly and Annual Water Use Consumption Data is done electronically which made it very difficult for the staff to show me any actual Consumption Amounts (photo 10) as is required in the Water Licence. Staff must be able to show the Inspector Consumption Figures on request. Licensee or Representative Inspector's Name Baba Pedersen Signature Signature Signature Date	items shou	ld be placed	where. 5	. The Lined Berm area v	within th	e Metal [Dump Sit	e (photos 7, 8	3 and 9) conta	ins man	У

partially submerging everything inside and there are visible Sheens on the surface in a few spots. 6. The Daily, Weekly, Monthly and Annual Water Use Consumption Data is done electronically which made it very difficult for the staff to show me any actual Consumption Amounts (photo 10) as is required in the Water Licence. Staff must be able to show the Inspector Consumption Figures on request. Licensee or Representative Inspector's Name Baba Pedersen Signature Signature Signature Date	various con	tainers of a	variety of	Oils and Lubricants, lot	ts of Meg	a Bags o	f Contan	ninated Soil a	nd Paint and	other	
Monthly and Annual Water Use Consumption Data is done electronically which made it very difficult for the staff to show me any actual Consumption Amounts (photo 10) as is required in the Water Licence. Staff must be able to show the Inspector Consumption Figures on request. Licensee or Representative Inspector's Name Baba Pedersen Signature Signature Signed Original on File Date	Containers	both Open a	and Closed	d. There is approximate	ely 12 inc	hes of w	ater thro	oughout the e	ntire Berm Ar	ea, fully	or

- ✓ The licensee has cleaned the noted oil-paint sheen from ponding water by absorption using cotton-pad and then cleared the ponding water to sewage lagoon using vacuum truck. The absorbed cotton-pad then burned inside a trench and buried.
- vi. a summary of any abandonment and restoration work completed during the year and an outline of any work anticipated for the next year;

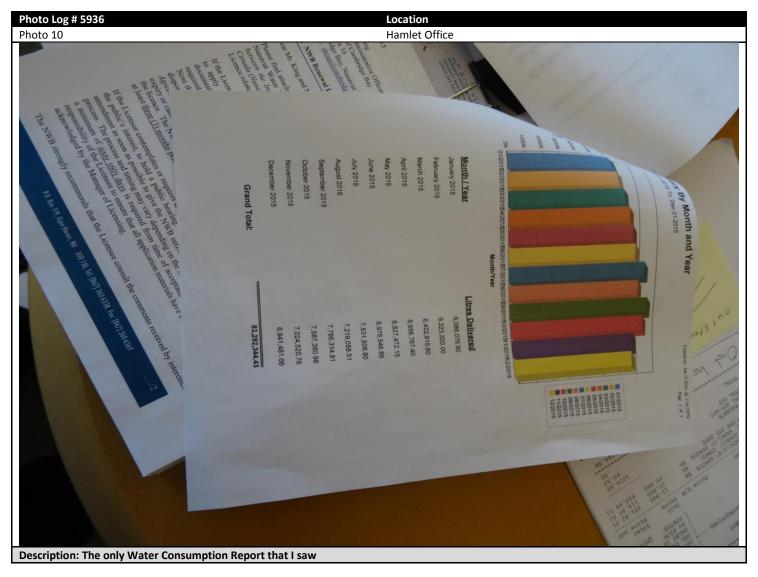
me any actual Consumption Amounts (photo 10) as is required in the Water Licence. Staff must be able to show the Inspector Consumption Figures on request. Licensee or Representative Inspector's Name Baba Pedersen Signature Signature Signed Original on File Date	partially su	bmerging ev	erything i	nside and there are visi	ible Shee	ns on the	e surface	in a few spot	ts. 6. The Dail	y, Weekl	у,
Licensee or Representative Licensee or Representative Inspector's Name Baba Pedersen Signature Signature Signed Original on File Date	Monthly an	d Annual W	ater Use (Consumption Data is do	ne electi	onically	which m	ade it very di	fficult for the	staff to s	show
Licensee or Representative Inspector's Name Baba Pedersen Signature Signature Signed Original on File Date	me any act	ual Consump	otion Amo	ounts (photo 10) as is re	equired in	the Wa	ter Licen	ce. Staff mus	t be able to s	how the	
Baba Pedersen Signature Signed Original on File Date Date	Inspector C	onsumption	Figures o	on request.

The licensee uses Fluid Manager Database for water supply quantity and calculates daily, monthly and annual consumption. The responsible staff and the Director of Works have access to the information to provide as requested. Also, record can be print out anytime as needed. There is no other system to measure the quantity but the truck volume and house tank of water supply are close to accurate.
