YEAR BEING REPORTED: 2021

The following information is compiled pursuant to the requirements of Part B, Item 1 of Water License No. 3BM-CAM2030 issued to the Municipality of Cambridge Bay.

Licensee Licensee Representative Hamlet of Cambridge Bay NA Licence No. / Expiry Representative's Title 3BM-CAM2030 Land / Other Authorizations Land / Other Authorizations Inspector Date of Inspection Jonathan MESHER September 6, 2021 Activities Inspected ☐ Drilling ☐ Mining ☐ Reclamation ☐ Fuel Storage ☐ Camp ☐ Construction ☐ Roads/Hauling Other: ☑ Other: Hamlet waste storage. **Conditions:** A - Acceptable C - Concern U - Unacceptable NA – Not Applicable NI - Not Inspected Condit Water Use Comment **Site Conditions** Haz/Mat Management Condition Comment Condition ion Intake/Screen NA Water Management Structures Storage C NA Flow Measure. Device NA Culverts / Bridges NA Spills NA Source: NA Drainage NA Spill Plan NI Water Use: NA Erosion / Sediment NA Recirculation (y/n) NA Mitigation Measures Α **Administrative** Reclamation Activities NA Records NI Materials Storage NA Reports NI **Waste Disposal** Plans NI Signage **Notifications** Waste Water NA Α Solid Waste NA **Monitoring** Other Hazard

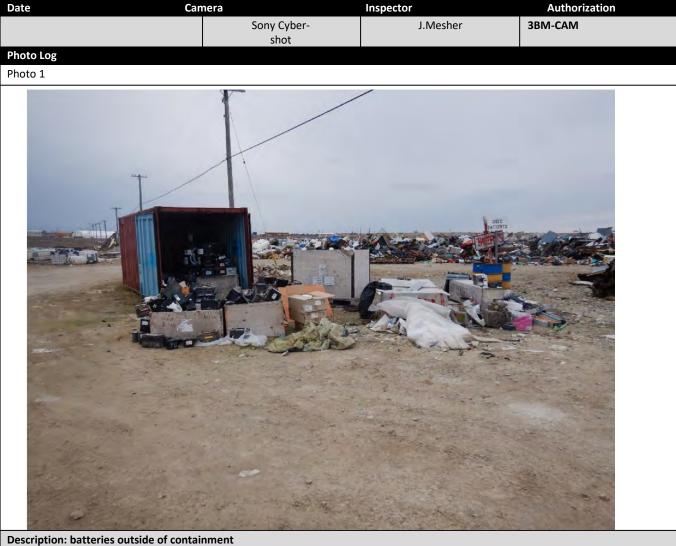
- a) During the inspection there was various batteries stored inside wooden boxes and a sea can, there was also batteries scattered around the storage area outside of containment. PART D, item 11 of the licence 3BMCAM2030 states; "The Licensee shall segregate and store all hazardous materials and/or hazardous Waste within the Solid Waste Disposal Facility in such a manner as to prevent the deposit of deleterious substances into any Water, until such a time that the materials have been removed for proper disposal at an approved facility." see photo 1 for the battery storage.

- 1) The licensee is to ensure all Hazardous waste is segregated and stored in a way to prevent waste from entering water, the inspector recommends storing all hazardous waste at the metal waste area within the berms on site.
- 2) The licensee is to provide a plan to sort, package and ship hazardous materials out in the next sealift season to an approved facility.
- 3) The licensee is to ensure only approved waste is burnt within the landfill.
- 4) The licensee is to ensure all effluent from the landfill is captured in the retention sewage lagoon as required in the licence.

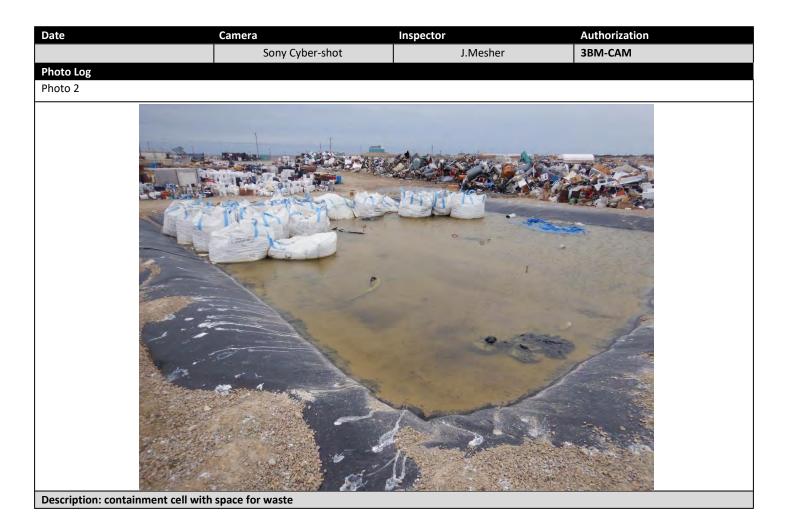
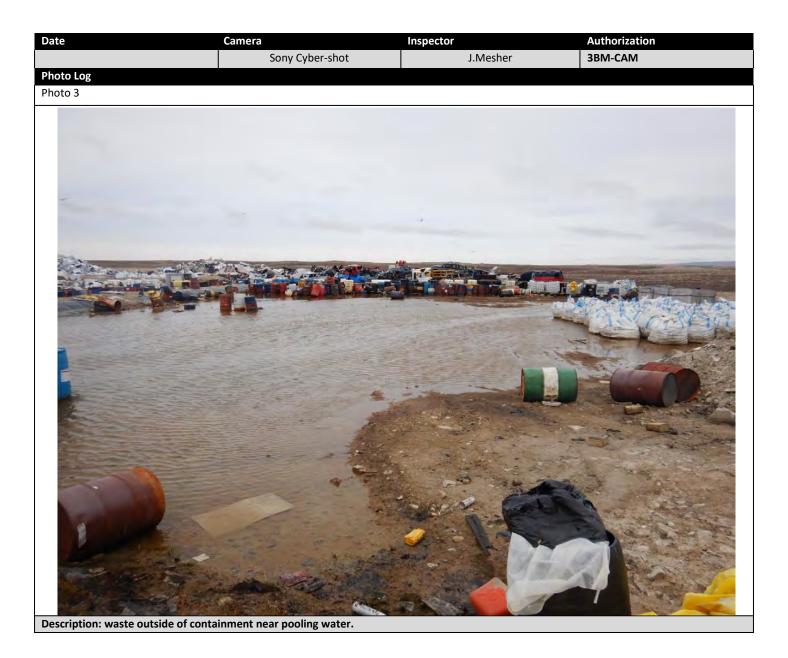
- b) During the inspection the Hazardous material containment cells appeared to be retaining water and it appeared that there was significant room in this containment. See photos 2 and 3 for the hazardous material berm.

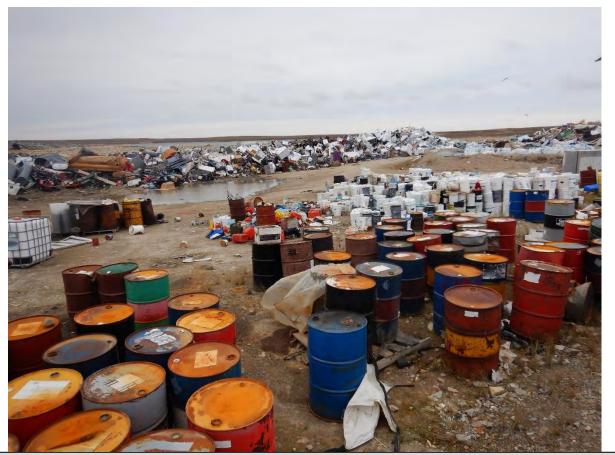
Photo 4

- c) The inspector noted significant hazardous material outside on containment within the metal dump. See photos 4, 5 and 6 for the waste mentioned.

Description: various wastes outside of containment

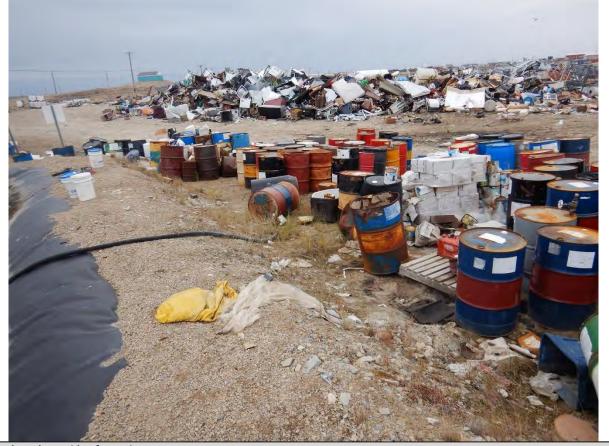
Description: barrels outside of containment
