June 10, 2001 Municipal Water Use Inspection - Report

MUNICIPAL WATER USE INSPECTION FORM

Licensee: Municipality of Cape DorsetLicence No.: unlicenced

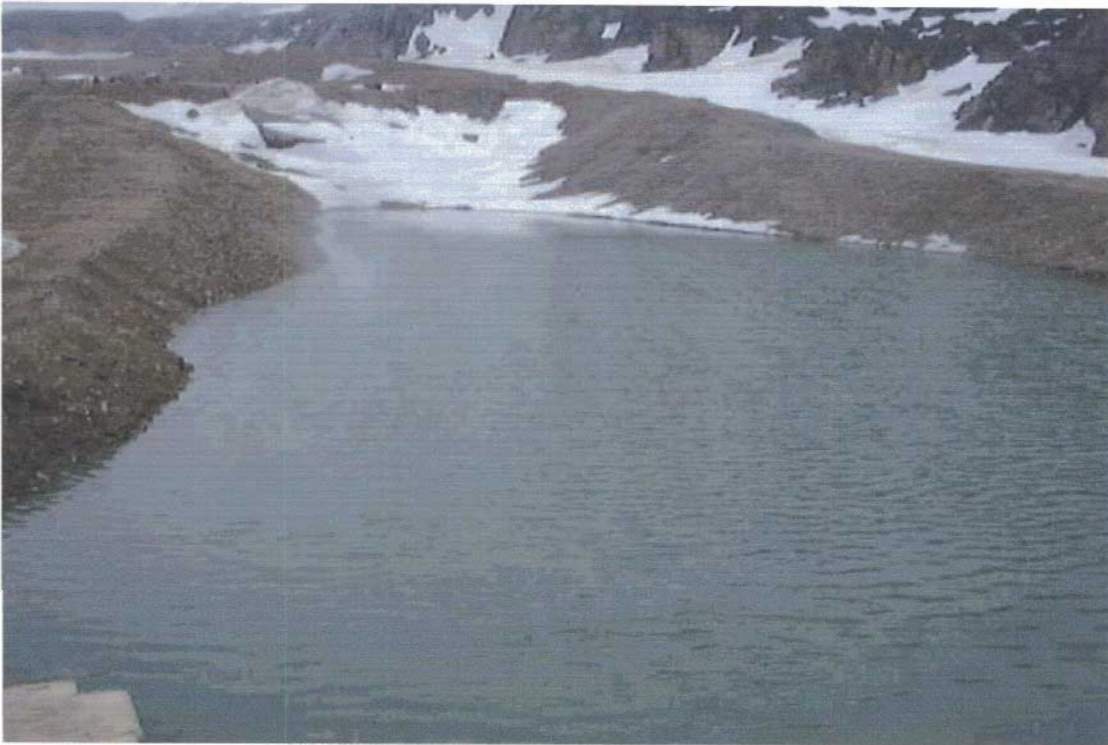
- **Sewage waste disposal:** At the time of the inspection, the new sewage disposal facility did not appear (figure 1), and reportedly was not, utilized. However, flow was noted at the decant culvert of the first lagoon cell, and sewage effluent was observed following the same discharge path (figure 2) as had been observed during the previous inspection. The attached analytical results relating to a sample taken just below the first cell's discharge culvert reveal that levels of ammonia (2.39 mg/L vs 2.2 mg/L) and phenols (20 µg/L vs 4 µg/L) faintly exceed the *Canadian Water Quality Guidelines for the Protection of Freshwater Aquatic Life*. Due to weather delays, bacteriological parameters could not be analysed. In parallel, the old sewage lagoon serves as the main sewage truck discharge point. In light of its limited size (figure 3), the old lagoon is likely overtaxed and cannot provide sufficient retention time prior to the release of its contents to the environment.

figure 1. First cell of the new sewage disposal facility; 2001/06/10.

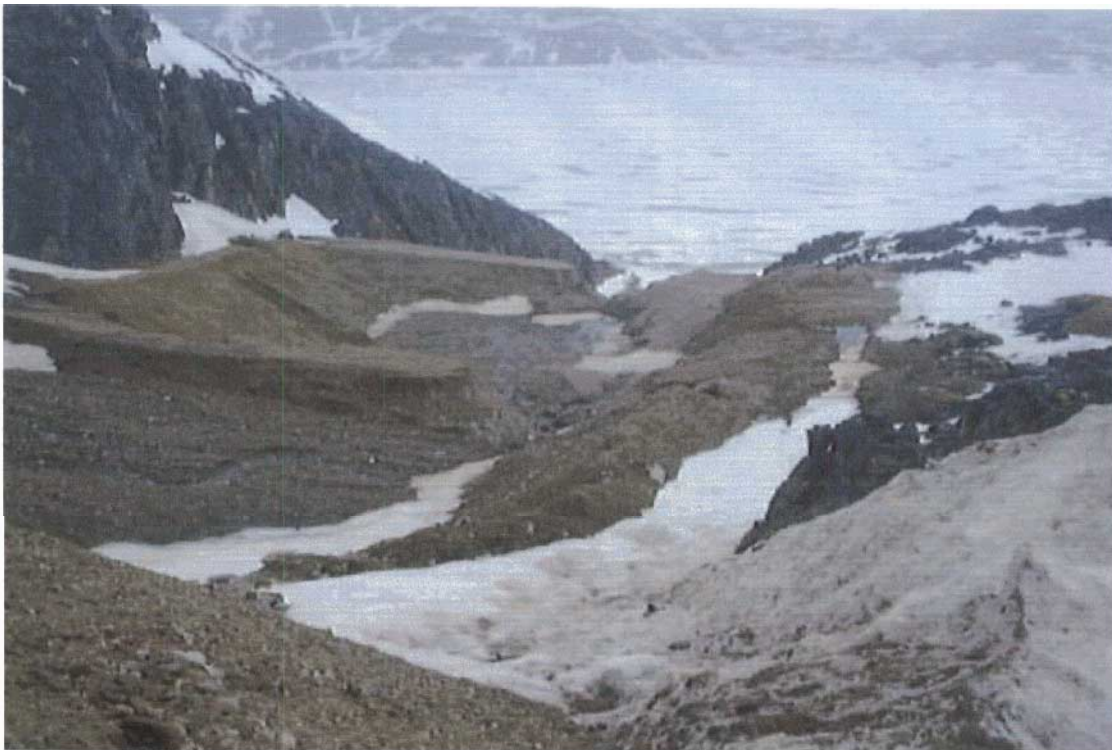
figure 2. Path of discharge from the first cell of the new sewage disposal site; 2001/06/10.

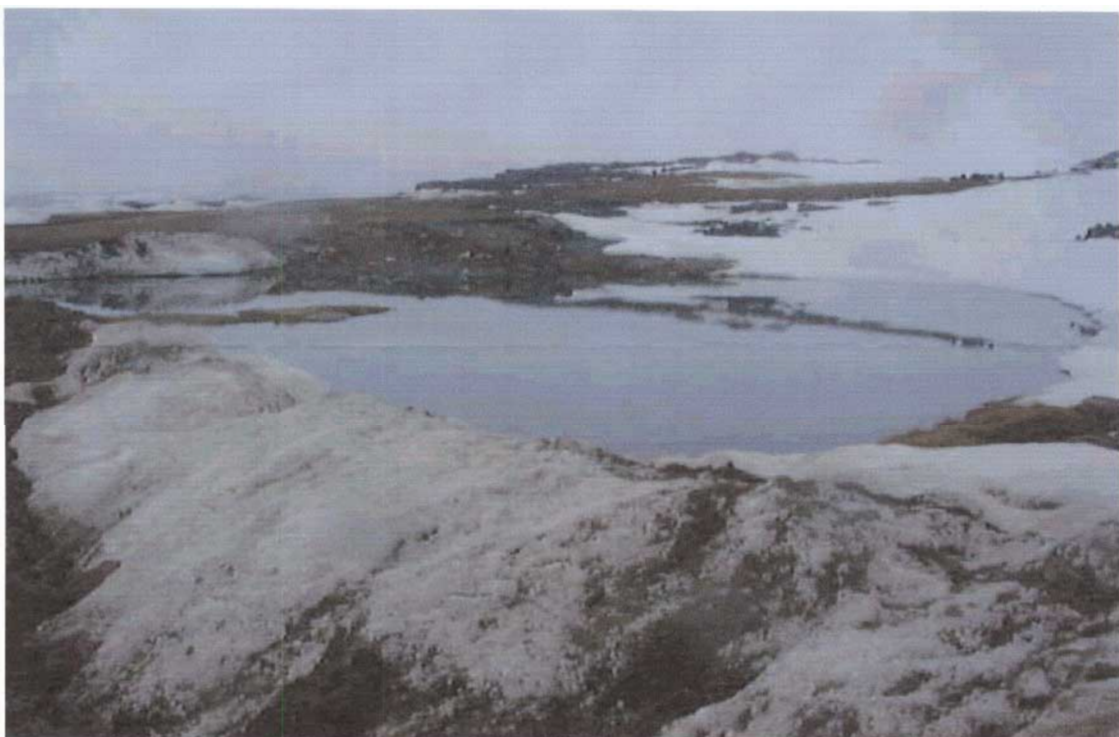
figure 3. Old sewage disposal facility; 2001/06/10.

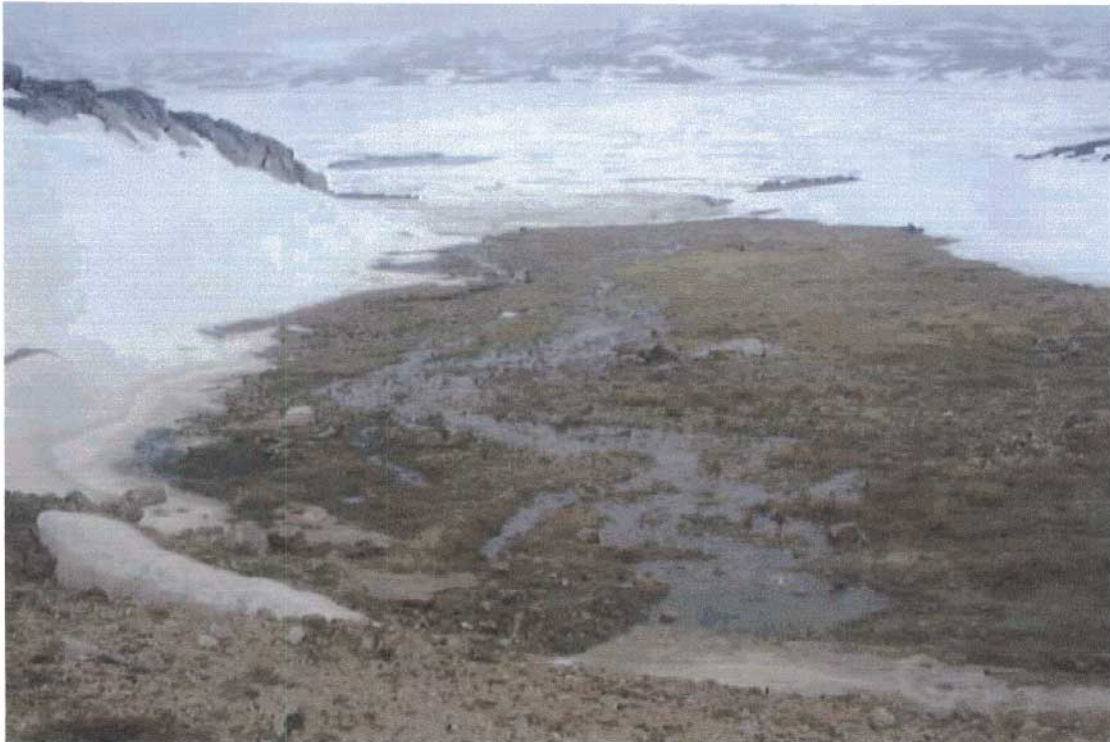
The attached analytical results relating to a sample taken about twenty metres along the main seepage vein below the access road (figure 4) indicate that ammonia (23.0 mg/L) and phenols (36 µg/L) exceed the *Canadian Water Quality Guidelines for the Protection of Freshwater Aquatic Life*. Nonetheless, as was the case for the new sewage lagoon, the microtox sample did not attribute toxicity to the effluent. This being said, the Inspector acknowledges that consultants have been retained by Community Government and Transportation to complete a *Sewage Treatment Facility Planning Study in Cape Dorset, Nunavut*.

figure 4. Path of discharge from the old sewage disposal facility; 2001/06/10.

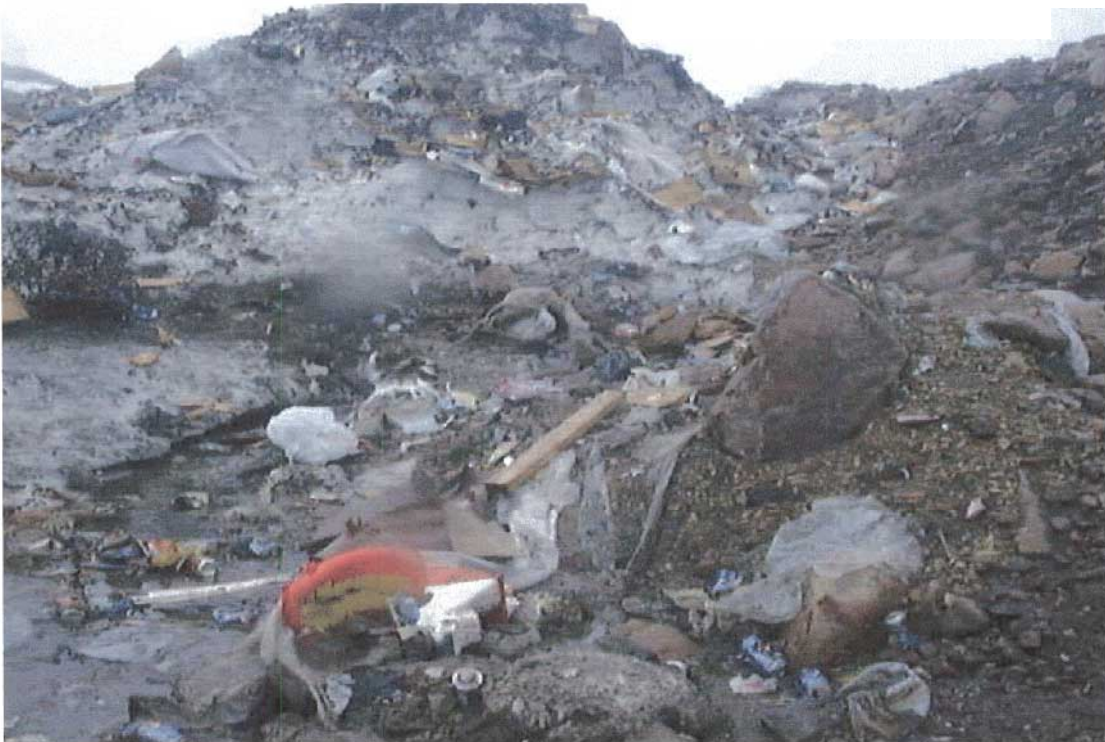
- **Solid waste disposal:** It was mentioned that the municipality hoped to fence the solid waste disposal facility before fall, however in the meantime a notable quantity of windblown garbage is scattered around the site. Further, runoff along the cliff face of the waste disposal valley poses concerns in regards to leachate production from the solid waste disposal facility (figure 5). As such, the attached analytical results reveal that ammonia (2.41 mg/L), cadmium (0.3 µg/L vs 0.017 µg/L), copper (16 µg/L vs 4 µg/L), iron (1.17 mg/L vs 0.3 mg/L), and zinc (95 µg/L vs 30 µg/L) exceed the *Canadian Water Quality Guidelines for the Protection of Freshwater Aquatic Life*. Hazardous materials are still disposed of haphazardly at the bulky waste disposal site, and it was again suggested that a sealift container be used to store hazardous materials and thus minimise the chances of release of contaminants to the environment. In addition, significant runoff was flowing through the bulky waste disposal area before reaching the highwater mark at the toe of the dump. The attached analytical results reveal that cadmium (0.5 µg/L), copper (5 µg/L), and zinc (114 µg/L) exceed the *Canadian Water Quality Guidelines for the Protection of Freshwater Aquatic Life*. Nevertheless, neither of the microtox samples from the solid waste disposal sites attribute toxicity to the sampled leachates.

figure 5. Leachate from the solid waste disposal facility; 2001/06/10.

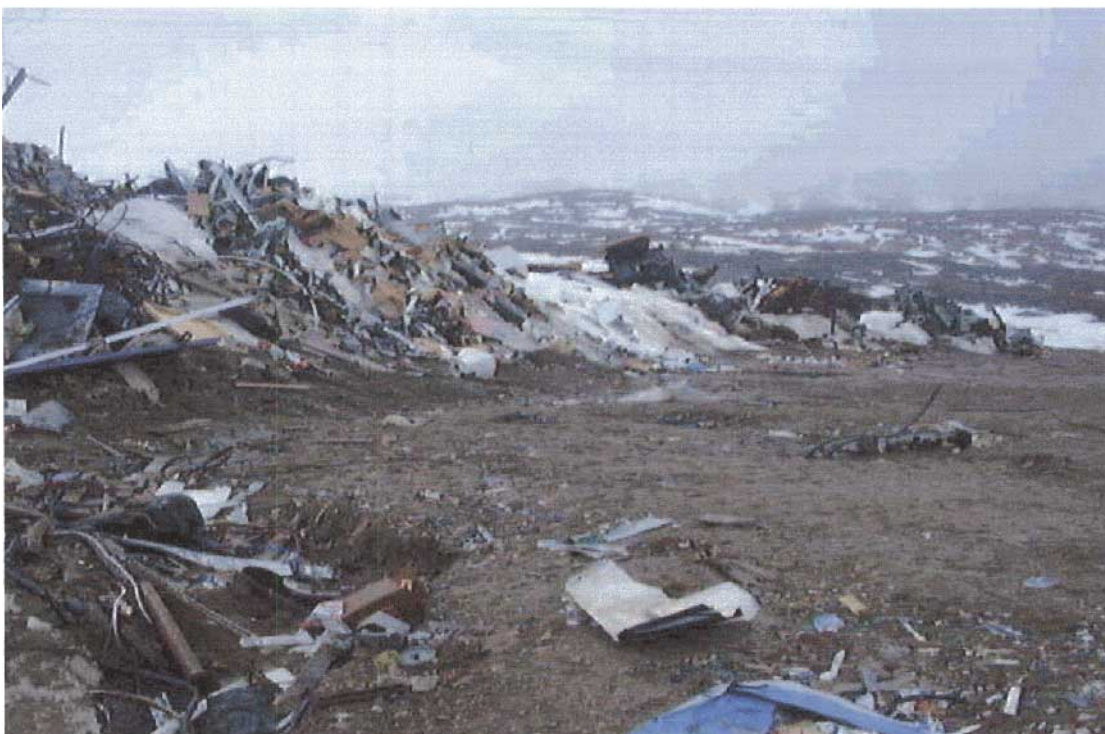
figure 6. Runoff flowing through the bulky wastes disposal facility; 2001/06/10.
