WATER LICENCE INSPECTION FORM

Licensee Representative												
Hamlet of Cape Dorset Jon Hussy												
Licence No. / Expiry Representative's Title												
3BM-CAP0810 Acting Senior Administrative Officer												
Land / Other Authorizations												
None												
Date of Inspection Inspector												
May 17, 2017 Jonathan Mesher												
Activities Inspected ☐ Camp/Municipality ☐ Drilling ☐ Mining ☐ Construction ☐ Reclamation ☐ Fuel Storage												
Roads/Hauling	Other:		,g	Other:			Recolumnation		uorotorage	,		
Conditions: A - A	ditions: A - Acceptable		C - Concern U - Unacceptal		• • • • • • • • • • • • • • • • • • • •		Not Applicabl					
Water Use	Condition	Comment Site (Conditions		Condit ion	Comme nt	Haz/Mat Ma	anagement	Condition	Comment		
Intake/Screen	NI	Wate	er Management S	Structures	Α		Storage		Α			
Flow Measure. Device	С	Culve	erts / Bridges		Α		Spills		NI			
Source:	NI	Drain	nage		Α		Spill Plan		Α

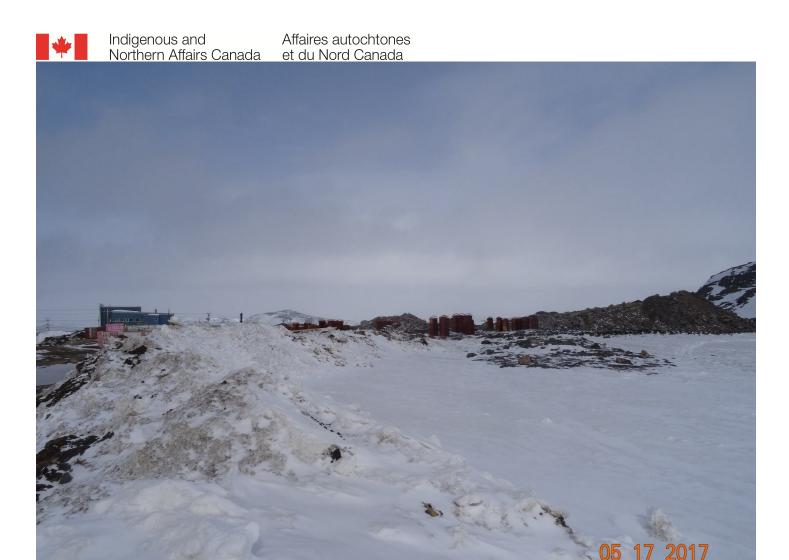
Figure 1: snow piled near Ice Lake

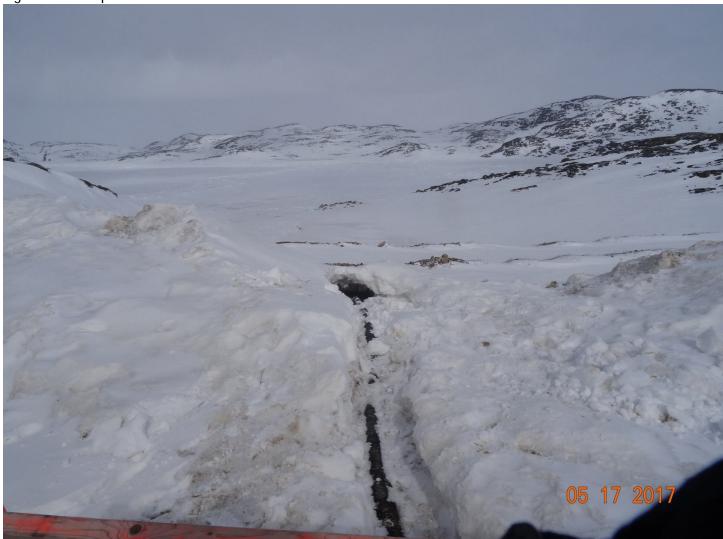
- 2. Sewage Disposal Facility
 - a. During the inspection the Hamlet was using the Emergency Lagoon and decanting across the road to a run-off area with diversion berms to slow the flow, it does not appear to the inspector to effect inland waters. (Figure 2).

Figure 2: Emergency Lagoon outflow

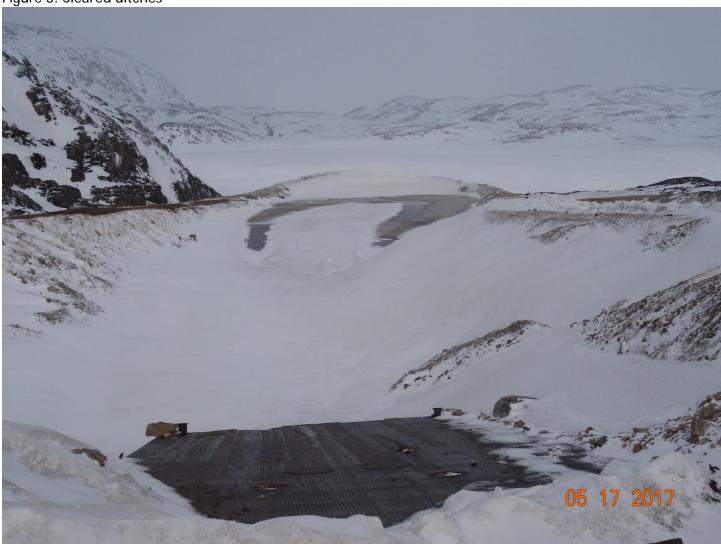
- ii. Culverts connecting the 3 cells where free of ice to allow flow within the system
 - iii. The 3 cells where decanted in the fall of 2016 to allow earlier use in the summer of 2017 (Figures 4, 5 and 6).

Figure 4: Cell 1

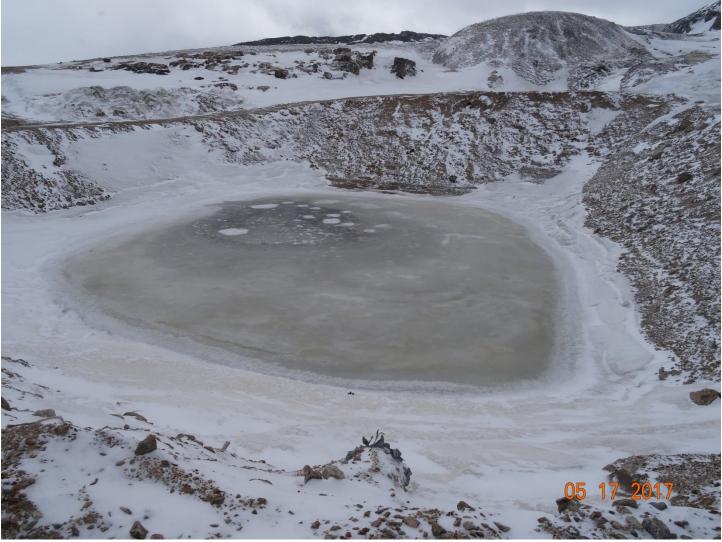
Figure 6: Cell 3

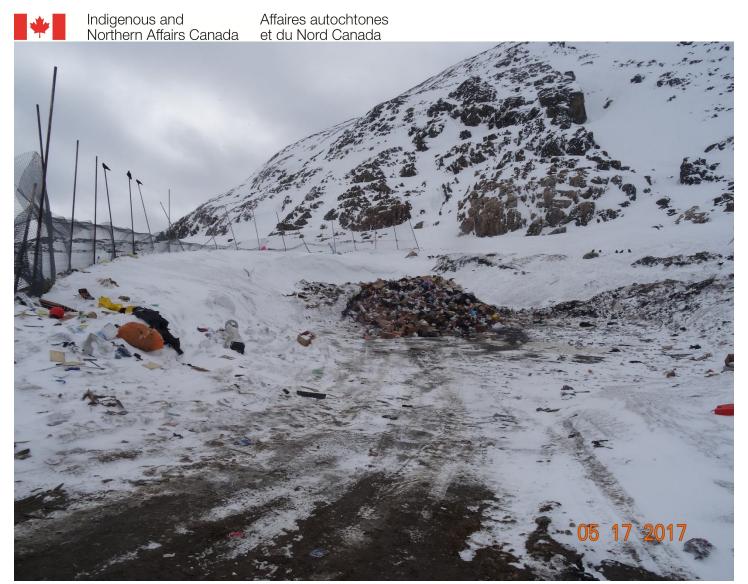
- a. The Licensee manages domestic waste through a burning and covering procedure, see figure 7 for a picture of this facility.
 - b. There were no signs of leachate coming from the facility at the time of inspection.

Figure 7: solid waste disposal facility
