**ANNUAL REPORT  
FOR THE HAMLET OF KINNGAIT, 2021**

**YEAR BEING REPORTED: 2021**

The following information is compiled pursuant to the requirements of Part B, Item 1 of Water Licence # 3BM-CAP1925 issued to the Hamlet of Kinngait.

WATER LICENCE INSPECTION FORM

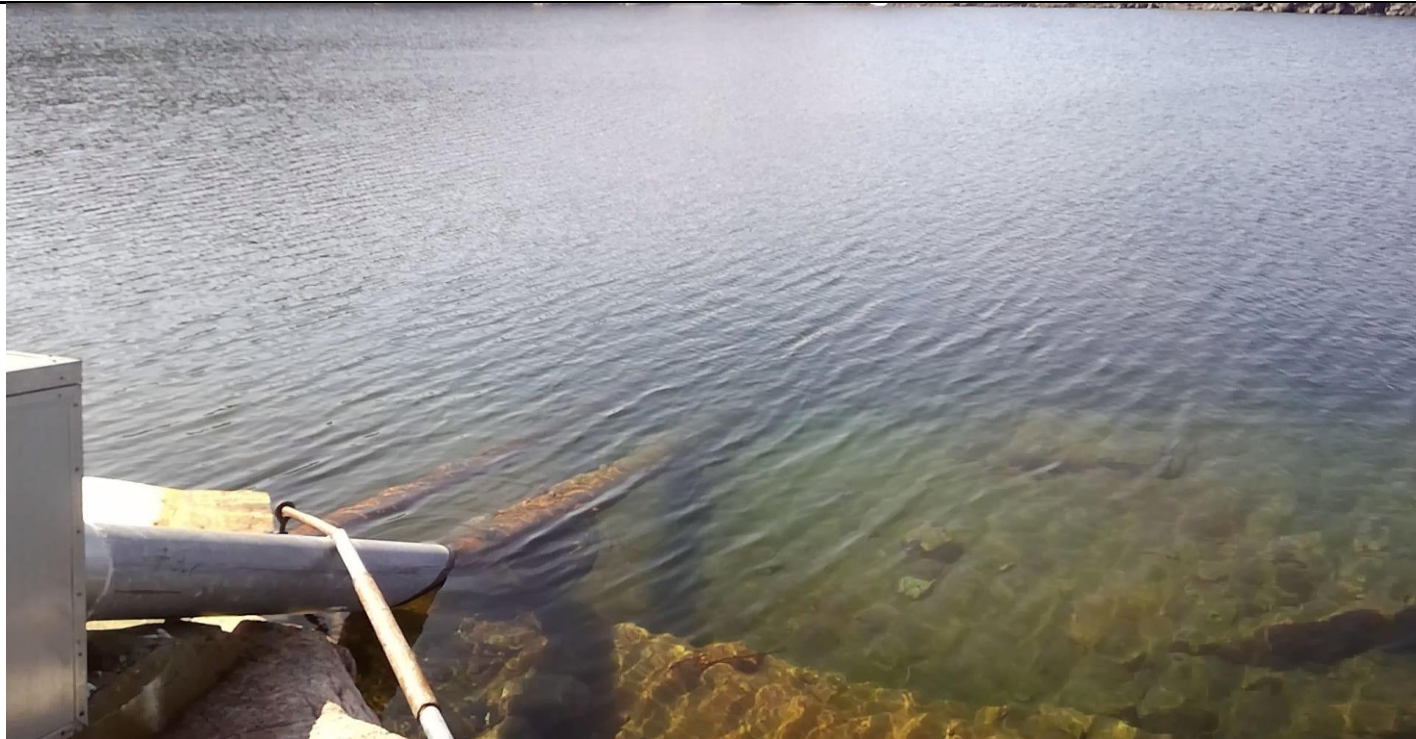
| Date | Camera | Inspector | |
|---|---|---|--|
| Photo 1 | | Cape Dorset, NU | |

5. During the inspection WRO Monteith did observe rusting of the pipe at Tee Lake below grade of the water table. (Photo 1).
6. Monitoring Station Cap-1 was observed at the water fill station.
7. The length of piping from the potable water source to the truck fill station is approximately 1,318.93 metres (1.3km) as measured from Google Earth (photo 2).
8. The Hamlet water fill station was observed. No water meter was observed at the time of the inspection.
9. Water Usage Records were emailed to WRO Monteith by Grant Scott, Interim Senior Administrative Officer, Hamlet of Cape Dorset. The report shows 41, 169m<sup>3</sup> was withdrawn from Tee Lake(photo 12).

| Date | Camera | Inspector | |
|---|---|---|--|
| Description: Tee Lake: 2x water withdrawal pipes | | | |

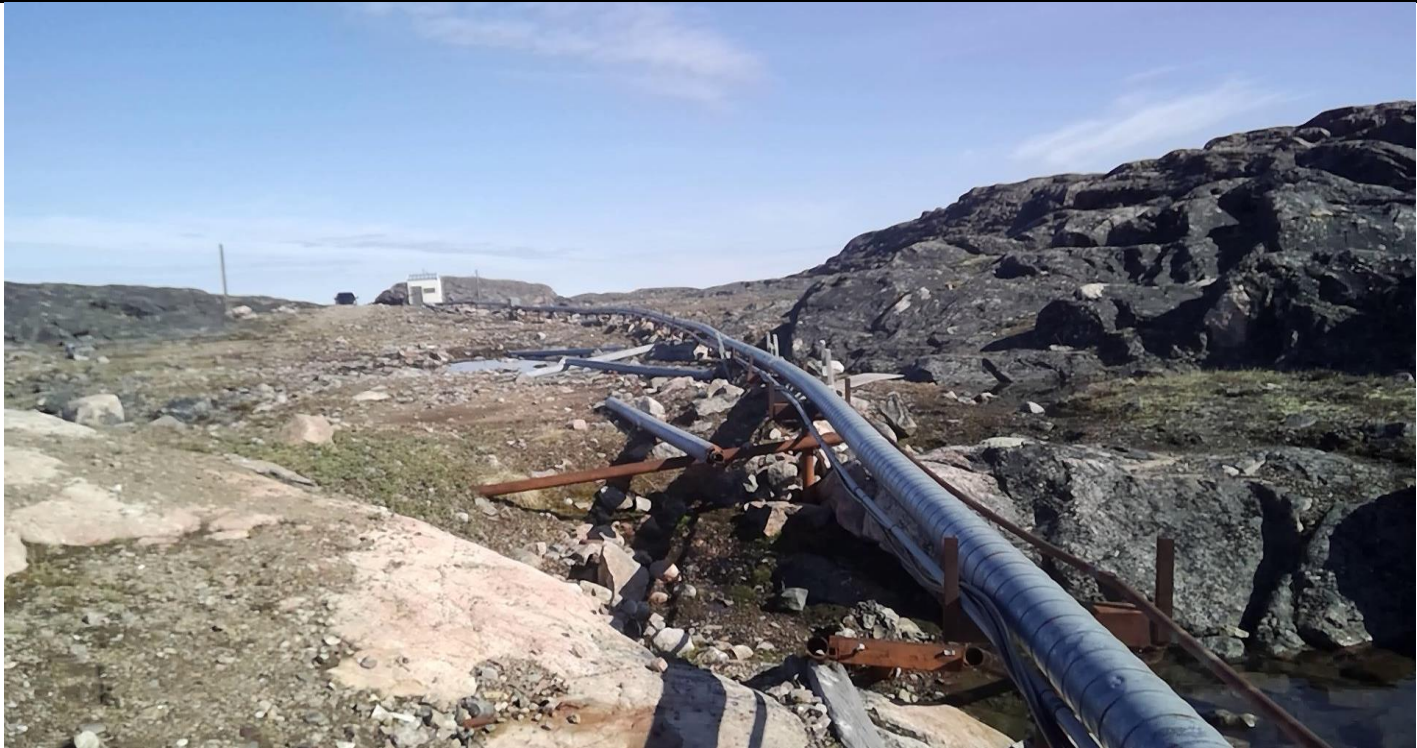
| Photo Log | Location |
|---|---|
| Photo 2 | Kimmirut |

| Photo Log | Location |
|---|---|
| Description: Pipe Line from water source to water treatment plant. No concerns | |

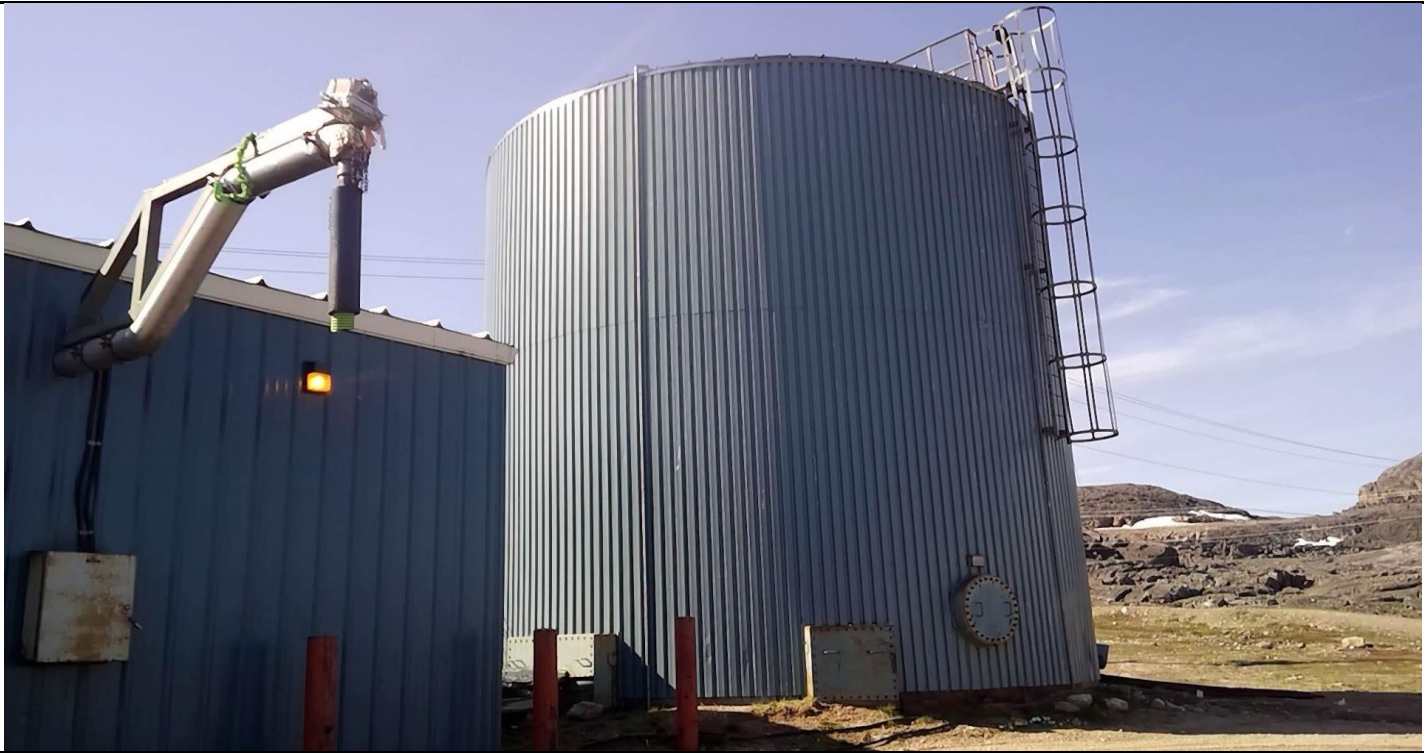
| Photo Log #1 | Location |
|---|---|
| Photo 3 | Kimmirut |

Description: Water Treatment Plant

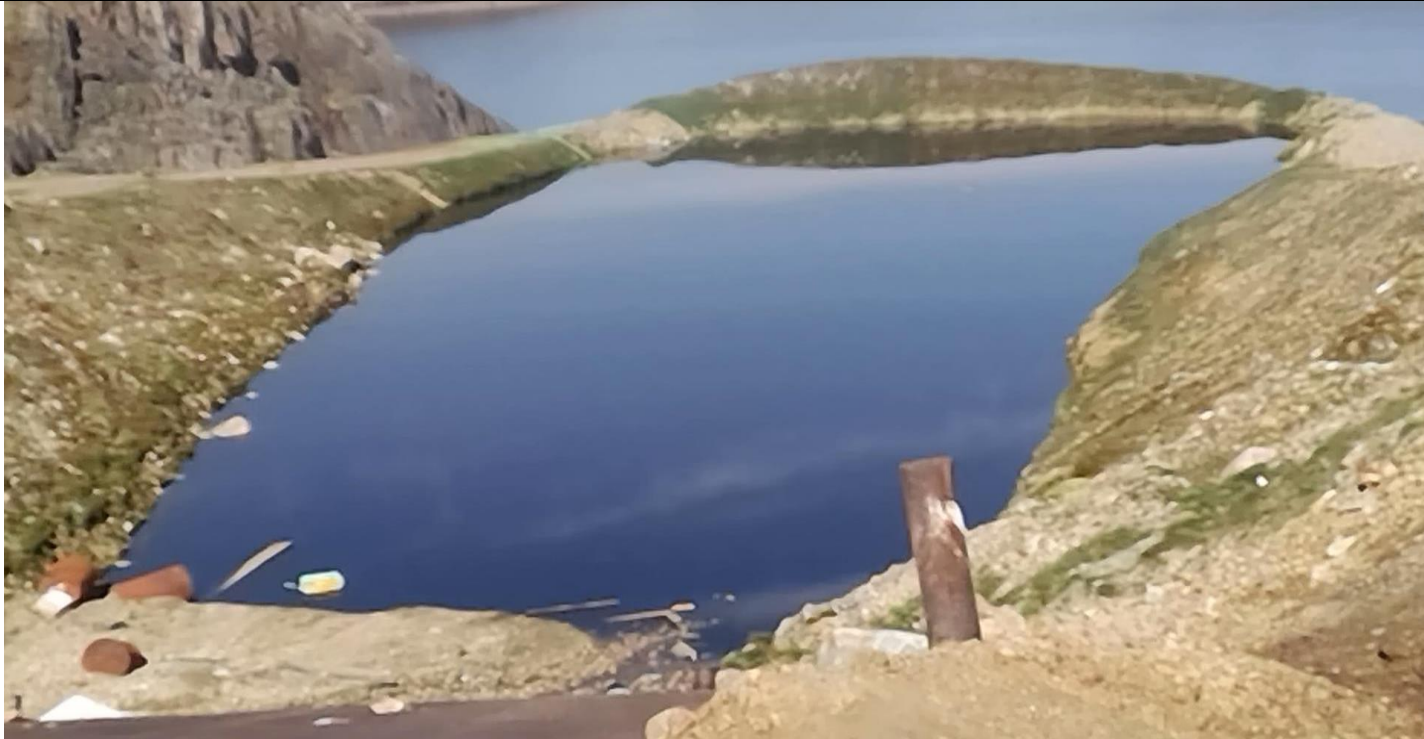
| Photo Log #1 | Location |
|---|---|
| Photo 4 | Kimmirut |

10. At the time of the inspection the sewage lagoon, a 3 tiered cell sewage lagoon much like a sump pit was in-use and appeared to be operating as intended(Photo 4). The top two cells have culverts to maintain sufficient freeboard. The third and lowest cell has a couple of culverts to maintain a freeboard, but if the intent of the sewage lagoons is to settle all suspended solids and decant at specific times of the year, this lagoon isn't doing that. As each cell fills up, it drains into the next cell. But once at the bottom cell, the intent should be to hold the waste, and decant after notifying the inspector. The current method if intended is to always maintain a freeboard, and allow waste to flow out at the culverts when the cells are filled to the culvert line. After the third and lowest cell, the run off has approximately 100 metres counting the distance from the top of the cell wall to the ocean. A drainage ditch was created along the south side of the lagoon, to divert any runoff from Nungaaait Mountain and the solid waste facility. This drainage ditch has a monitoring station titled CAP-3. The drainage ditch also showed signs of overflow from the sewage lagoon cells (Photo 3). An Emergency Lagoon was also observed at the time of the inspection.

11. The freeboard for highest upper cell was at the level of the culvert, which is approximately 1 metre from the top of the sewage lagoon cell wall. The second cell also had a culvert which appeared to be an overflow culvert to maintain the 1 metres freeboard on the lagoon. The cell wall on the second tier middle lagoon was not even in height. The culvert may have been installed to maintain the 1 metre freeboard, but in other areas of the walls, the freeboard was below 1 metre (Photo 2). The corner of cell 2 appeared to have no lining, and waste was leaking through to the third tier by exfiltration. Monitoring Station Cell-4 should be here, but the sign was down. The third and last cell was full to the lower culverts spilling out. No 1 metre freeboard on the lower cell with sewage table at the lower culvert.

Description: Cell 3 full, overflows into already full Cell 2, which then spills into Cell 3 through a spill way culvert. Cell 3 full, spilling out uncontrolled out of the 3 cell lagoon.

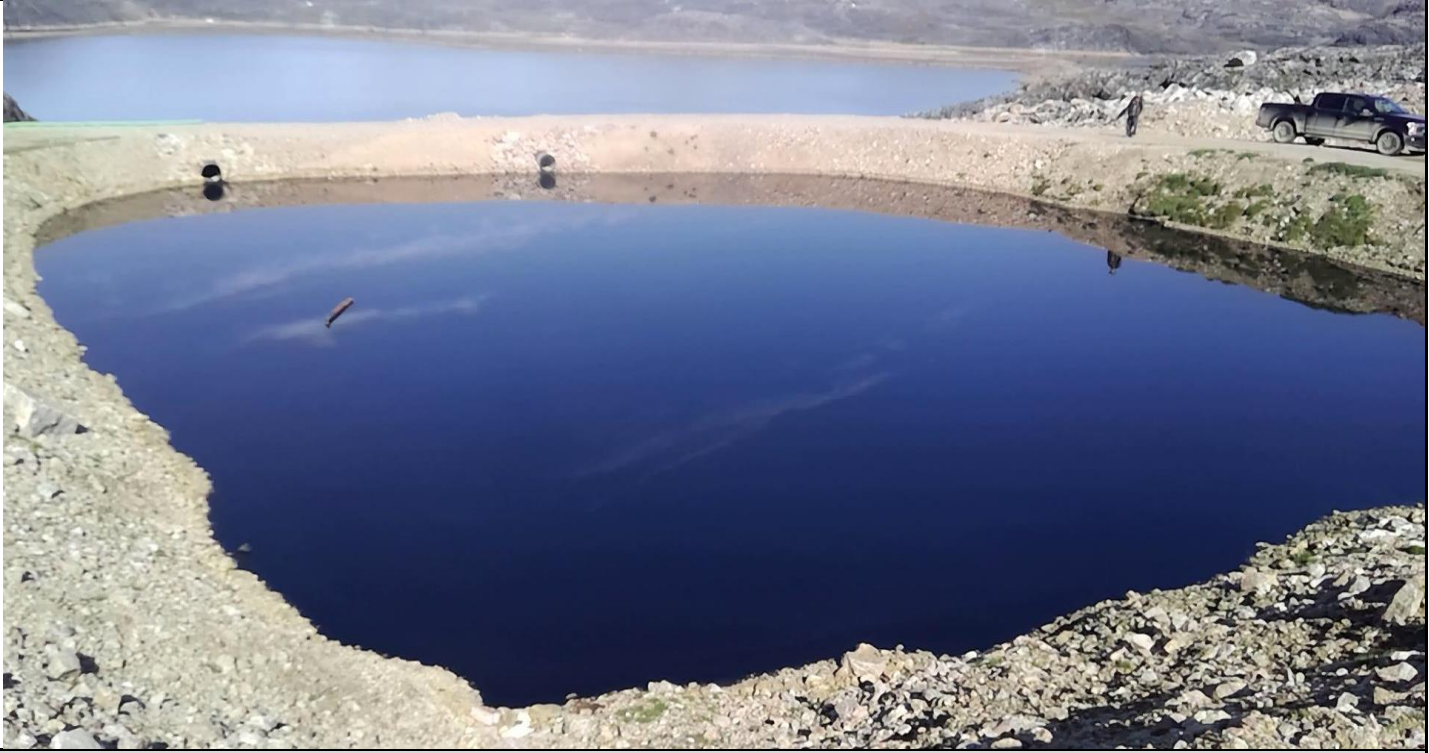
| Photo Log #1 | Location |
|---|---|
| Photo 5 | Kimmirut |

Description: Cell 3 full, and spilling out the overflow culvert. An uncontrolled discharge of waste.

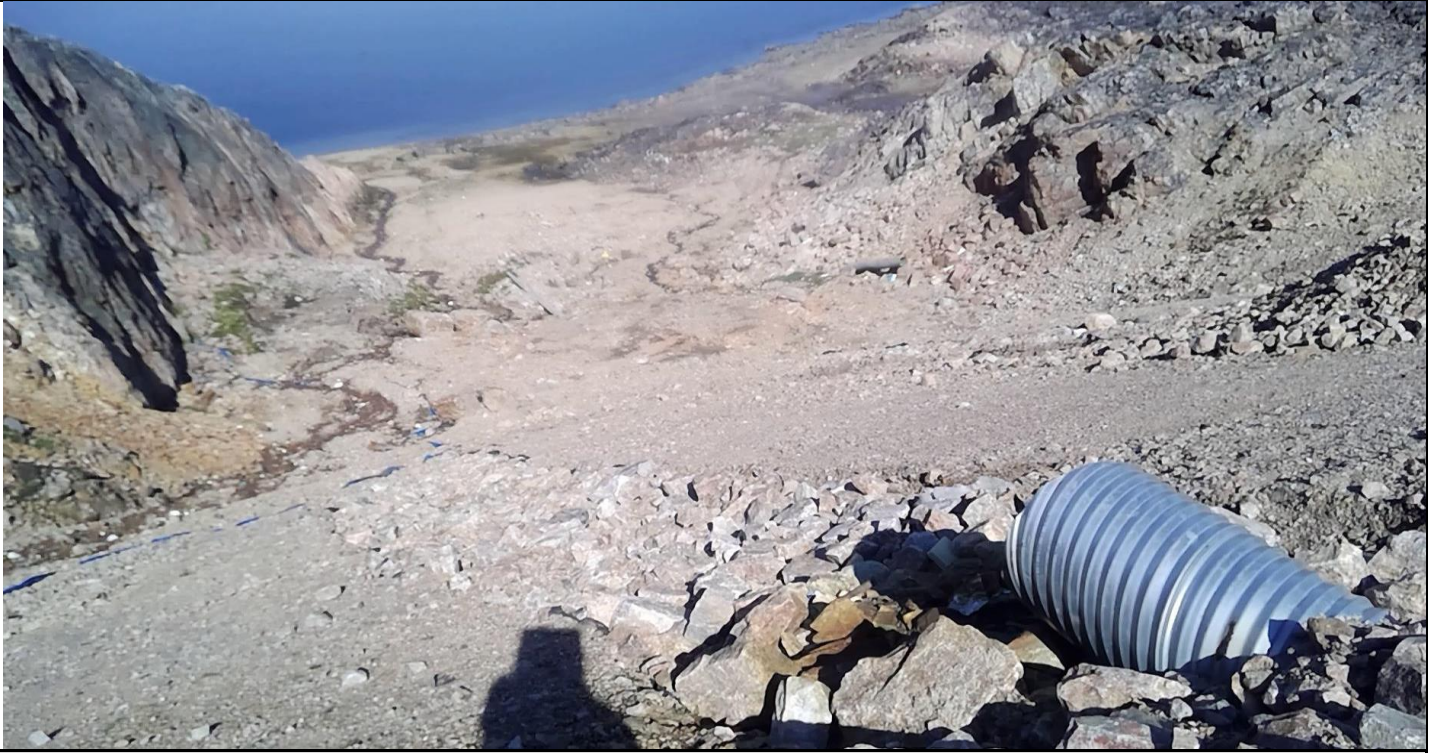
| Photo Log | Location |
|---|---|
| Photo 6 | Kimmirut |

Description: The uncontrolled discharge of sewage down the spill way has caused erosion and sedimentation. A spill report was requested and submitted to the NT\NU Spills line.

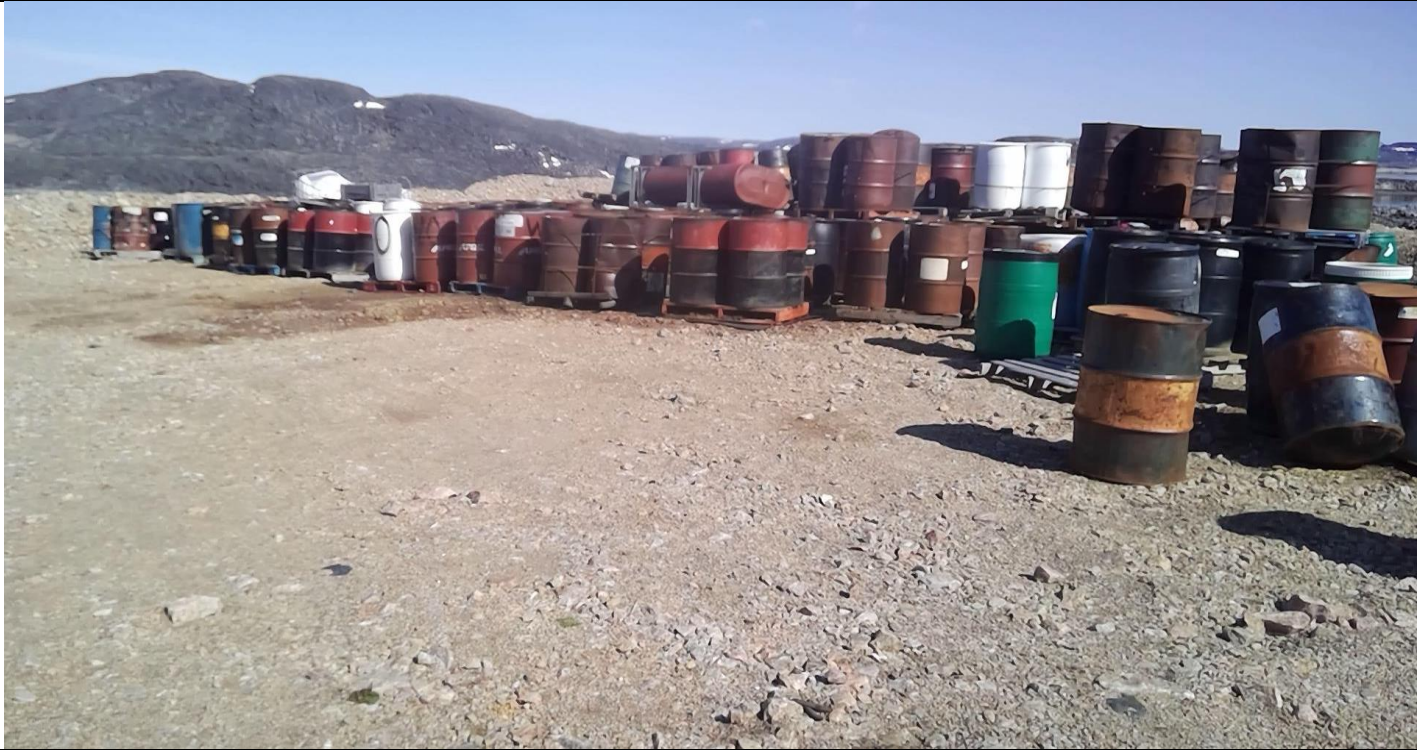
| Photo Log | Location |
|---|---|
| Photo 9 | Kimmirut |

Description: 3 walled, non-engineered berm for storage of drums of hazardous waste. Active spill coming from drums. Spill of this size was not observed in 2020.

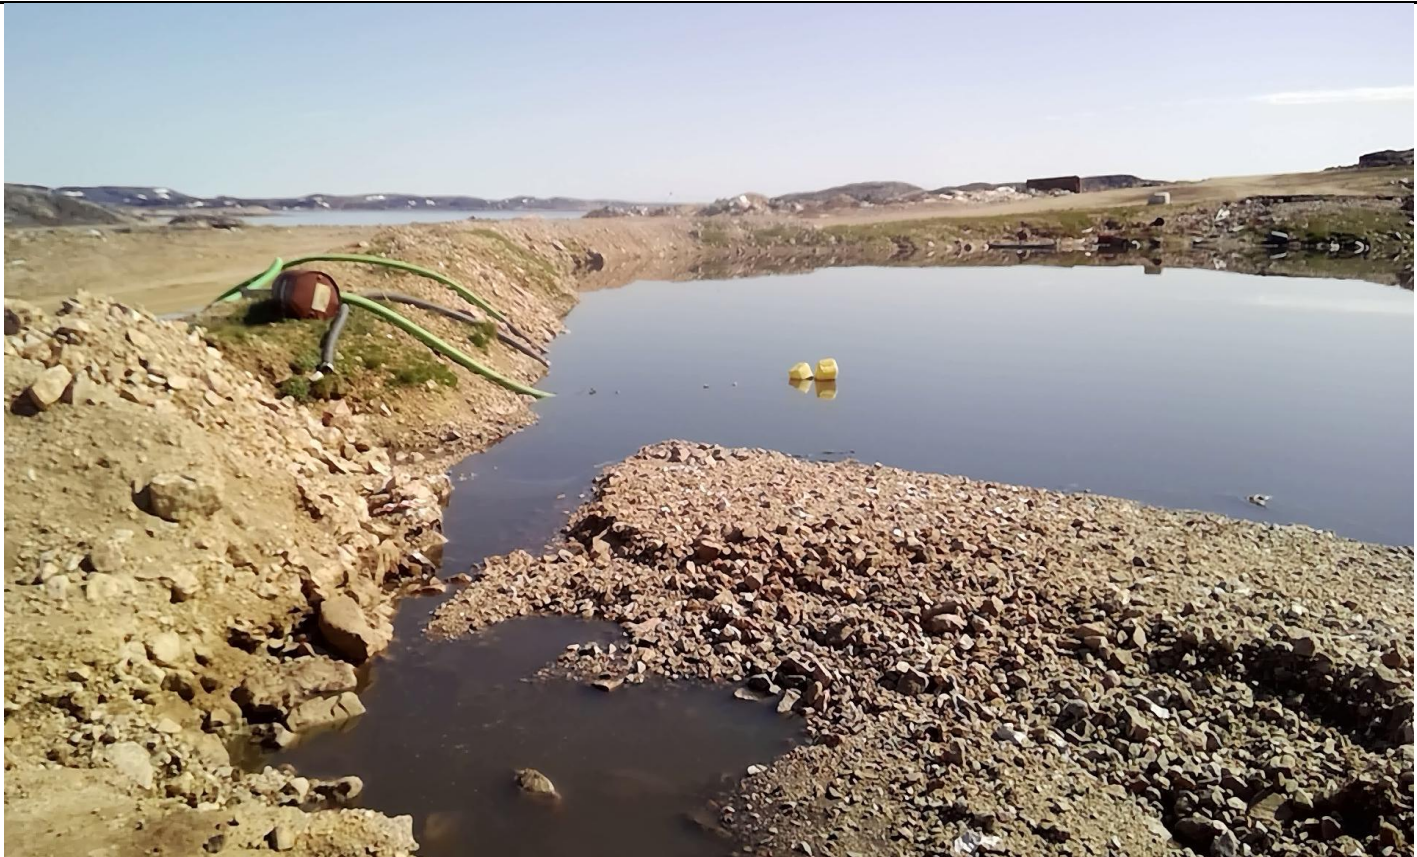
| Photo Log | Location |
|---|---|
| Photo 10 | Kimmirut |

12. The emergency lagoon appears to have been built to capture run off from the 3 tier lagoon, but showed signs of recent use. Hoses litter the area, and must have been used to decant the emergency lagoon, and had shown signs of past overflow from run-off water. Across the road from this emergency lagoon was berm walls constructed to capture the run off that had entered the emergency lagoon, overflow, and also where they would decant from the emergency lagoon. A monitoring station listed as CAP-5 sign was also observed there. The emergency Lagoon is approximately 171 metres away from the high water mark of the ocean.

Description: Unreported spill at the emergency lagoon. A spill report submission was requested, and clean up. Walls of emergency sewage lagoon repaired, and 1 metre free board now maintained.

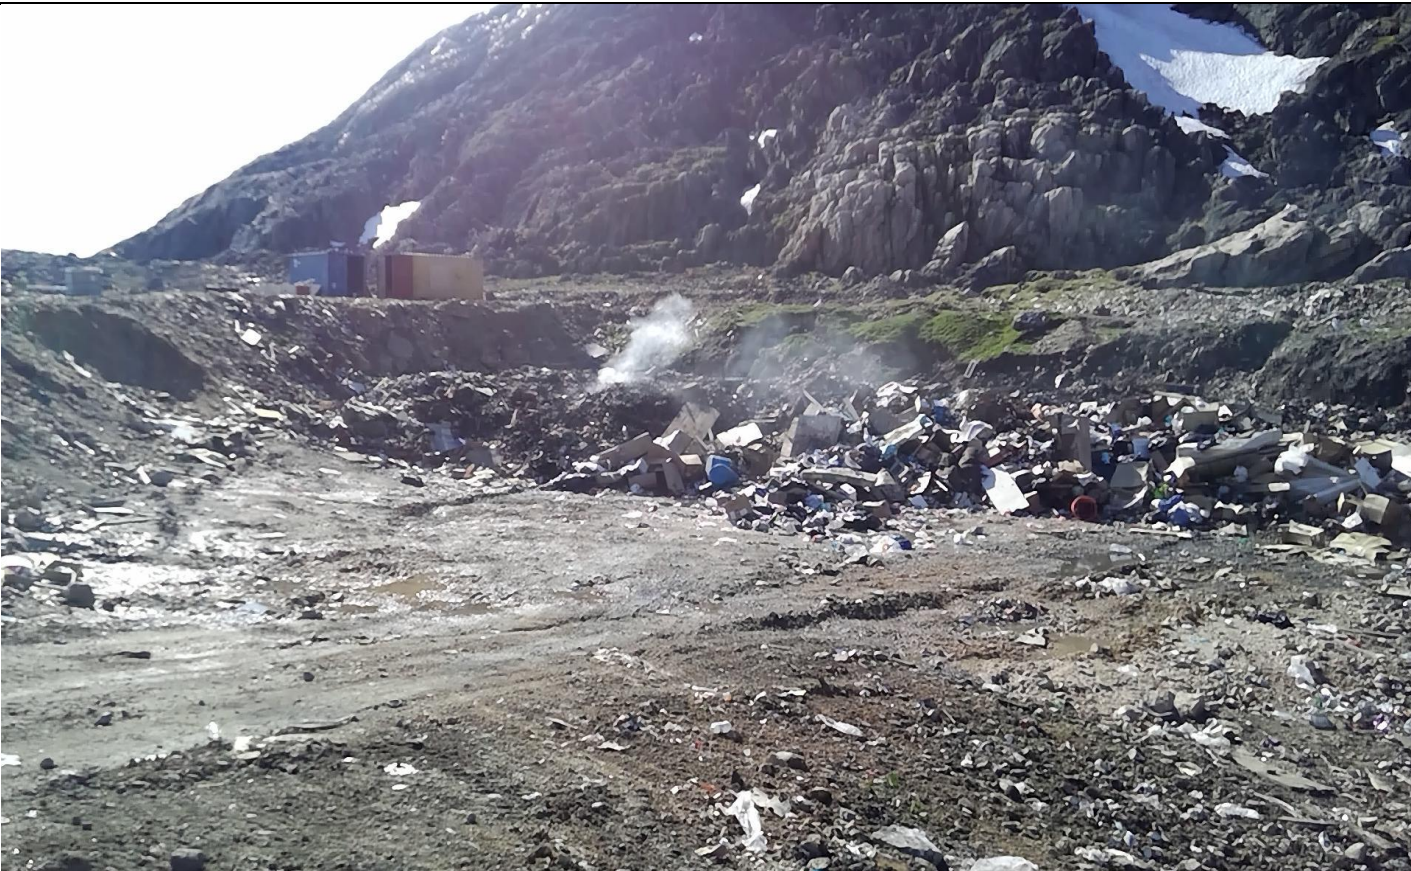
Photo 11

15. The open pit burning has fencing along the top of the pit, along the north east side of the pit. Probably to capture windblown garbage as the prevailing winds comes from the North West. The fencing is damaged. The approximately 4 metre high posts that support the fencing is bent out of shape, and the fencing itself is folded outwards from the post, and doesn't appear to be operating as intended.

Description: Fencing at the burn and cap section of the solid waste facility. Fencing condition has been demolished.

| <p>The following information is a summary of the actions required by the licensee to promote and ensure compliance:</p> <ul style="list-style-type: none"><li>• Repair to the fencing on the north east side open pit burning may mitigate any windblown garbage from blowing away and impacting any water bodies. Erection of another fence on the North West side may mitigate garbage from entering the sewage lagoon cells and compromising its capacity.</li><li>• Send hazardous waste to a proper Hazardous Waste Facility to free up room in the current Hazardous Waste Facility. Keep copies of Hazardous Waste Manifest for verification purposes.</li><li>• Repair of the wall at the Solid Waste Facility was not requested, and has resulted in the accumulation of surface water. The accumulated water will have to be tested, and if found to have contaminants, be treated before being released. The intention of Part D: Item 10 is to implement appropriate erosion and diversion control methods to prevent the entry of water into the facility and to prevent the retention of water to minimize surface water accumulation in the facility. In regards to Part D: Item 6, the licensee was not compliant on this dam.</li><li>• Test the bermed water inside the solid waste facility, and provide results to the inspector, and submit results in 2021 Annual Report.</li><li>• The Licensee is reminded to remain diligent to prevent wastes from entering water, and the environment.</li><li>• Ensure all monitoring sites have the signs indicating that it is a monitoring site, and have it listed in the <i>Official Languages of Nunavut</i></li></ul> | | | |

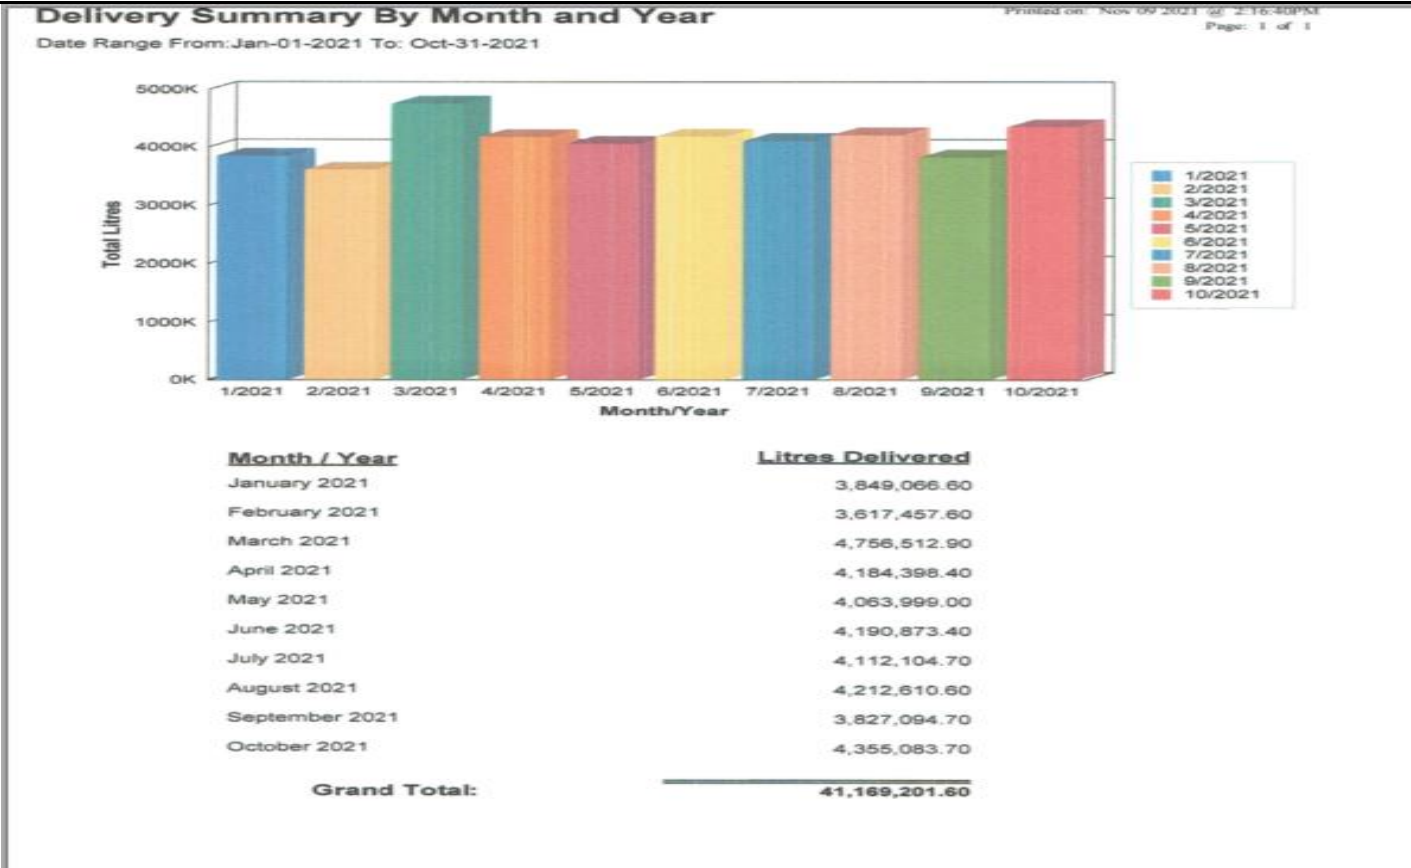
Photo 12

Description: Water Usage Report for January, 2021 to October 2021. Shows 41, 169m<sup>3</sup> withdrawn from Tee Lake.
