August 28, 2001 Municipal Water Use Inspection - Report

MUNICIPAL WATER USE INSPECTION FORM

Date: 2001/08/28 Licensee Rep. (Name/Title): Harry Aggark / Foreman
Licensee: Hamlet of Chesterfield Inlet Licence No.: N6L4-1538 (expired)

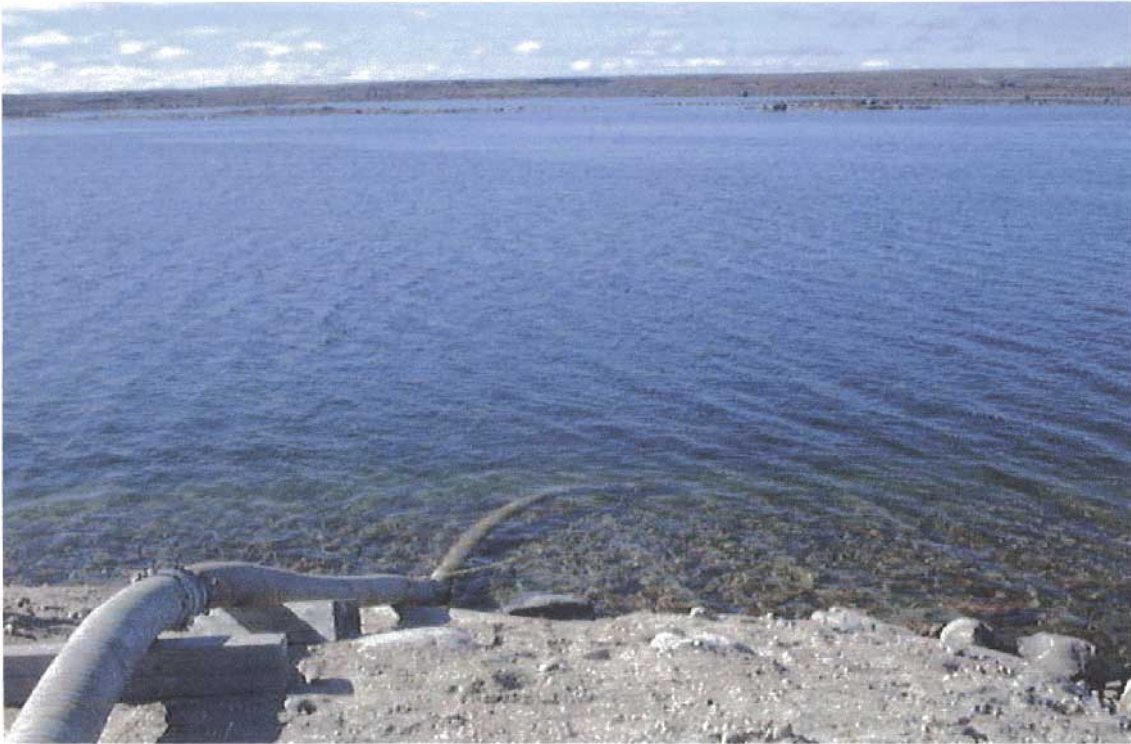
figure 1. Water intake facility at First Lake; 2001/08/28.

- **Water supply:** At the time of the inspection, final groundwork was being carried out in preparation for the annual refill, from First Lake (figure 1), of the municipal water reservoir (figure 2). However, concerns were expressed in regards to the refilling operation since murky water had recently been noted by municipal staff during truckfill, and a boiling order had consequently been issued. In light of this, the raw water sample taken during the inspection was collected from the reservoir instead of the supply source at First Lake. While the Inspector apologizes for the lateness of the report, the attached analytical results relating to the reservoir sample indicate that the municipal raw water supply meets the *Guidelines for Canadian Drinking Water Quality*, save for a single exception: a field pH of 8.7, which lies slightly above the 6.5-8.5 aesthetic objective. Given the above results, the Inspector recognizes that the new water truck awaited on the summer sealift ought to adequately address the matter.

Comments: Final groundwork being carried out in preparation for the annual refill, from First Lake, of the municipal water reservoir. Submersible pump and intake line at the reservoir not serviced since their installation; arrangements taken. Chlorination in use.

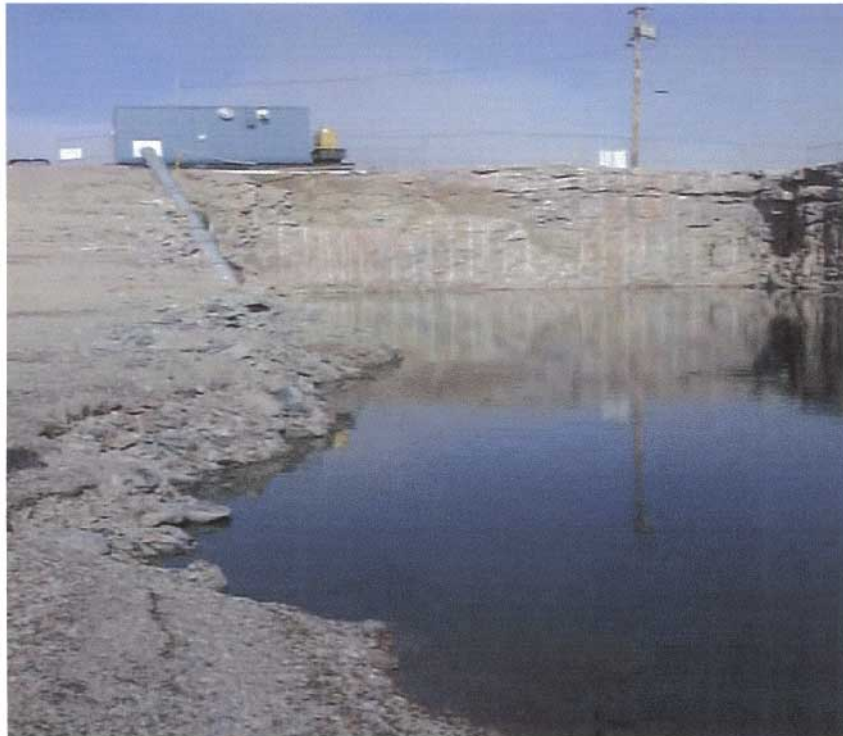
figure 2. Municipal water reservoir, prior to refilling operations; 2001/08/28.

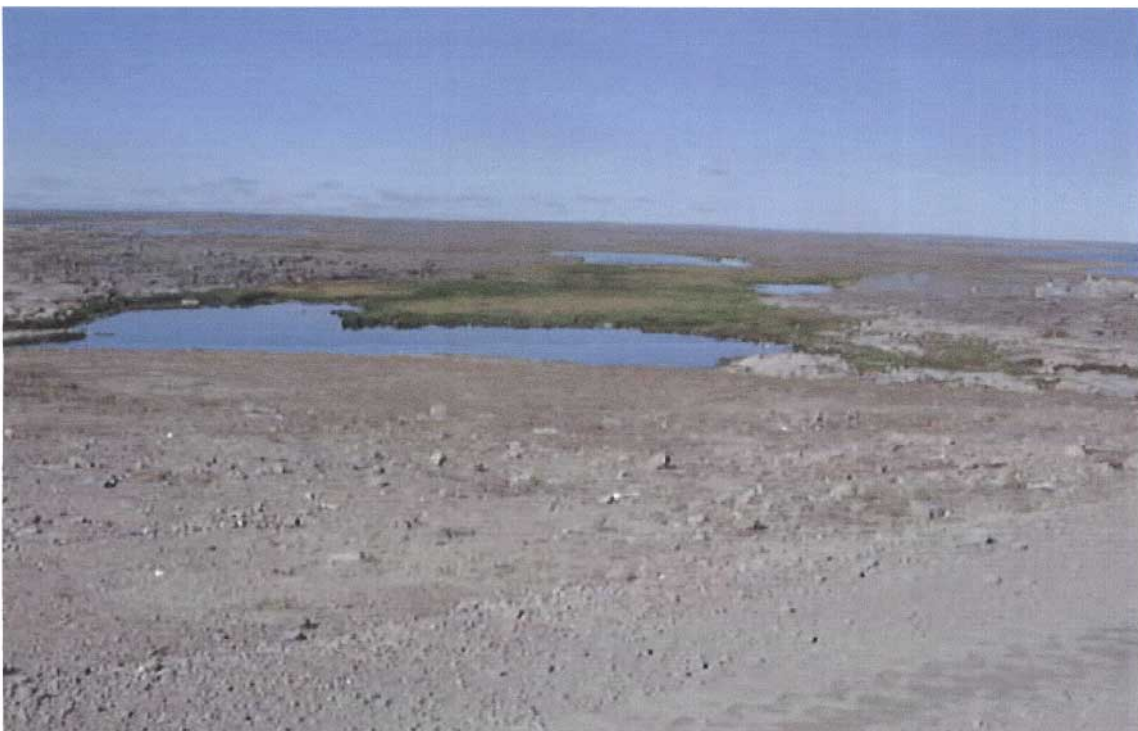
figure 3. Sewage disposal facility, adjacent to the solid waste disposal site; 2001/08/28.

- **Sewage disposal:** No concerns were noted in regards to the sewage disposal facility (figure 3). In fact, the abundant vegetation along the path of effluent discharge (figure 4) seemingly adds to the primary treatment provided by the initial retention time at the sewage disposal facility. Thus, the attached analytical results relating to a sample taken 50 metres downslope of the sewage discharge point reveal that all tested parameters meet the *Canadian Water Quality Guidelines for the Protection of Freshwater Aquatic Life*, save for field pH (9.1 vs 6.5-9.0).

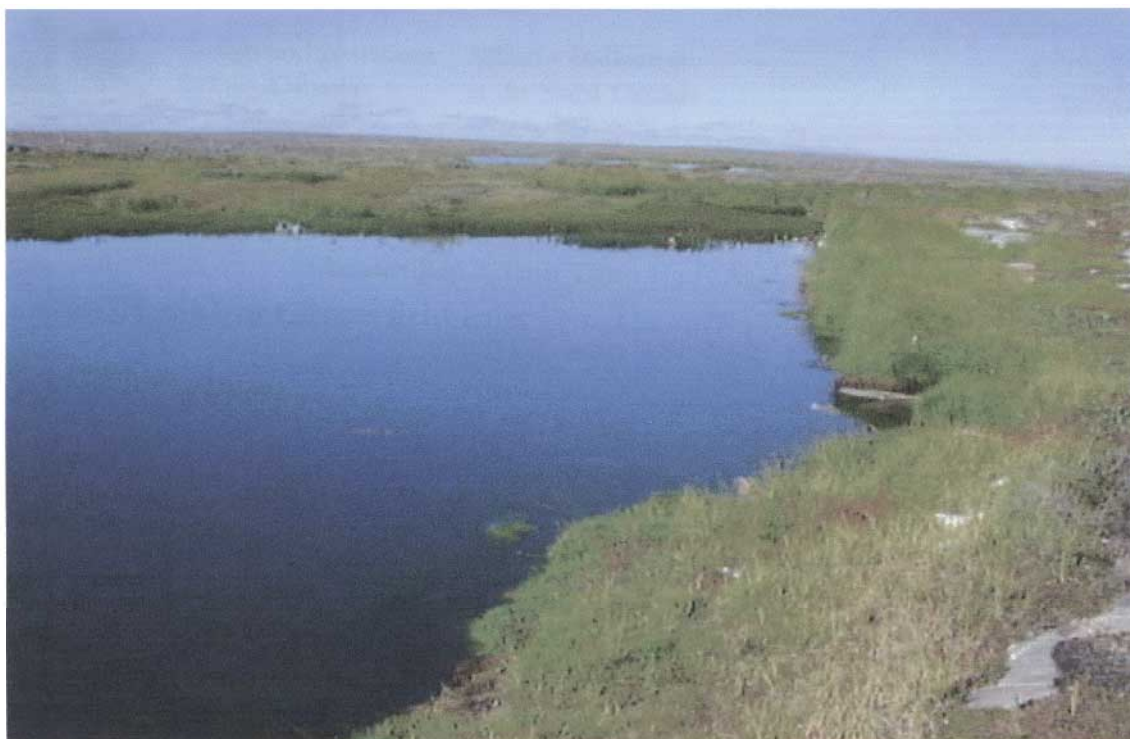
figure 4. Path of effluent discharge from the sewage disposal facility; 2001/08/28.

Nevertheless, the Microtox sample, which constitutes a reliable toxicity indicator (IC_{50}), shows that half of light-producing bacteria were inhibited by a sample concentration of 42%, whereas 50% and over is considered non-toxic. Thus, in an attempt to pinpoint the cause of the faint toxicity attributed to the sewage effluent discharge, a wider range of parameters will be sampled during the next municipal water use and waste disposal inspection.

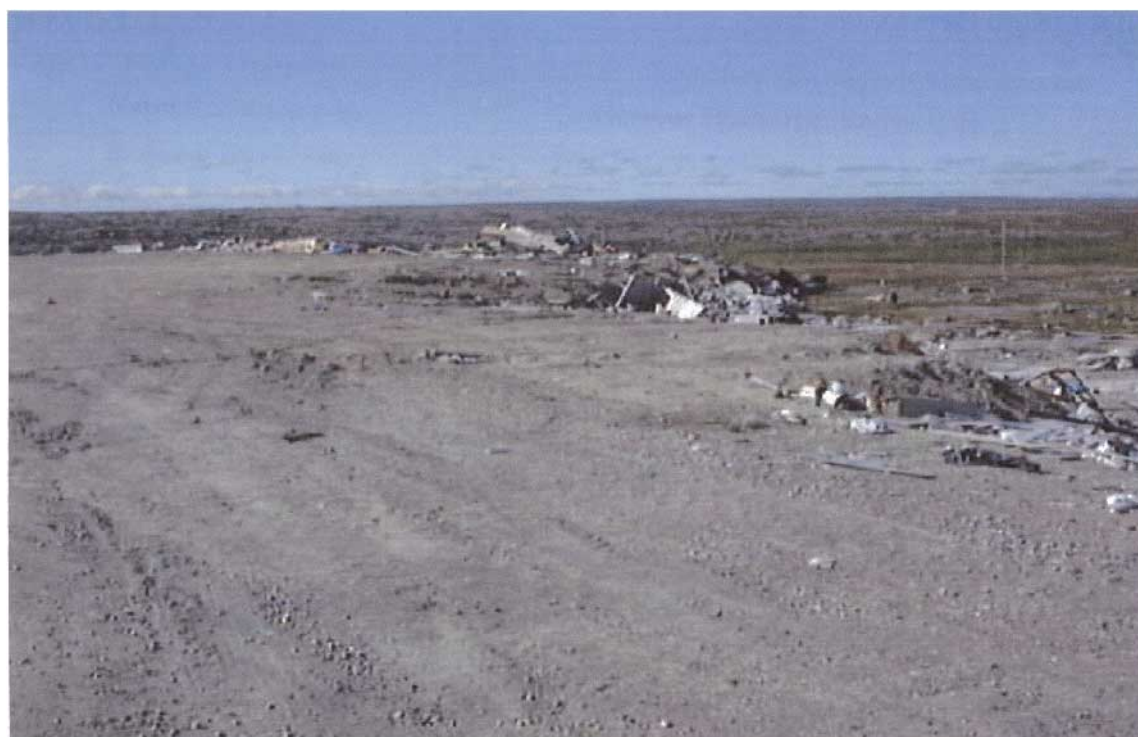
figure 5. Solid waste disposal facility; 2001/08/28.

- **Solid waste disposal:** Combustible household wastes are well managed, as the wastepile is regularly burnt and periodically compacted/covered (figure 5). Further, bulky metal wastes are segregated, and a form of containment is now provided for batteries and similar hazardous materials. In addition, as opposed to observations made during the previous inspection, leachate was no longer flowing from the toe of wastepile. However, concerns remain in regards to waste oil management. Indeed, leaking drums and hydrocarbon-contaminated soil were both noticeable at the waste oil storage site (figure 6). Taking into account the associated potential for the deposit of waste into waters, the state of the waste oil storage needs to be remedied. As such, the Inspector acknowledges that the Hamlet plans to contact neighbouring communities equipped with waste oil furnaces regarding the possibility of dispatching them the Hamlet's waste oil on sealift backhauls.

Comments: No concerns noted in regards to the sewage disposal facility; abundant vegetation along path of discharge. Solid waste disposal facility apparently well-managed; wastepile to be compacted towards the toe of the dump and covered before fall freeze up. No noticeable leachate flowing from the facility. Bulky metal wastes are segregated. Containment now provided for the storage of batteries and similar hazardous materials. Signs of hydrocarbon contamination observed in the waste oil storage area. Overdue requirements of the now expired Water licence: Operation and Maintenance (O&M) and Abandonment and Restoration (A&R) plans.

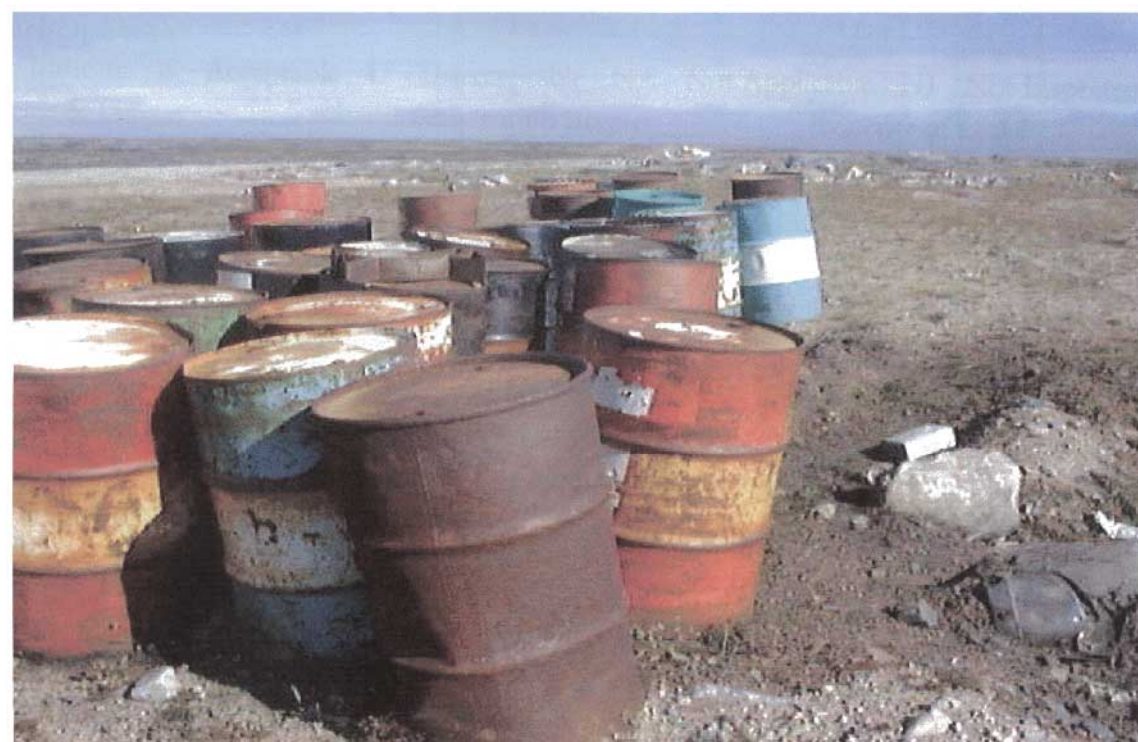
figure 6. Signs of hydrocarbon contamination at the waste oil storage site; 2001/08/28.
