Clyde River Water License Application

**The Hamlet of Clyde River
Nunavut, Canada**

FSC Project No: 2002-1000-050

Date: January 2003

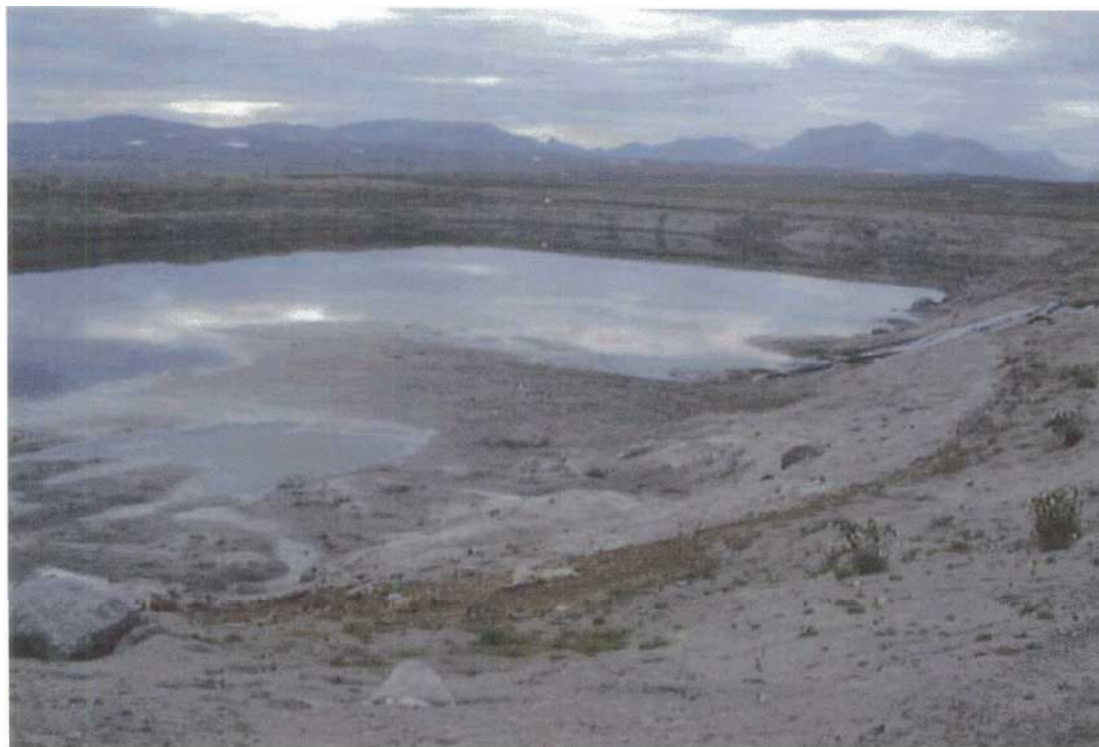
- **Sewage disposal:** At the time of the inspection, the sewage disposal facility had already been almost entirely decanted (figure 1). However, it was mentioned that recurring concerns with the sewage lagoon's freeboard and decant structure were again noted this summer. In relation to the annual decant, the inspector points out that it may be advisable to restrict the flow of discharge, thus spreading the decant over a longer period of time in order to maximize aerobic decomposition and secondary biological treatment. Indeed, the attached analytical results relating to a sewage effluent sample collected 10 metres downstream of the decant structure (figure 2) reveal that concentrations of ammonia (118 mg/L vs 2.2 mg/L) and phenol (590 µg/L vs 4 µg/L) considerably exceed the *Canadian Water Quality Guidelines for the Protection of Freshwater Aquatic Life*. Furthermore, while values of biological oxygen demand (291 mg/L) and of faecal coliform (510 000 CFU/100 ml) are also high, the Microtox sample, constituting a reliable toxicity indicator (IC₅₀), shows that half of light-producing bacteria were inhibited by a sample concentration of 5.6%, whereas 50% and over is considered non-toxic.

figure 1. Recently-decanted sewage disposal facility; 2001/08/02.

In parallel, it was mentioned during the inspection that since the retention capacity of the sewage disposal facility is nearly exceeded before the annual decant, the Municipality intends to commission a replacement sewage disposal facility. In this regards, the Inspector underlines that both the abandonment of the current facility and the establishment of a replacement one are undoubtedly of concern to the Nunavut Water Board (NWB), even though the Municipality has not yet been issued its Water licence. Therefore, the Inspector trusts that the Municipality will adopt a diligent stance and provide relevant plans to the NWB before reclamation and/or construction work is undertaken.

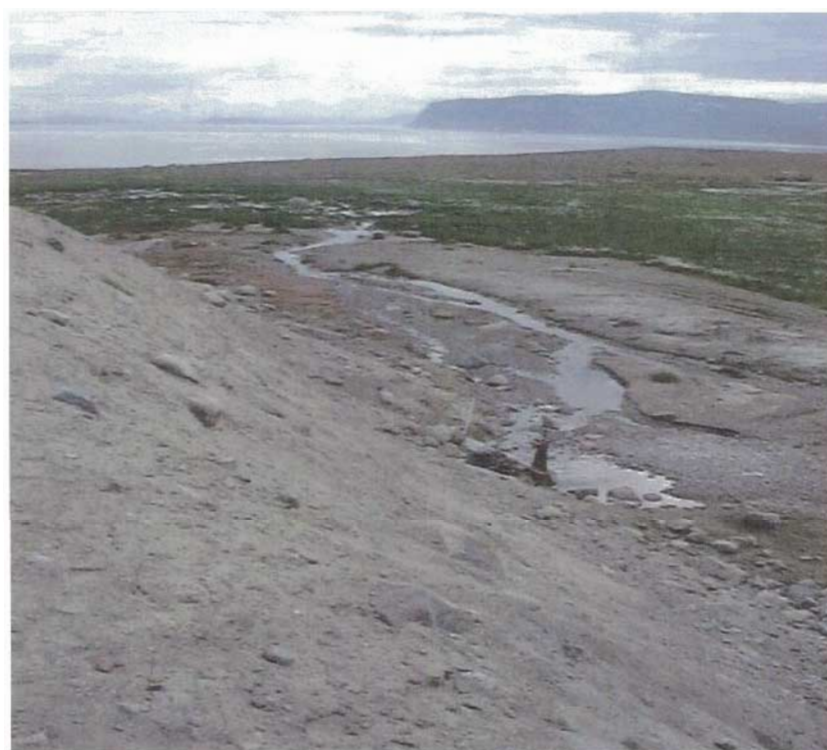
Comments: Decant of the sewage disposal facility initiated through pump siphoning over the berm; active thawing of the drain valve again required. Reportedly very little freeboard remaining prior to the sewage lagoon's decant. Slightly slumped sections noticeable along the decant face of the lagoon berm, but less seepage noted than during the previous inspection. Bulky metal wastes and hazardous materials segregated (batteries are neutralized prior to disposal) from the household wastes which are regularly burnt, and annually covered. Pooled water and marshy areas present along the toe of the partially fenced solid waste disposal facility, but no flow observed along an apparent path of runoff. Signs of ground contamination at the waste oil storage site. Landfarm site for hydrocarbon-contaminated soil erected by a third party alongside the solid waste disposal facility; winter winds tore down part of its perimeter fence and snowdrifts from the site reportedly hindered access to the dumpsite.

figure 2. Decant structure and path of discharge from the sewage lagoon; 2001/08/02.

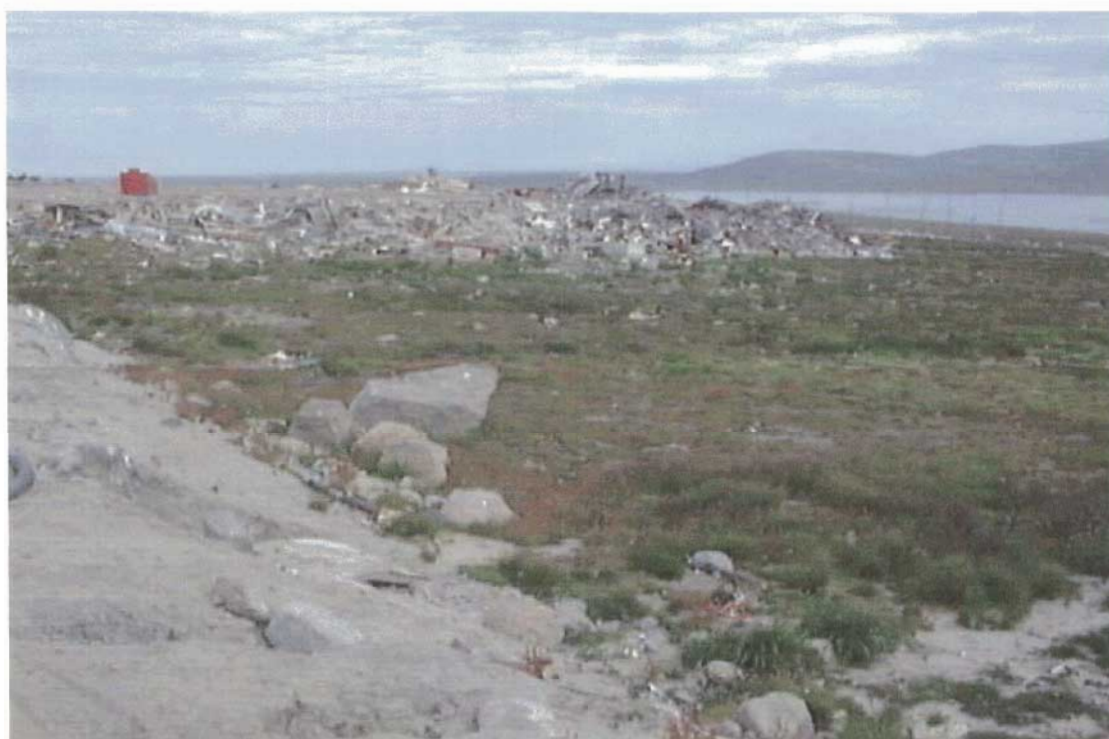
- **Solid waste disposal:** Combustible wastes are regularly burnt and covered, and the wastepile at the solid waste disposal facility is covered on an annual basis (figure 3). Further, despite the fact that a section of fence was erected according to prevailing winds, a considerable amount of windblown waste is nonetheless noticeable beyond the perimeter of the facility. Therefore, the Inspector reiterated during the inspection that the existing fence should be expanded upon to fully enclose the solid waste disposal facility. Additionally, while pooled water and marshy areas were noted immediately downslope of the wastepile (figure 4), no flow of leachate could be observed along an apparent path of runoff from the site (figure 5). In related matters, hydrocarbon contamination was once more noted at the waste oil storage site (figure 6). Consequently, the Inspector acknowledges that the Municipality's plans to install a larger form of containment, and is investigating different on-site disposal options.

figure 3. Solid waste disposal facility; 2001/08/02.

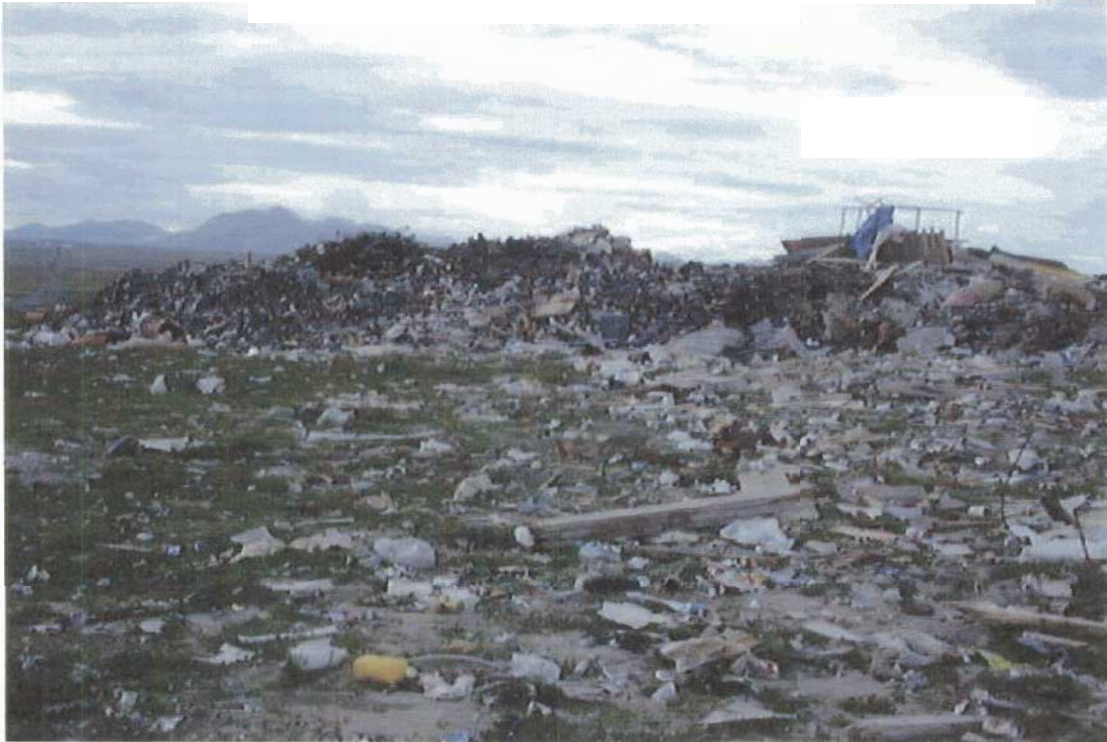
figure 4. Toe of the solid waste disposal facility; 2001/08/02.

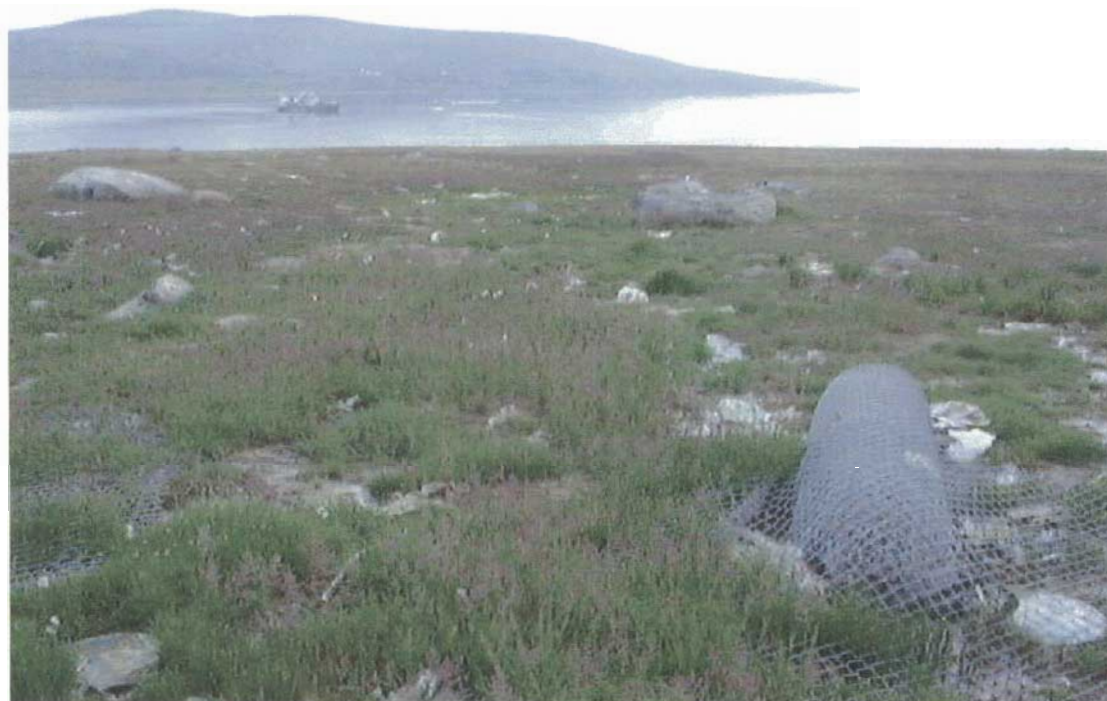
figure 5. Apparent path of runoff from the solid waste disposal facility; 2001/08/02.

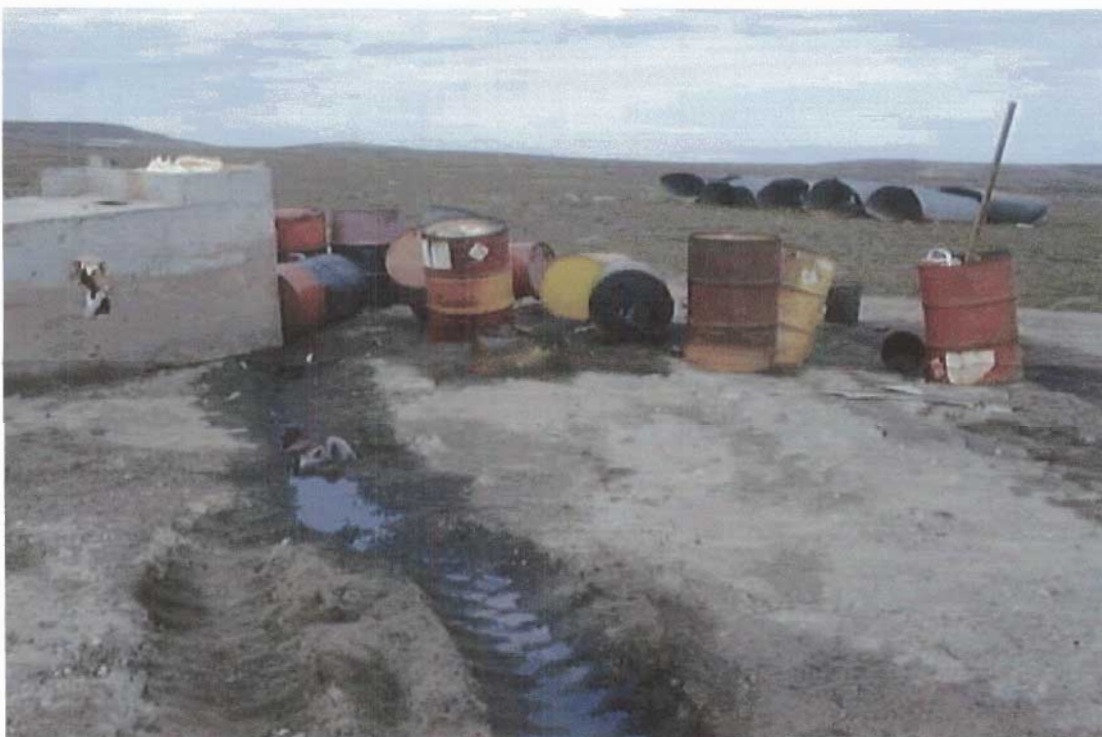
The waste oil area, within the bulky waste site has continually been found to have hydrocarbon contamination. The INAC report of 2001 states “hydrocarbon contamination was once more noted at the waste oil storage site” and that the municipality had in place a plan to deal with this issue. Yet the 2002 report noted the same problem. This is a recurring issue, which should be dealt with by the municipality.

figure 6. Hydrocarbon contamination at the waste oil storage site; 2001/08/02.

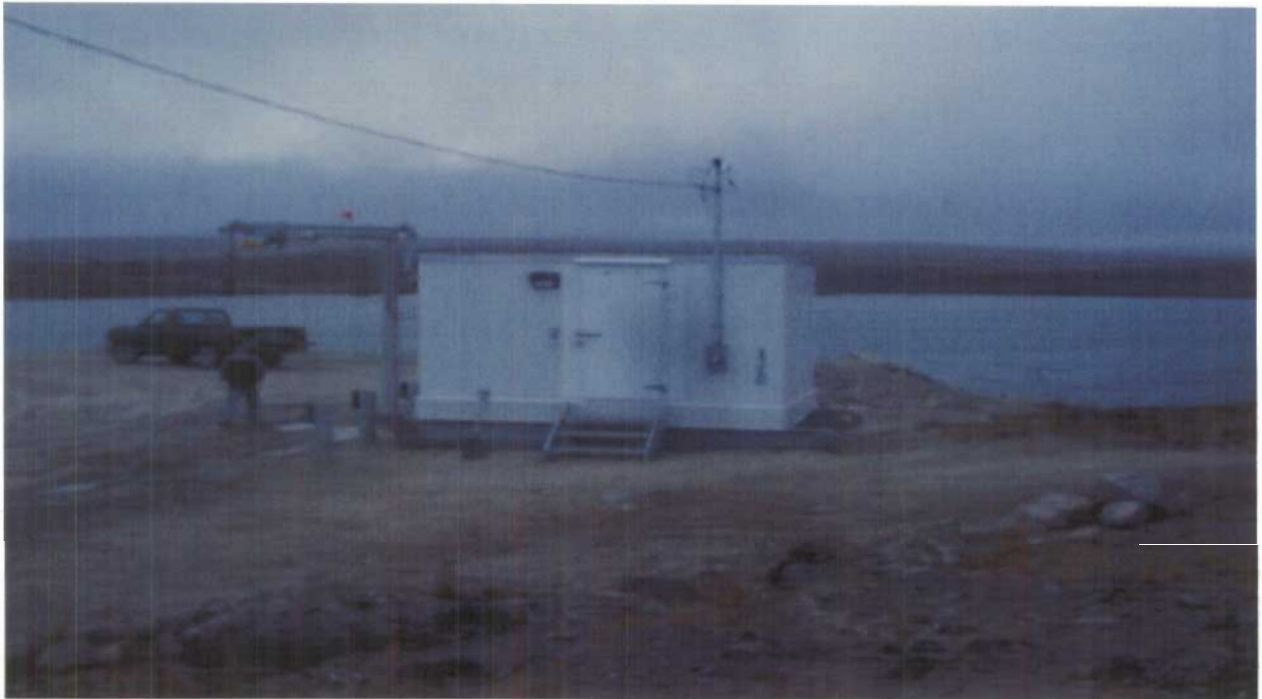
(Figure 1)

- 1. Water supply:** No concerns were noted regarding the water intake and supply facility. Further, the attached analytical results relating to samples taken in the vicinity of the intake station indicate that all tested parameters meet the *Guidelines for the Canadian Drinking Water Quality*. Please find attached analysis report. (Figure 1 Refers to Water Source)

- Clyde River, Water Supply, Site Located N70 28 57.4 W68 36 53.5

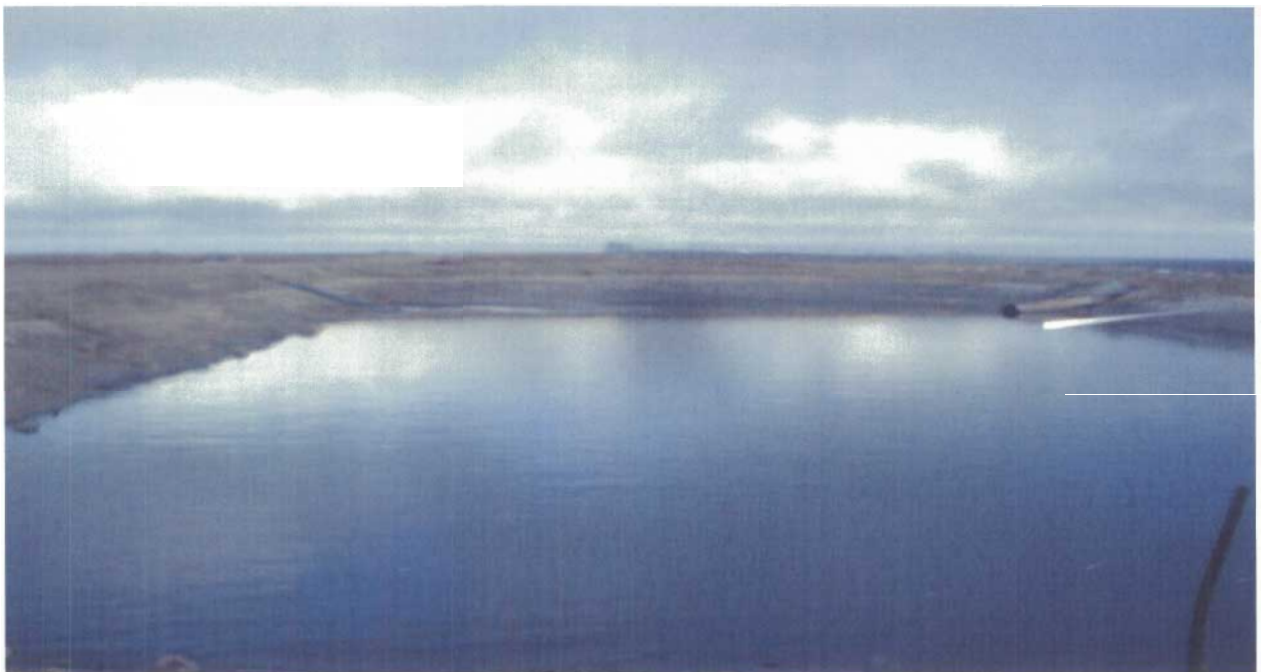
(Figure 2)

- Clyde River, Sewage Disposal, Site Located N70 28 10.7 W68 38 00.9

Comments: With respect to the sewage treatment, very little seepage occurs from the structure of lagoon. Siphoning from the lagoon was quit apparent from the previous months, as it left an obvious path - (runoff). It was noted that the valve was still open during the time of inspection. When the inspector questioned as to how long it was opened, it was replied that it usually open for the month of August. No further details to note. As for the solid waste disposal site; recommendations were made, with respect to the ground contamination at the waste oil storage site, to look into having it cleaned. Also bulky metal waste site, still has a lot of batteries laying around, that aren't neutralized, a plan to properly store items such as batteries and other hazardous material should be in place for this community. Burn and landfill site, once again a lot of wind blown garbage within the down slope of the main dump.

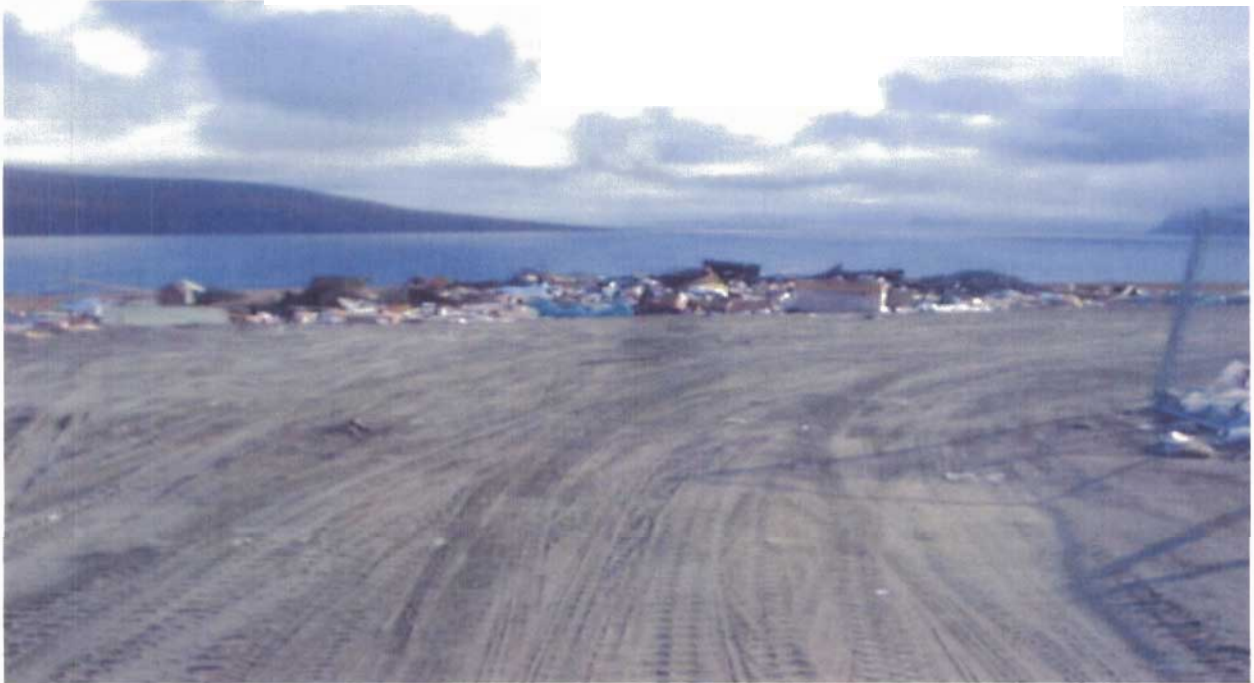
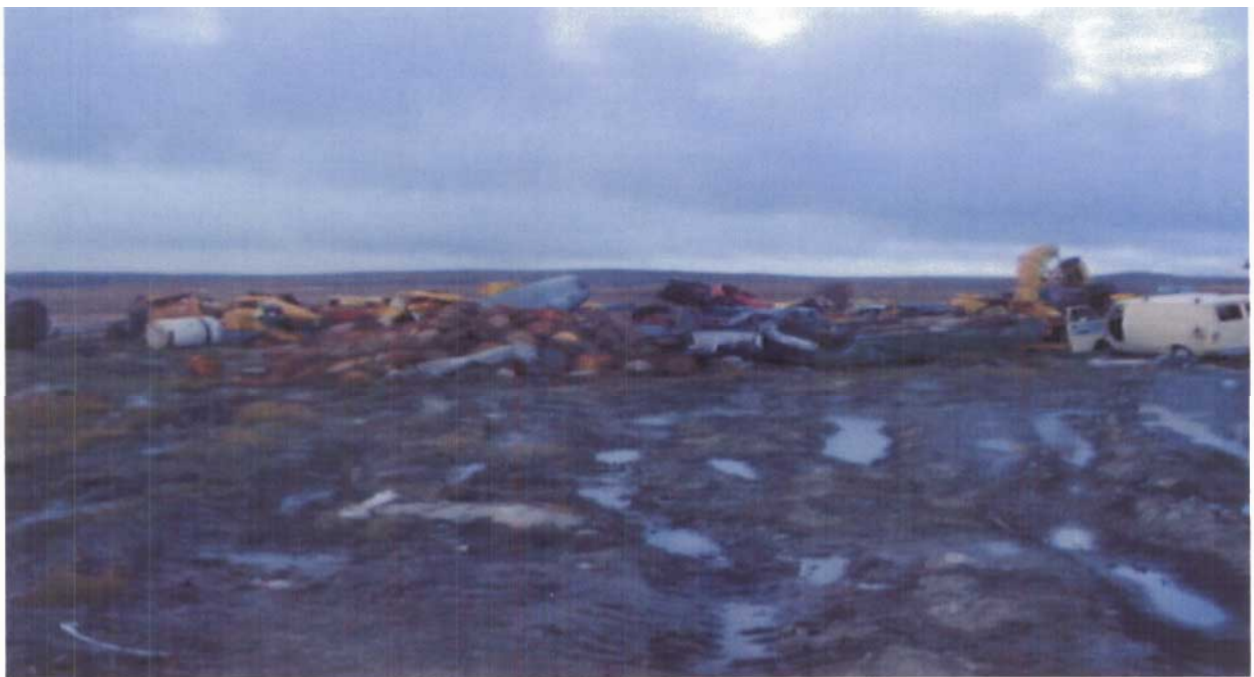
- 3. Solid waste disposal:** The inspector observed during inspection, bulky metal waste mixed with combustible household material. Also during the inspection the inspector observed hazardous material (e.g. batteries, waste oil) within both waste disposal sites. There are numerous waste oil drums with hydrocarbon contamination within the solid waste site. To prevent further environmental damage to the surrounding area, it was recommended that, some action be taken to improve this situation. No sample were collected in this area, as it was dry.

It was further noted that due lack of fencing windblown garbage is scattered within the surrounding area. It was recommended that the community of Clyde River looks into completing the fencing around the perimeter of the dump to limit further environment concerns. (Figure 3, 4,7, 8 Refers to the Solid Waste & Waste Oil Sites)

- Clyde River, Solid Waste Disposal (Main Dump) Site: N70 28 09.9 W68 38.03.9

- Clyde River, Solid Waste Disposal (Metal Dump) Site: N70 28 08.5 W68 37 47.8

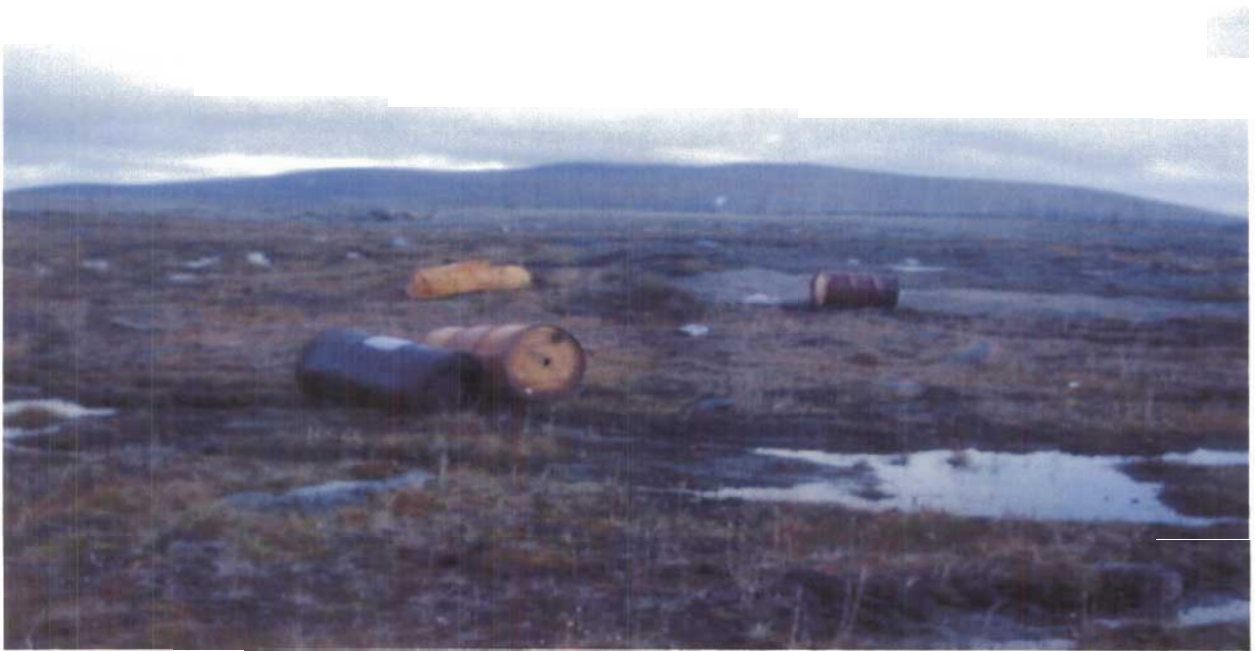
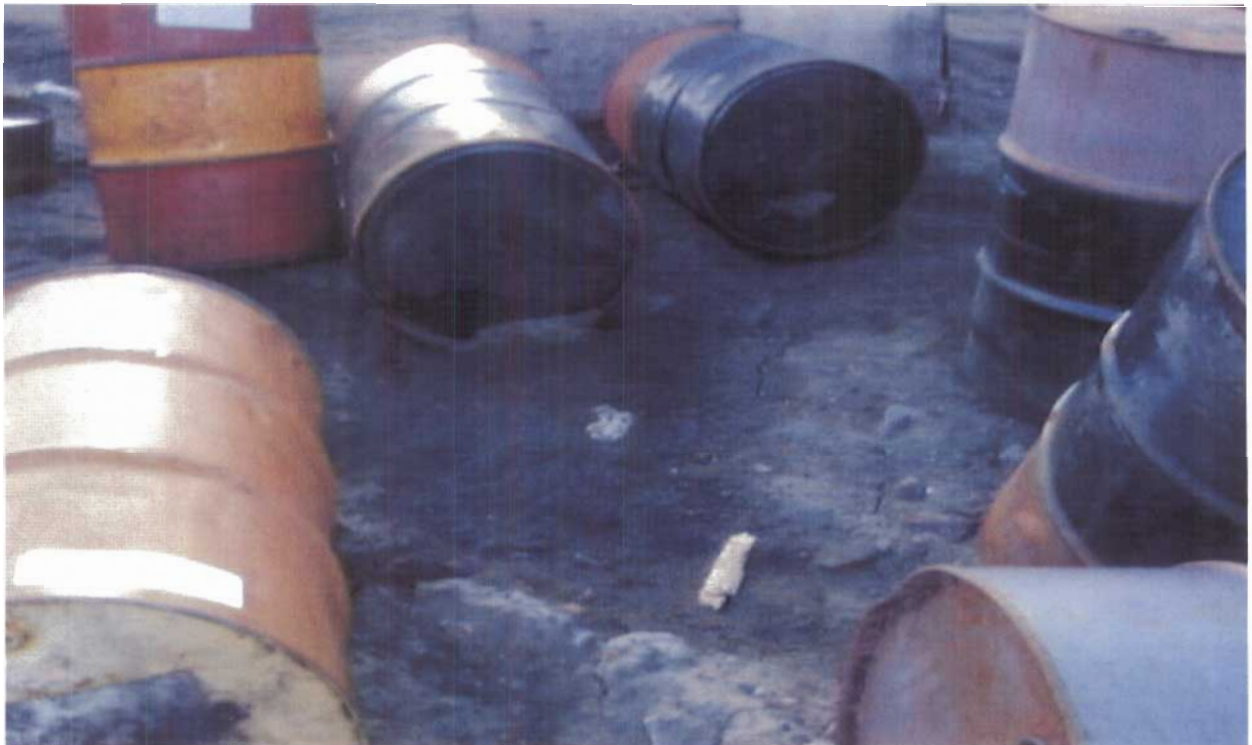
- Clyde River, “Waste Oil Drums Shows Evidence of Leaks”
