5.0 Site Development

5.2. Berm Construction

5.4. Interim Inspection

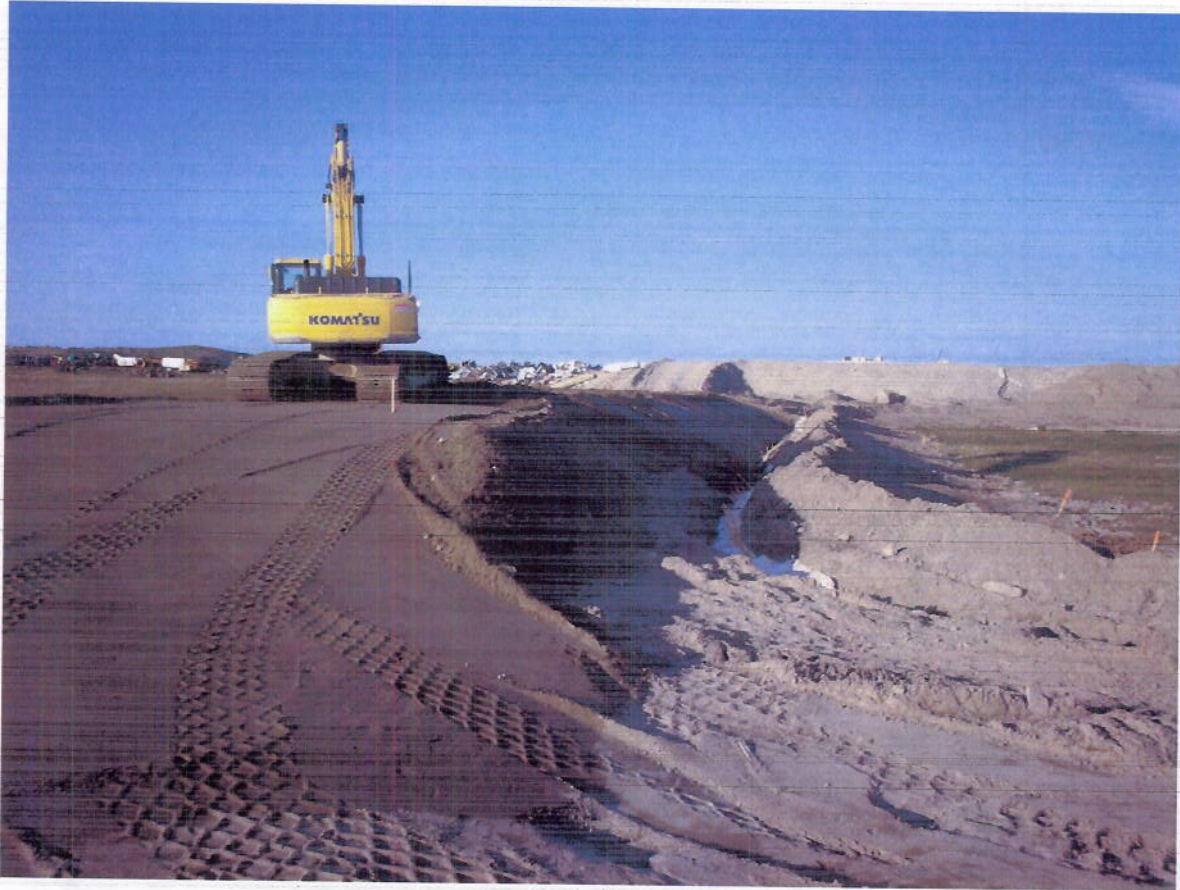
Image 5.2.1 Berm Construction

Construction of the new cell began in 2009 as part of the Phase II developments. Trow's field staff inspected the entire process to ensure quality control of the operations and make informed decisions on-site to move the project forward in an efficient method. Kudlik followed specifications for quantities and placement of granulars to form the berms. Proper compaction was completed using the 8 ton Vibratory Highway Type Roller in lifts of 300mm and tested by Trow's staff. Kudlik's surveyor made continuous measurements as the berms developed to keep grade and alignment true.

The end of Phase II developments establish the new cell complete with proper berm slopes at 3H:1V along the entire structure as well as re-establishing the proper slope along the outer portion of the existing cell.

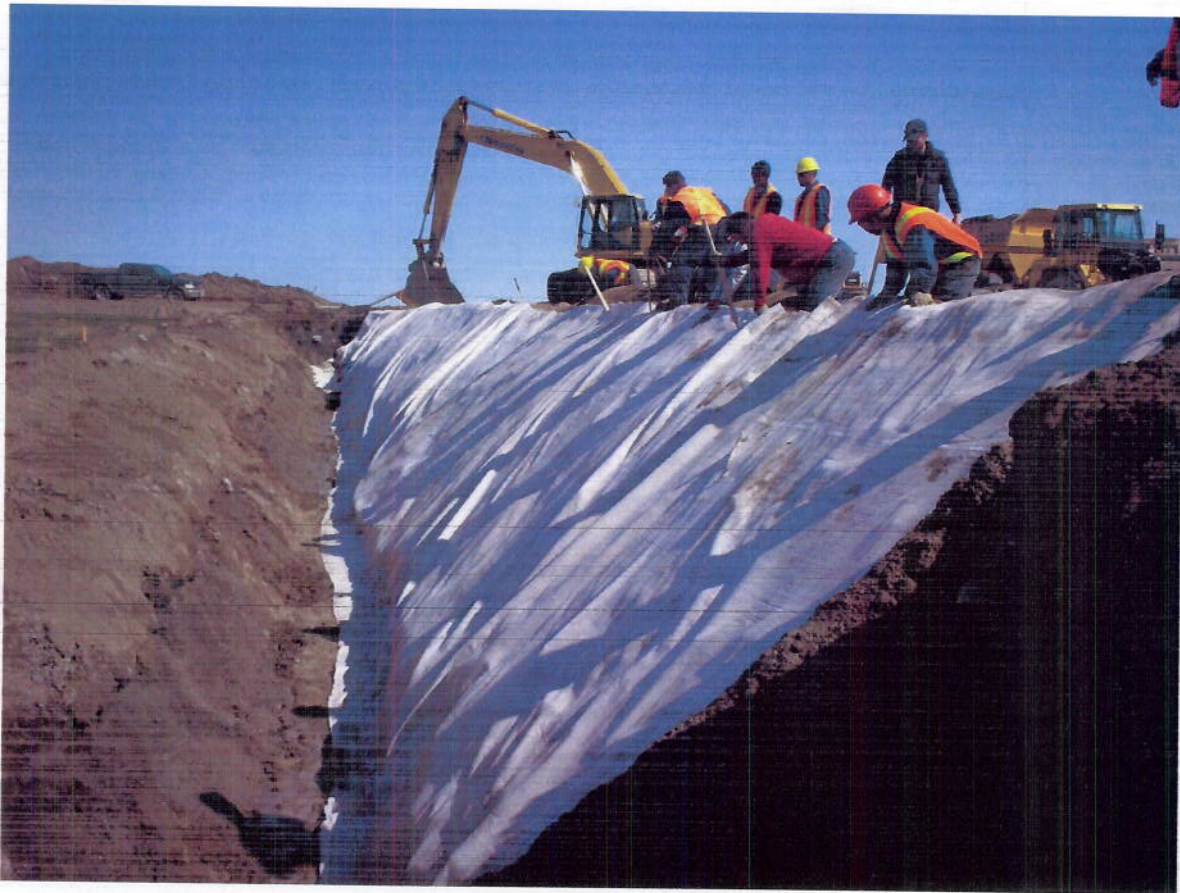
Image 5.3.1 Liner Installation

Upon completion of the main core of the berms, a polyethylene impenetrable liner was installed around the inside circumference of the cell, keyed into both the top and toe of the berm structure. This liner will provide the primary containment for the lagoon with the berm permafrost core providing backup.

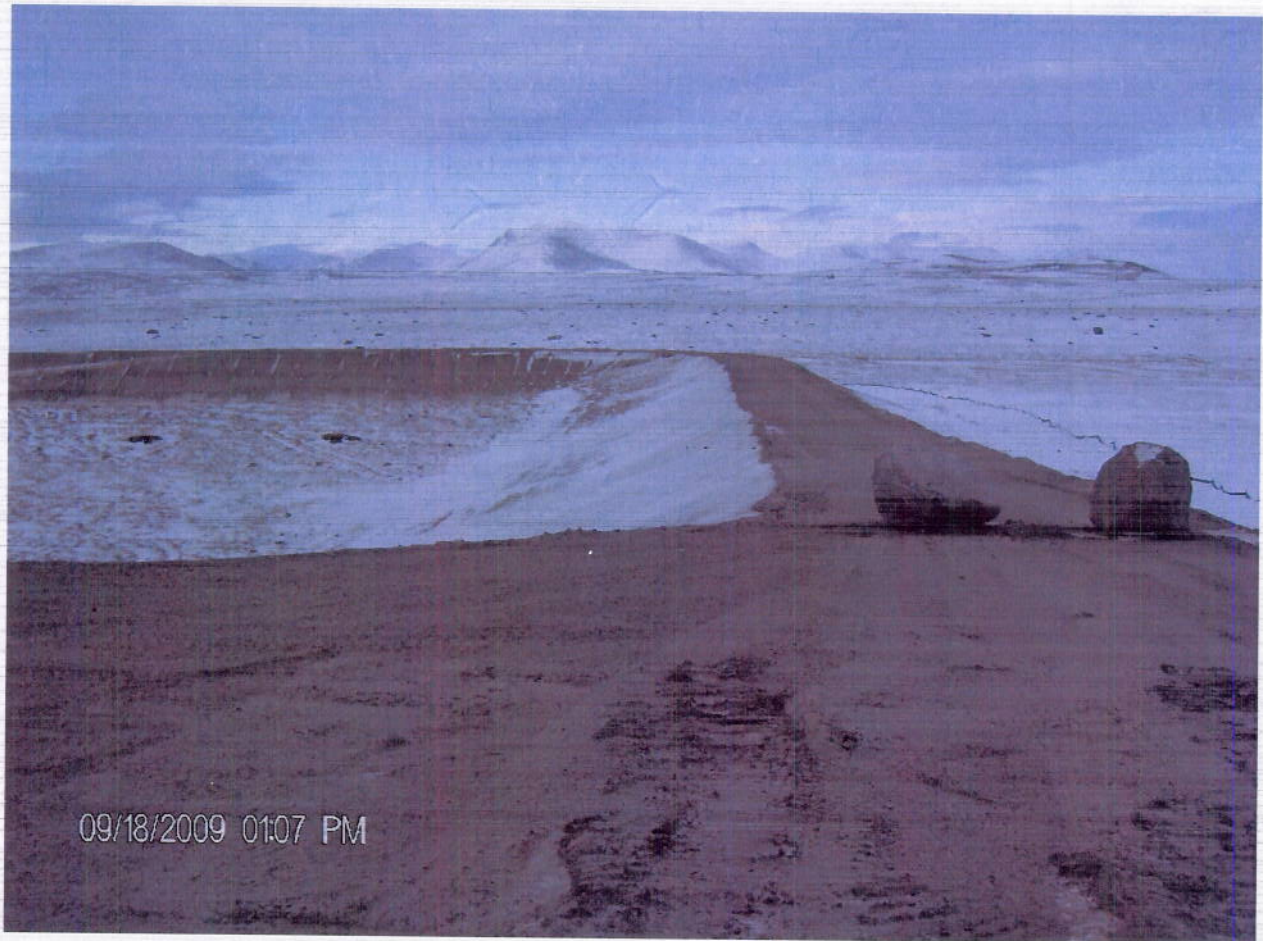
Image 5.4.1 Completed Berms of New Cell

Following the end of the Phase II construction season, Trow made final reviews of the 2009 developments to ensure the design was followed through and installations properly constructed.

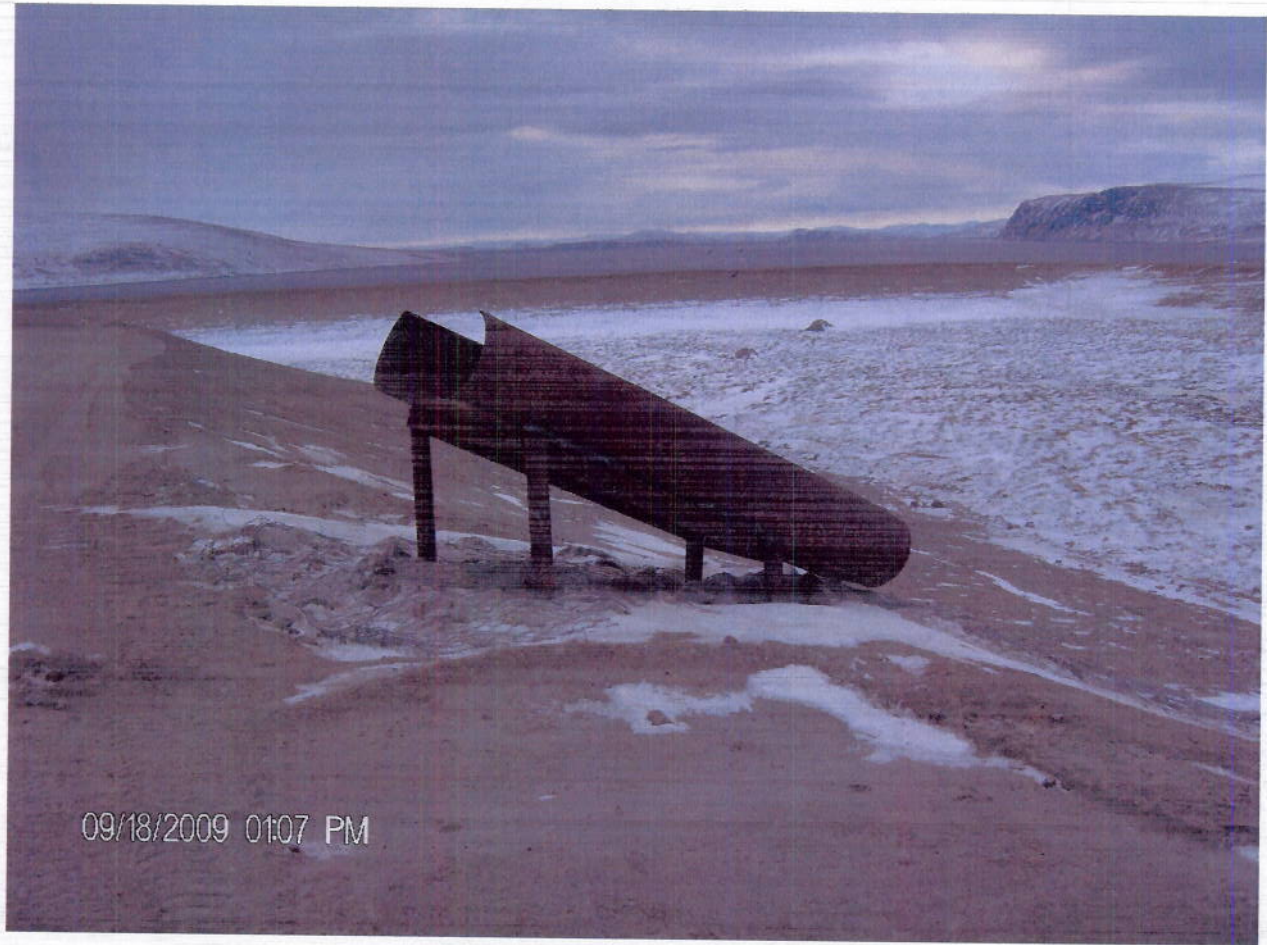
Image 5.4.3 Completed Shute Structure

barrier stones set in place. Shutes were installed to prevent structural erosion to the berms when the sewage trucks discharge.
