### August 17, 2000 Water Use Inspection - Report

## MUNICIPAL WATER USE INSPECTION FORM

Licensee: Municipality of Clyde River Licence No.: unlicensed

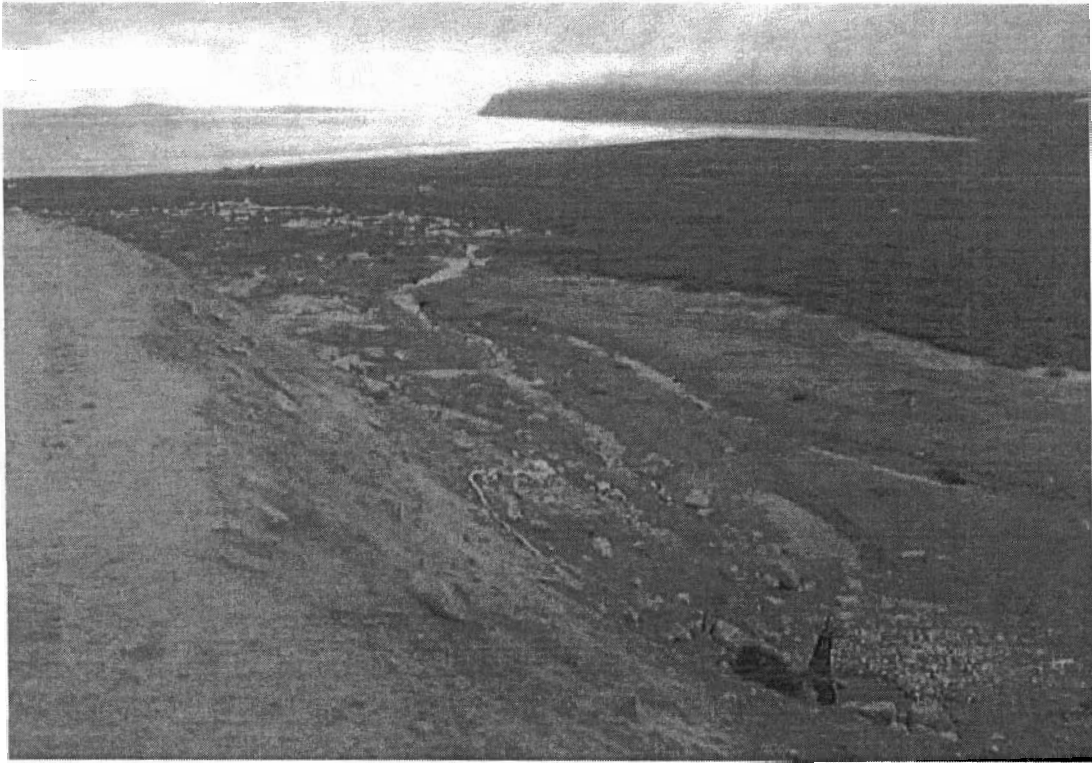
- **Sewage waste disposal:** Several concerns regarding to the structural integrity of the sewage lagoon were noted. At the time of the inspection, the drain valve was still frozen (figure 1), thus postponing the intended decant of the lagoon. Further, it was related that the icing-up of the decant structure was a typical circumstance, although thawing efforts were usually successful earlier in the summer. As such, due to the very limited freeboard remaining before the sewage lagoon's berm was overtopped and a potential breach occurred (figure 2), the Municipality would shortly have to resort to pumping the contents of the sewage lagoon over the berm. In addition, several veins of seepage were evident along a soft and saturated section of the lagoon's toe (figure 3). Such seepage events, which were also underlined in the last municipal water use inspection report, bring forth significant implications as the facility was not designed to be permeable. Consequently, by copy of this letter to Community Government and Transportation (GC&T), the Inspector trusts that the Municipality will be provided with assistance and/or recommendations on the matter.

Comments: Intended decant of the sewage lagoon hindered by the freeze-up of the drain valve. Substantial seepage observed along a section of the toe where berm material is soft and saturated. Very limited freeboard atop the face opposite to the lagoon's discharge chute, however signs of overtopping were not discernable. Metal dump is somewhat scattered yet isolated, whereas no segregation occurs at the solid waste disposal site itself. Dump is partly fenced. Leachate pooled immediately downslope of the wastepile, but no active runoff was apparent. Waste oil management deficiencies noted.

figure 1. Sewage lagoon's frozen decant structure; 2000/08/17.

Geotechnical Inspection: May be warranted due to outstanding structural integrity concerns

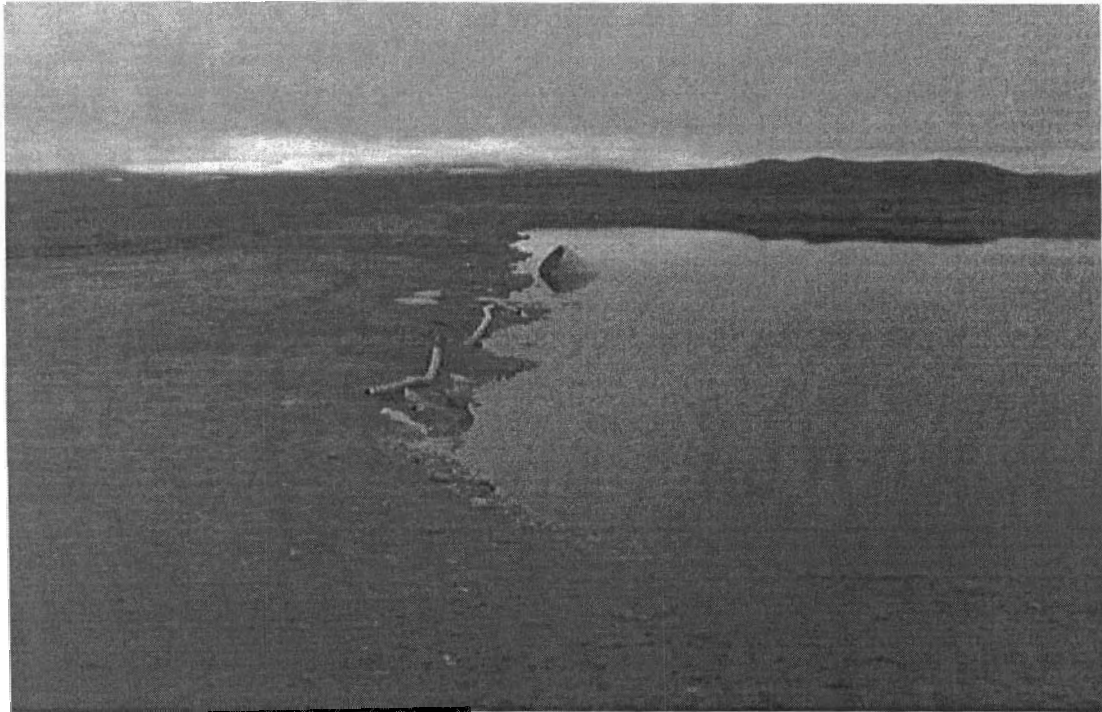
figure 2. Minimal freeboard of the sewage lagoon; 2000/08/17.

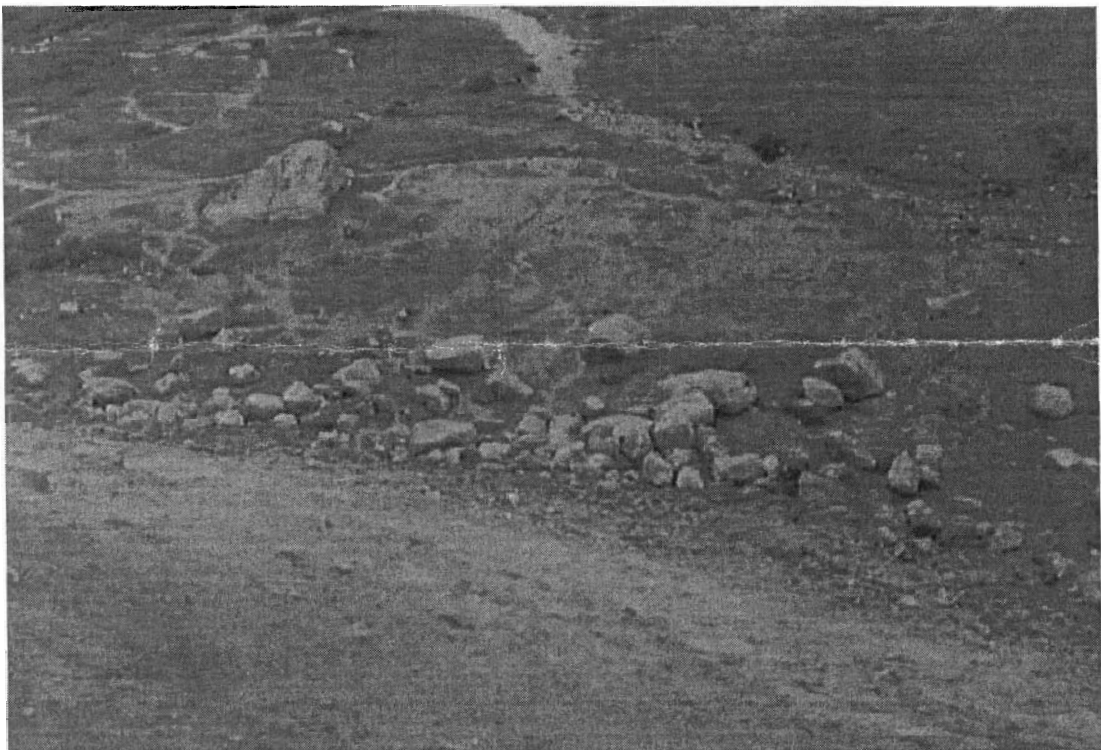
In parallel, attached are the analytical results relating to effluent sampled from the main seepage vein of the sewage lagoon. While the concentrations of the tested parameters proved generally acceptable, the ammonia level is notably elevated.

figure 3. Veins of seepage along the toe of the sewage lagoon; 2000/08/17.

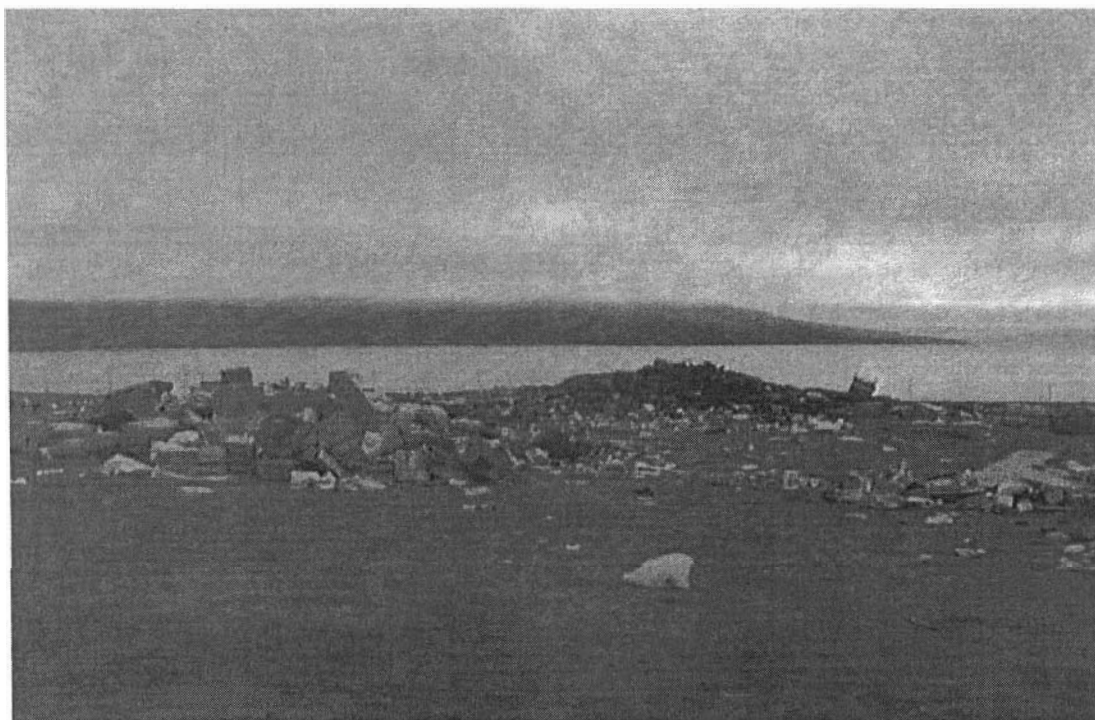
- **Solid waste disposal:** Minimal segregation takes place at the solid waste disposal site (figure 4), save for the redirection of bulky wastes towards the nearby metal landfill. In this regards, the use of a sealift container for the isolation and storage of hazardous materials would be advisable. Although combustible waste is burned/compacted and periodically covered, and a snow fence is installed along the prevailing winds, a fair quantity of waste material is nonetheless windblown beyond the disposal site proper. Accordingly, the Inspector would recommend expanding the existing fence so as to fully enclose the solid waste disposal site.

**figure 4.** Solid waste disposal site; 2000/08/17.

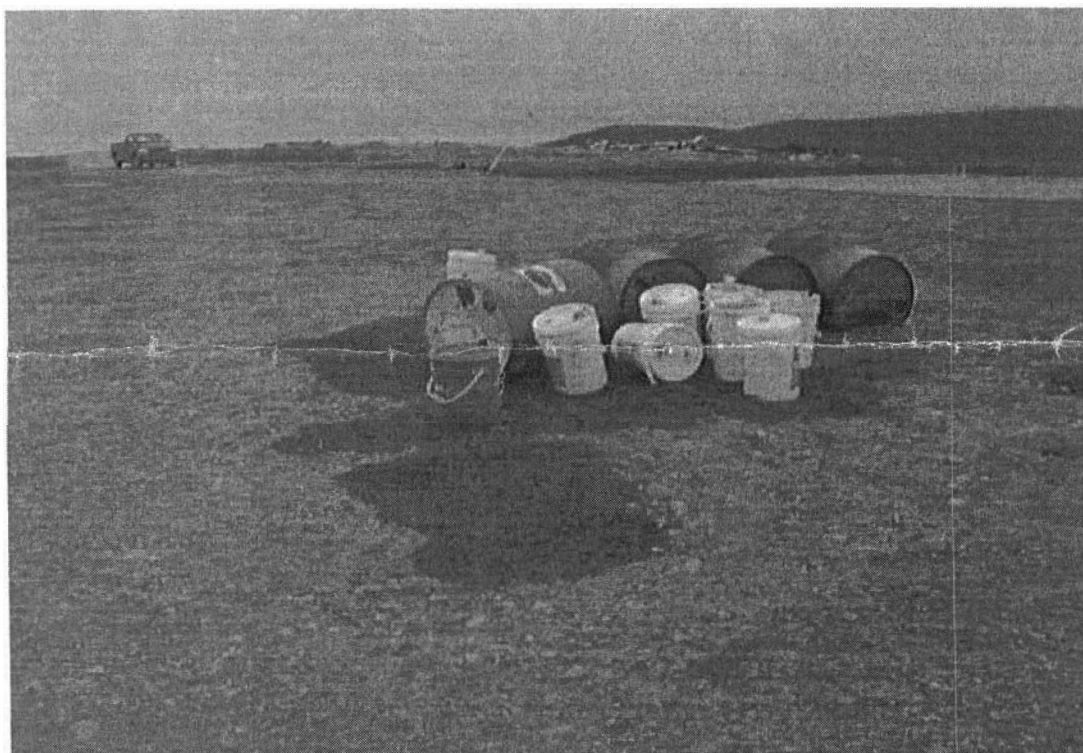
On a side note, it should be pointed out that discarded waste oil inevitably leads hydrocarbon-contaminated soil, and can ultimately imply the deposit of waste into water. Thus, the Municipality ought to prevent leakages at the waste oil storage by the municipal garage, or the partly reclaimed waste oil disposal site, from reaching nearby watercourses. Furthermore, the Municipality should take necessary means to ensure that undisclosed dumping of potentially hazardous waste does not occur within its facilities (figure 6).

**figure 6.** Various liquid waste dumped by an unknown party; 2000/08/17.
