August 2, 2001 Municipal Water Use Inspection - Report

MUNICIPAL WATER USE INSPECTION FORM

Date: 2001/08/02 Licensee Rep. (Name/Title): David Arreak / Foreman
Licensee: Municipality of Clyde River Licence No.: unlicensed

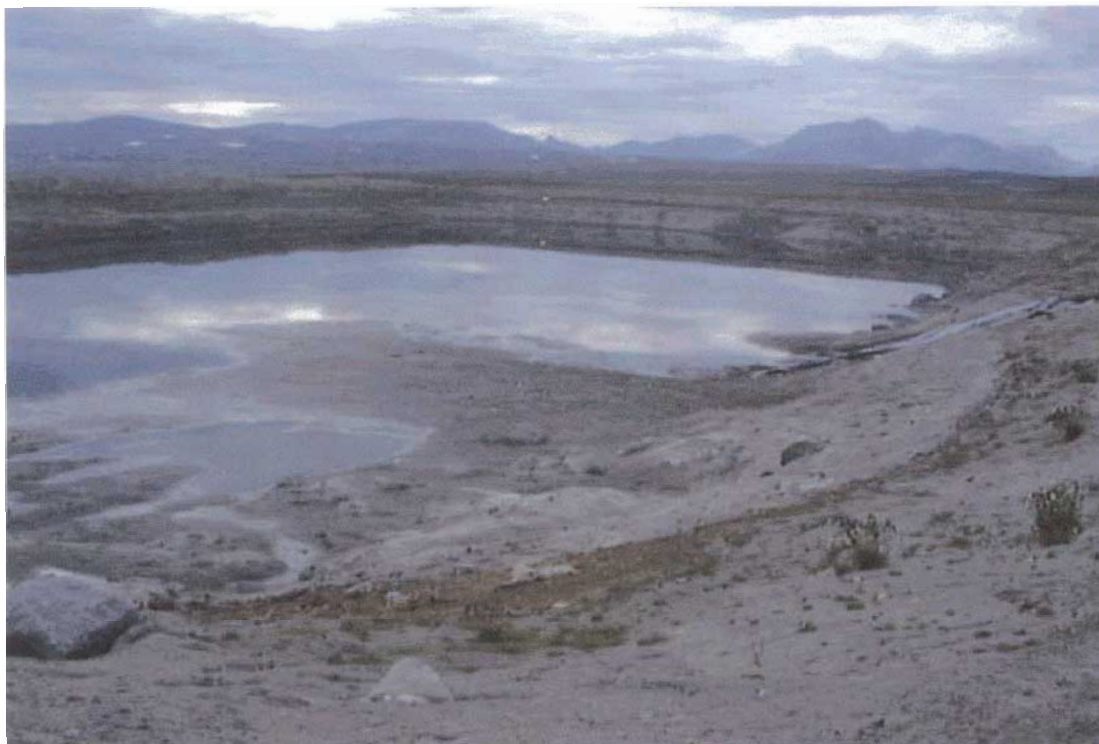
- **Sewage disposal:** At the time of the inspection, the sewage disposal facility had already been almost entirely decanted (figure 1). However, it was mentioned that recurring concerns with the sewage lagoon's freeboard and decant structure were again noted this summer. In relation to the annual decant, the inspector points out that it may be advisable to restrict the flow of discharge, thus spreading the decant over a longer period of time in order to maximize aerobic decomposition and secondary biological treatment. Indeed, the attached analytical results relating to a sewage effluent sample collected 10 metres downstream of the decant structure (figure 2) reveal that concentrations of ammonia (118 mg/L vs 2.2 mg/L) and phenol (590 µg/L vs 4 µg/L) considerably exceed the *Canadian Water Quality Guidelines for the Protection of Freshwater Aquatic Life*. Furthermore, while values of biological oxygen demand (291 mg/L) and of faecal coliform (510 000 CFU/100 ml) are also high, the Microtox sample, constituting a reliable toxicity indicator (IC₅₀), shows that half of light-producing bacteria were inhibited by a sample concentration of 5.6%, whereas 50% and over is considered non-toxic.

figure 1. Recently-decanted sewage disposal facility; 2001/08/02.

In parallel, it was mentioned during the inspection that since the retention capacity of the sewage disposal facility is nearly exceeded before the annual decant, the Municipality intends to commission a replacement sewage disposal facility. In this regards, the Inspector underlines that both the abandonment of the current facility and the establishment of a replacement one are undoubtedly of concern to the Nunavut Water Board (NWB), even though the Municipality has not yet been issued its Water licence. Therefore, the Inspector trusts that the Municipality will adopt a diligent stance and provide relevant plans to the NWB before reclamation and/or construction work is undertaken.

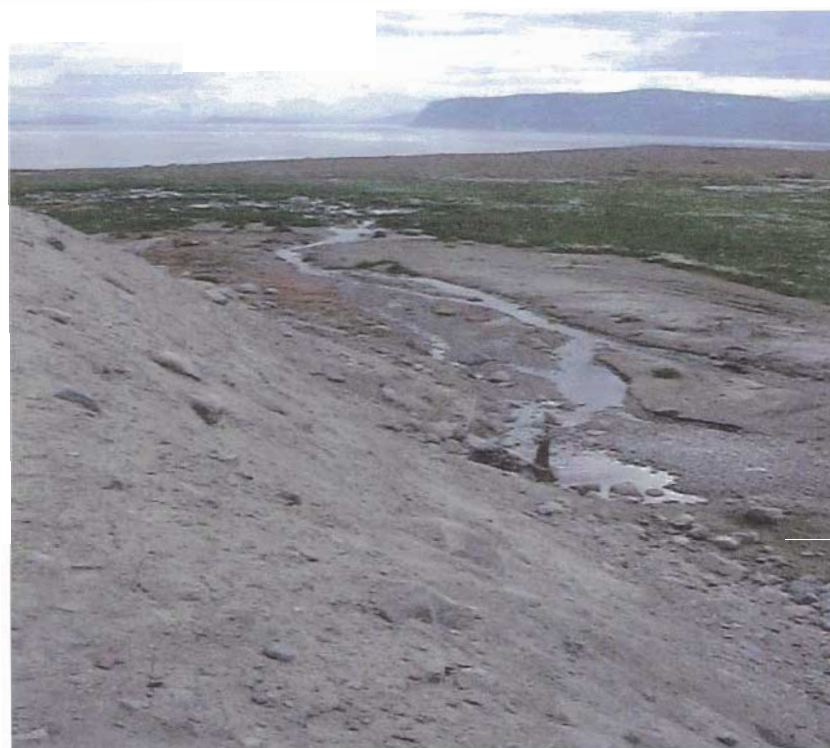
Comments: Decant of the sewage disposal facility initiated through pump siphoning over the berm; active thawing of the drain valve again required. Reportedly very little freeboard remaining prior to the sewage lagoon's decant. Slightly slumped sections noticeable along the decant face of the lagoon berm, but less seepage noted than during the previous inspection. Bulky metal wastes and hazardous materials segregated (batteries are neutralized prior to disposal) from the household wastes which are regularly burnt, and annually covered. Pooled water and marshy areas present along the toe of the partially fenced solid waste disposal facility, but no flow observed along an apparent path of runoff. Signs of ground contamination at the waste oil storage site. Landfarm site for hydrocarbon-contaminated soil erected by a third party alongside the solid waste disposal facility; winter winds tore down part of its perimeter fence and snowdrifts from the site reportedly hindered access to the dumpsite.

figure 2. Decant structure and path of discharge from the sewage lagoon; 2001/08/02.

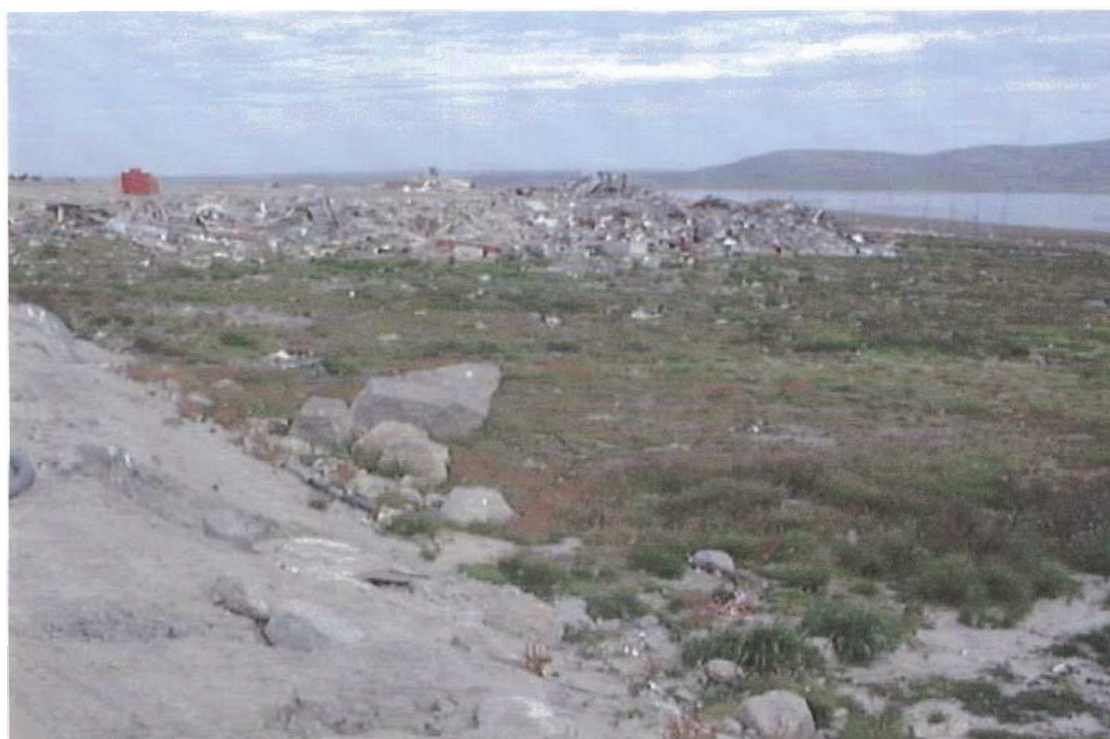
- **Solid waste disposal:** Combustible wastes are regularly burnt and covered, and the wastepile at the solid waste disposal facility is covered on an annual basis (figure 3). Further, despite the fact that a section of fence was erected according to prevailing winds, a considerable amount of windblown waste is nonetheless noticeable beyond the perimeter of the facility. Therefore, the Inspector reiterated during the inspection that the existing fence should be expanded upon to fully enclose the solid waste disposal facility. Additionally, while pooled water and marshy areas were noted immediately downslope of the wastepile (figure 4), no flow of leachate could be observed along an apparent path of runoff from the site (figure 5). In related matters, hydrocarbon contamination was once more noted at the waste oil storage site (figure 6). Consequently, the Inspector acknowledges that the Municipality's plans to install a larger form of containment, and is investigating different on-site disposal options.

figure 3. Solid waste disposal facility; 2001/08/02.

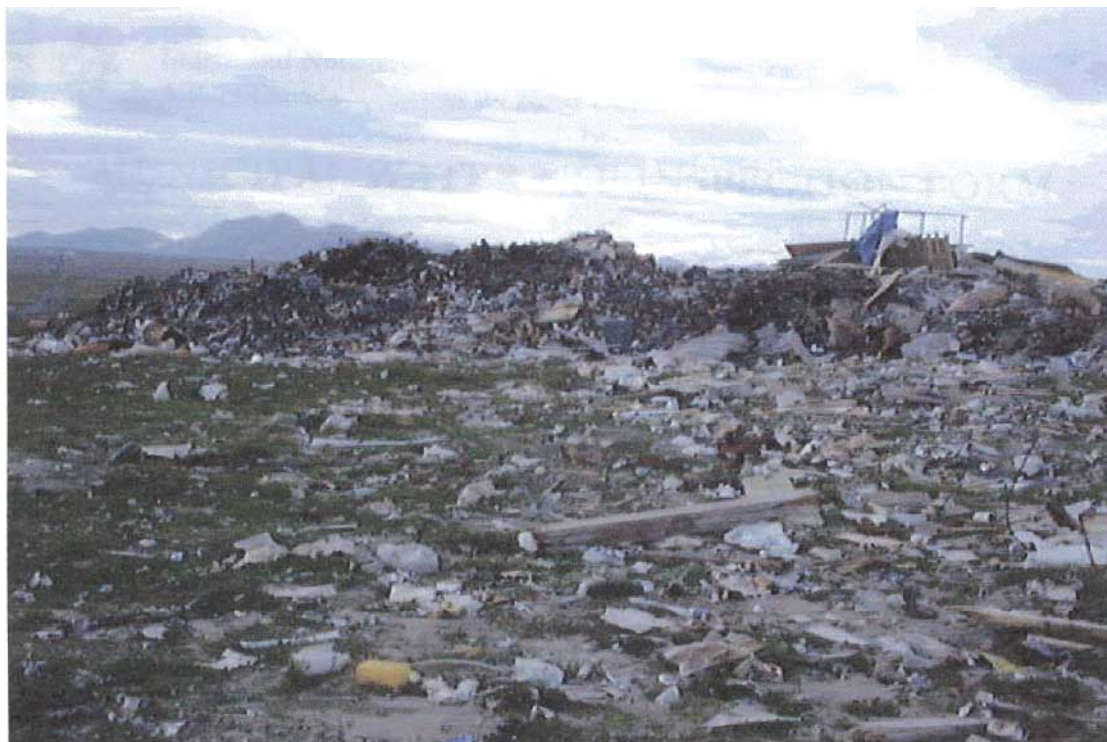
figure 4. Toe of the solid waste disposal facility; 2001/08/02.

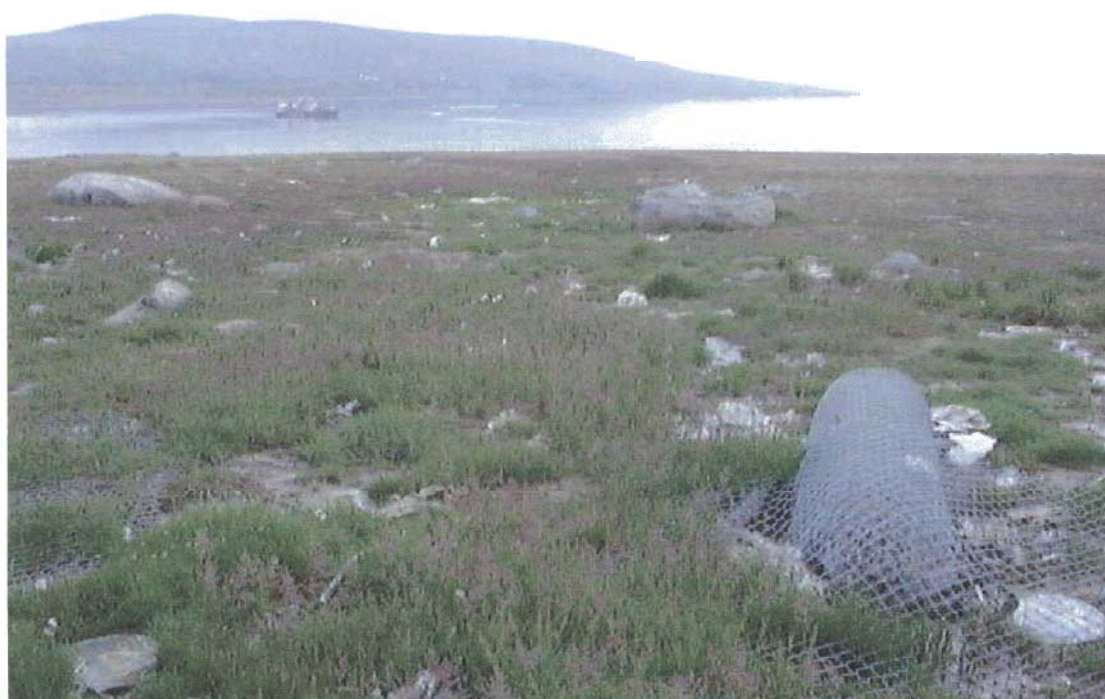
figure 5. Apparent path of runoff from the solid waste disposal facility; 2001/08/02.

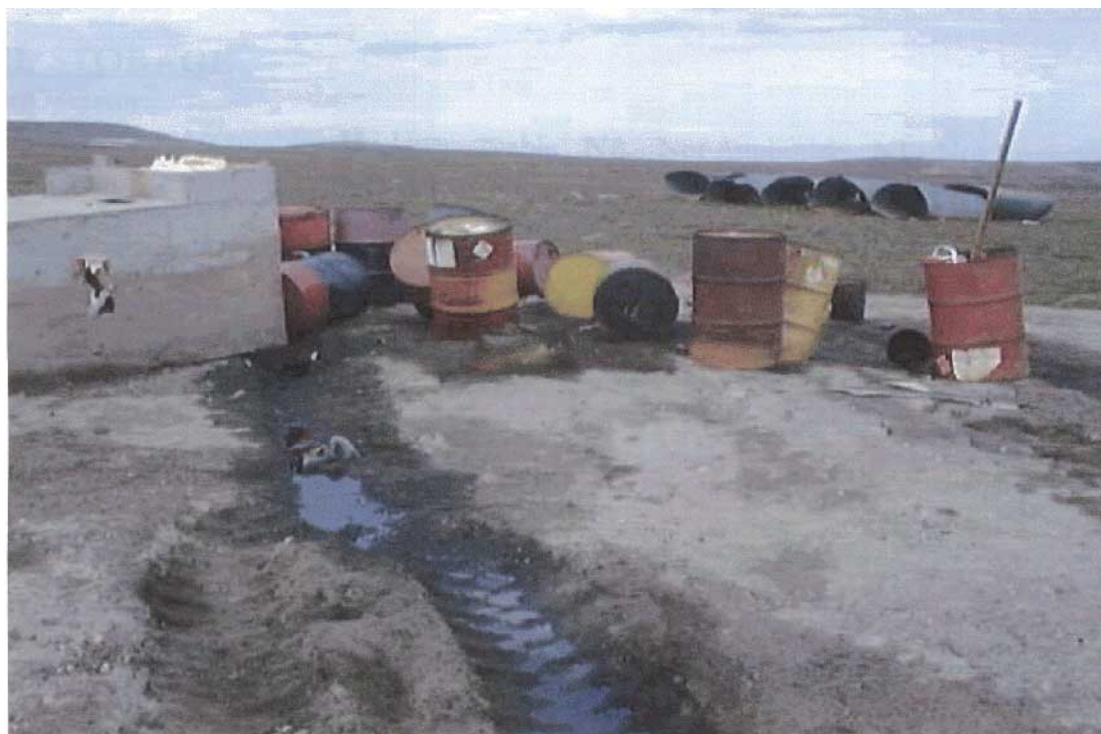
figure 6. Hydrocarbon contamination at the waste oil storage site; 2001/08/02.
