WATER LICENCE INSPECTION FORM

| Hamlet of Clyde River | Bhabesh Roy , Johnathan Paulluq, Moe Kuluguktuk |
| 3BM-CLY1419 Renewal Licence | Municipal Engineer – GN- C&GS , Acting Senior Administration Officer, acting Hamlet foreman |
| October 3, 2019 | Joseph Monteith |

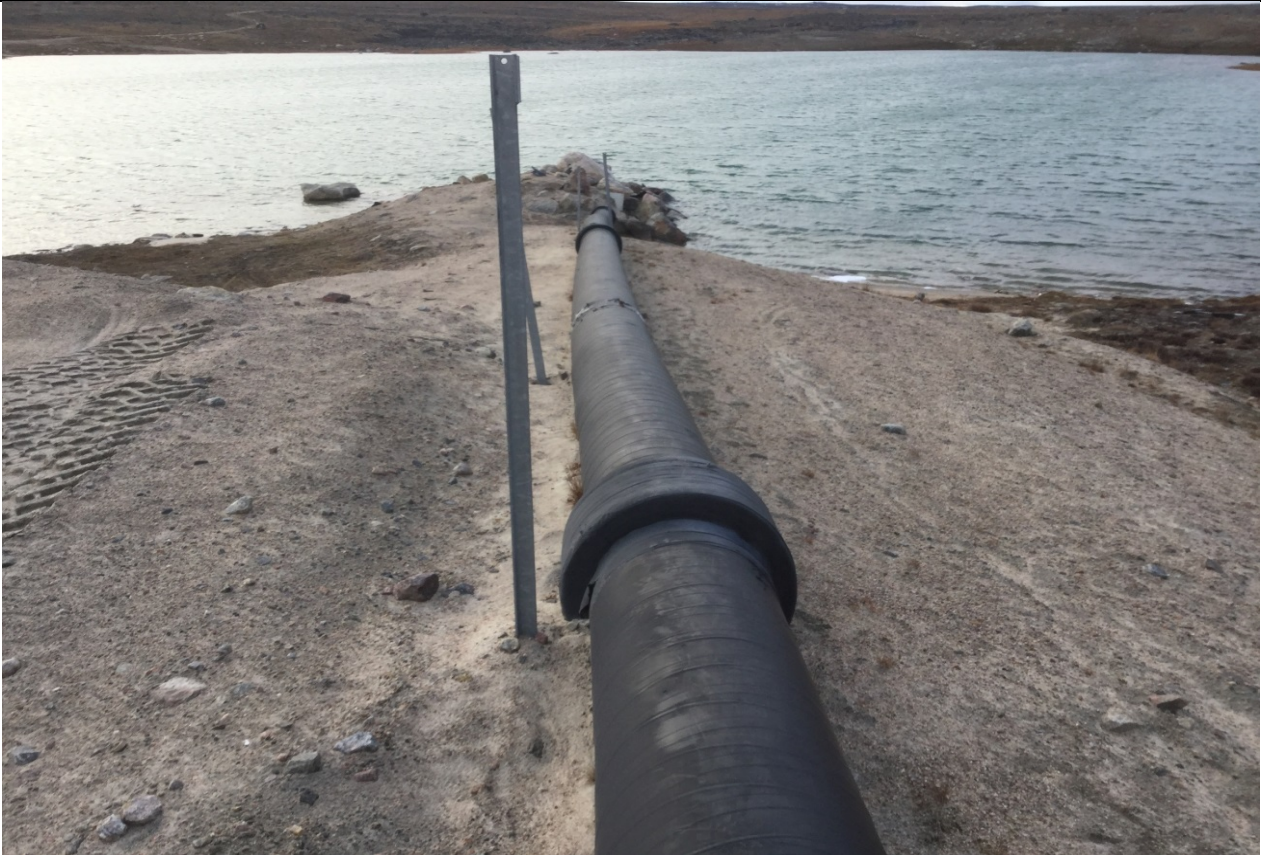
| Date | Camera | Inspector | Authorization |
|---|---|---|---|
| Photo 1 | | Clyde River,NU | |

- 3. Water is withdrawn from Water Source Lake. GPS Coordinates: Lat: N70° 28' 59.339" Long: W68° 36' 48.744 (photo 1).
- 4. The condition of the piping was good. The length approximately 47 metres. Diameter 8 inches, with a 4 inch internal pump housed within the intake pipe. The pipe has a fish mesh screen (photo 2).

Description: Water Source Lake. Water Extraction pipe

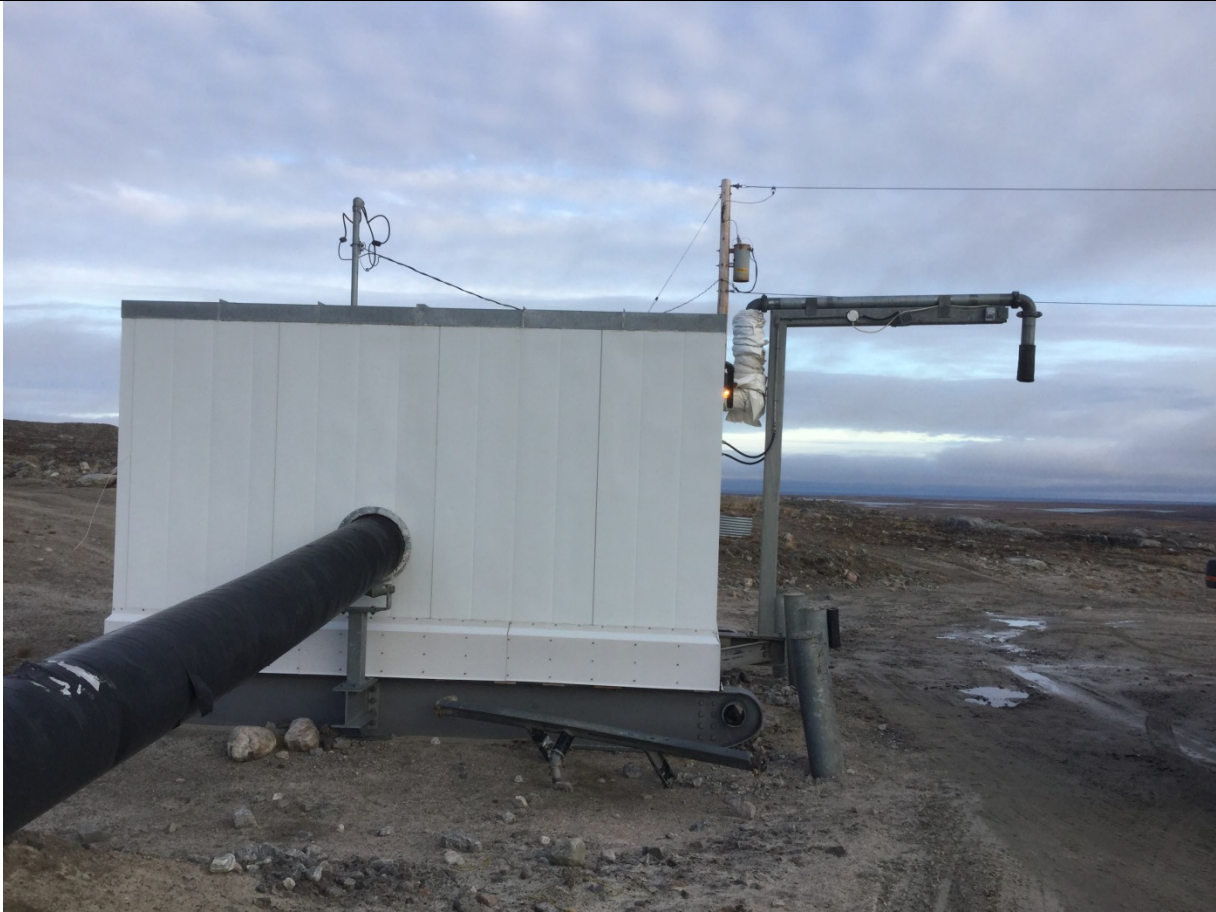
| Photo Log #1 | Location |
|---|---|
| Photo 2 | Clyde River, NU |

Description: Water Pump House, and Truck Fill Station

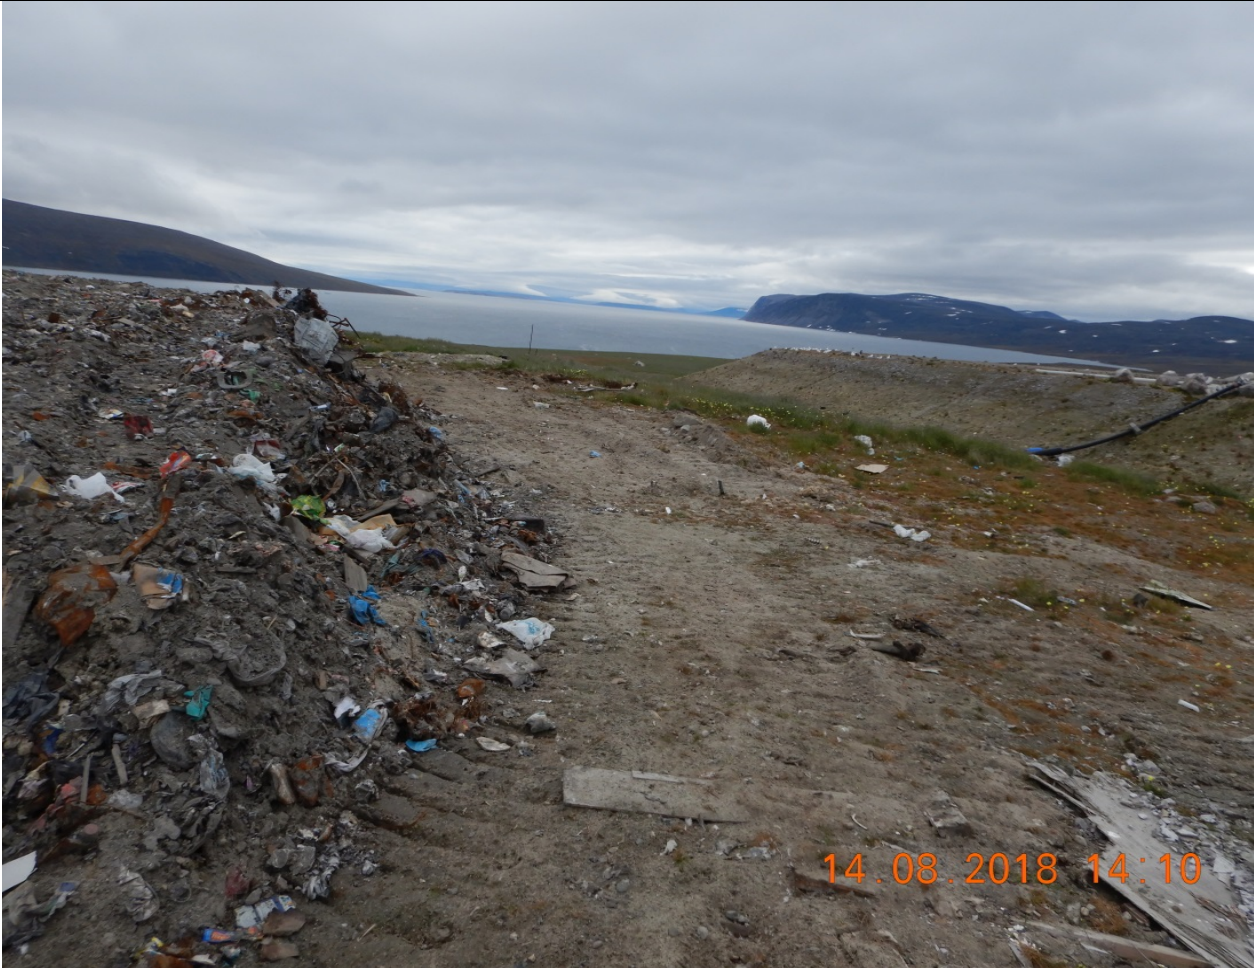
| Photo Log #1 | Location |
|--|---|
| Photo 5 | Clyde River, NU |

- 14. The fencing approximately 1.5 metres high is damaged some parts of the north side of the fire pit. The fencing only covers a portion of the fire pit portion and should have more fencing put in to mitigate any garbage from blowing across the environment (photo 5).

| Photo Log #1 | Location |
|--|---|
| Description: Fire Pit – No fencing on East Side, wind may blow ash and debris out of area onto the environment, to the sewage lagoon | |

-The Open Pit Burning Area has some damage to the fencing that could be fixed with maintenance. The fencing only covers a portion of the open pit burning, and could use some more fencing to ensure wind does not displace any loose garbage and deposit them onto the environment, any water bodies, and other parts to the Hamlet land farm.

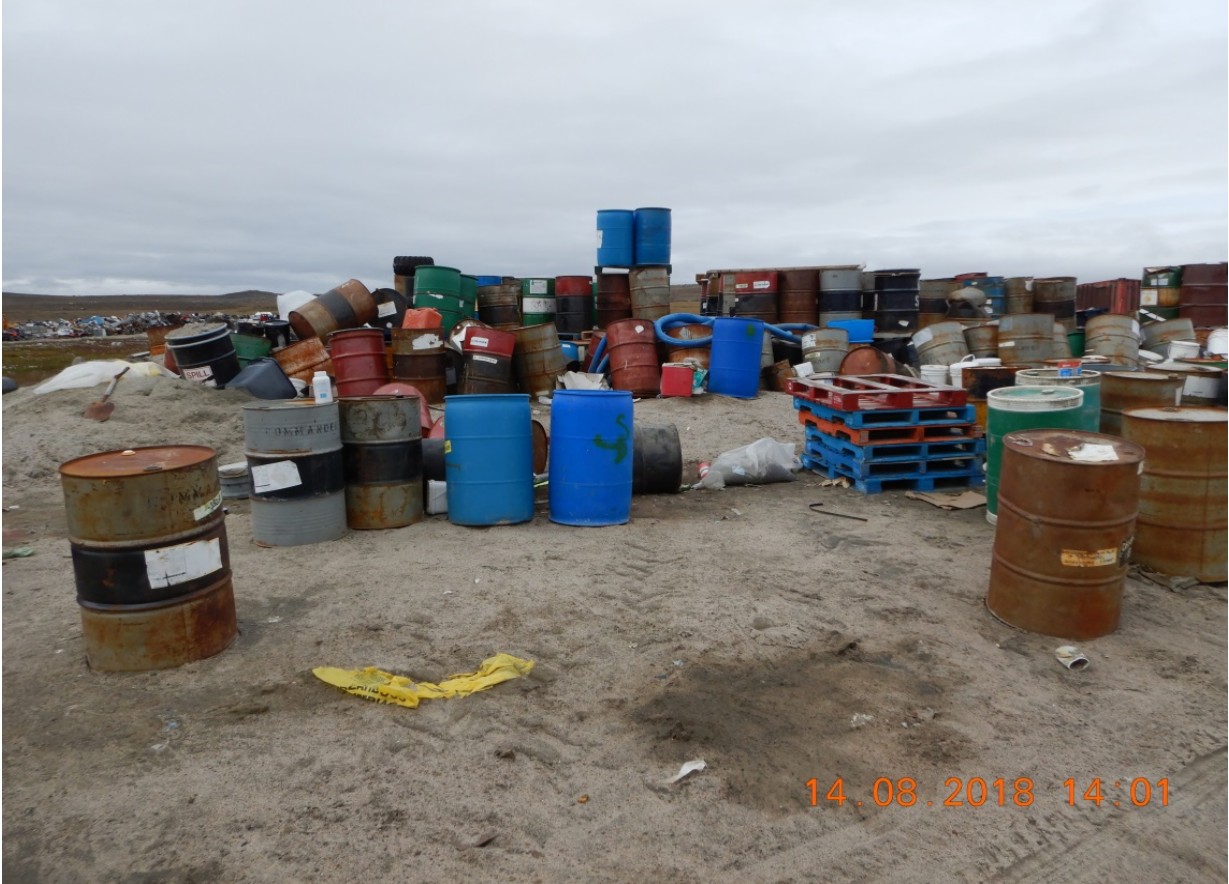
Photo 7

- 17. Hazardous Waste section contains a few sea cans(full), a bermed area full of waste oil drums, some packaged ready for delivery, other waste oil drums litter the inside and outside of the berm, spilling its leaked contents onto the ground all around the area. Some of the sea cans are left open to the environment.
- 18. The Hamlet was really good for signage, properly posting their segregated wastes, and this may have helped the public in segregating their hazardous wastes.

Description: Hazardous Waste Berm – overfilled with waste oil drums. Waste oil drums deposited outside of bermed area.

- Make a plan to send out Hazardous Waste to approved Hazardous Waste Facility to make room for any future hazardous waste in the bermed section of the Hazardous Waste Facility.
- The bulk metals portion is not bermed, and has the potential of releasing hazardous waste directly onto the environment. Rain has the potential washing away any hazardous waste onto the environment, which may migrate to any water bodies.
- Limit the amount of water withdrawal to the authorized amount listed in the water licence, or apply to the Water Board for an amendment to increase water withdrawal amount.
- Record your Annual Reports and books and records in Metres Cubed as per the Nunavut Water Regulations.

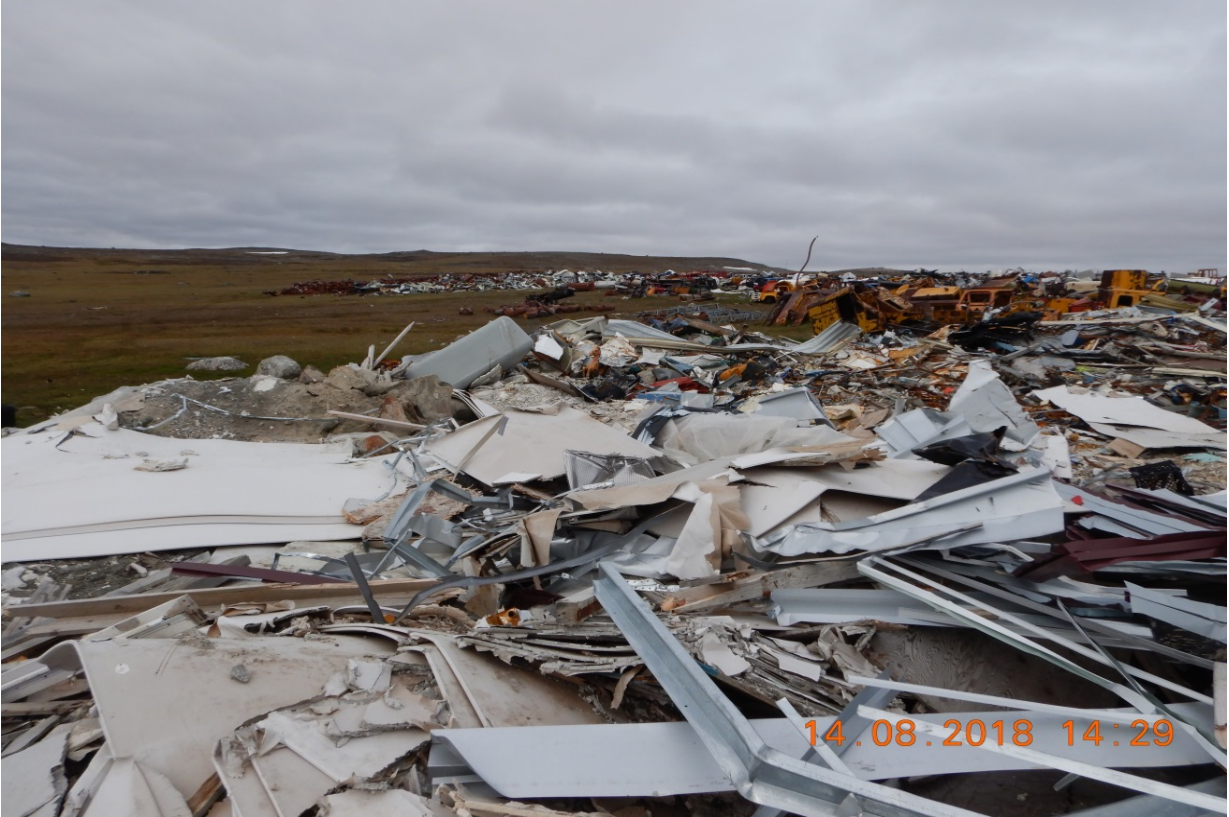
Photo 8

- 16. There is no berm to contain any leachate coming from bulk metal section of the land farm. Contaminants may migrate with rain water contaminating the environment on its migration to the down slope to the ocean (photo 8).

Description: the outer extent of bulk metal section of land farm, no berm to mitigate any potential deposit of wastes onto environment
