Report on Water Supplies

And Wastes Disposal

Clyde River, N.W.T.

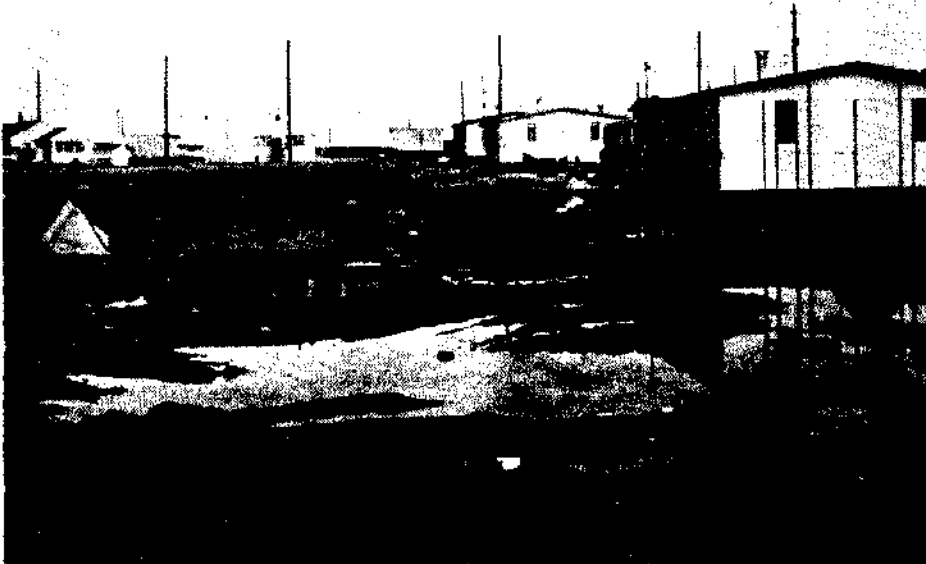
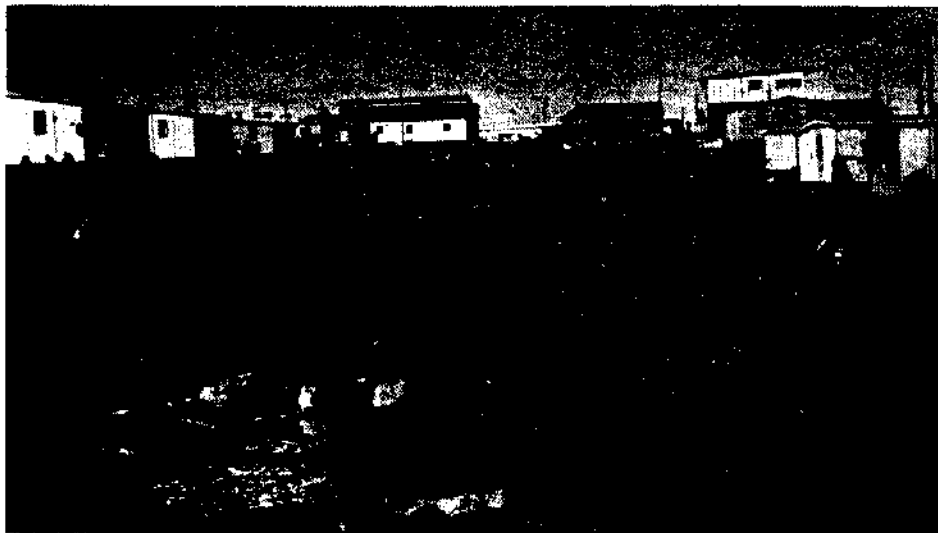
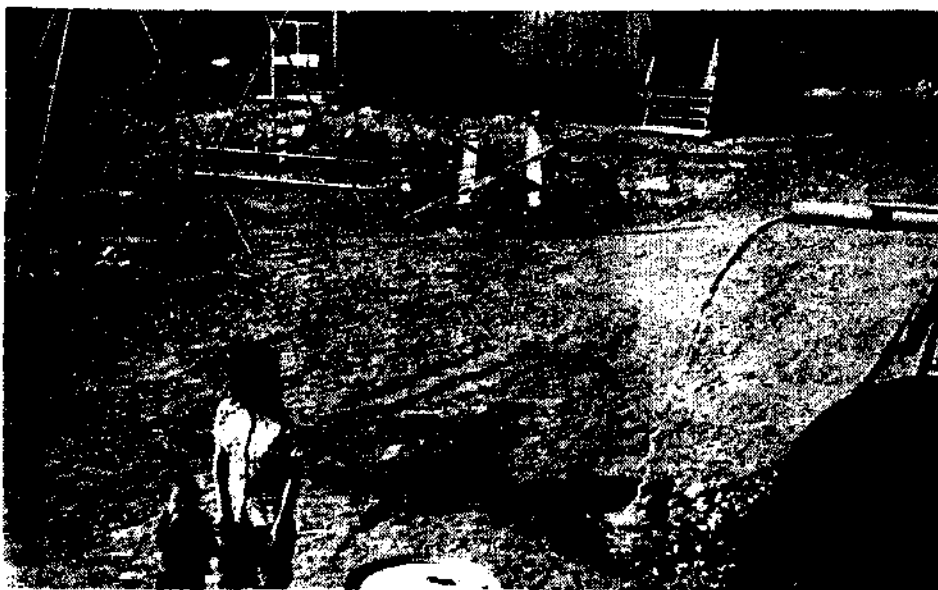
Waste water is spilled beside all buildings.

The discharge of liquid wastes beside every home, business and public building presents a serious public health problem. These wastes contain intestinal bacteria in probably all cases. The occasional unintentional spillage of honey bags also adds to the problem.

It is likely that the high incidence of infectious hepatitis last winter (12%) is a direct result. The ice slides and rinks created by these frozen liquid wastes are the favorite play areas of the children. They slide on them on sleighs, their backs and stomachs and tumble about on them. In the warmth of winter days, the surfaces of the ice melt somewhat and the hands and clothes of the children become contaminated. The contamination from the childrens' clothes passes to the hands of all members of the households, and schools and from thence to the water and food. Infectious hepatitis is commonly spread by contaminated hands touching the water and food, and conditions at Clyde River were ideal for such a transmission route. The unusually high incidence of the disease last winter in Clyde River and other Baffin communities where similar conditions exist, bears out this hypothesis. This is not intended to infer that the disease organisms were not also passed from one person to another by way of unwashed hands, especially in view of

Photos No. 5, 6 and 7
Liquid Wastes Disposal
Note discharge from school runs into playyard
