**Broughton Island and Clyde River
Sanitary Site Clean-Up**

**SANITARY SITE CLEAN UP
CLYDE RIVER, N.W.T.**

93-1232-01-01
July 1993

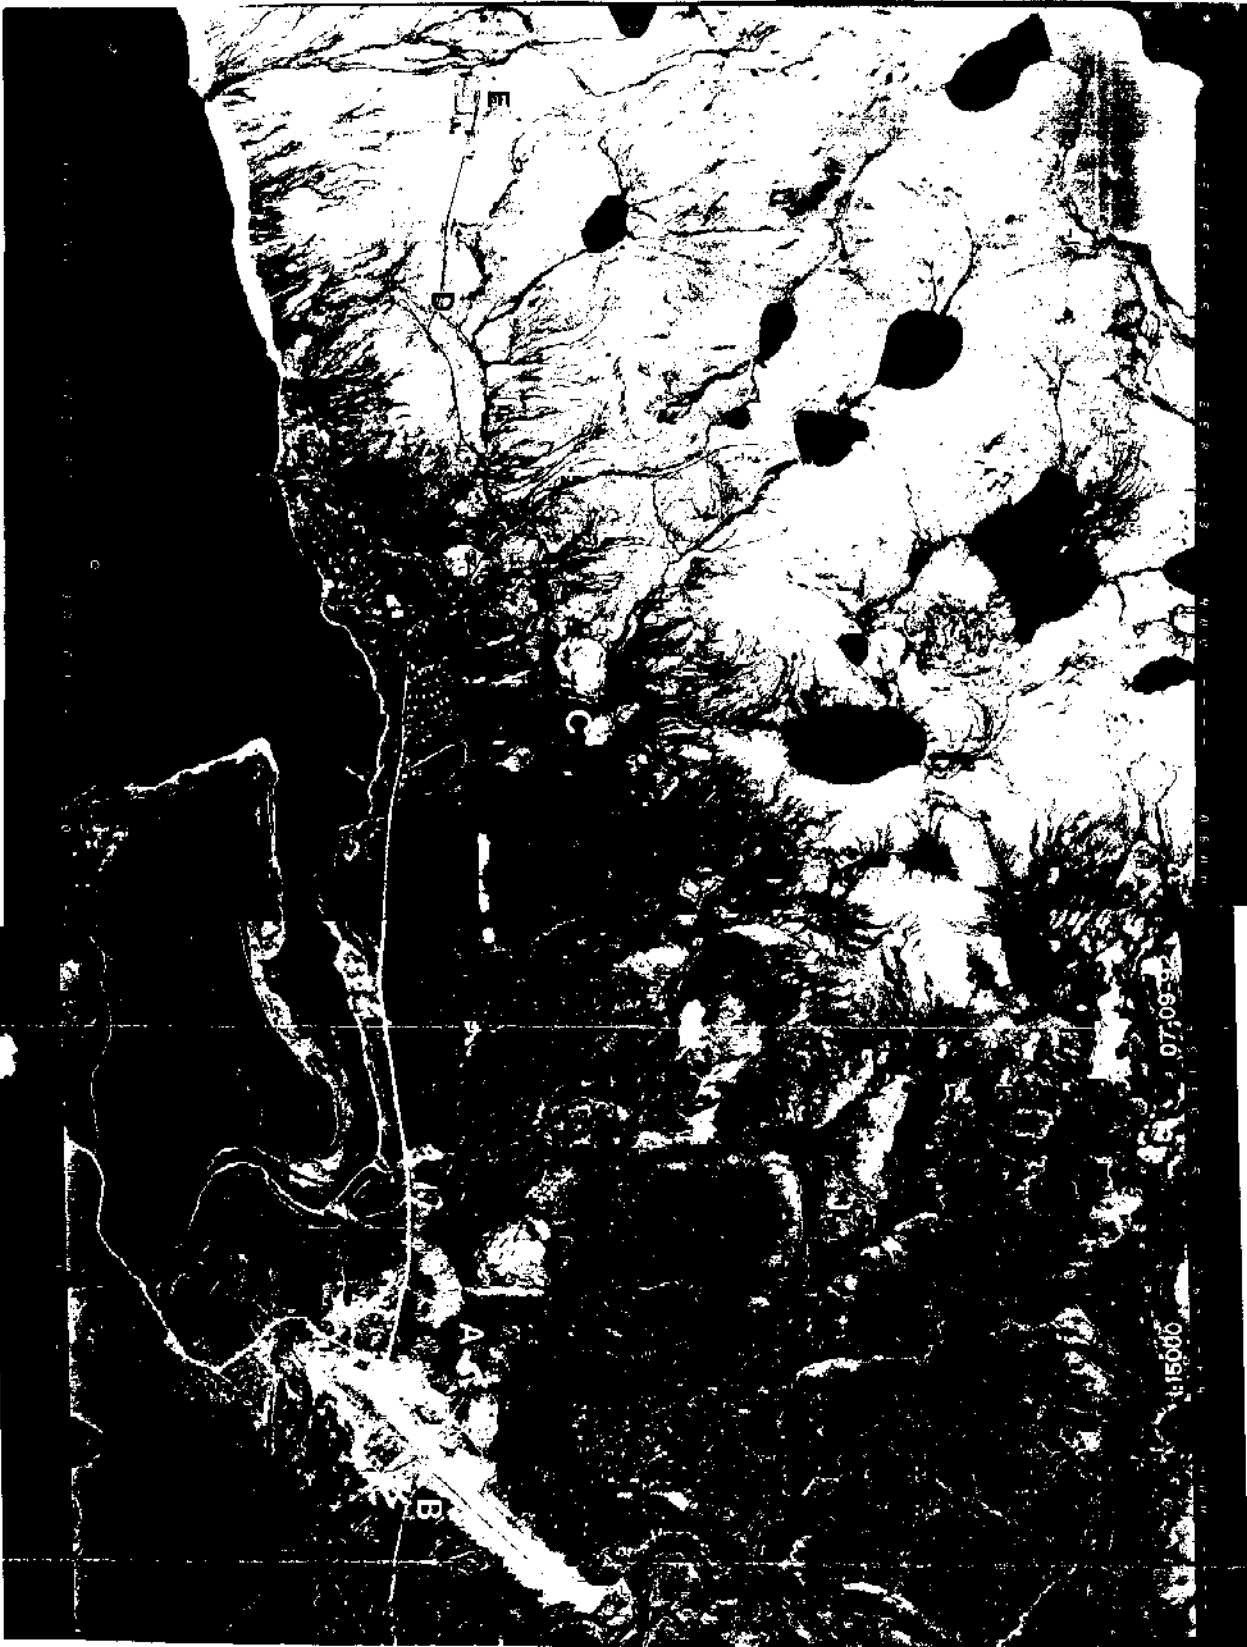
PHOTO PLATE #1

- **Photo Plate 1** is a high level air photograph showing the community area, the potential gravel sources (A,B,C), and the old and new landfill areas (D,E).
- **Photo Plate 2** is a low level air photograph showing the landfill area, the cemetery, borrow source, working face of the landfill, and water sample locations.
- **Photo Plates 3 and 4** are ground level photographs of the working face of the landfill.

- A POTENTIAL GRANULAR SOURCE LOCATIONS
- B POTENTIAL GRANULAR SOURCE
- C POTENTIAL GRANULAR SOURCE
- D LANDFILL AREA TO BE CLOSED
- E NEW SOLID WASTE AND SEWAGE LAGOON AREA

- Borrow source A is located 2.1 kms northeast of the Community on the south side of the runway. (See **Photo Plate 1**, source marked 'A'). A material sample was taken from this source and the results of the grain size analysis indicates a sandy gravel with approximately 10% fines.

- Borrow source B is located 2.8 kms northeast of the Community north of the runway. This source is marked 'B' on **Photo Plate 1**. A sample from this source was taken and found to contain high organic content. This material is not suitable for capping material and, therefore, a grain size analysis was not completed.

- Borrow source C is located 0.7 kms north of the Community and is shown as 'C' on **Photo Plate 1**. This source was inaccessible at the time of the site visit due to heavy snow cover. In discussion with the Hamlet foreman, we understand this source is inaccessible for most of the year and is, therefore, inappropriate for use in this project.

The waste disposal area is located on the face of a ridge to the southwest of the community. The area is accessible year round by a road which runs along the spine of the ridge. To the north of the landfill is the Hamlet cemetery. The relative locations of the road, community, cemetery, and landfill are shown on **Photo Plate 1**.

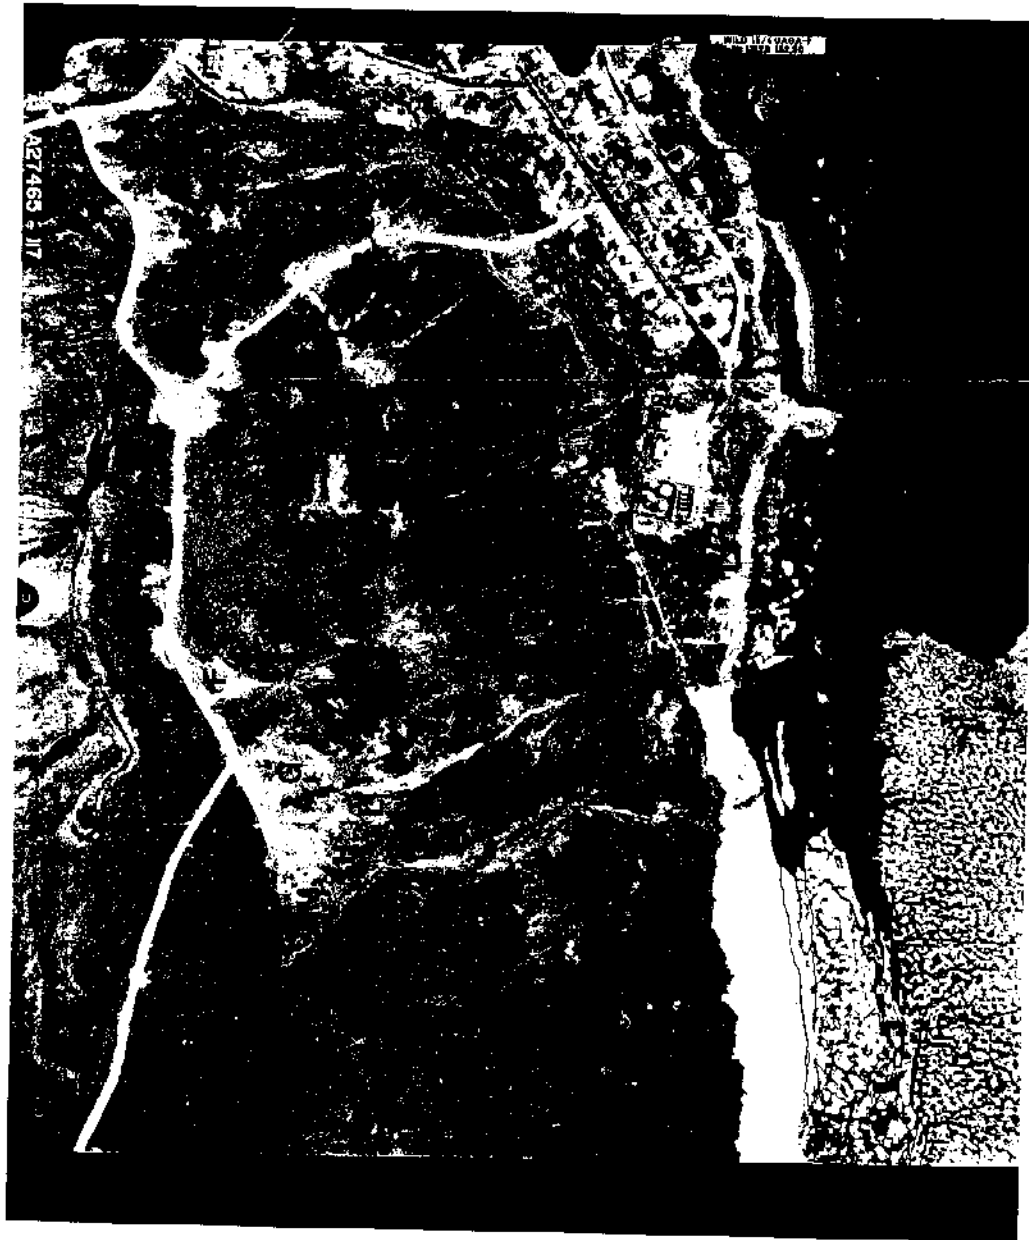
PHOTO PLATE #2

- F CEMETERY SITE
- G CURRENT GRANULAR SOURCE FOR LANDFILL COVER
- H WORKING FACE OF LANDFILL
- I SMALL BARREL DUMP
- J WATER SAMPLE POINT #1
- K WATER SAMPLE POINT #2
- L VIEW FOR PHOTO PLATE 3
- M VIEW FOR PHOTO PLATE 3A AND 4

- The fourth granular source is located at the old landfill site and has been used in the past for capping material. This source is marked 'G' in **Photo Plate 2**. Grain size analysis results for this source is included in the Appendix. This material is a silty sand with 22% fines.

The source at the landfill site (marked 'G' in **Photo Plate 2**) is the best material of the four for use as a material cap and is located closest to the work area. The material is, therefore, recommended for use and is to be placed and compacted as follows:

The landfill area consists of a granular plateau with a 10 m high bluff on the south face. The foreman stated that the landfill was operated by pushing the waste over the edge of the bluff and capping the waste mass with granular material. According to the Hamlet foreman, the waste mass extends 30 m to 50 m into the plateau area and there is approximately 1.0 m of cover material over the waste mass. At the base of the bluff is a natural drainage course that drains snow melt water through a bog and into the bay. The plateau and drainage area can be seen in **Photo Plate 2**.

The landfill cover material used by the Hamlet is from the north side of the plateau, shown as 'G' on **Photo Plate 2**. The material is stock piled with a dozer and then placed with a loader over the waste mass.

According to the Hamlet, in 1992 they had a barrel crusher on site. The crusher belongs to the Department of Indian and Northern Development (D.I.A.N.D.), and will travel to each of the communities in the Baffin Region over the next several years. The community undertook a crushing program of old waste oil barrels. These barrels are still located on the beach, shown as location 'I' on **Photo Plate 2**.

Water samples downstream of the landfill area were taken at locations 'J' and 'K', shown on **Photo Plate 2**. The results of these samples are included in Appendix #2. **Table #1** shows the results of these tests and previous testing by D.I.A.N.D. These samples indicate high levels of ammonia and are typical of the municipal sewage being disposed of in this area. We understand that by fall 1993 the sewage will no longer be disposed of at this location.

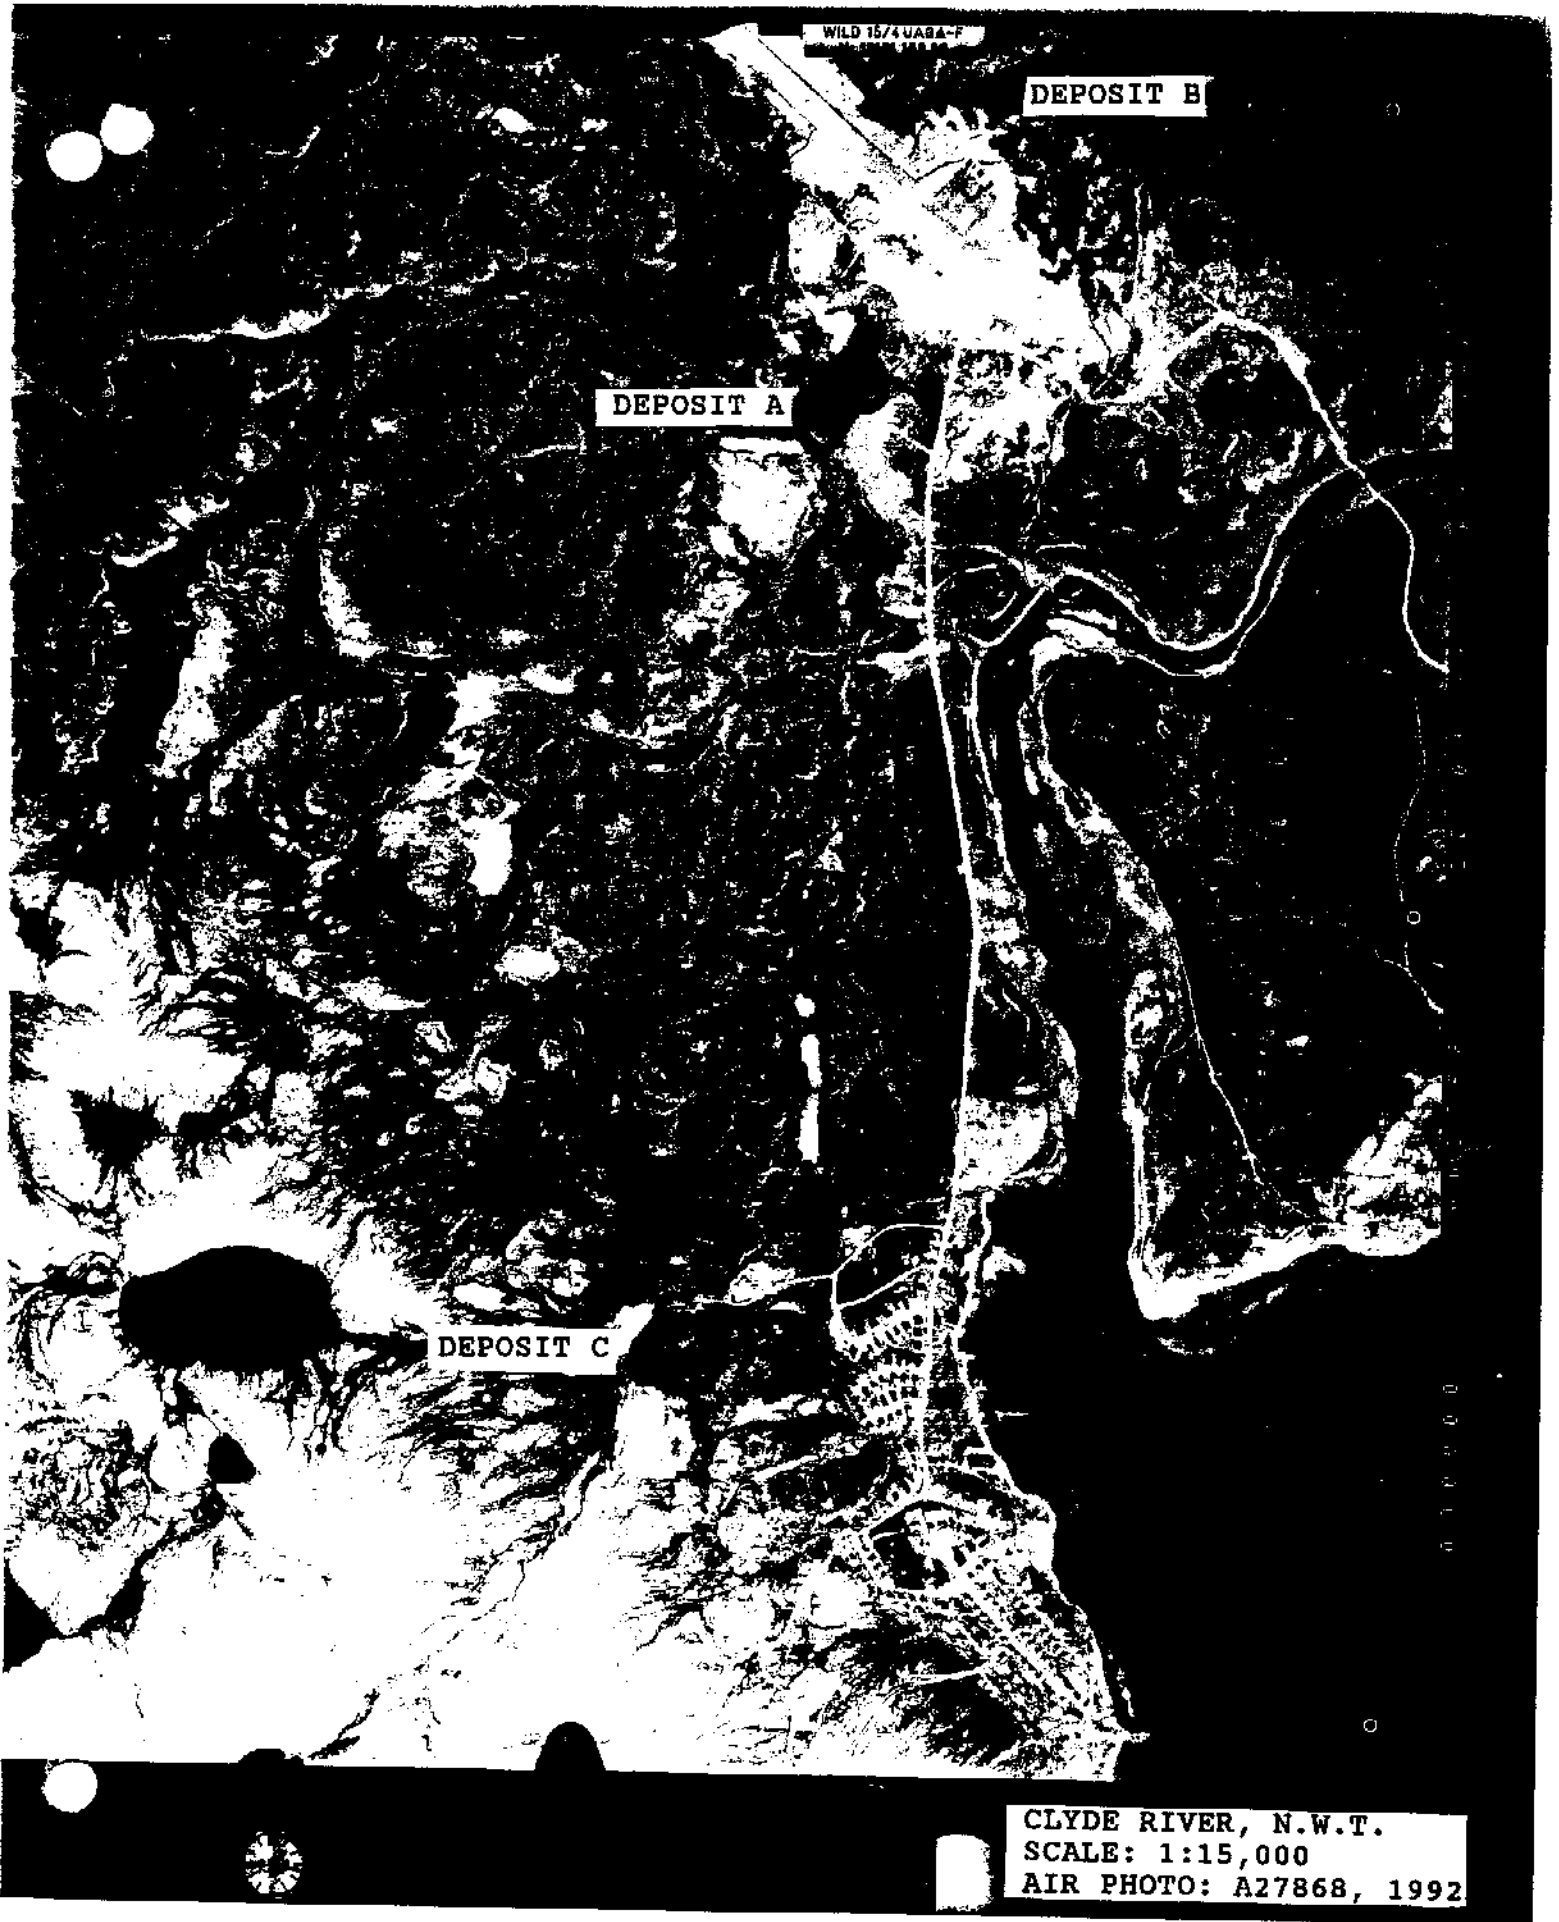
FIGURE 1

Several granular borrow sources were identified in the reports reviewed. Although these reports are somewhat dated, they appear to confirm that sufficient granular resources are available near the community. Two of the more promising deposits exist on the west and east sides of the airstrip. The west side deposit is located on the north side of the road, just outside the airport boundary. This deposit is immediately north of a depleted sandy gravel borrow source; see Deposit A - Figure 1. The deposit is reported to contain poorly graded sands with some boulders. The fine content was estimated to be 50 to 60 percent.

The deposit on the east side of the airstrip (Deposit B - Figure 1) consists of poorly graded sands, of glaciomarine origin. The fine content is reported to be quite low, but the volume of material is high and localized finer materials are likely to be present.

A third potential deposit is located north of the community (Deposit C - Figure 1). It is likely to be predominantly poorly graded sands and gravels, but localized zones of finer materials may be present.

CLYDE RIVER, N.W.T.
SCALE: 1:15,000
AIR PHOTO: A27868, 1992
