CONSTRUCTION PROGRESS REPORT OF SEWAGE DISPOSAL FACILITY

**Project Progress Report
New Sewage Lagoon and Rehabilitation of
Existing Sewage Lagoon for the
Hamlet of Clyde River**

Prepared for:
**Department of Community Government and Services
Government of Nunavut**

OTCD00019055A
October 2009

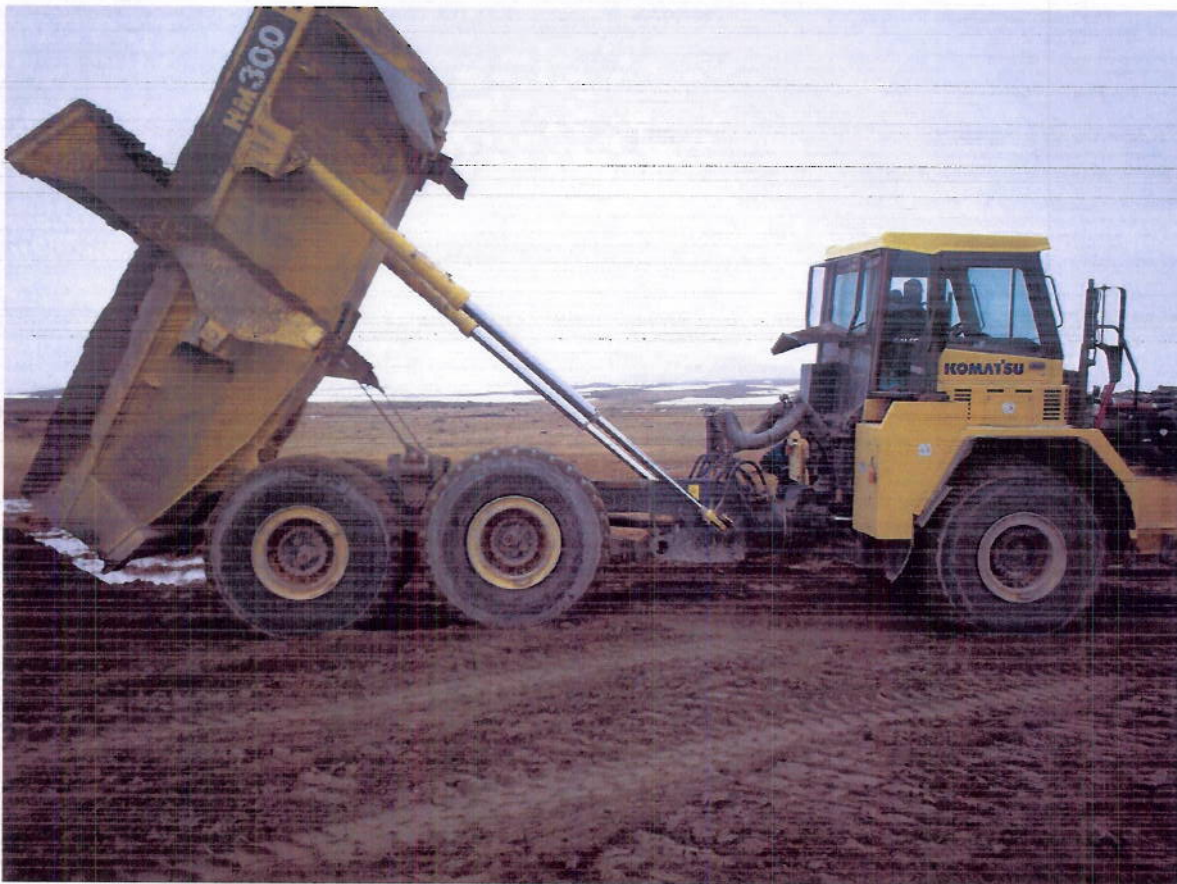
Image 3.3.1 Machinery Mobilized for Stockpile Operations

Phase I mobilization began in the summer season of 2008 where Kudlik barged in the necessary equipment to produce granular materials in the quarry, and to stockpile on-site materials processed. The main objective of Phase I was to prepare for the upcoming 2009 construction season by establishing the quarry, setting up the crusher and screener at the quarry, and preparing the raw materials for construction.

Equipment	Quantity
8 ton Vibratory Highway Type Roller	1
WA500 loader	1
komatsu hm300 trucks	3
Bulldozer	1
komatsu 400 excavator	2
10 wheel dumptruck	1
crusher	1
screener	1

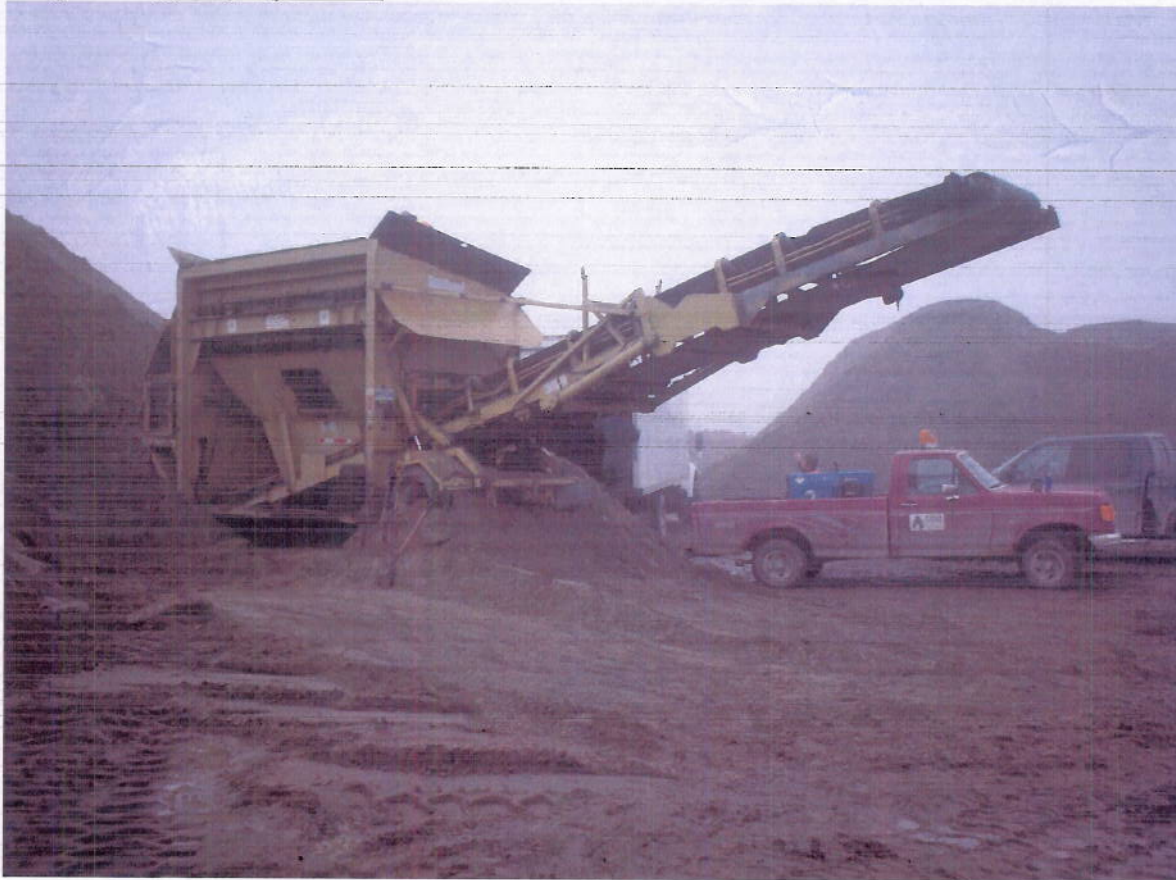
Image 4.6.1 Quarry Operations

The cumulative quantities quarried for the second season are as follows, and completes the necessary volumes of stockpiled material for the project:

Material	Estimated Quantity m3	Processed Material m3
Granular A	160	160
Granular C	53,000	53,000
Rip-rap	52	52
Sand	5,150	5,150
