**Re: September 4, 2002 Municipal Water Inspection - Report**

MUNICIPAL WATER USE INSPECTION REPORT

Licensee: Municipality of Coral Harbour    Licence No.: Unlicensed at the time of inspection.  
New NWB3COR0207

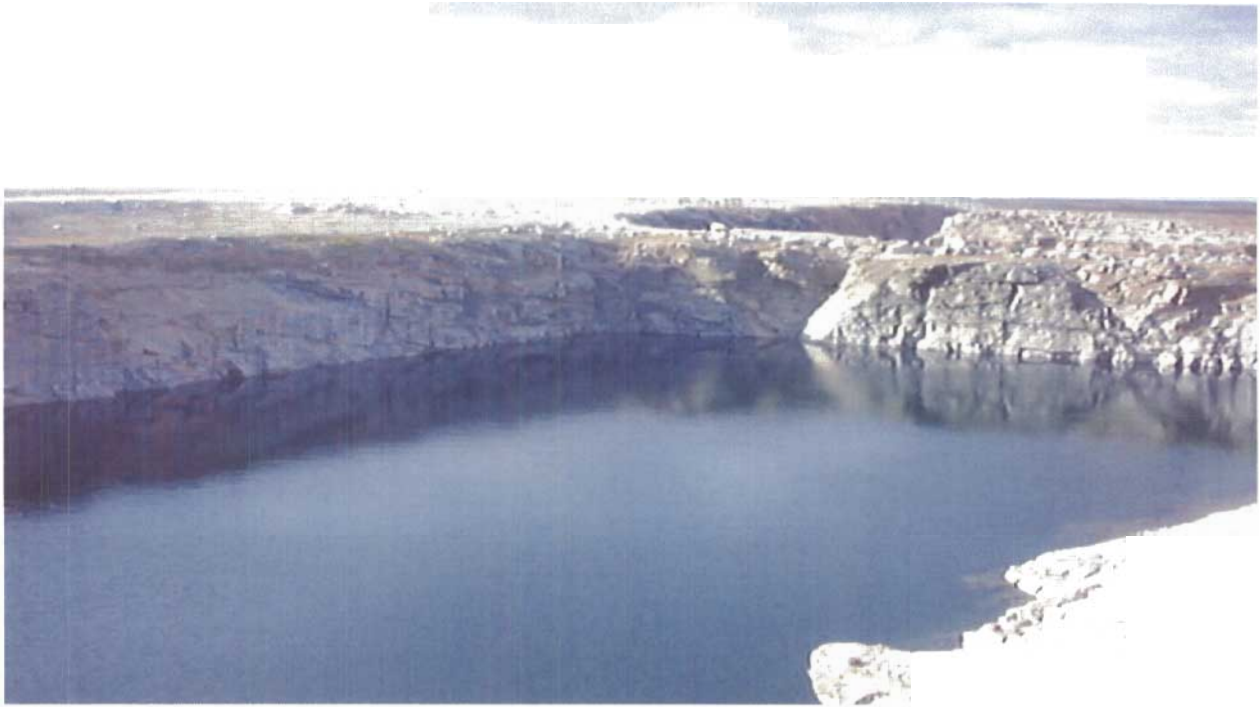
(Figure 1)

- Coral Harbour, Water Supply Reservoir, Site: N64 08 37.6 W83 10 20.2

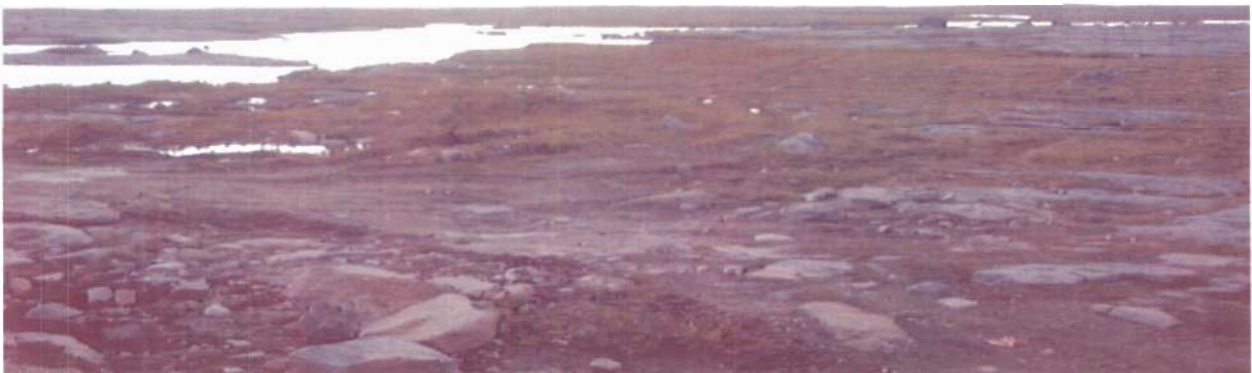
(Figure 2 SNP-COR-1)

- Coral Harbour, Main Water Source (River) Site: N64 08 37.6 W83 11 57.6

- 1. Water supply:** No concerns were noted regarding the water intake and supply facility. Further, the attached analytical results relating to samples taken in the vicinity of the intake station indicate that all tested parameters meet the *Guidelines for the Canadian Drinking Water Quality*. Please find attached analysis report. (Figure 1-2 Refers to Water Sources) New **SNP-COR-1** Refers to Raw Water Supply Prior to Treatment, and is monitoring point for the quantity being withdrawn from source, (not the quality).

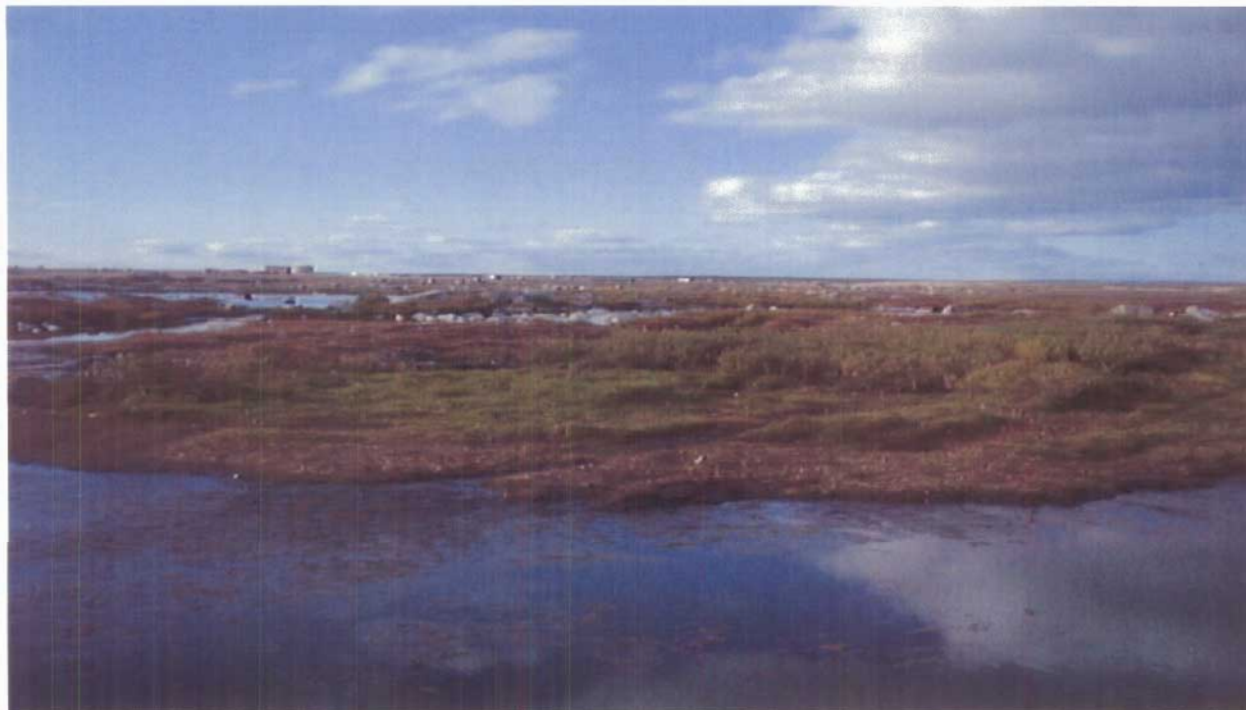
(Figure 3 SNP-COR-3)

- Coral Harbour, Sewage Disposal (Lagoon) Site: N64 09 48.2 W83 11 45.9

- 2. Sewage disposal:** Standard truck drop off point. There are a series of small ponds that lead down through a flow path a good distance from the ocean. At the time of inspection two main ponds were quite dry, no flow down stream noticed. Samples were collected three (300) hundred feet from the drop off point. However, the attached analytical report reveals that it meets the municipal waste water guideline. (Figure 3-4 Refers to the Sewage Disposal) ("New **SNP-COR-3** Refers to Effluent Discharge from the Sewage Disposal Facilities")

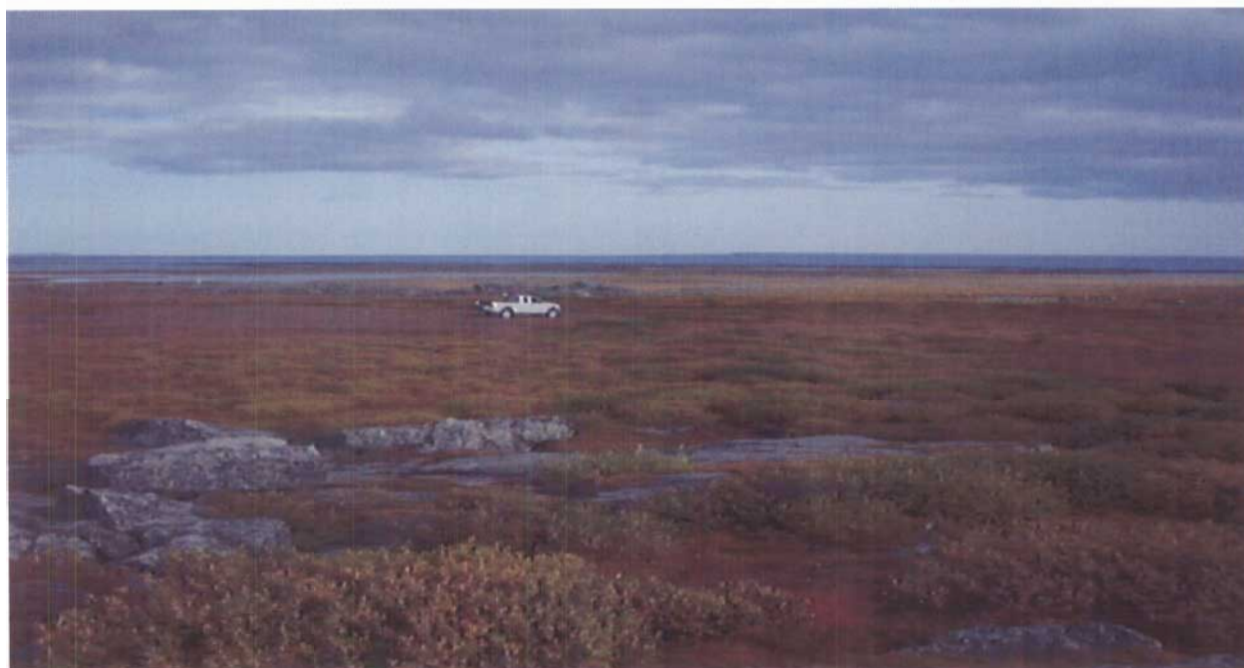
(Figure 4 SNP-COR-3)

- Coral Harbour, Sewage Runoff (Field) Site: N64 09 45.4 W83 11 27.7

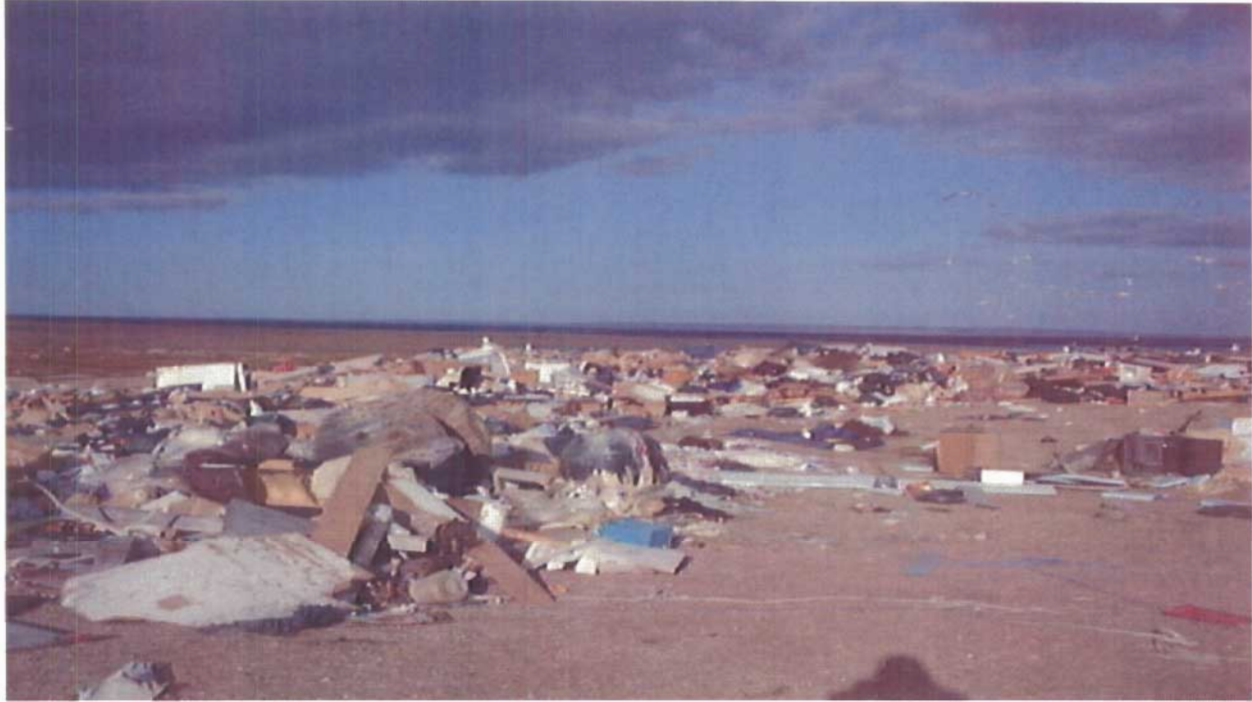
(Figure 5 SNP-COR-2)

- 3. Solid waste disposal:** During the time of inspection a lot of windblown garbage was observed. There is no fencing within this area which has a lot to do with this problem. I was advised that improvement to both bulky and combustible waste are

- Coral Harbour, Solid Waste Disposal (Main Dump) Site: N64 09 36.7 W83 11 36.0

in the works. The plans is to clean up the bulky metals first and to transport to a new location. The capital plan for this relocation will take some time to complete.  
(Figure 5-6 Refers to Solid Waste Disposal) ( "New **SNP-COR-2** Refers to Runoff from the Solid Waste Disposal Facilities")

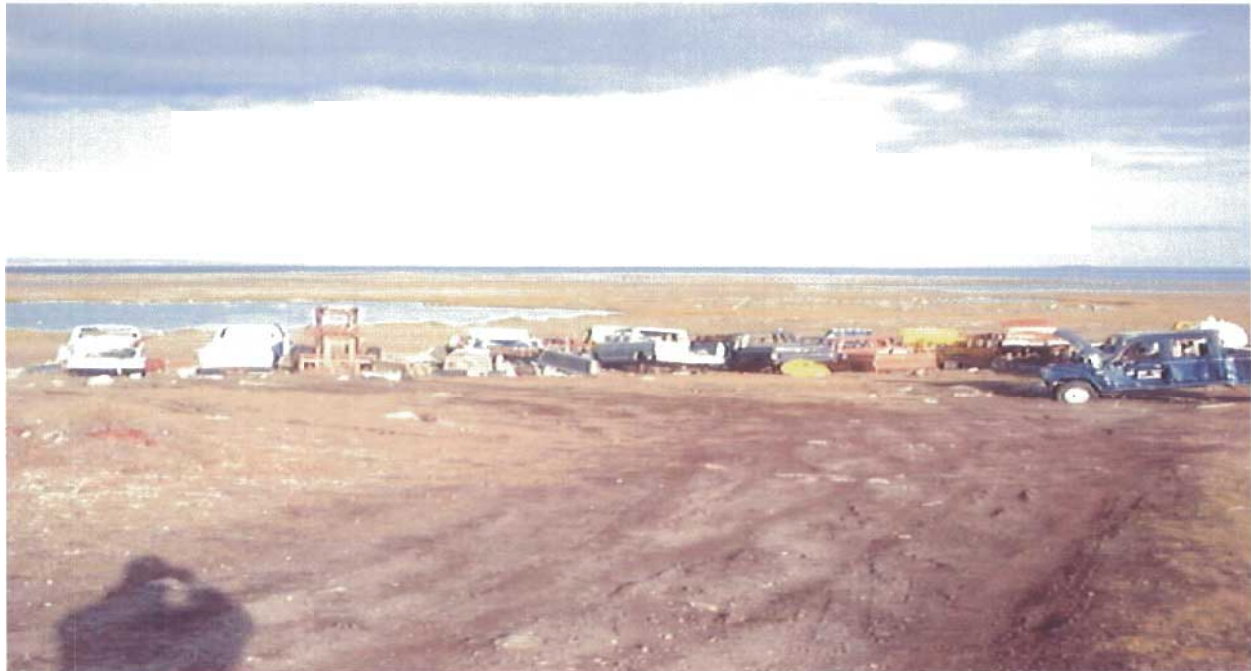
(Figure 6 SNP-COR-2)

- Coral Harbour, Solid Waste Disposal (New Metal Dump) Site: N64 09 31.6 W83 11 28.9

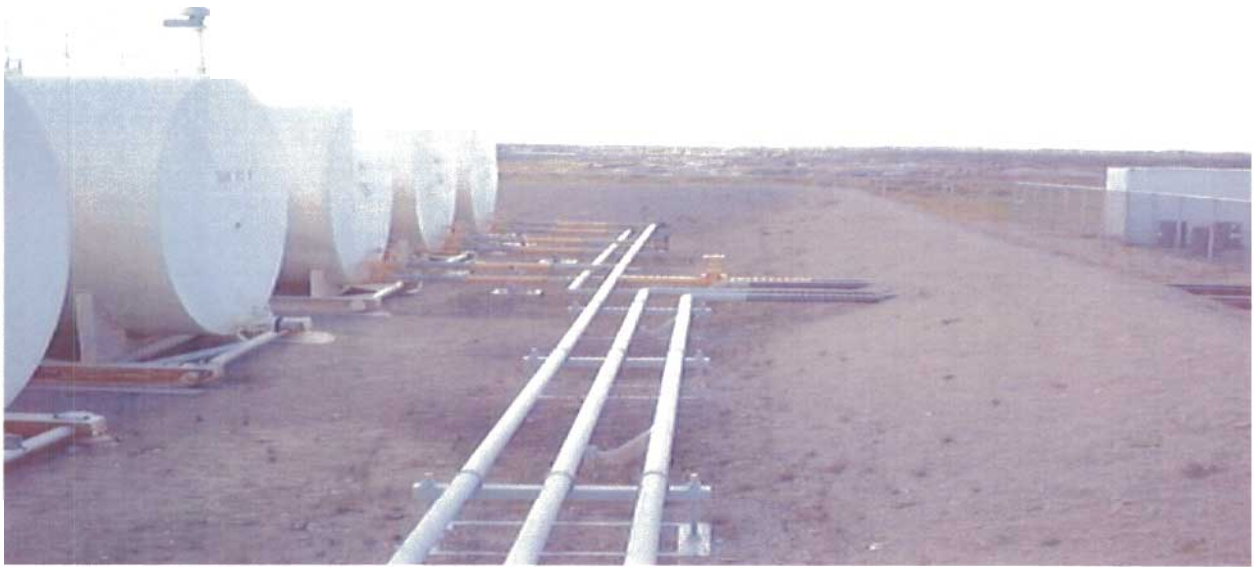
(Figure 7)

- Coral Harbour, Community Tank Farm, Site: N64 07 58.9 W76 32 16.9

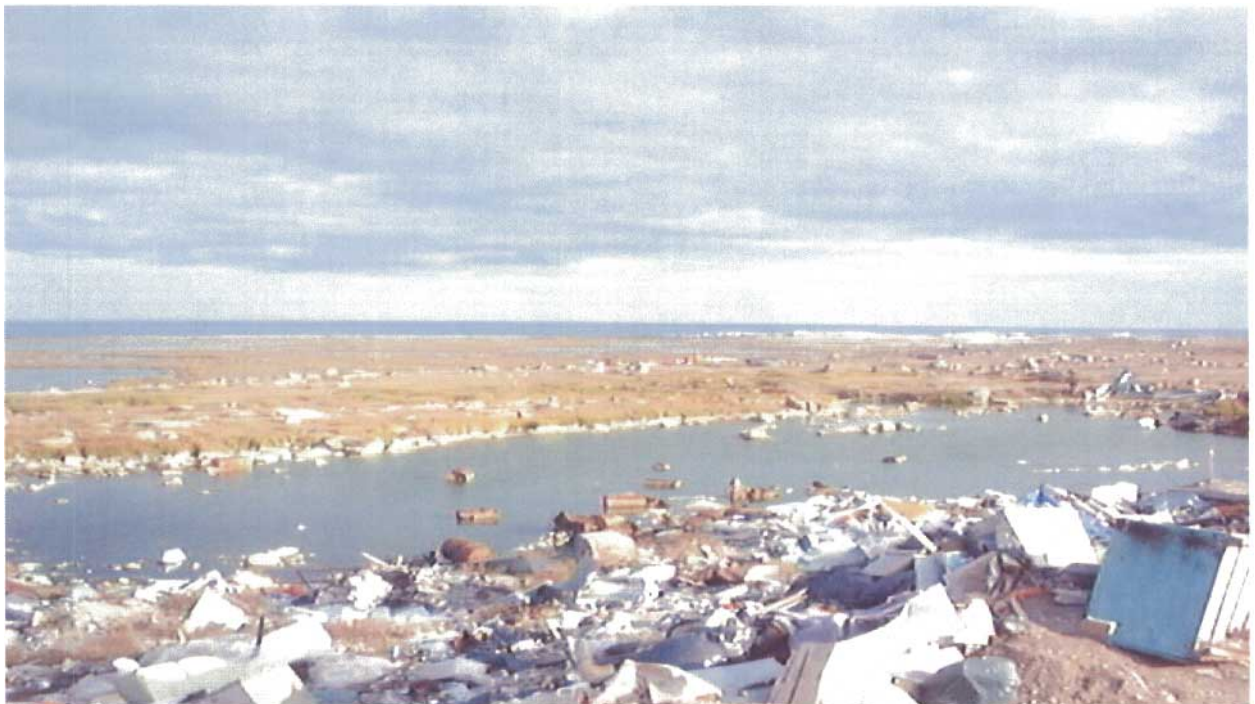
(Figure 8)

- Coral Harbour, Windblown Garbage, Mixture of Metal & Burnables

Comments: As noted in previous reports, the main structure of the lagoon consist of series of small water bodies within the sewage discharge area, which then appears to travel towards to the ocean. The inspector noted a lot wind blown garbage within the sewage disposal area, which results from no fencing at the waste disposal site. Something that could be look into in the near future. As for the waste disposal site (bulky metals), it was brought to the attention of the inspector that a new site had been developed, for the bulky metals. A capital plan is now in place to remove all old bulky metals waste from the existing site to the new one, which should be complete within the 2 years, as to what the inspector was informed.
