Community Visit Report – Gjoa Haven

Assistance with Water Licence Compliance Issues

OTT-00209248-A0

March 2013

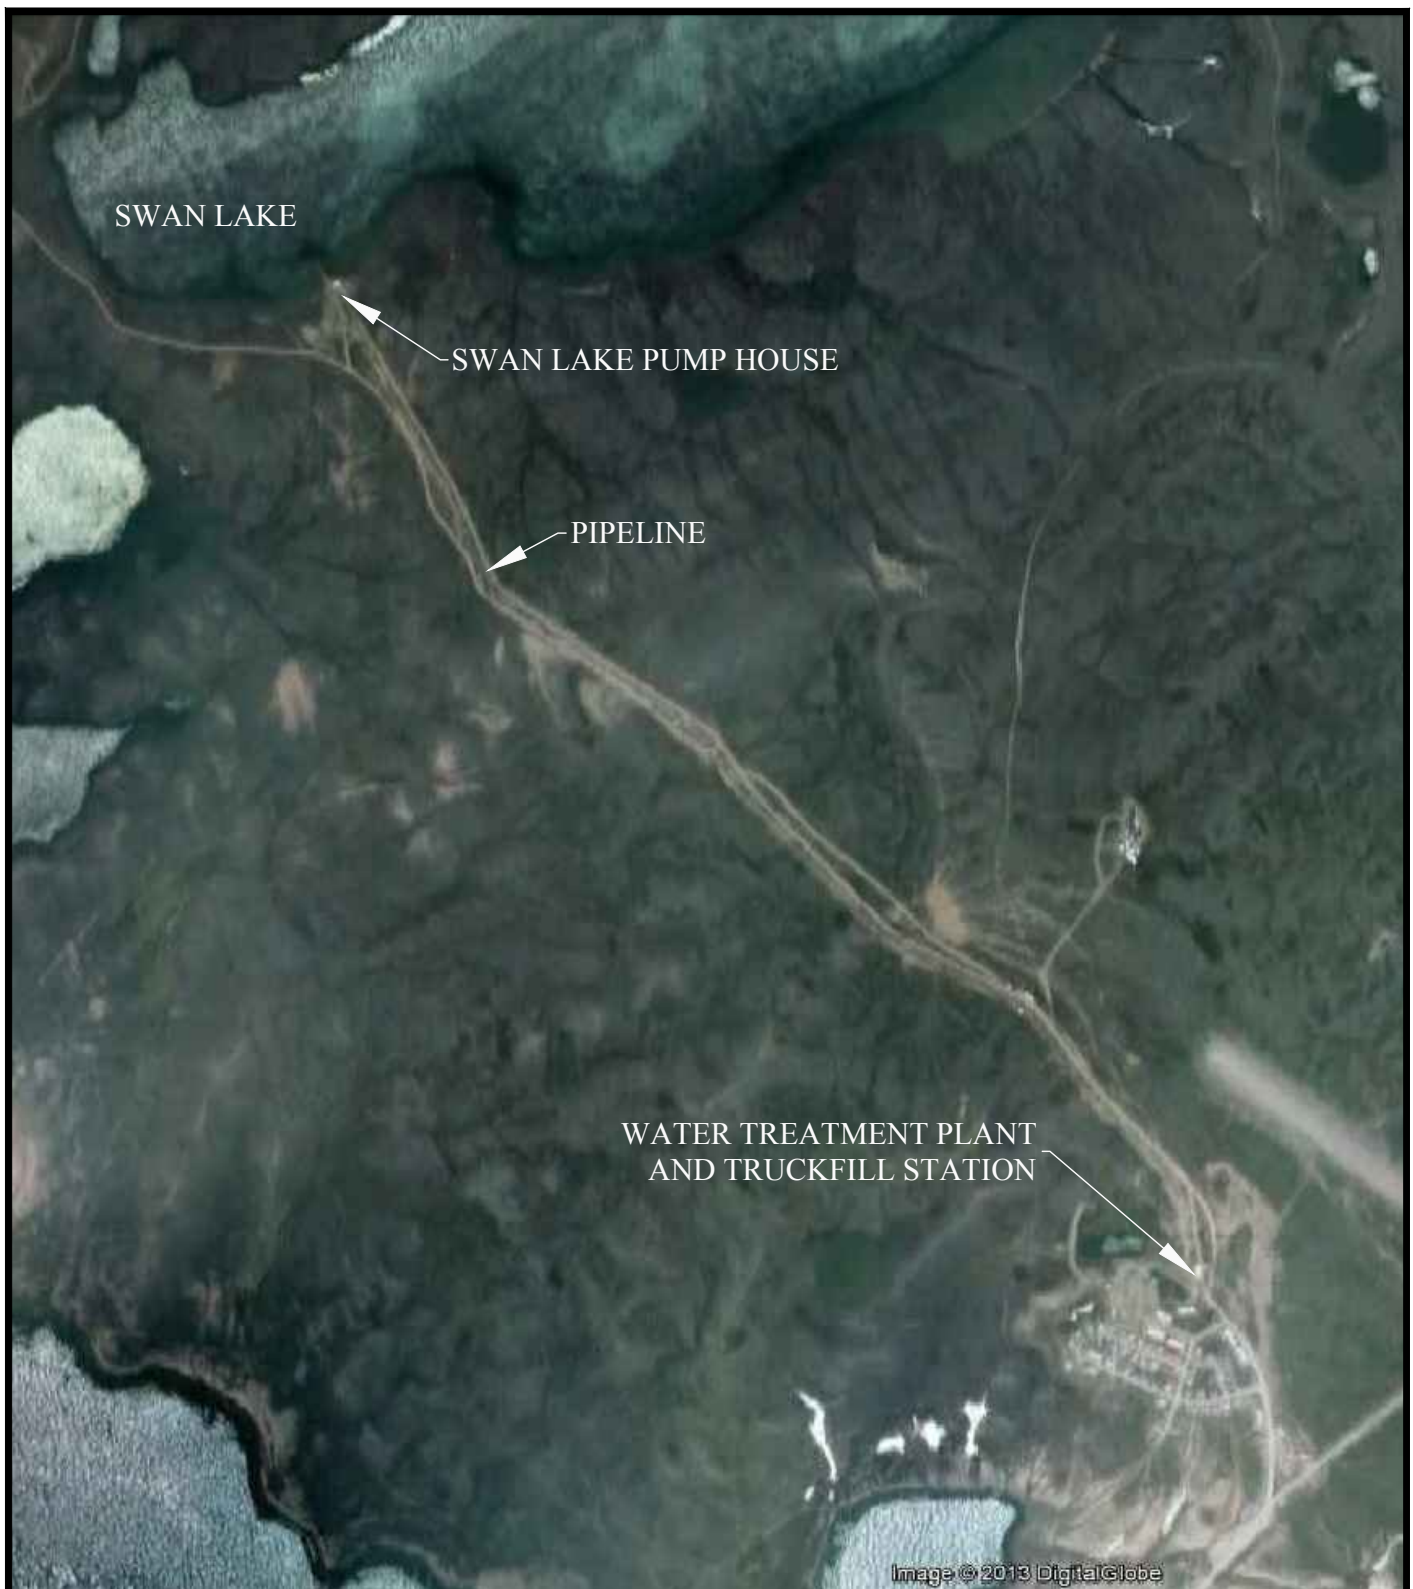
scale	NTS	CLIENT:	GJOA HAVEN	project no.
date				OTCD000209248
drawn by				FIG 01
M.KELLEY		TITLE:	WATER SYSTEM

Water is drawn into the pump house at Swan Lake via a pair of inclined shaft intakes. The pump house contains heating equipment, provided to avoid freeze of the transmission watermain linking the pump house and water treatment plant. There is also a truck loading arm at the pump house, which can provide for continuing service should there be operating issues with the transmission watermain. Photograph 1 depicts the exterior of the Swan Lake pump house.

Water is conveyed to the treatment plant via a transmission watermain that is approximately 3 kilometres in length. There have been reports of past operating challenges due to freeze of this watermain. Attentive operation by on-site CGS personnel appears to have improved the reliability of this watermain.

The water treatment plant is located adjacent to the developed area of the Hamlet, and south of the airport. This facility contains pressure filters, chlorination equipment, a treated water storage tank and equipment for truck loading. The facility appeared to be in good order. Treated water chlorine is measured and recorded on an on-going basis. Backwash water from the pressure filters is disposed of into a bermed area to the rear of the water treatment plant. This backwash stream is treated with a dechlorination chemical prior to discharge.

The various elements of the water supply system are depicted on Figure 1.

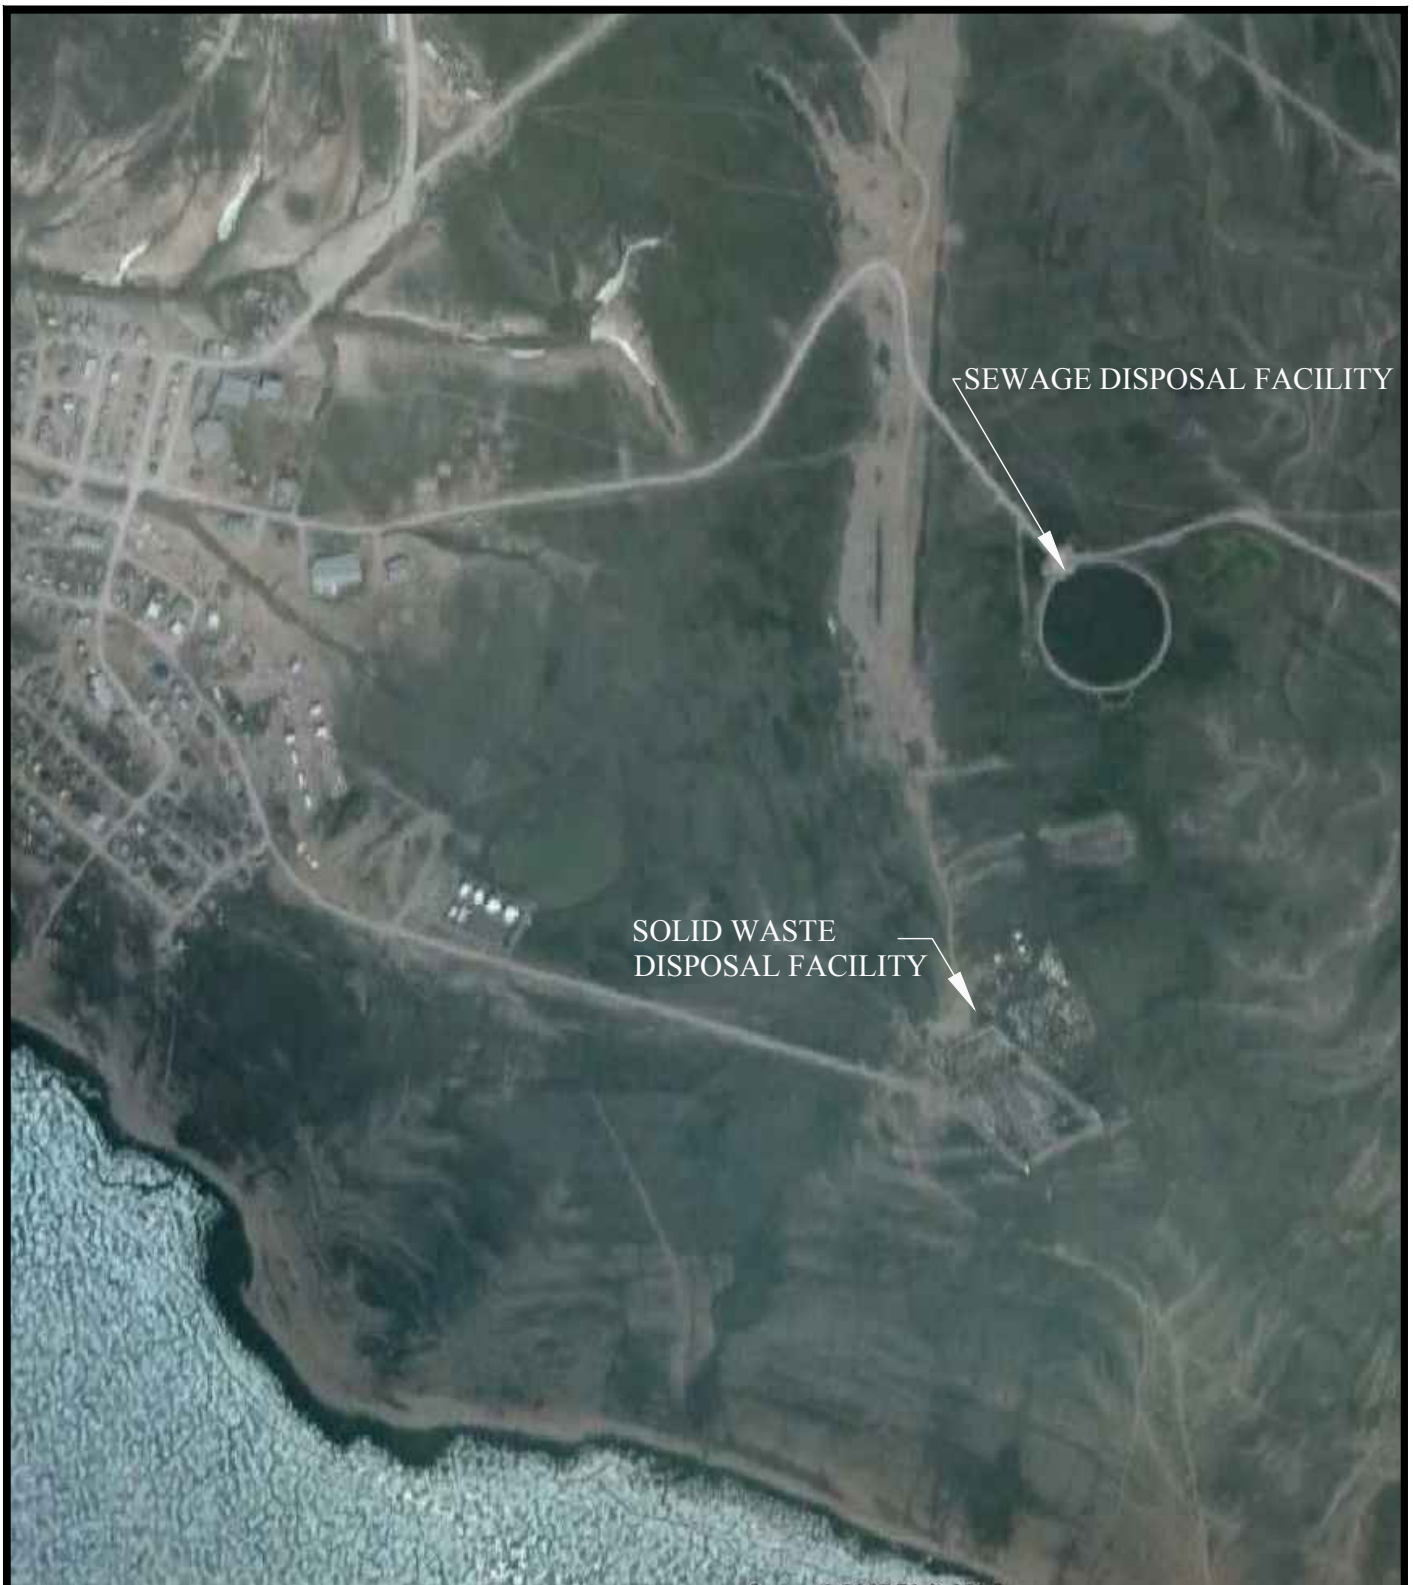
scale NTS	CLIENT: GJOA HAVEN	project no. OTCD000209248
date 22/03/13	TITLE: WASTE DISPOSAL FACILITIES	FIG 02
drawn by M.KELLEY

Waste water generated in the community is hauled to a site that is approximately 1.5 kilometres southeast from the centre of the Hamlet. This facility is a constructed lagoon that is approximately 180 metres in diameter. Sewage is discharged at the north side of the lagoon, and the discharge point is opposite the sewage receiving point. A semi-circular secondary cell that is approximately 40 metres in diameter has been provided adjacent to the primary cell and directly below the discharge from the primary cell. The discharge arrangement between the cells appears to be a pipe. The precise details of this discharge method were challenging to observe due to snow cover. Photograph 3, which was taken near the discharge point from the primary cell, illustrates the lagoon berms and the sewage discharge point. Photograph 4 illustrates the discharge pipe between the cells and the berms for the secondary cell. Effluent from the lagoon system is conveyed through an undefined wetland area prior to discharge into the sea. The wetlands provide a flow path approximately 1,000 metres prior to entering the marine environment. Figure 2 illustrates various features of the waste water management and disposal system.

The current solid waste disposal site is located approximately 1.8 kilometres southeast from the centre of the Hamlet and approximately 700 metres south of the sewage off-loading point at the lagoon. Figure 2 illustrates the location and some features of this facility. A former solid waste disposal area, which is reported to have been cleaned-up was noted along the road to the existing solid waste facility. Photograph 5 depicts this former disposal area.

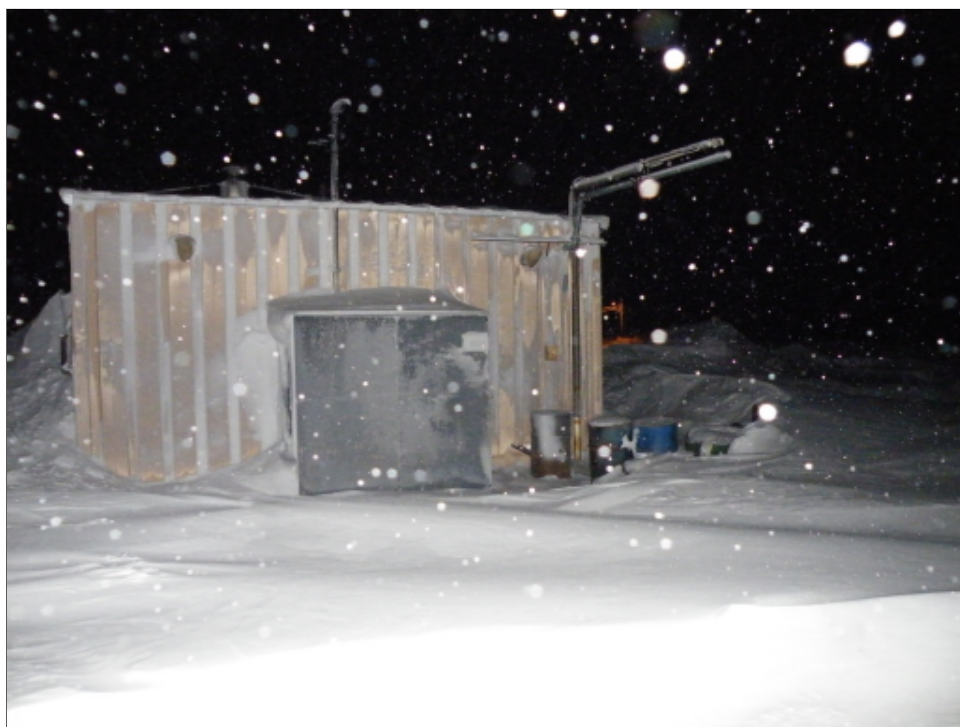
Photo 2: Abandoned Truck-fill Station

An abandoned truck-fill station is located 40 metres to the south of the water treatment plant. This facility appears to have been out of service for an extended period. A return to service is not possible due the breach in the Water Lake berm. Photograph 2 depicts this abandoned facility.

As reported above in Section 2.1, there is an abandoned truck fill station located approximately 40 m south of the new water treatment facility. An abandonment and restoration plan (AR plan) shall have to be prepared for this facility by CGS.

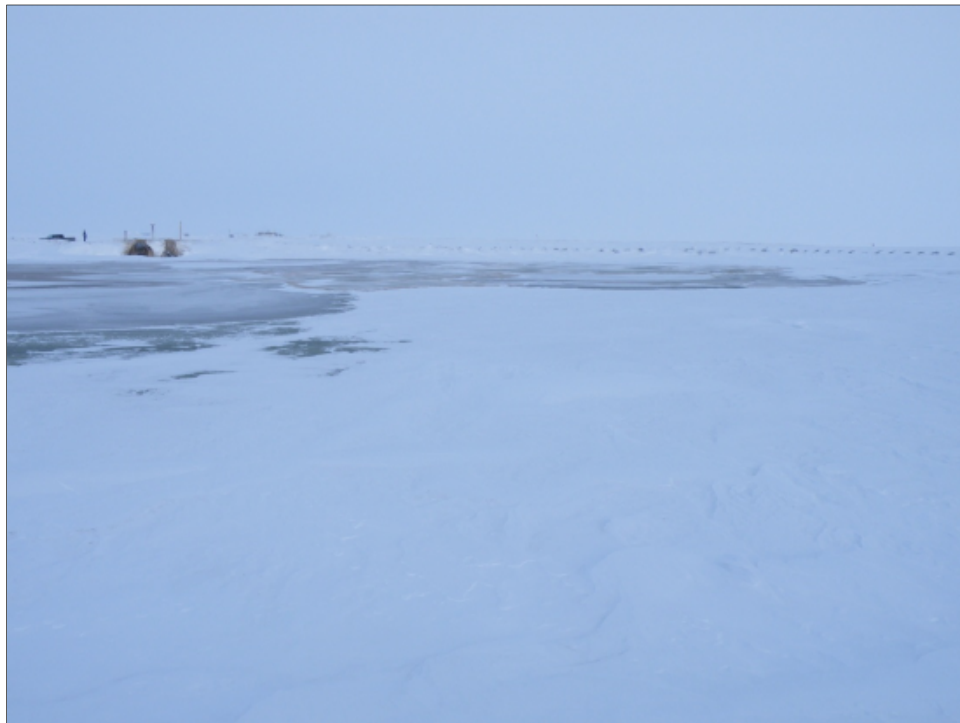
Photo 3: Near the Discharge Point from the Sewage Lagoon Primary Cell

There have been reports of instability for portions of the lagoon berms, and the matter of freeboard has been raised by the AANDC inspector. It has been reported that localized repairs have been conducted on the lagoon berms.

The Licence contains a definition of the term Final Discharge Point, but the location of this point is not precisely defined in the Licence. During the site visit, no signage was noted at the monitoring points. Geo-referenced coordinates were obtained for the sewage off load point.

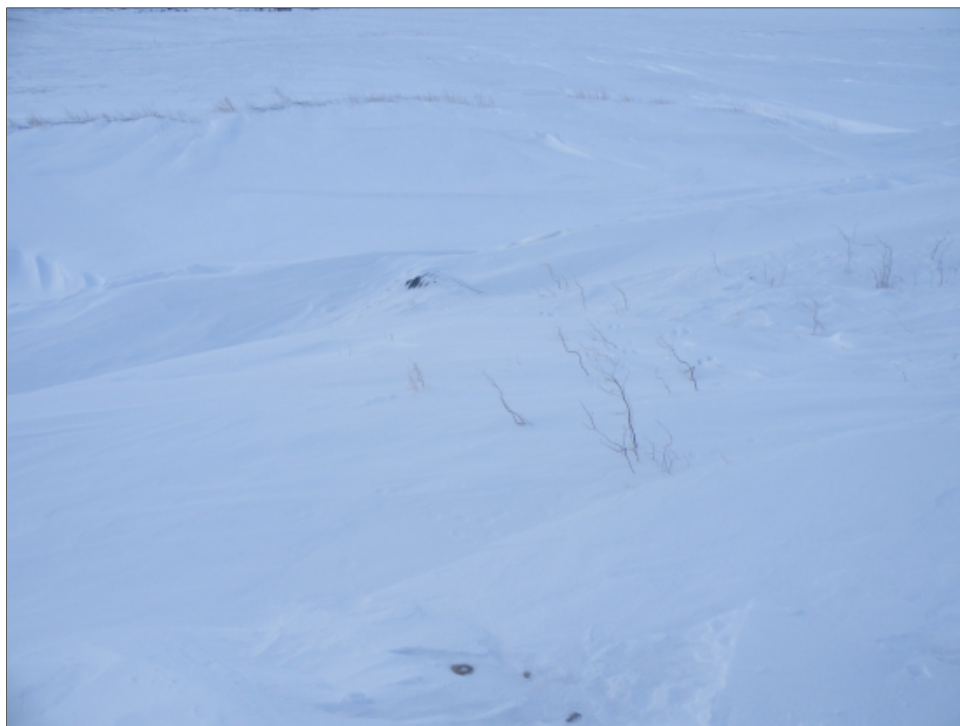
Photo 4: Discharge pipe between the Cells and the Secondary Cell

As reported in 2012 Annual Report, an overflow pipe has been installed with a freeboard of 1.3 m with respect to the lowest crest of the berm. This overflow pipe is intended to maintain a minimum freeboard of greater than 1 m as per the requirements of the water licence. It was possible to confirm the presence of this pipe, but due to snow cover at the time of community site visit, it was impossible to verify compliance with the freeboard concern.

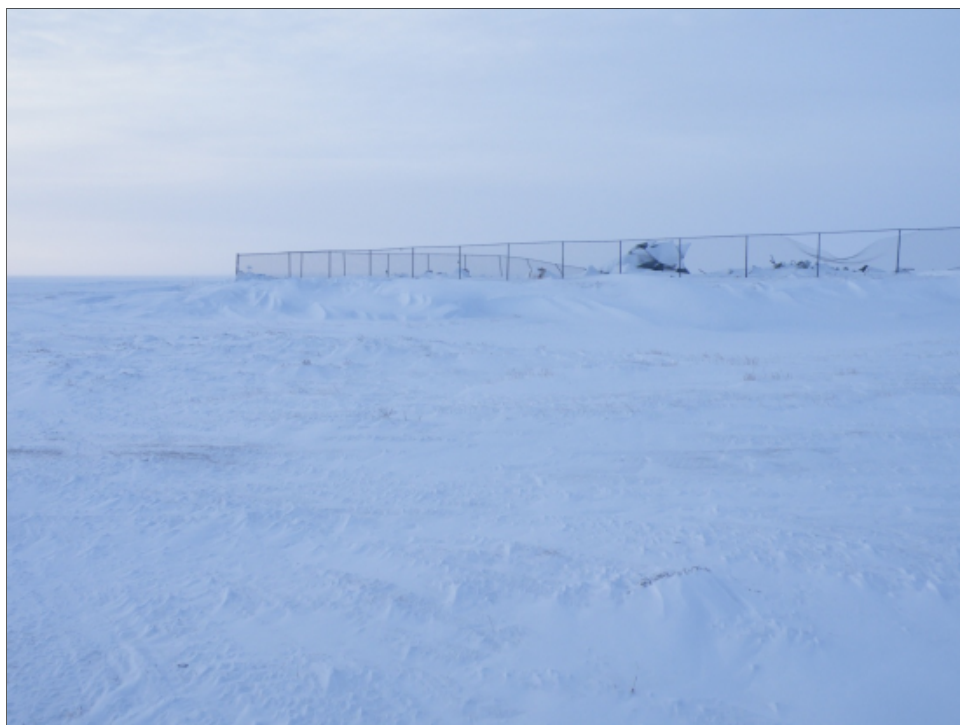
Photo 6: Berm and Fence at Solid Waste Disposal Site

Approximately half of the perimeter of the solid waste disposal site is delineated by a fence. The west, south and east sides of this area appear to have been bermed. The fencing is in fair to poor condition with several openings, no gates and portions that have fallen over. Photograph 6 depicts a portion of the berm and fence. Photograph 7 depicts that area within the fenced perimeter where municipal solid waste is deposited. There was no indication of segregation of solid waste or management of hazardous wastes.

To mitigate negative environmental effects of leachate the Hamlet should segregate and contain hazardous waste. This can be accomplished by storing hazardous waste in a shipping container, then transfer it south to a licensed hazardous waste disposal facility once the container is full. The leachate from the waste disposal site should also be contained and properly managed. This can be accomplished by lining down gradient corner of the landfill berm. The water from the landfill will collect in this area and can be tested and based on the results, discharged either into the sewage lagoon for treatment or to the natural environment.

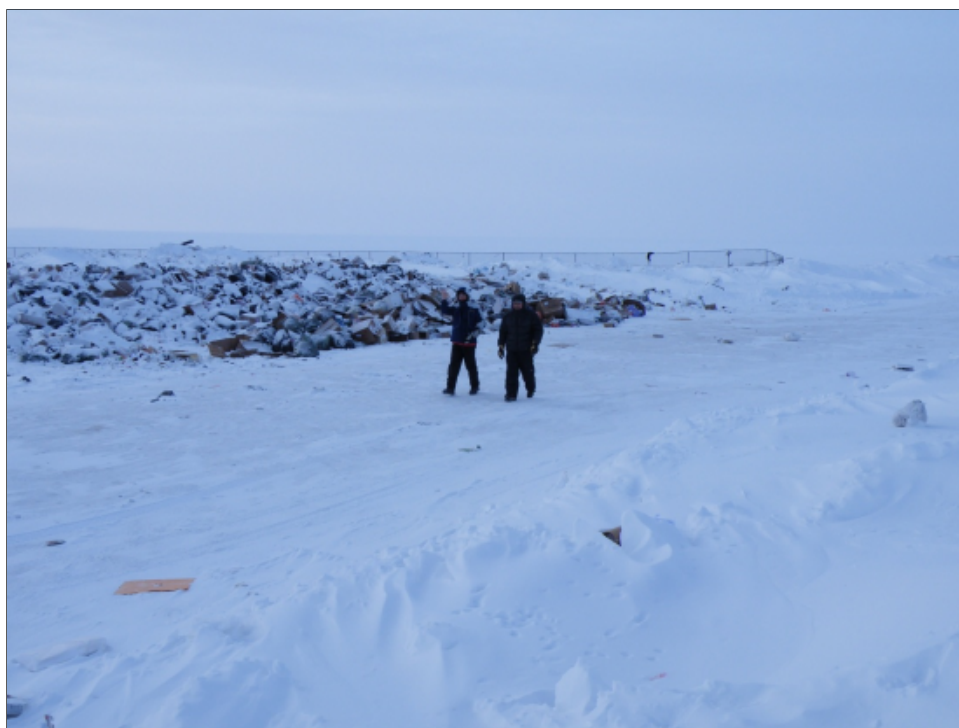
Photo 7: Active Solid Waste Disposal Area

The 2009 inspector's report identified the occurrence of sewage and landfill effluent mixing at the solid waste disposal site. Currently there is no segregation or proper containment of hazardous waste at the site. Furthermore, the solid waste disposal site is not designed to contain leachate onsite. The berm located at the down gradient corner of the site does not contain an impervious liner and therefore, leachate passes through the berm into the environment.

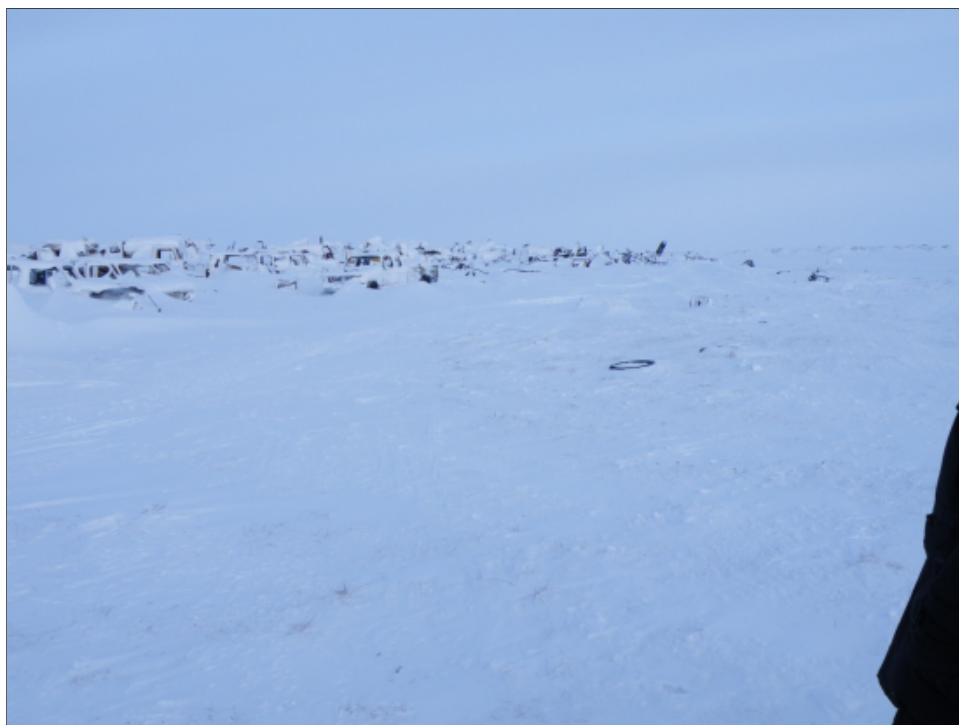
Photo 8: Bulky Metal Disposal Area

Beyond the fenced perimeter this is a substantial area where scrap metal has been disposed of in a generally un-managed fashion. Photograph 8 illustrates a portion of this area.
