Annual Report-2018

Water Licence: 3BM-GJO 1828

RE: 3BM-GJO 1828 (previous 3BM- GJO 1318)- Annual Report 2018, Gjoa Haven

AANDC Inspection Report- 2018

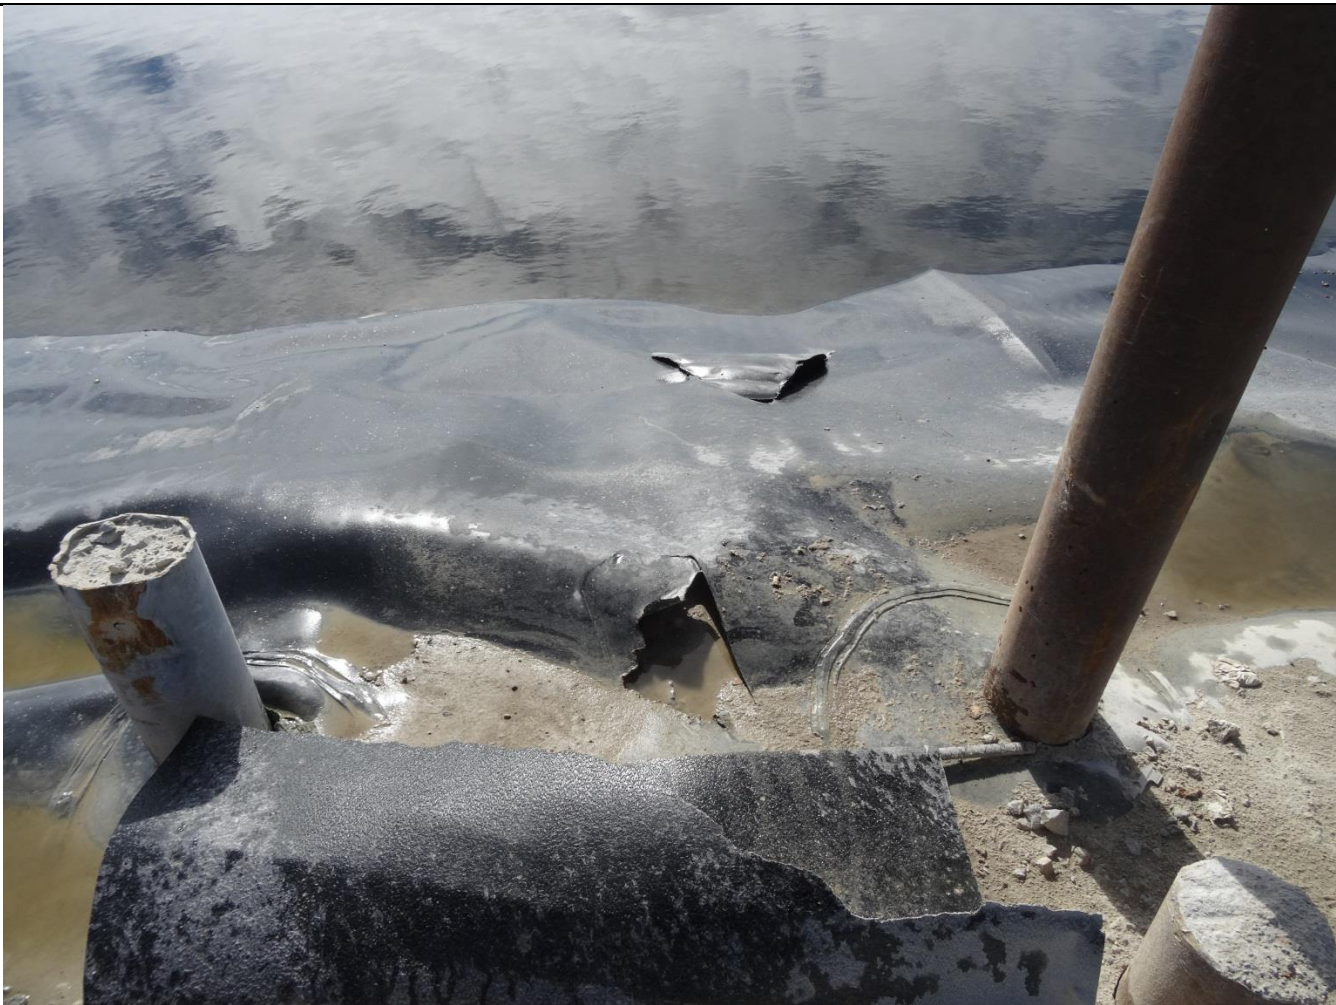
Photo 1

Description: Tear #1 and #2 in Sewage Lagoon Liner at Truck Dumping Location requiring Repair after Decanting – July 13th

- HDPE liner was repaired by placing a new liner piece on top of existing liner covering all the 4 spots as reported in AANDC inspection report. The new liner was welded along the perimeter with the existing liner and it covered all 4 spots and concern of any nearby area damage in future. Monitoring station GJO-4 moved to new location N 68° 36' 59.8" and W 95° 49' 48.1" as the best representation of Final station of effluent run-off towards the Ocean. GJO-2 moves to new location with GPS address: N 68° 37' 13.7" and W 95° 50' 23.2". Signage was installed at this station for sampling point and awareness information of run-off.

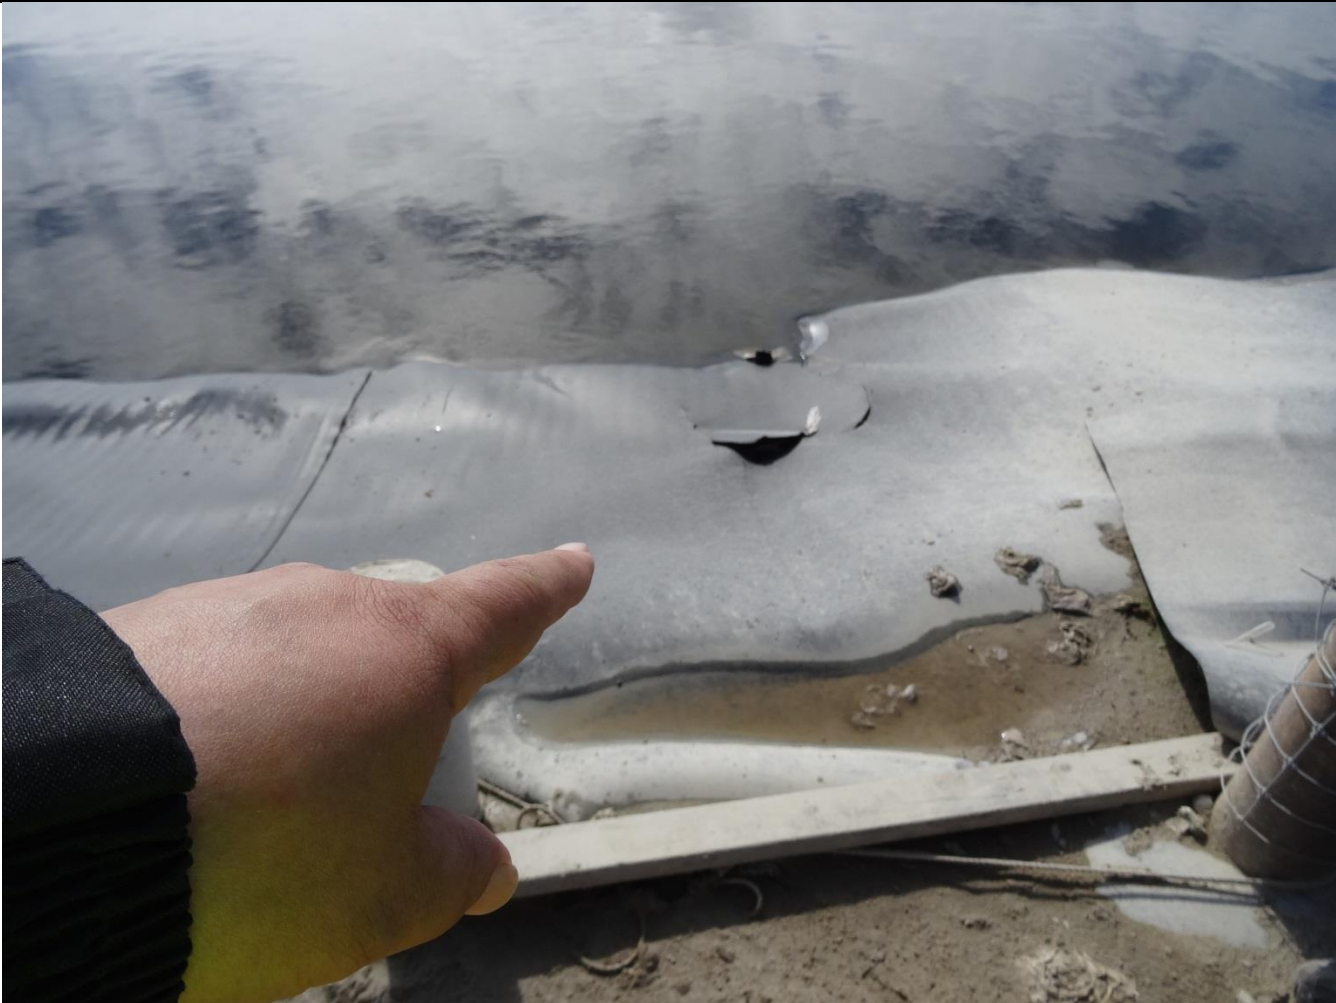
Photo 2

Description: Tear #3 and #4 in Sewage Lagoon Liner at Truck Dumping Location requiring Repair after Decanting – July 13th

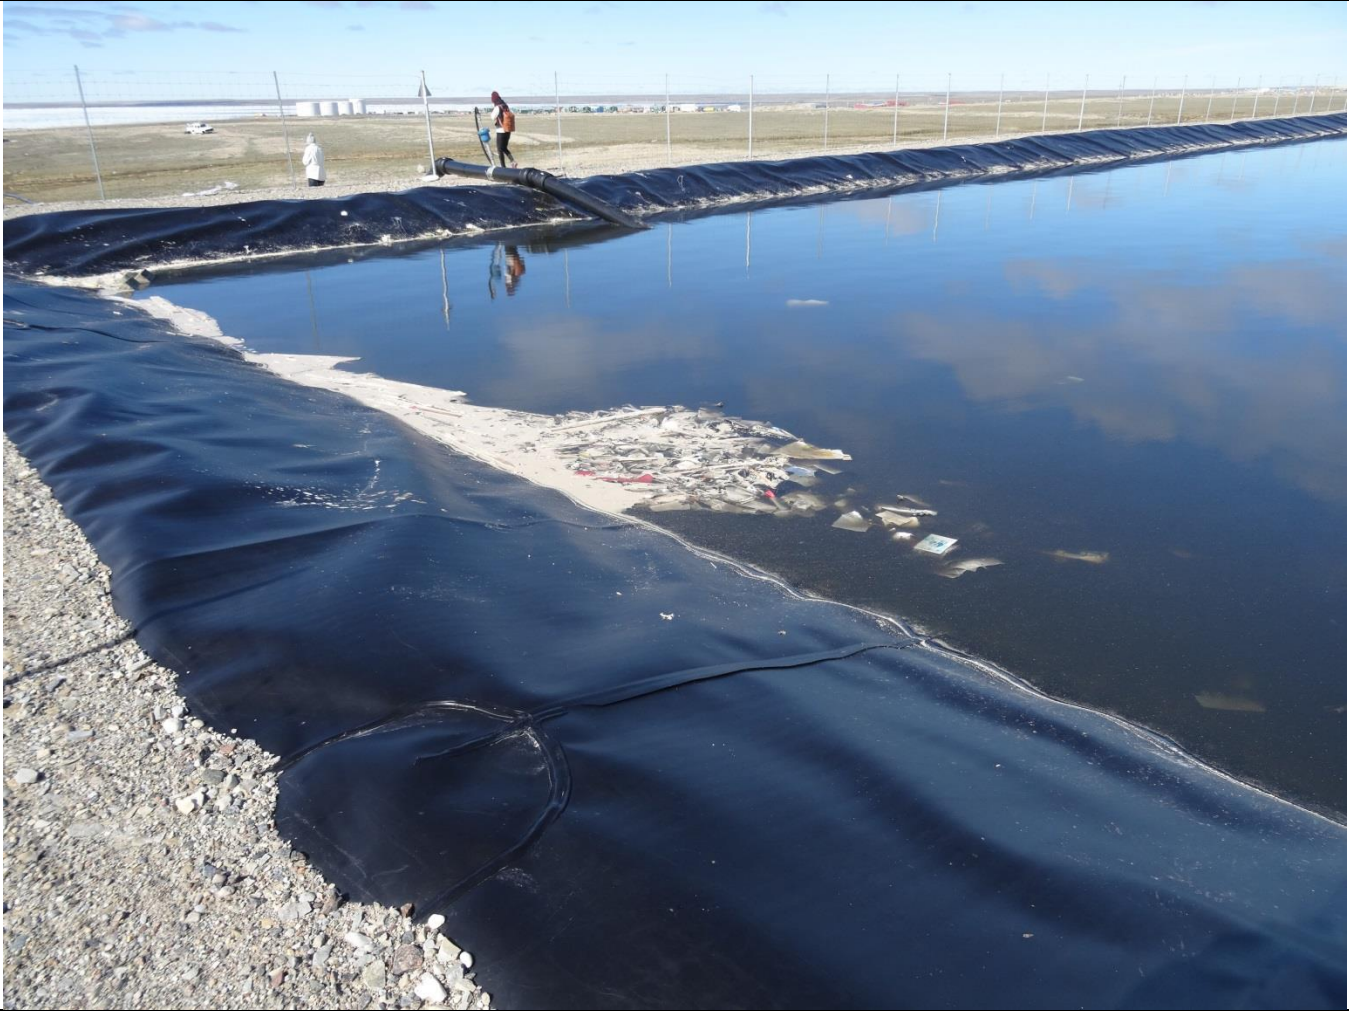
Photo 3

Description: Sewage Lagoon showing high level of Liquid Contents and Floating Debris – July 13th

- Lagoon water decanted using alternate mechanical pump but very slowly due to breakdown of the gate valve of original decanting structure. A new gate valve was purchased but installation can be next year as the season was over for such integration.

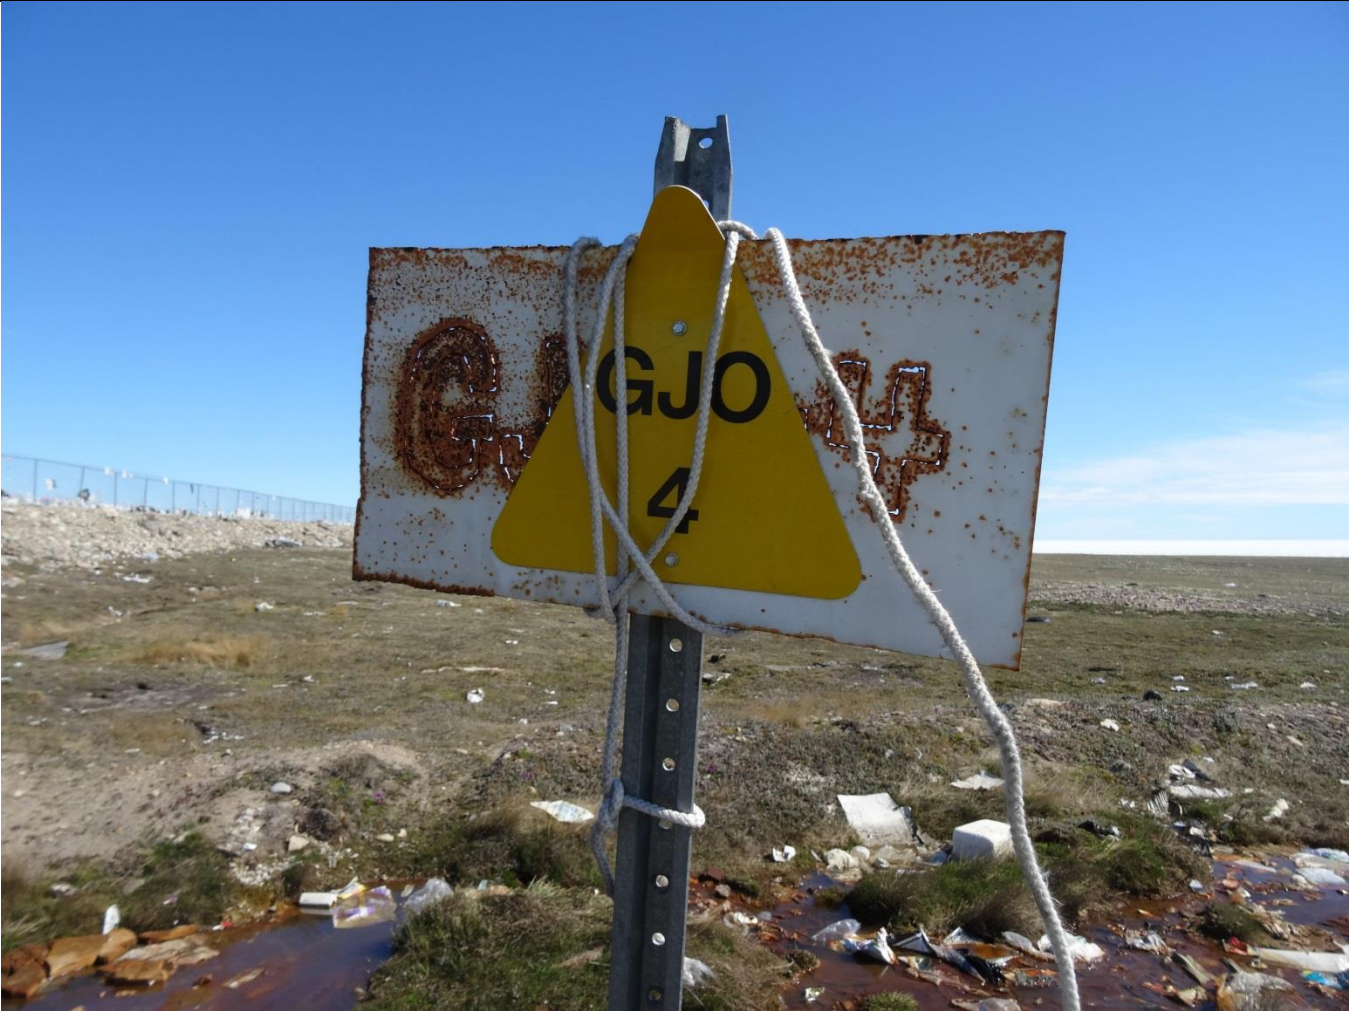
Photo 4

Description: Old Sample Station GJO-4 – Final Discharge – to be moved to new location to better reflect Final Discharge Criteria – July 13th

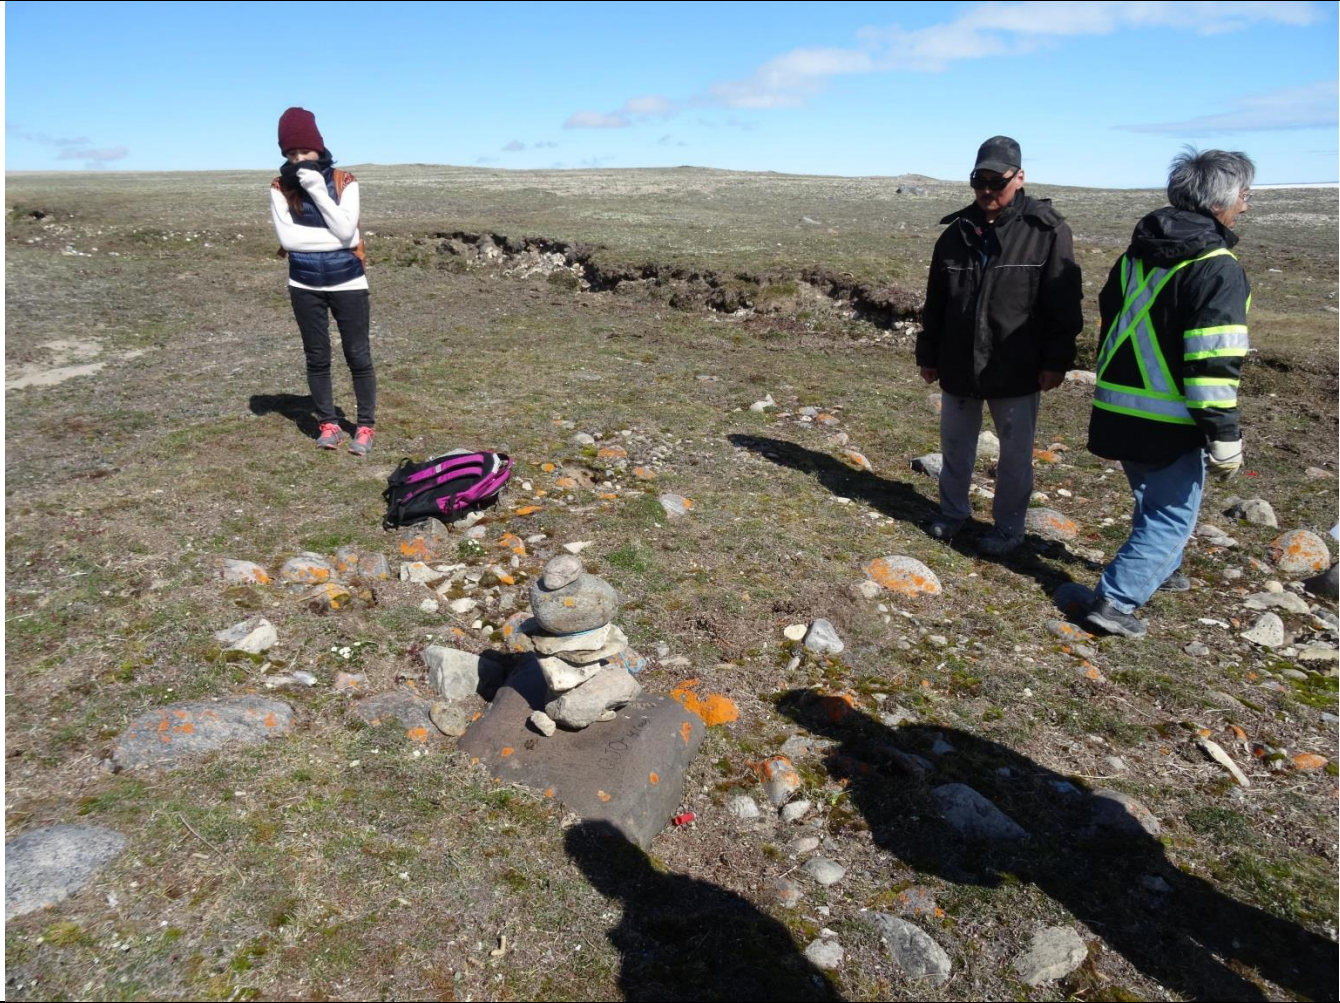
Photo 5

Description: New location of Sample Station GJO-4 to better reflect Final Discharge Criteria – July 13th

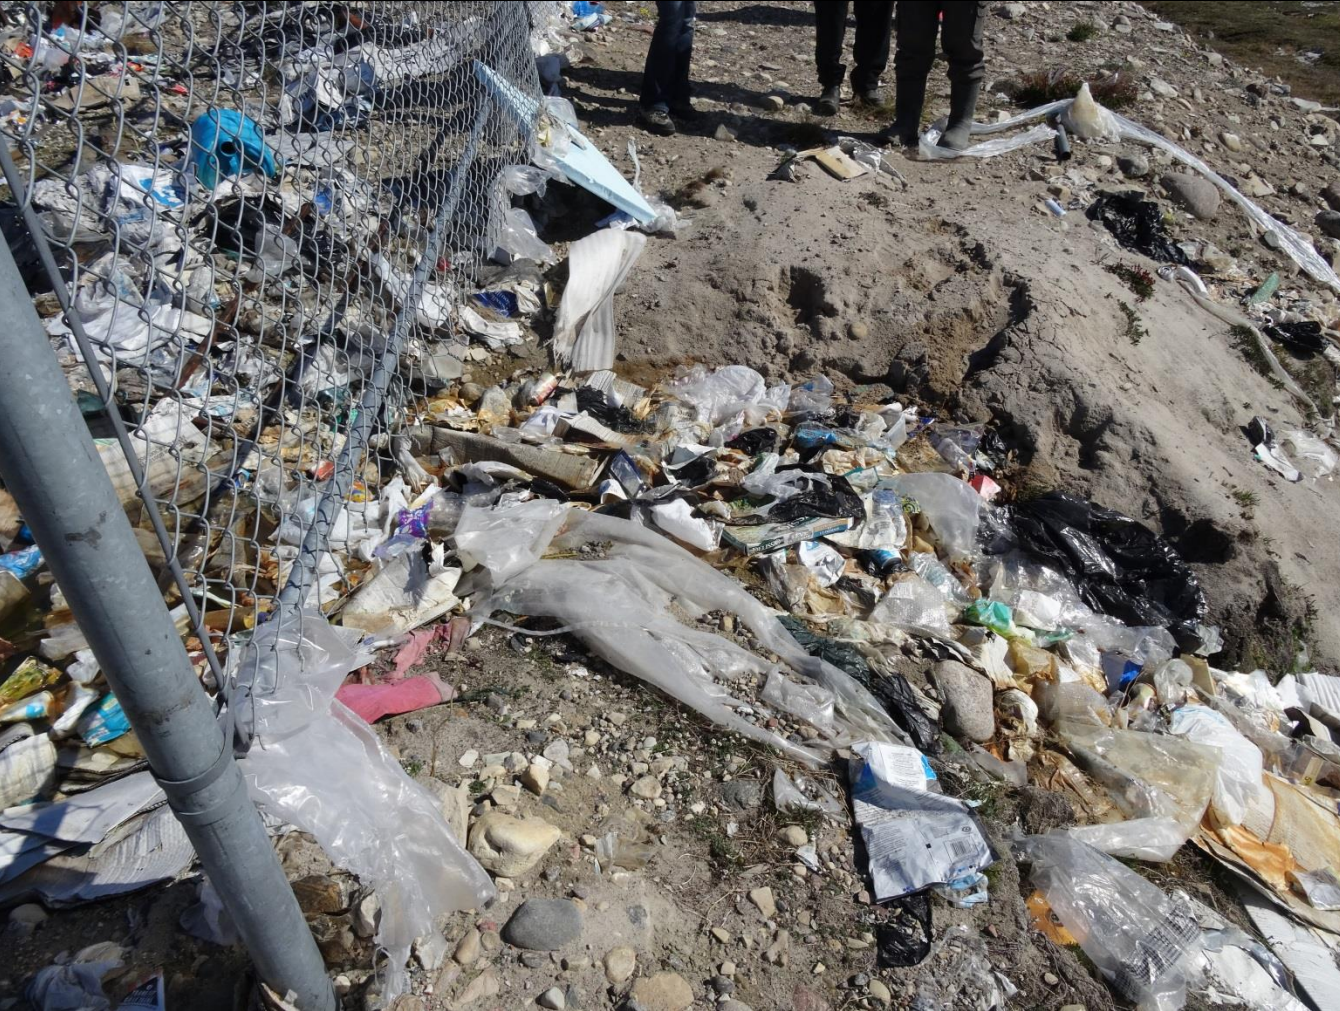
Photo 6

Description: View #1 of Breach in Dump Berm – Directed to Repair within 14 Days – July 13th

- Open areas at the solid waste berm was repaired as reported and with satisfaction of AANDC inspector in 14 days deadline.

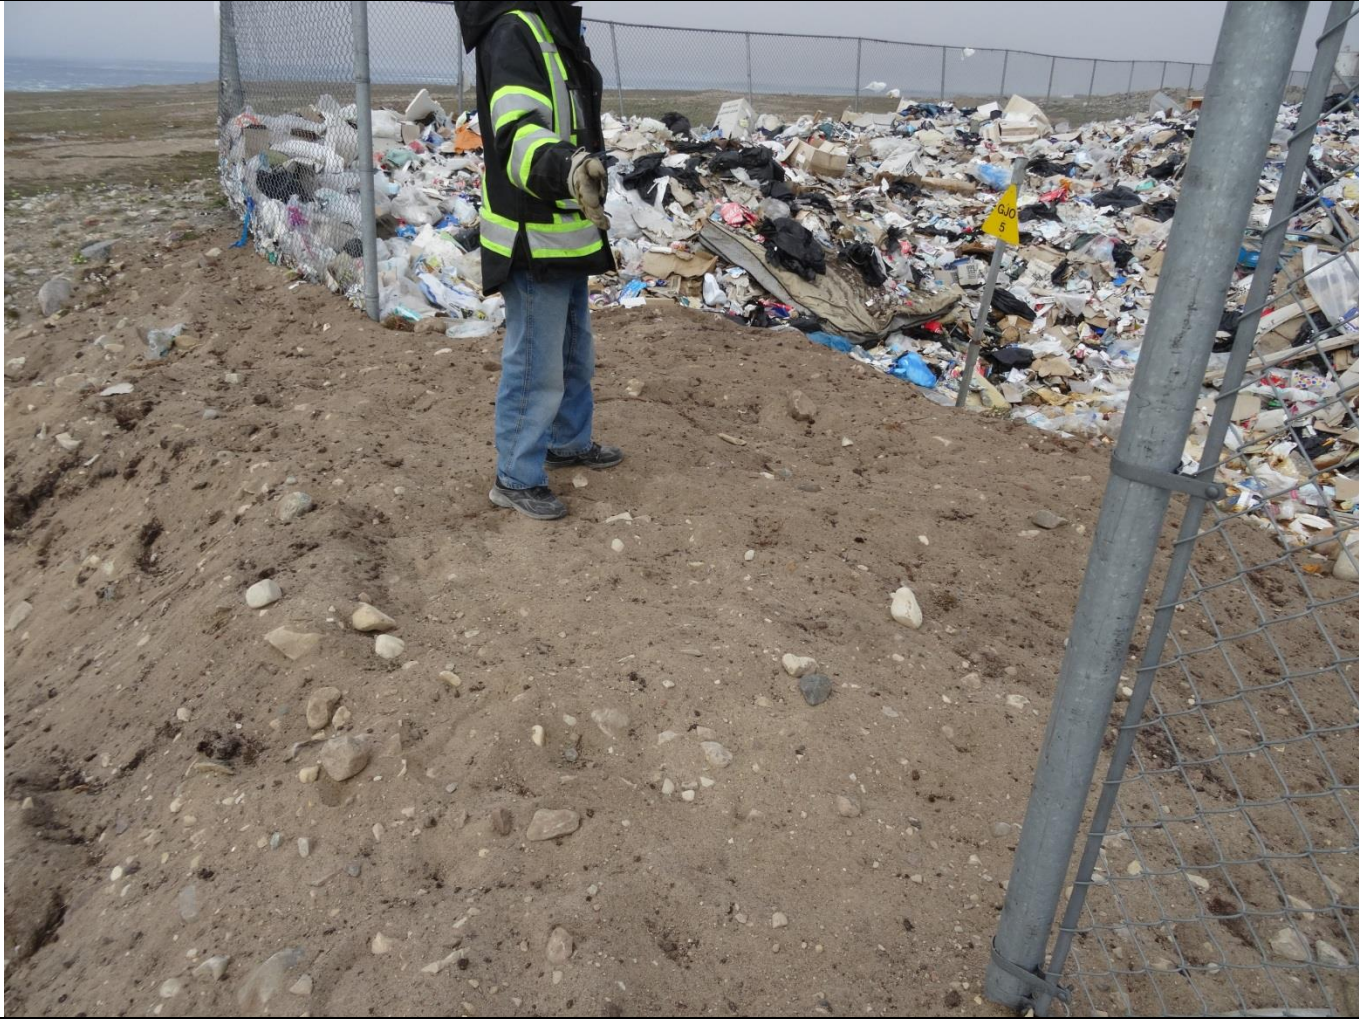
Photo 10

Description: View #2 of Repair to Breach in Dump Berm as Directed – July 27th – Very Nice Job – Thank You
