# **Annual Report 2020**

Water License: 3BM-GJO 1828

The Hamlet of Gjoa Haven has prepared this 2020 Annual Report to be submitted to the Nunavut Water Board (NWB) to meet requirements of the Water Licence 3BM-GJO 1828, Part B General Conditions. This report covers the period from January 01- December 31, 2020.

WATER LICENCE INSPECTION FORM

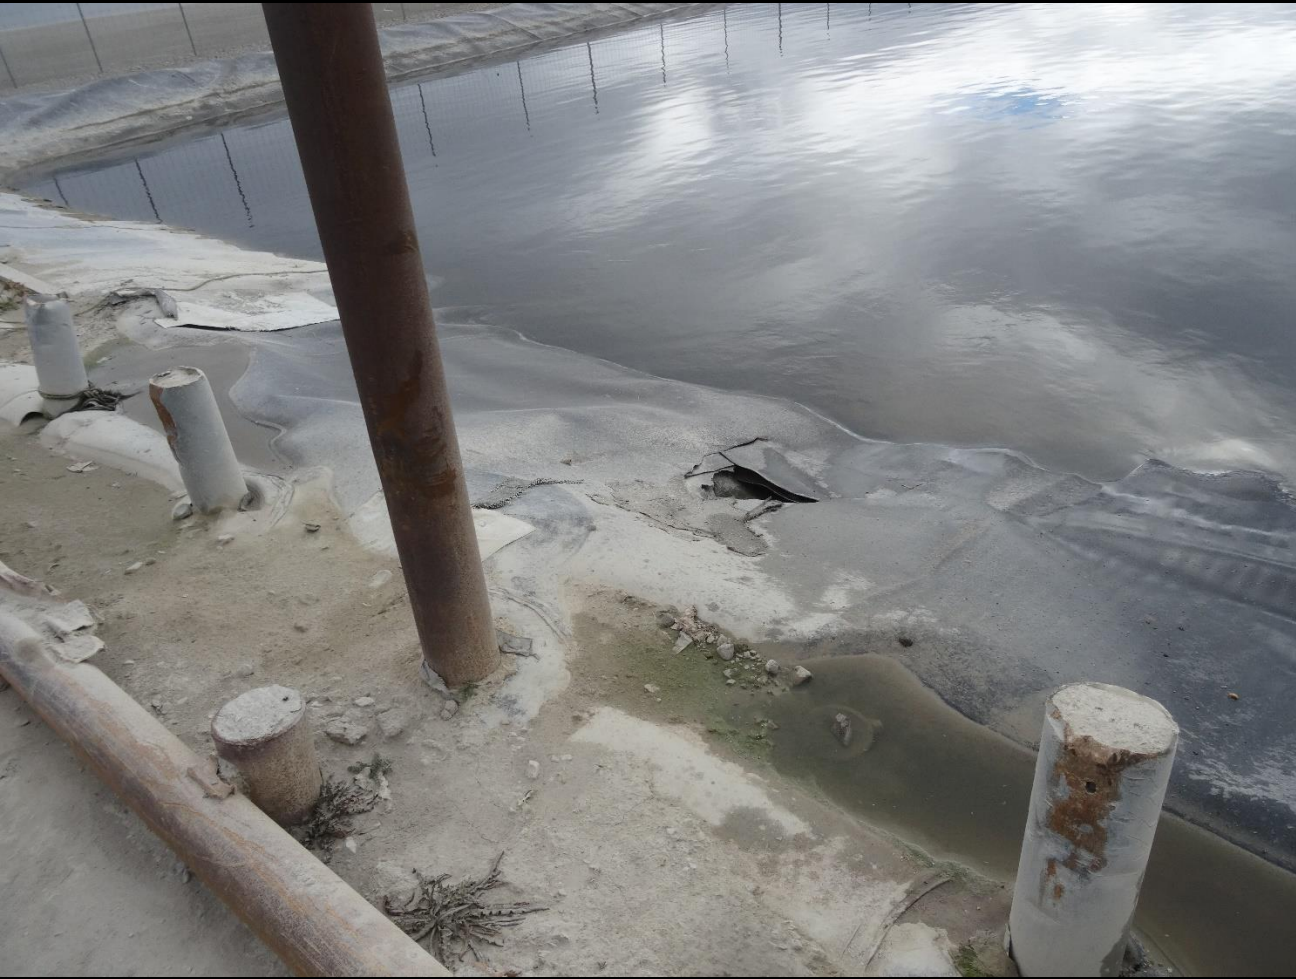
Description: Installation of GJO-1 Signage at Swan Lake Raw Water Intake location			
Photo Log # DSC06025			
Photo 2

Description: Hole in Sewage Lagoon Liner requiring Repair as at 2020 August 12

The ripped spots of HDPE liner at the sewage dropping pad were repaired by Hamlet operators as identified during the inspection on Aug 12, 2020.

- The hole in the lagoon berm liner is repaired.
- Lagoon effluent was decanted using the decanting structure after replacing the valve gate which failed two years back.
- Burning of loose materials helps in reduction of waste, but only can be carried based on the weather and airflow direction

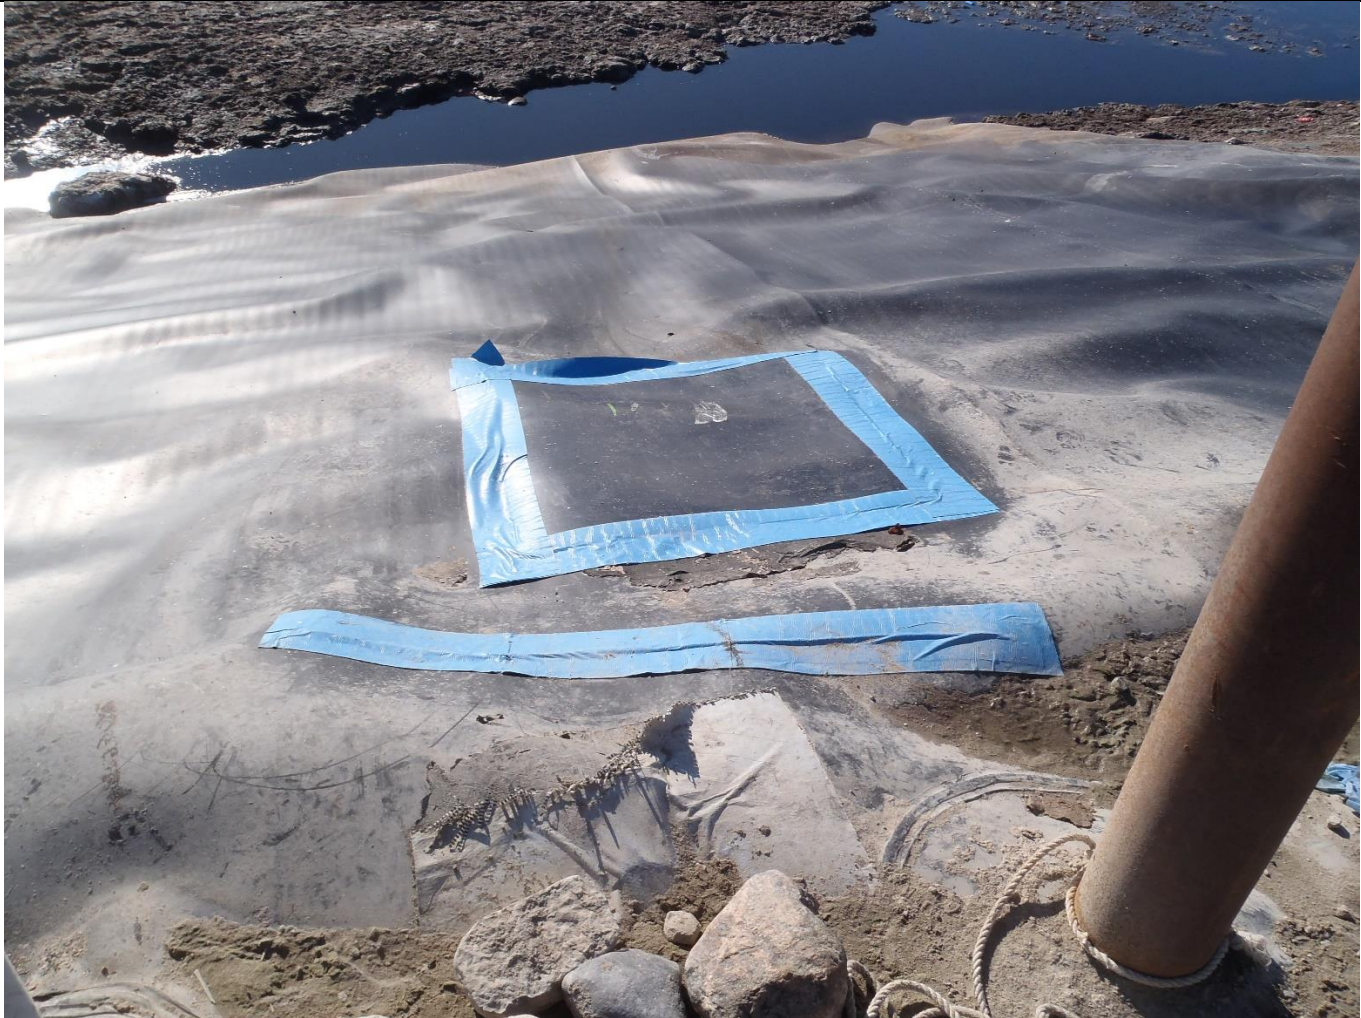
Photo 3

Description: Hole in Sewage Lagoon Liner AFTER REPAIR as at 2020 September 9

the required Repairs and submitted Photographic Proof to the Inspector on September 9, 2020. Thank you very much

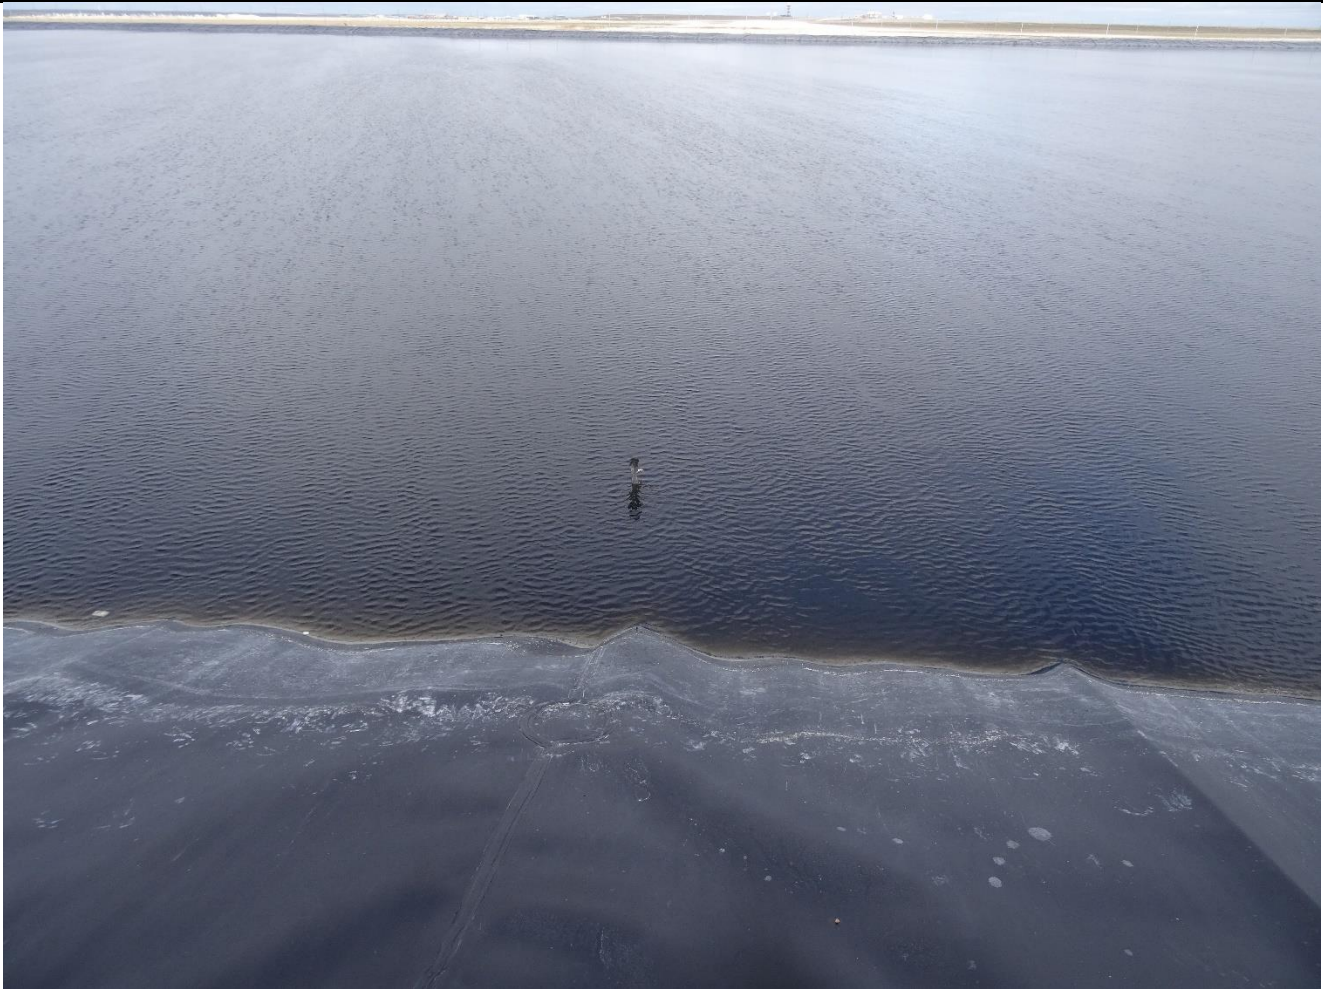
Photo 4

Description: Presumed Tear in South Side of Sewage Lagoon Liner to be verified/repared AFTER Decant Program is complete

3. The Licence Holder MUST check the presumed tear in the Sewage Lagoon Berm Liner on the South Side of the Sewage Lagoon AFTER the Decant Program is Complete and Repair as Required PRIOR to September 30, 2020

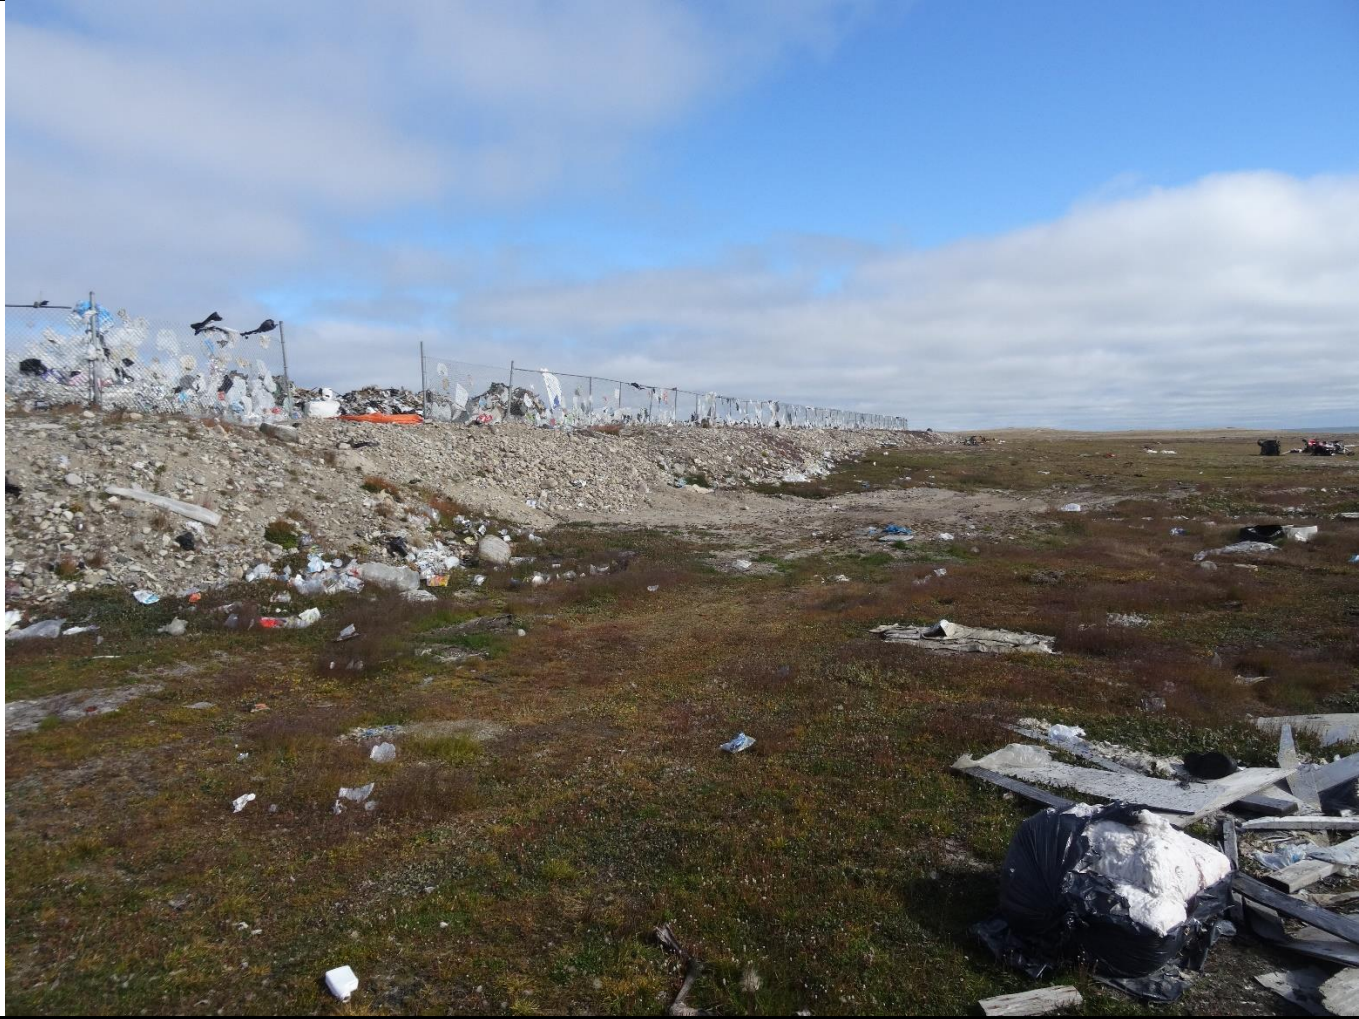
Photo 6

Description: Damaged Section of Fencing for the Garbage Dump beside Sample Station GJO-5 requiring Repair

6. The Licence Holder shall repair the Damaged Section of the Garbage Dump Fence beside Sample Station GJO-5 AND provide Photographic Proof to the Inspector PRIOR TO September 30, 2020

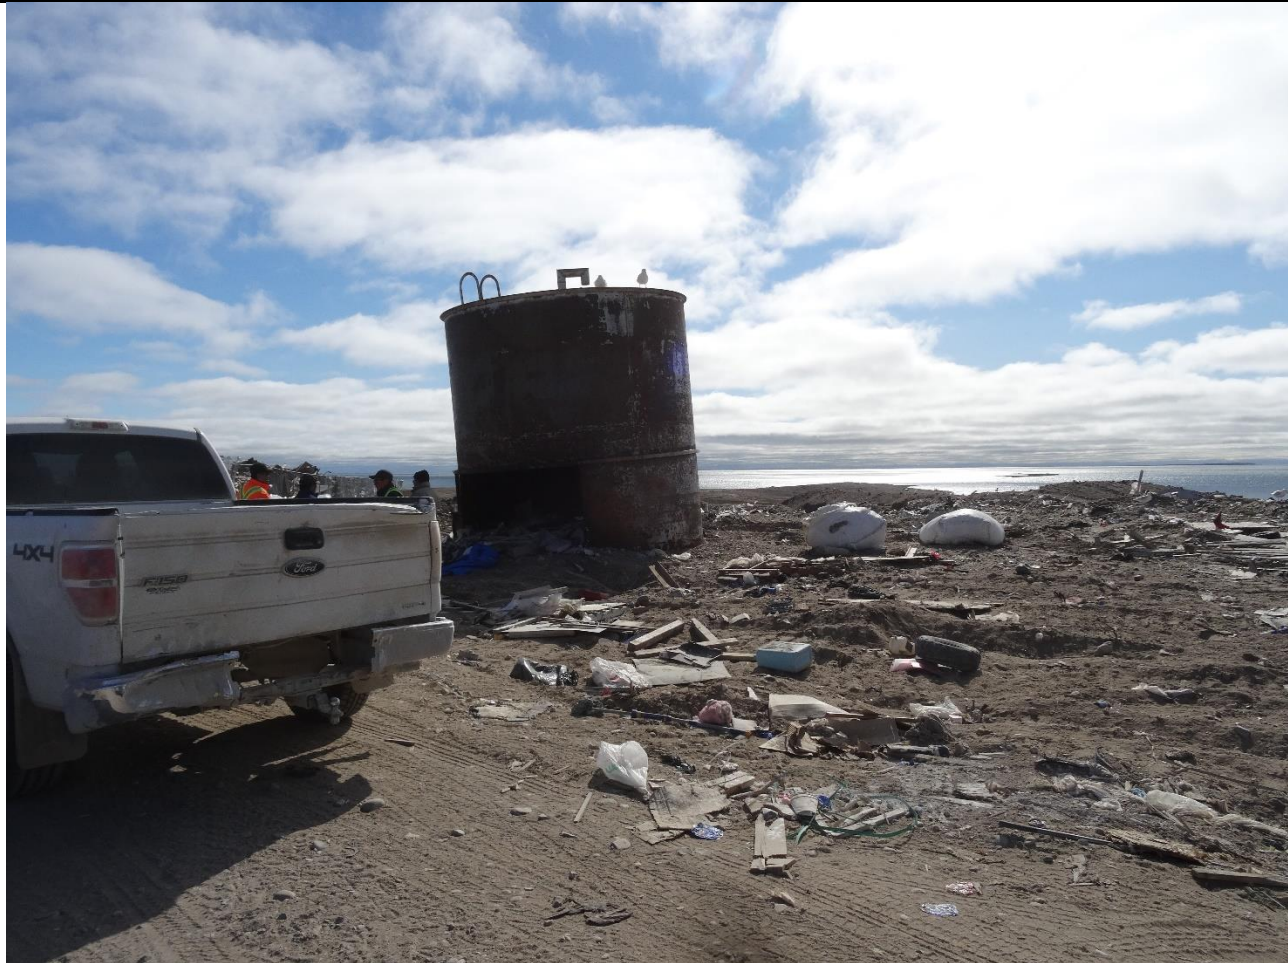
Photo 8

Description: Old Fuel Tank the Hamlet plans to modify and use as a Burn Box for Non Hazardous Materials

8. The Licence Holder shall move the old Fuel Tank within the Garbage Dump Fenced Perimeter to be used as a Burn Box for Non-Hazardous Materials
9. The Inspector witnessed the excellent job the Licence holder is doing with the Storage and Crating of Used Batteries. Thank you for this. The only recommendation the Inspector has to improve on this would be to store the Crated Batteries within a Sea Can

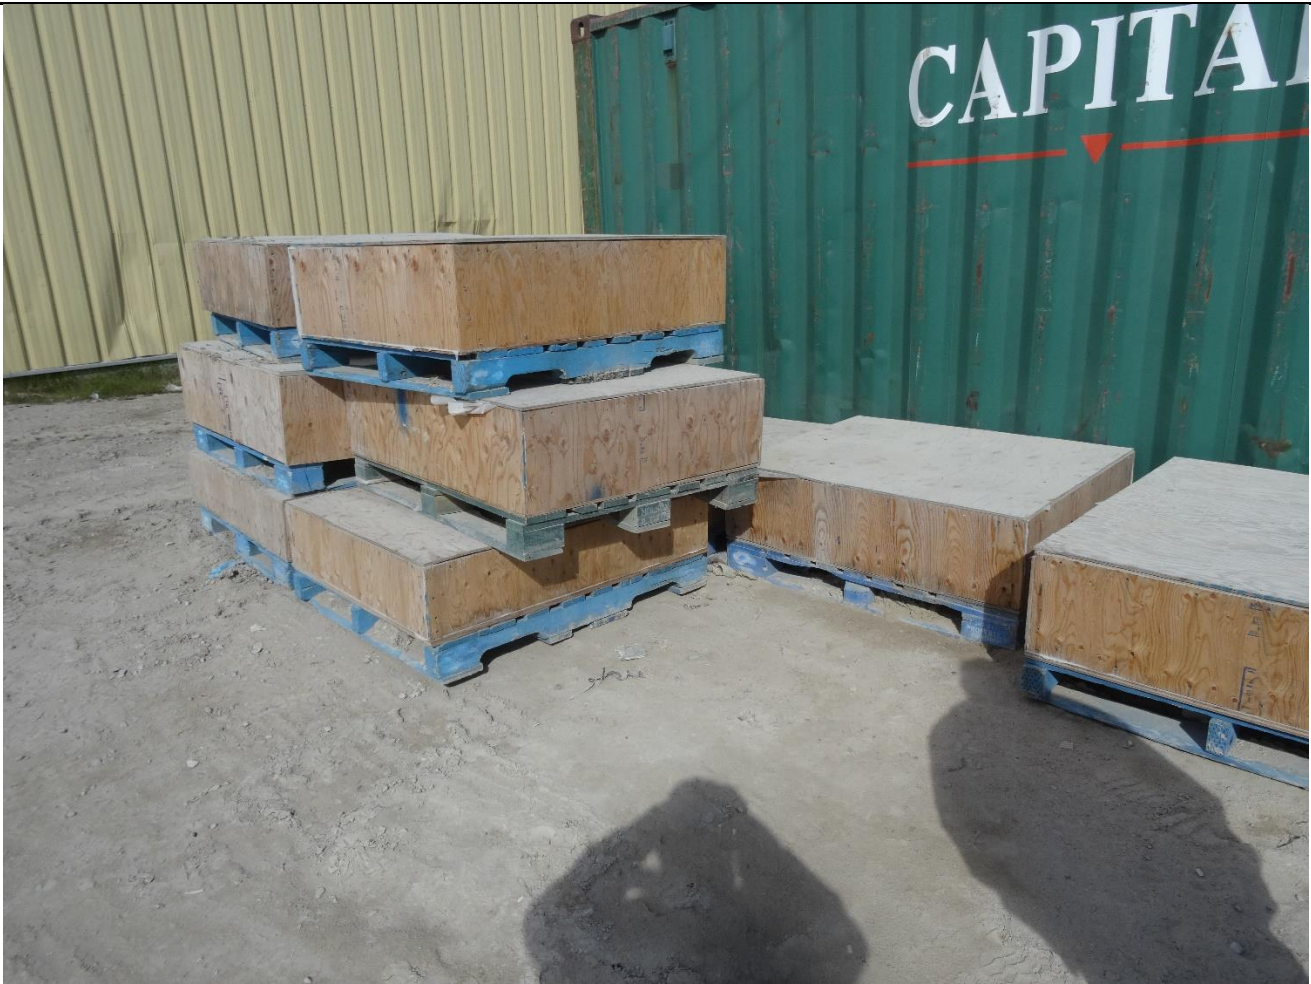
Photo 9

Description: Crates of Used Batteries waiting for shipment South for proper disposal – Very Nice Job, Thank You Very Much!

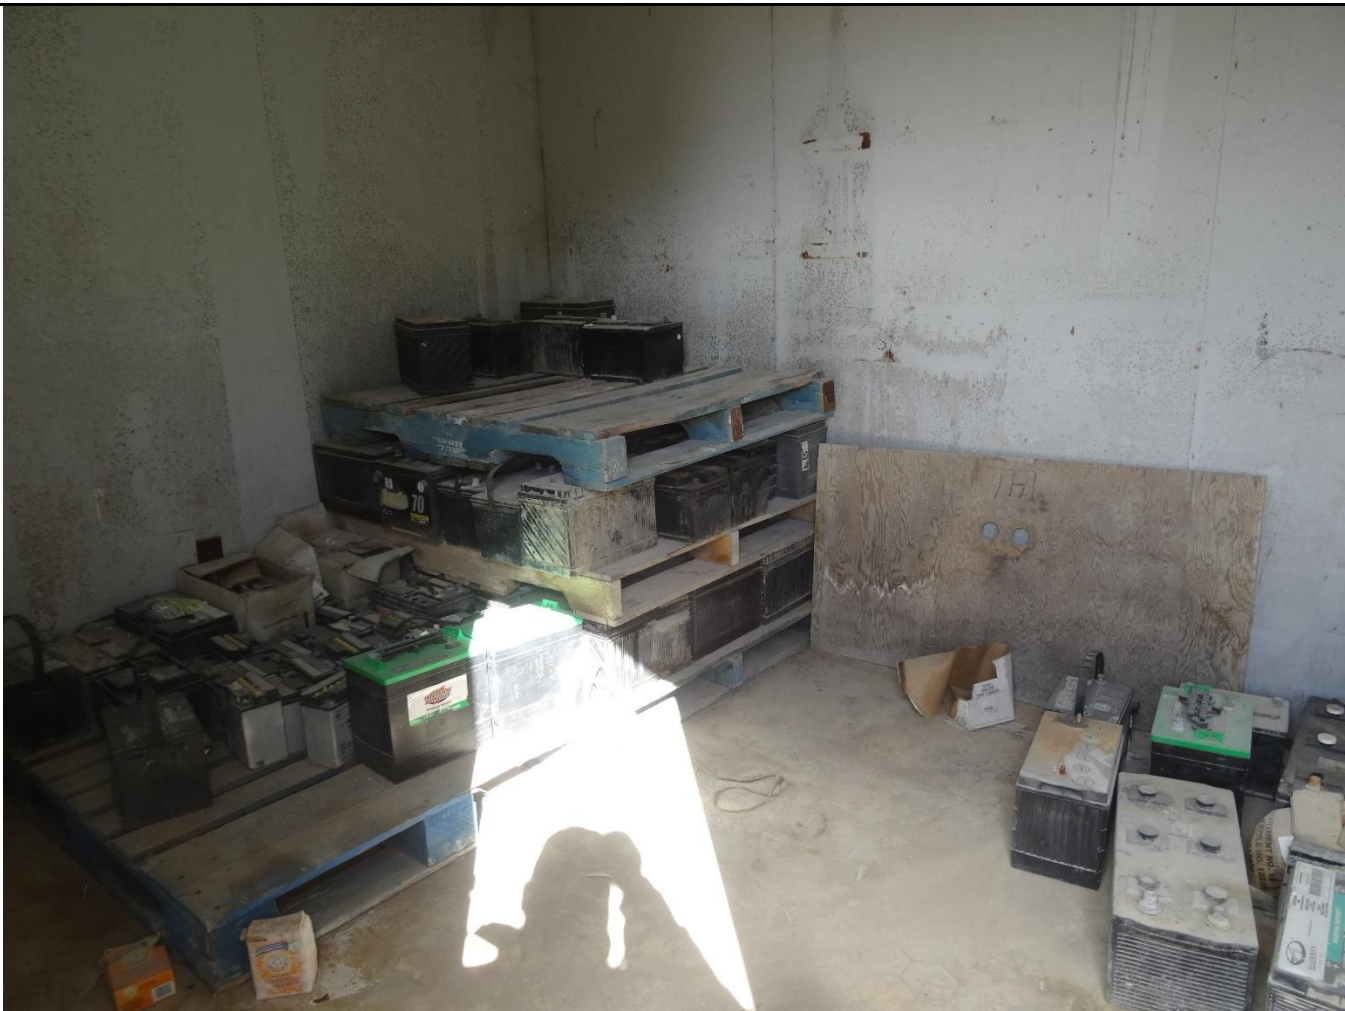
Photo 10

Description: Temporary Storage Area for Used Batteries waiting to be Crated Up – Very Nice, Thank You Very Much!
