# ANNUAL REPORT FOR THE MUNICIPALITY OF GJOA HAVEN

**YEAR BEING REPORTED: 2023**

The following information is compiled pursuant to the requirements of Part B, Item 1 of Water License No. 3BM-GJO1828 issued to the Municipality of Gjoa Haven.

### Appendix D: CIRNAC Inspection Report

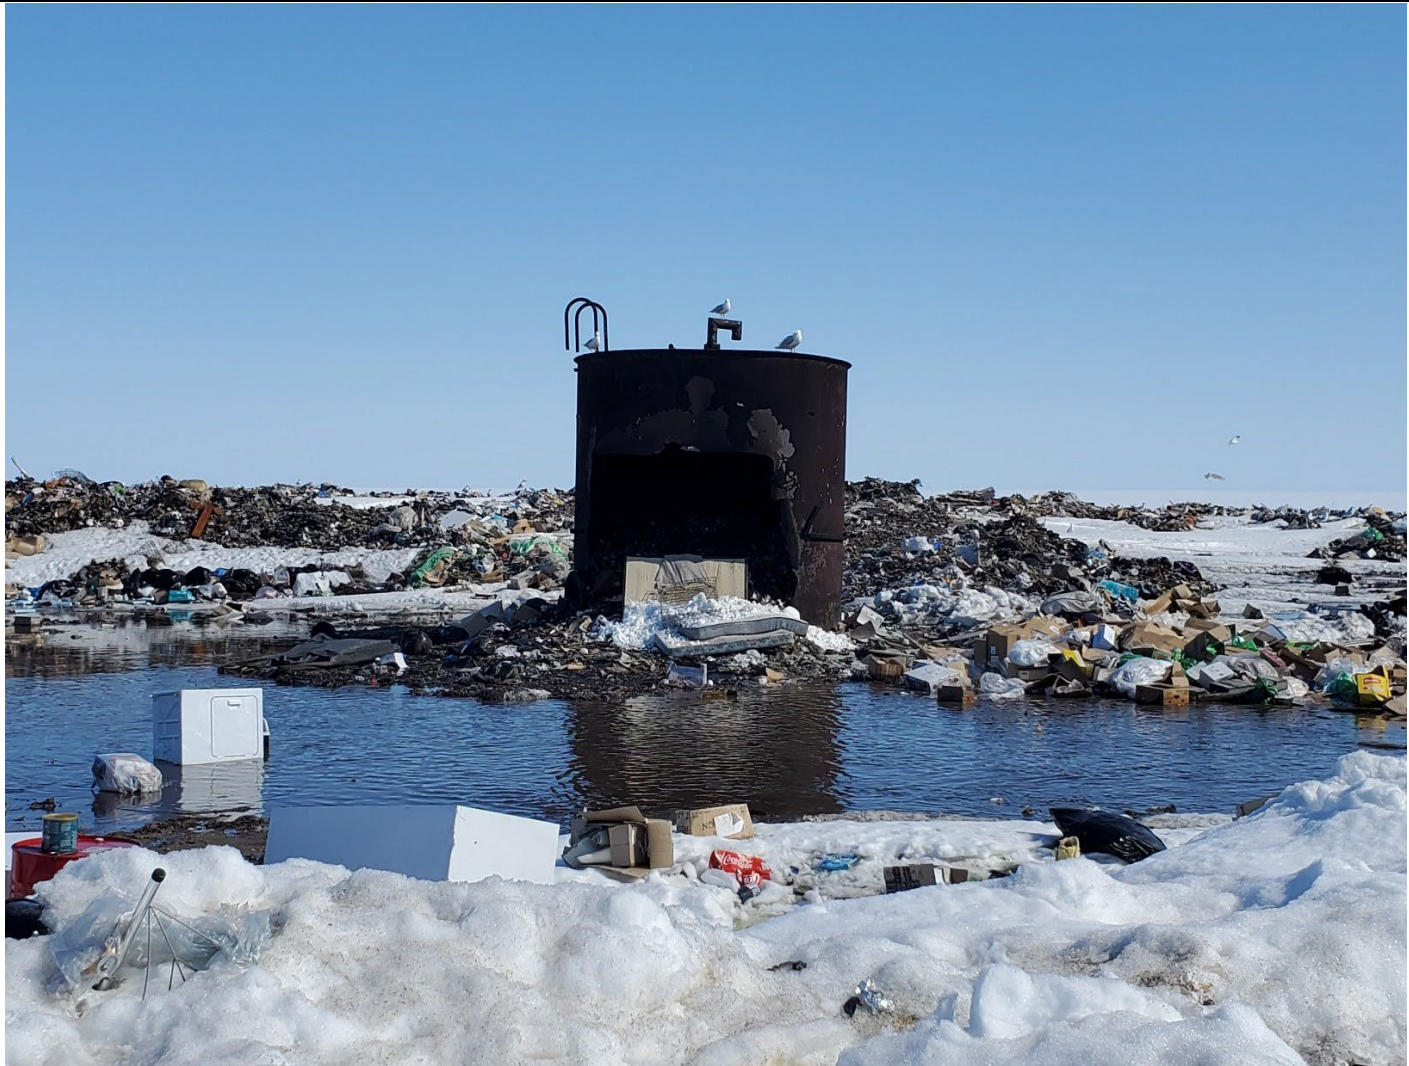
Date	Camera	Inspector	Authorization
	Sony Cyber-shot	J.Mesher	3BM-GJO
Photo Log			
Photo 1

Description: dump flooded with water.

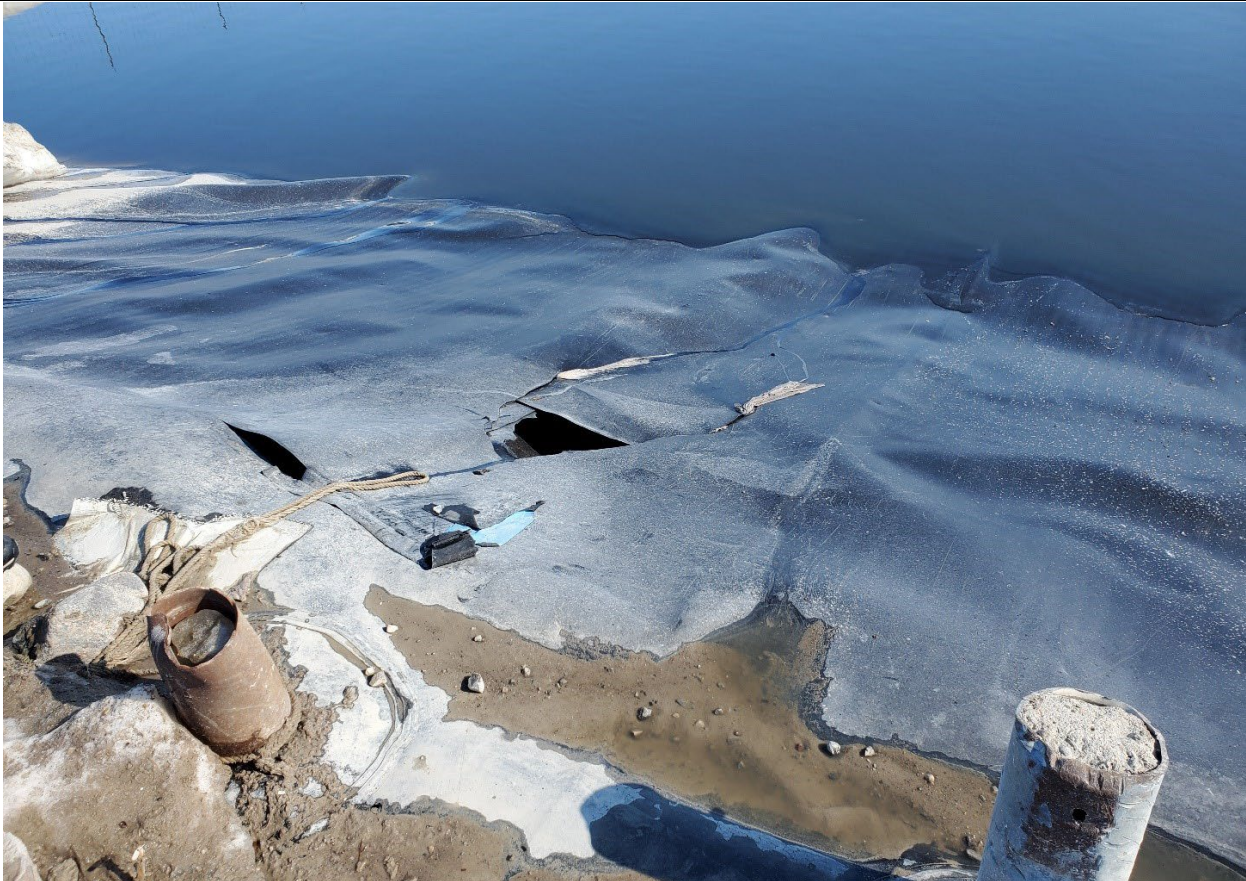
Date	Camera	Inspector	Authorization
	Sony Cyber-shot	J.Mesher	3BM-GJO
Photo Log			
Photo

Description: rip in liner.

- The tear in the lagoon liner is to be repaired upon thaw in 2024. Freeze up in 2023 occurred prior to Municipal procurement of resources required to complete the repair.
- As per the 2023 CIRNAC inspection, the licensee is to provide an as-built drawing, boundaries, storage locations for various types of waste at the landfill and ensure the wastes are stored in an approved manner. The current site is a non-engineered landfill therefore there are no as-built drawings. The Solid Waste Improvement planning project report will be included with the 2024 Annual Report. When the site improvements are completed as-builts and an updated O&M manual will be submitted.
- The fence was repaired to contain windblown litter. The improved Solid Waste Site will include reinforced fencing.
- The improved Solid Waste site will include proper storage of hazardous waste.

A. The licensee is to repair the lagoon liner to ensure the waste water is properly contained.			
B. The licensee is to provide an as-built drawing, boundaries, storage locations for the various types of waste at the landfill and ensure the wastes are stored in an approved manner.

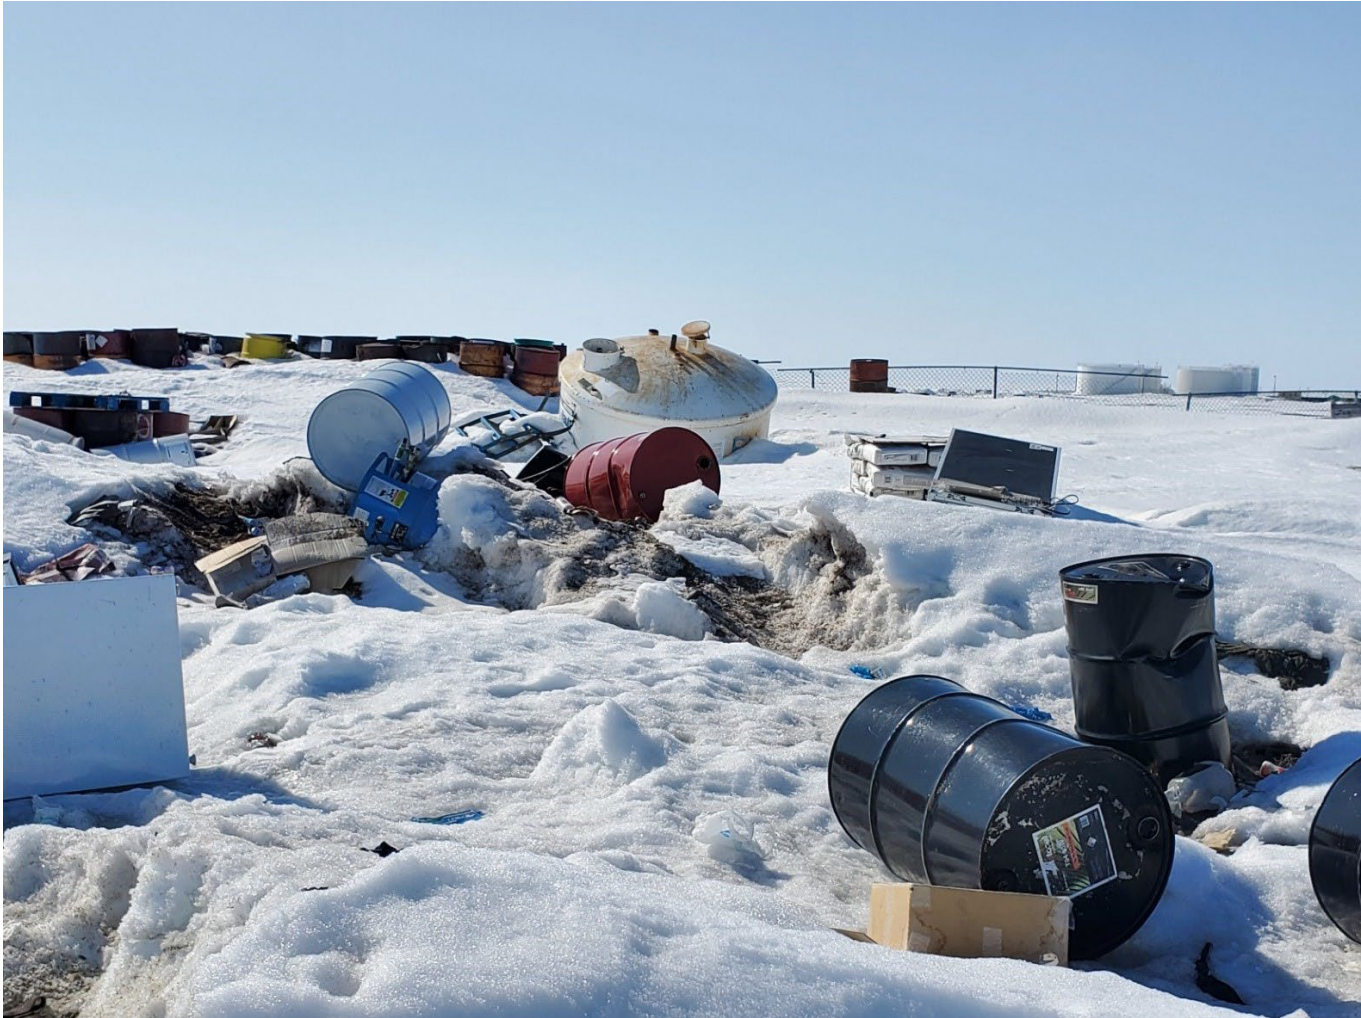
Photo 4

Description: potentially hazardous waste does not appear to be properly contained.

C. The licensee is to repair the fence to contain the windblown litter.			
D. The licensee is to ensure the hazardous waste at the landfill is stored in a way approved by the Nunavut Water Board.

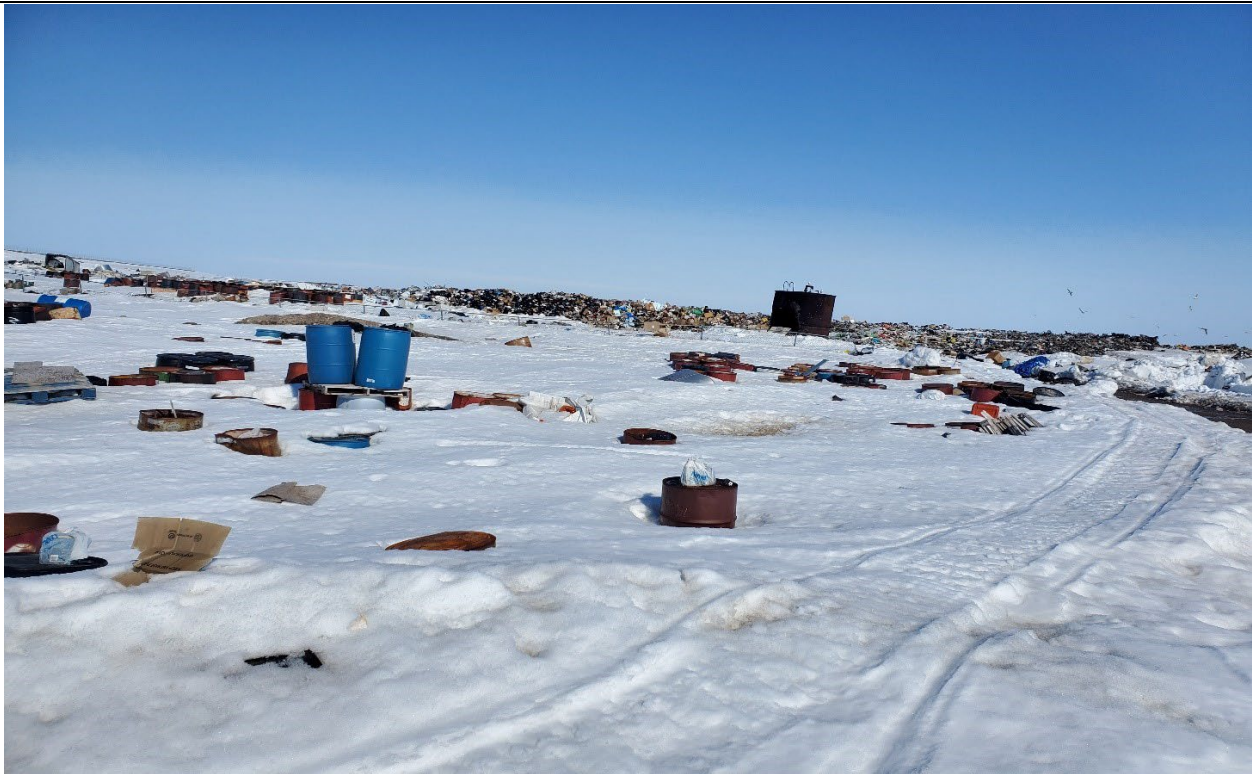
Photo 5

Description: scattered barrels of potentially hazardous waste.
