ANNUAL REPORT FOR THE MUNICIPALITY OF GJOA HAVEN

YEAR BEING REPORTED: 2024

The following information is compiled pursuant to the requirements of Part B, Item 1 of Water License No. 3BM-GJO1828 issued to the Municipality of Gjoa Haven.

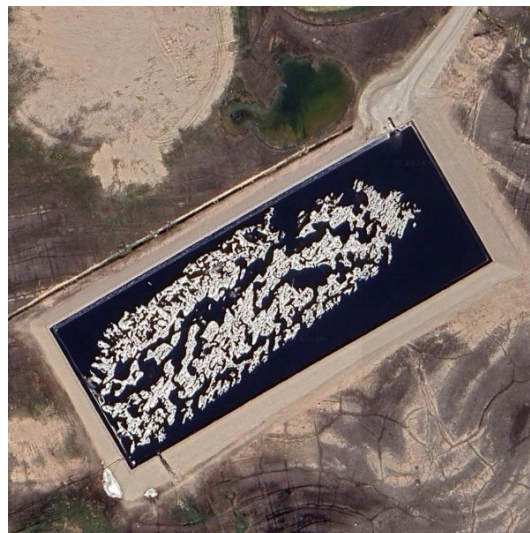
Figure 1: Gjoa Haven Sewage Lagoon

The Hamlet of Gjoa Haven's sewage lagoon consists of a single cell sewage lagoon which holds raw sewage for approximately 10 months before discharge into the designated wetland. Figure 1 shows a picture of the sewage lagoon.

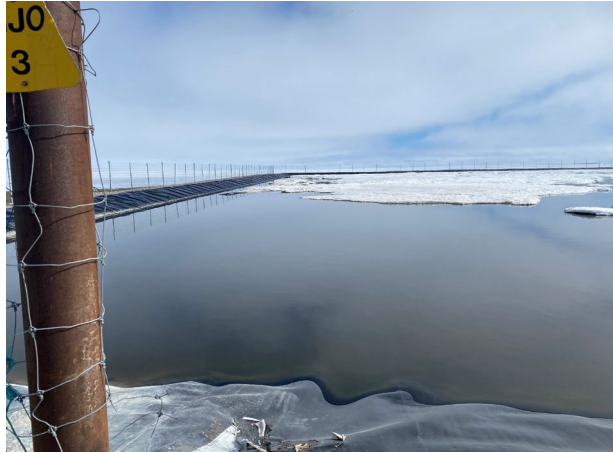
Figure 2a: Gjoa Haven Lagoon Levels, June 2024

Additionally, the sewage lagoon in Gjoa Haven has a tear in the liner resulting from an incident reported March 12 2024 where a vehicle drove into the lagoon. At that time, damage was not identified due to snow cover. There still are no signs of leakage nor damage to the structural integrity of the lagoon. To identify any potential further damage and for the Hamlet to repair the liner within the short time frame of the summer months, the lagoon requires decanting. Figures 2a,2b,3a, and 3b show the lagoon levels and the tear in the sewage lagoon liner as documented early June 2024.

The sewage lagoon is an impermeable lagoon utilizing a gravity fed decant during the ice-free summer period to the nearby wetland. To maintain the 1.0 m freeboard, decant is required and to begin on June 27, 2024. Effluent will be directed to the designated wetland where it would normally be discharged during the summer.
