Gjoa Haven, NU Sewage Lagoon – Abandonment and Reclamation Plan

July 18, 2014

Abandonment and Reclamation Plan Hamlet of Gjoa Haven, NU 11-5029

Dillon Consulting Limited

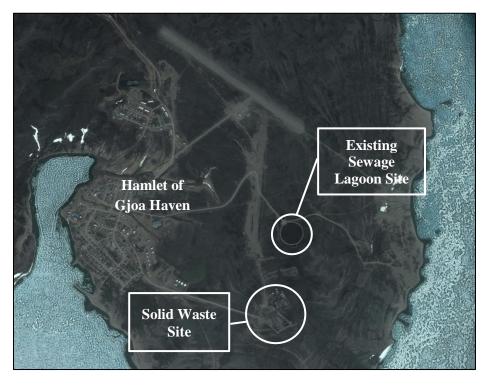
Figure 1: Gjoa Haven Sewage Lagoon Site Location

The former sewage lagoon is located 1.5 km from the community and has an approximate volume of 22,700 m³ of sewage. Sewage is collected from the community by a sewage truck and discharged into the single-cell sewage lagoon. It is a circular shaped lagoon with a truck turnaround pad and decant structure. **Figure 1** shows the location of the existing site in relation to the community.

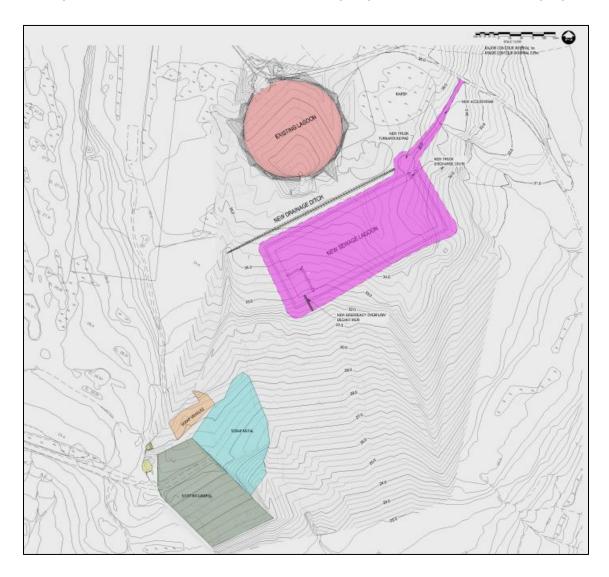
Figure 2: Site Plan of Existing Sewage Lagoon and New Sewage Lagoon

The hamlet plans to discontinue use of this site in the fall of 2013 once the new sewage lagoon has been commissioned. The new sewage lagoon has been constructed adjacent to the former sewage treatment site. The figure below shows the location of the new sewage lagoon in relation to the existing lagoon.

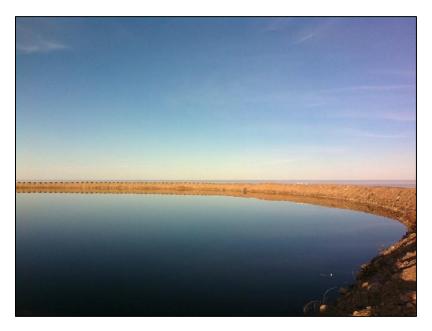
Photo 1: Existing Sewage Treatment Lagoon

The following photos were taken during a site visit in July of 2011. Photo 1 shows the existing sewage treatment lagoon. Photo 2 shows the 1.2 km path through the un-engineered wetland to the eventual discharge into the ocean and Photo 3 shows the outflow pipe for the existing sewage treatment lagoon.

Recently the sewage lagoon in Gjoa Haven has experienced a number of problems relating to the stability of the berm wall surrounding the lagoon. The first report of berm instability was in July 2004 when it was noted that raw sewage was being discharged from the lagoon each time a sewage truck disposed of its cargo. In September 2005, the berm walls were reinforced and built back up in order to stop the flow of the raw sewage from the lagoon. However, an inspection in September 2006 revealed that a section of the berm wall had collapsed and a continuous stream of raw sewage was being discharged into the surrounding wetland area. A smaller secondary containment berm was constructed in 2008 to hold

effluent that had leaked out of the lagoon. However, a section of the secondary containment berm has subsequently failed and effluent is seeping from the secondary cell into the surrounding environment.

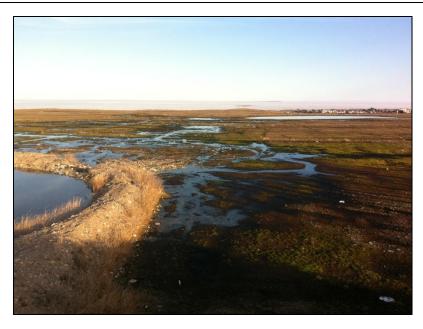
Photo 2: Un-Engineered Wetlands where Effluent is Discharged

Due to the collapse in the berm wall, sewage now flows from the lagoon along a 1.2 km path through a natural wetland. Discharge from the wetland percolates into the sandy soil matrix before it reaches the ocean edge eliminating a direct discharge route from the wetland into the ocean. A decant pipe was placed within the berm wall to allow for drainage of the effluent into the surrounding wetland. The lagoon relies on seepage through the berm wall as opposed to an annual decant event.
