## **Gjoa Haven, NU Sewage Lagoon – Abandonment and Reclamation Plan**

**- Updated Fall 2014 -**

Abandonment and Reclamation Plan

Hamlet of Gjoa Haven, NU

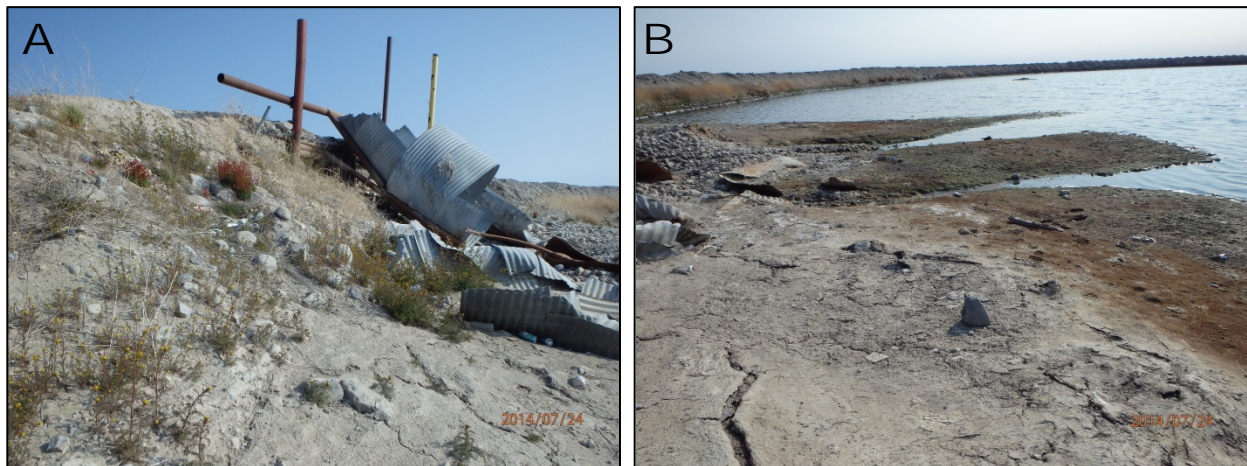
The following photos were taken during a site visit in July of 2014, representing the state of the former lagoon after eight months of inactivity. **Photo 1a** and **1b** show the former sewage treatment lagoon from the inlet. **Photo 2a** shows the outflow pipe within the berm, and **2b** shows the secondary containment cell. **Photo 3a** and **3b** show the low-laying area adjacent to the secondary containment cell where effluent was allowed to decant through an alternate wetland path. **Photo 4** shows the 1.2 km path through the un-engineered wetland to the eventual discharge into the ocean from the intended decant point in the berm.

**Photo 1: a – Former lagoon truck offload chute, b – View of Former Lagoon from inlet**

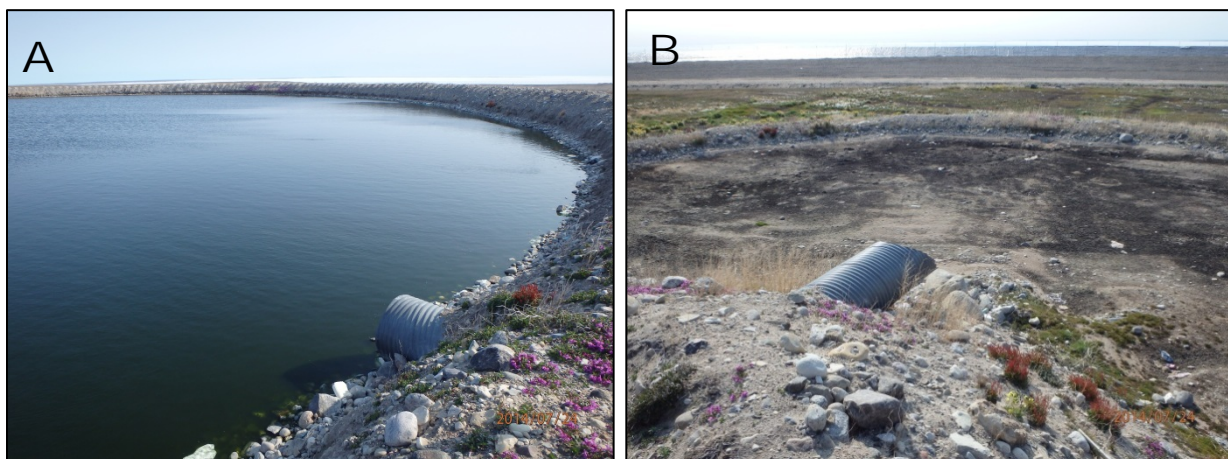
**Photo 2: a – Former lagoon outflow pipe, b – Secondary containment cell**

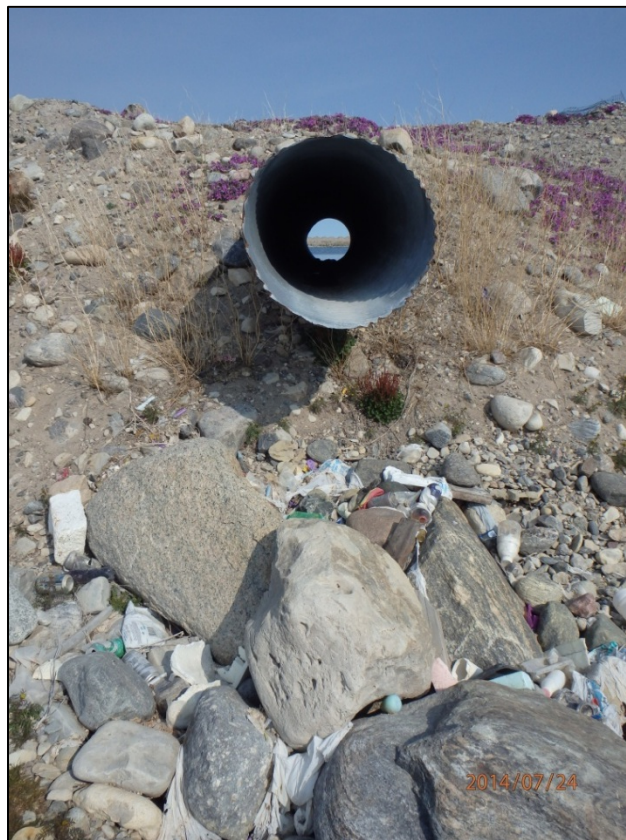
The former lagoon has an estimated capacity of 22,700 m<sup>3</sup>. The current volume of sludge and effluent in the former lagoon is unknown due to continuous seepage from the lagoon. At the time of a summer 2014 site visit (prior to discharge), the freeboard was approximately 0.5 m below the base of the berm on the north end (**Photo 5a**). The liquid effluent level was approximately 0.15 m below the outflow pipe on the south end of the lagoon. **Photo 5b** shows the outflow pipe into the secondary containment cell. The base of the outflow pipe measures approximately 0.65 m above ground level in the secondary containment cell (**Photo 6**).

**Photo 6: Outflow pipe to secondary containment berm**

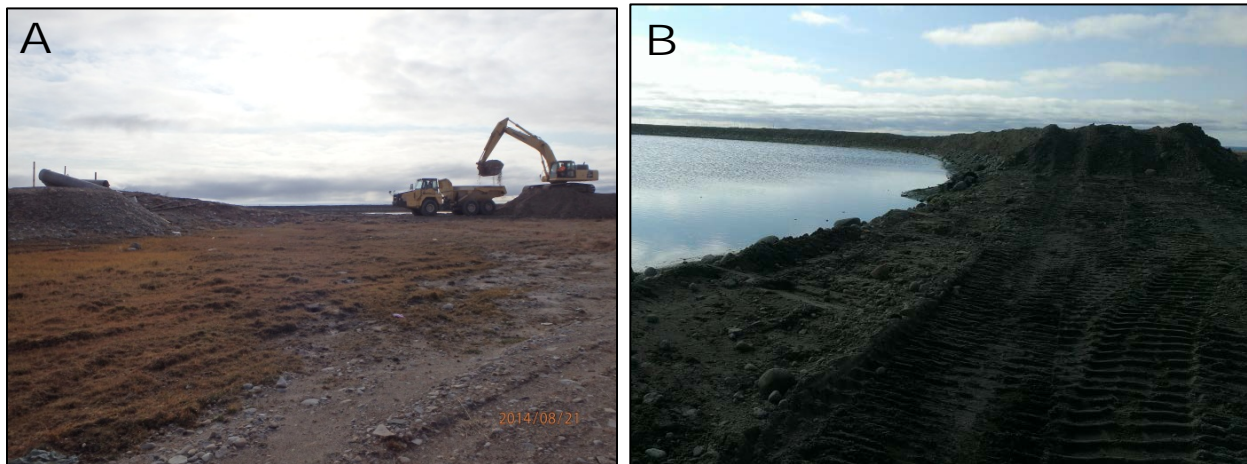
In August 2014, discharge of the lagoon effluent was commenced along with relocation of the berm material for the planned truck turn-around pad expansion and localized road improvements within the sewage treatment site (**Photo 7 & Photo 8**). Approximately 850 m<sup>3</sup> of sandy gravel material was relocated from the site for the turnaround pad, and 1800 m<sup>3</sup> for the road.

**Photo 7: a – Removal of berm material at north end of site, b – Graded berm at north end of site**

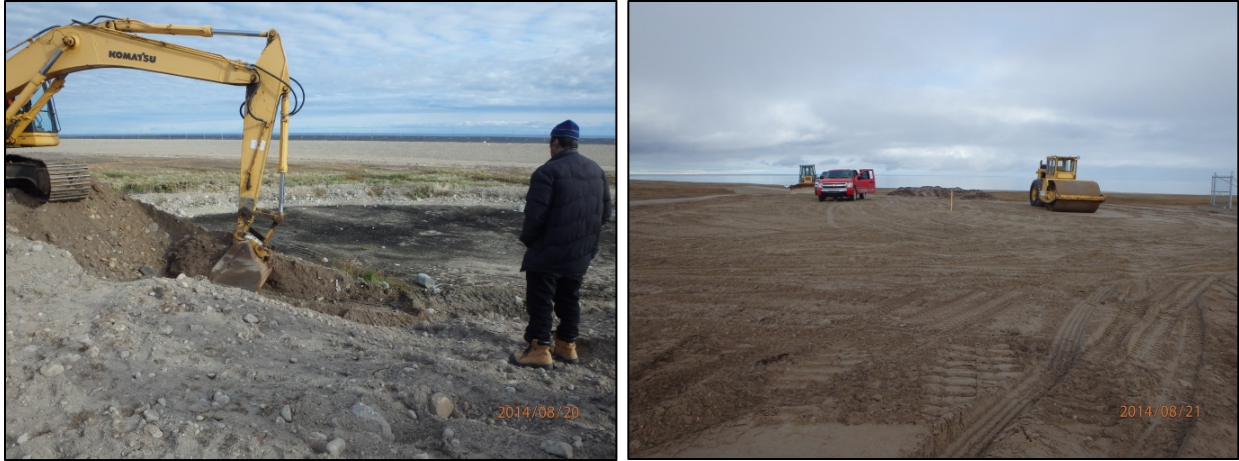
**Photo 8: a – Removal of clean berm material at south end of site, b - Preparing for truck turnaround expansion at the new lagoon site.**

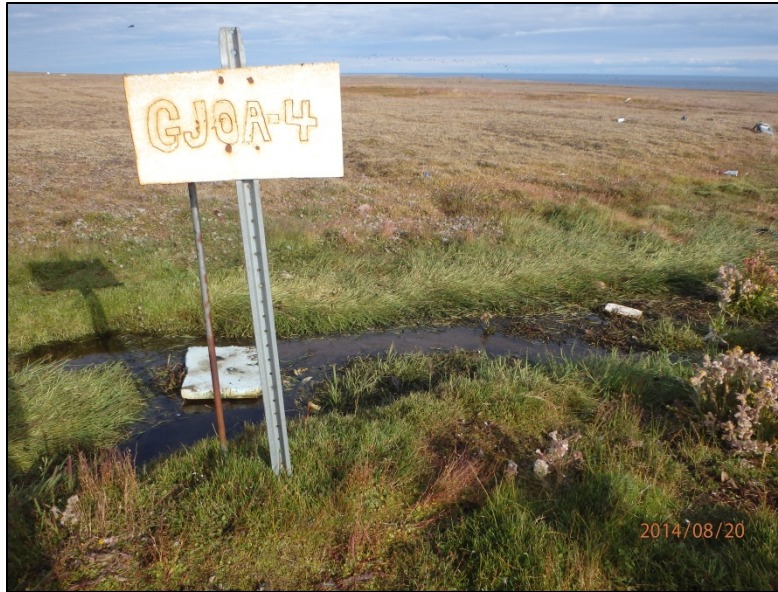
As per the requirements of the water licence, monthly water quality sample results from the former sewage lagoon to the receiving wetland environment must be monitored during the months of May to August, inclusive. Part H, Item 2 indicates the following monitoring program station for the sewage disposal facility (**Photo 9**):

**Photo 9: Monitoring station GJO-4 during discharge of former lagoon in August 2014**

Monitoring SNP GJO-4 at the end of wetland ensures the effluent final discharge to ocean in compliance with DFO regulation and EC guidelines. Part H Item 4 of the water licence requires samples taken at GJO-4 to be analyzed for the following parameters:

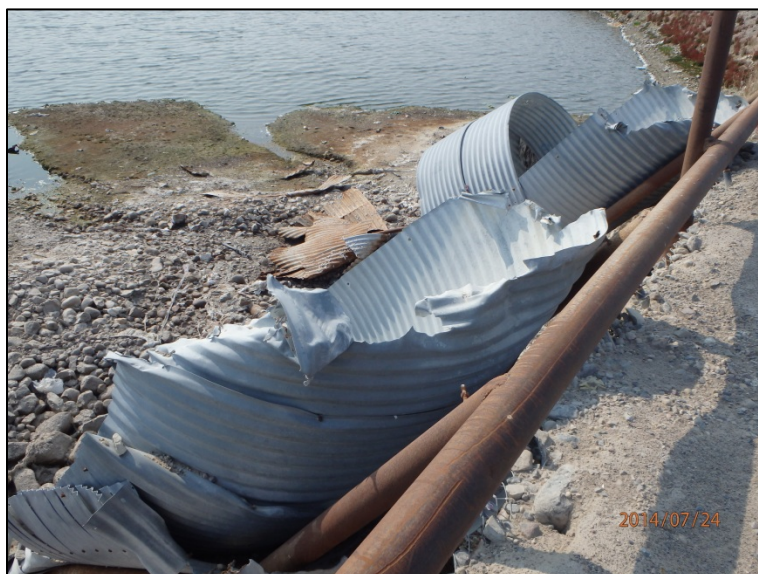
There are no buildings at the site of the former sewage lagoon. The truck discharge chute and outflow pipe will be removed from the site and disposed of in the solid waste facility (**Photo 10**). Signs for the newly constructed site will be erected. Existing signs from the former lagoon must be taken down and replaced with signs to notify the public that the site is closed. New signs are also required to indicate the

**Photo 10: Truck discharge chute and structures to be removed from the former lagoon site.**
