**ANNUAL REPORT  
FOR THE MUNICIPALITY OF GRISE FIORD, 2022**

The following information is compiled pursuant to the requirements of Part B, Item 1 of Water License # 3BM-GRI2025 issued to the Municipality of Grise Fiord.

WATER LICENCE INSPECTION FORM

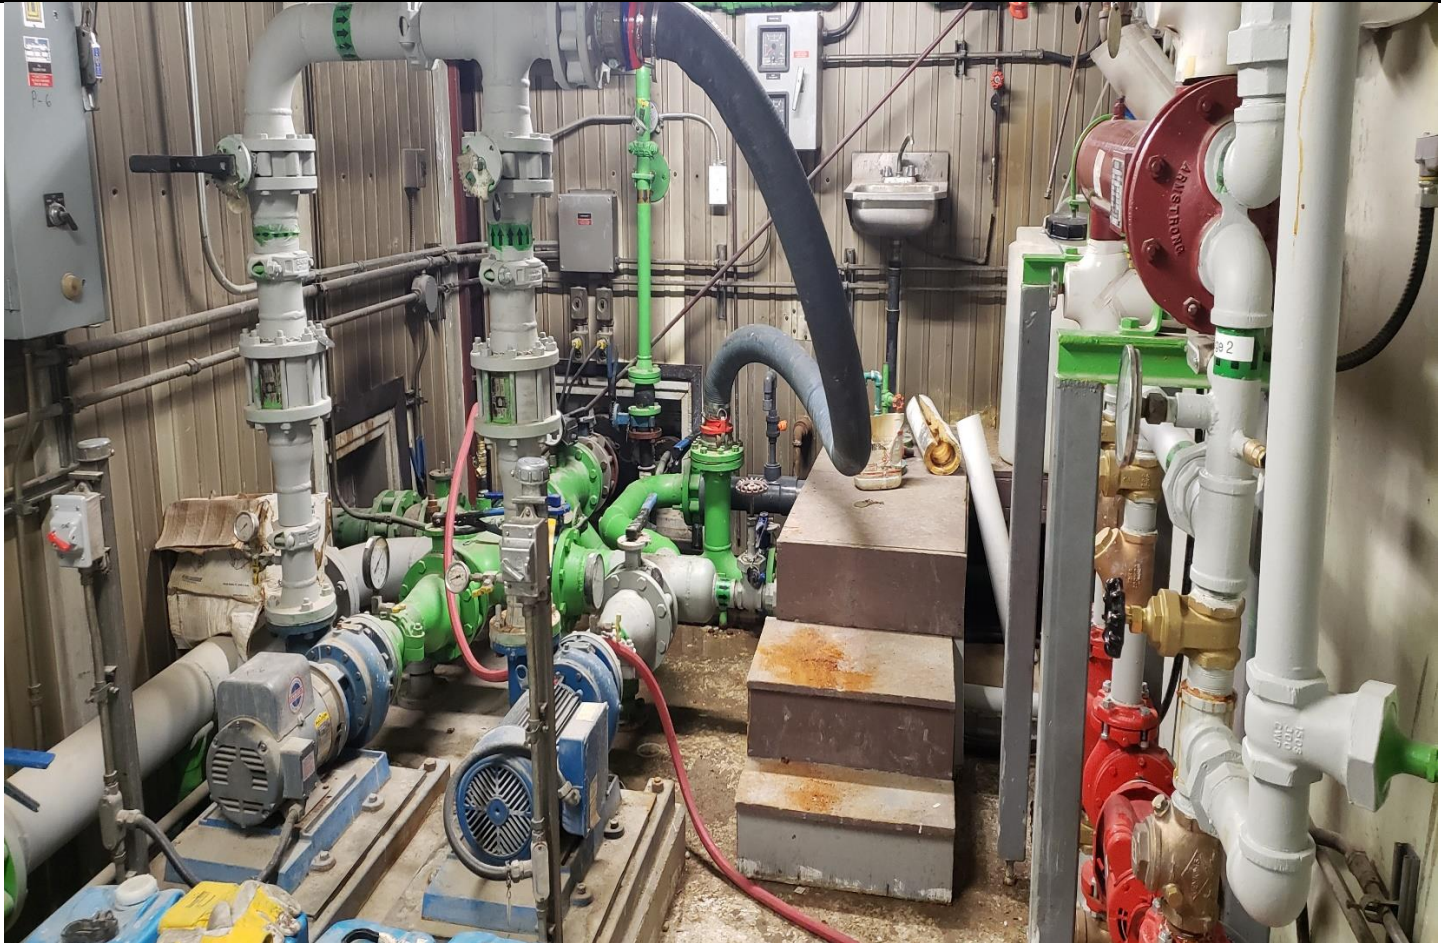
Description: Internal piping to distribute water to the 3 different water storage tanks.

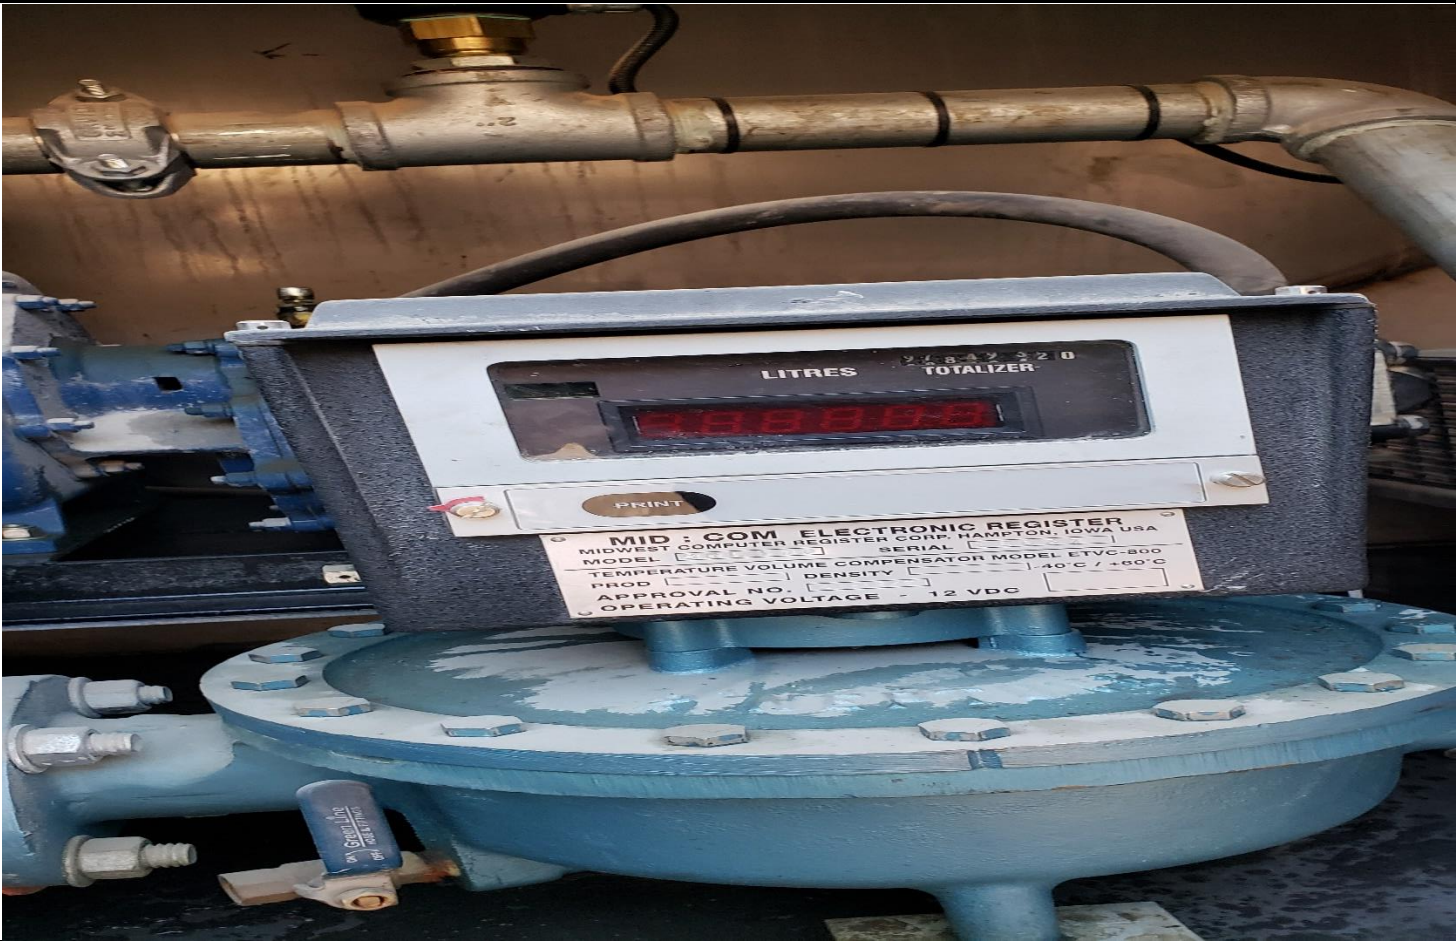
Photo Log  
Photo 9

6. The Water Treatment Plant , and its inner pipes (photo 5,6,7,8).
7. Couldn't get flow meter readings in the water treatment plant. Got Totalizer amount on the community water truck (photo 9).

Description: Water Meter on the Water Delivery Truck.. Totalizer reads

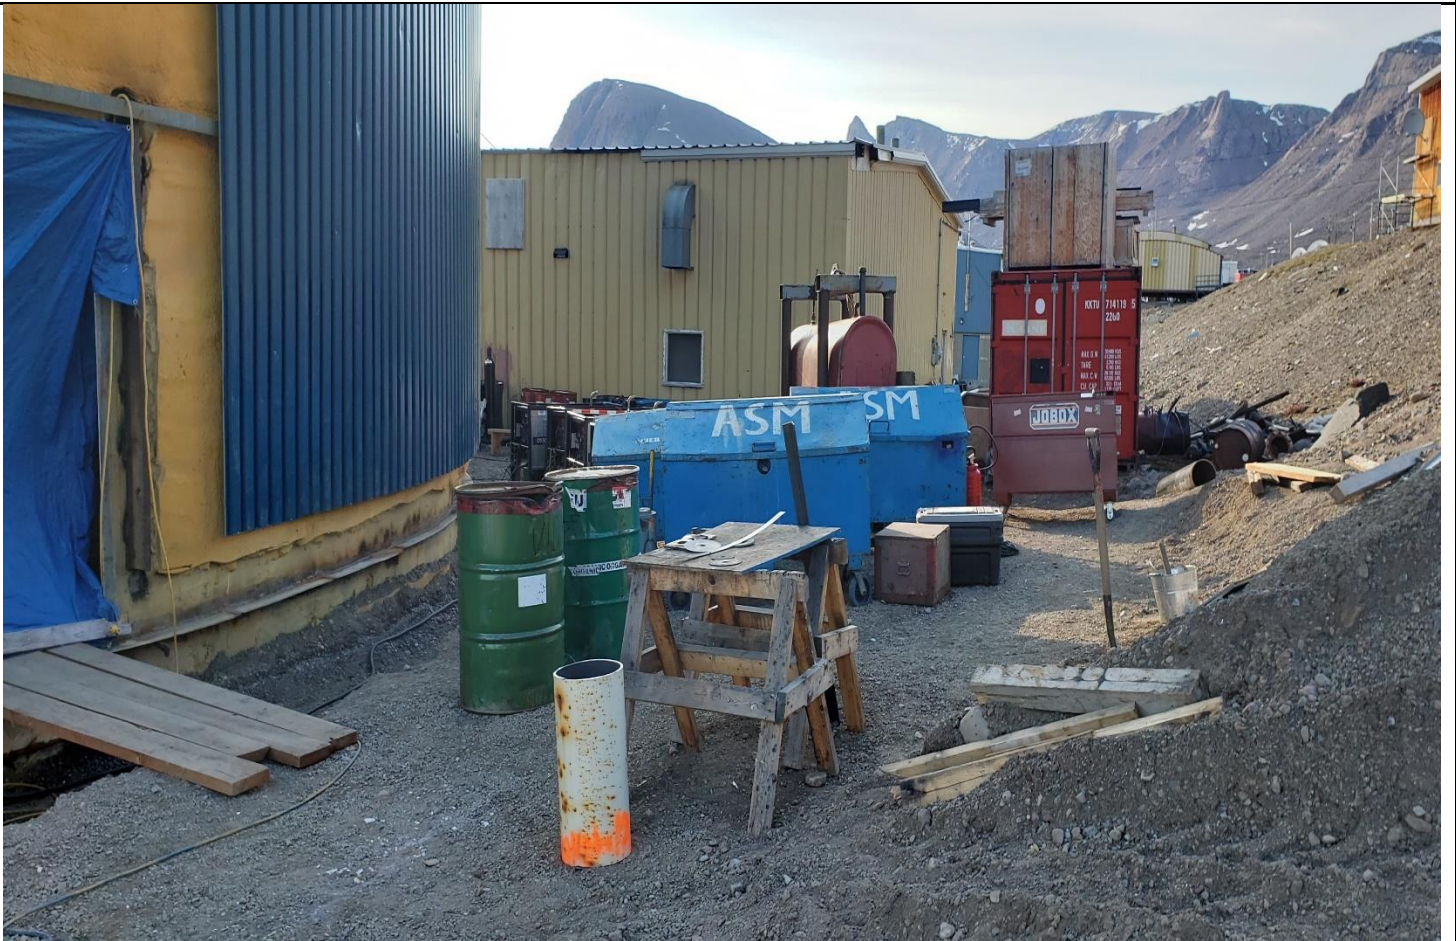
Photo Log  
Photo 10

9. Water Storage Tank under repair. Equipment outside of tank ( photo 10,11).
10. A bridge crossing was inspected within the community. No signs of erosion on the banks or sedimentation were observed in the fresh water. Buildup of sand was observed on the bridge. This buildup has the potential to spill over into the fresh water. A containment wall should be fixed onto the bridge, and maintained to prevent sedimentation into the river. (photo 17).

Description: Outside the Storage Tank, Storage Tank under repairs.

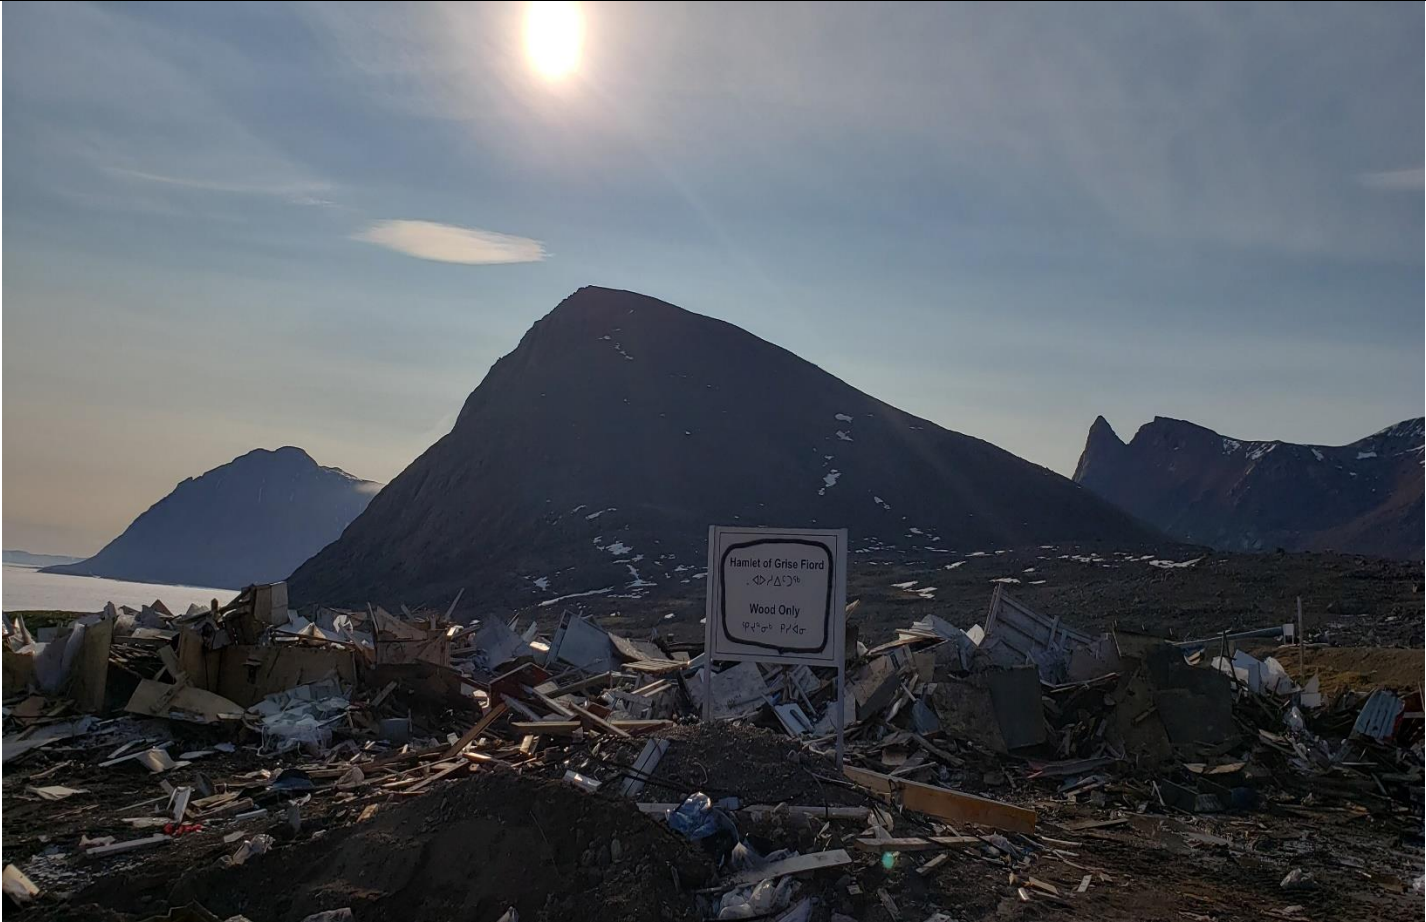
Description: Bulk woods section of the solid waste facility

- Erect fencing around the open pit burning section of the Solid Waste Facility to manage wind-blown litter (photo 8).
- Separate bulk metals, bulk wood, domestic waste, and hazardous waste to be in line with National Standards for the management of Solid Waste Facilities.
