ANNUAL REPORT FOR THE HAMLET OF GRISE FIORD

YEAR BEING REPORTED: 2023

Grise Fiord 2023 CIRNAC Inspection Report

WATER LICENCE INSPECTION FORM

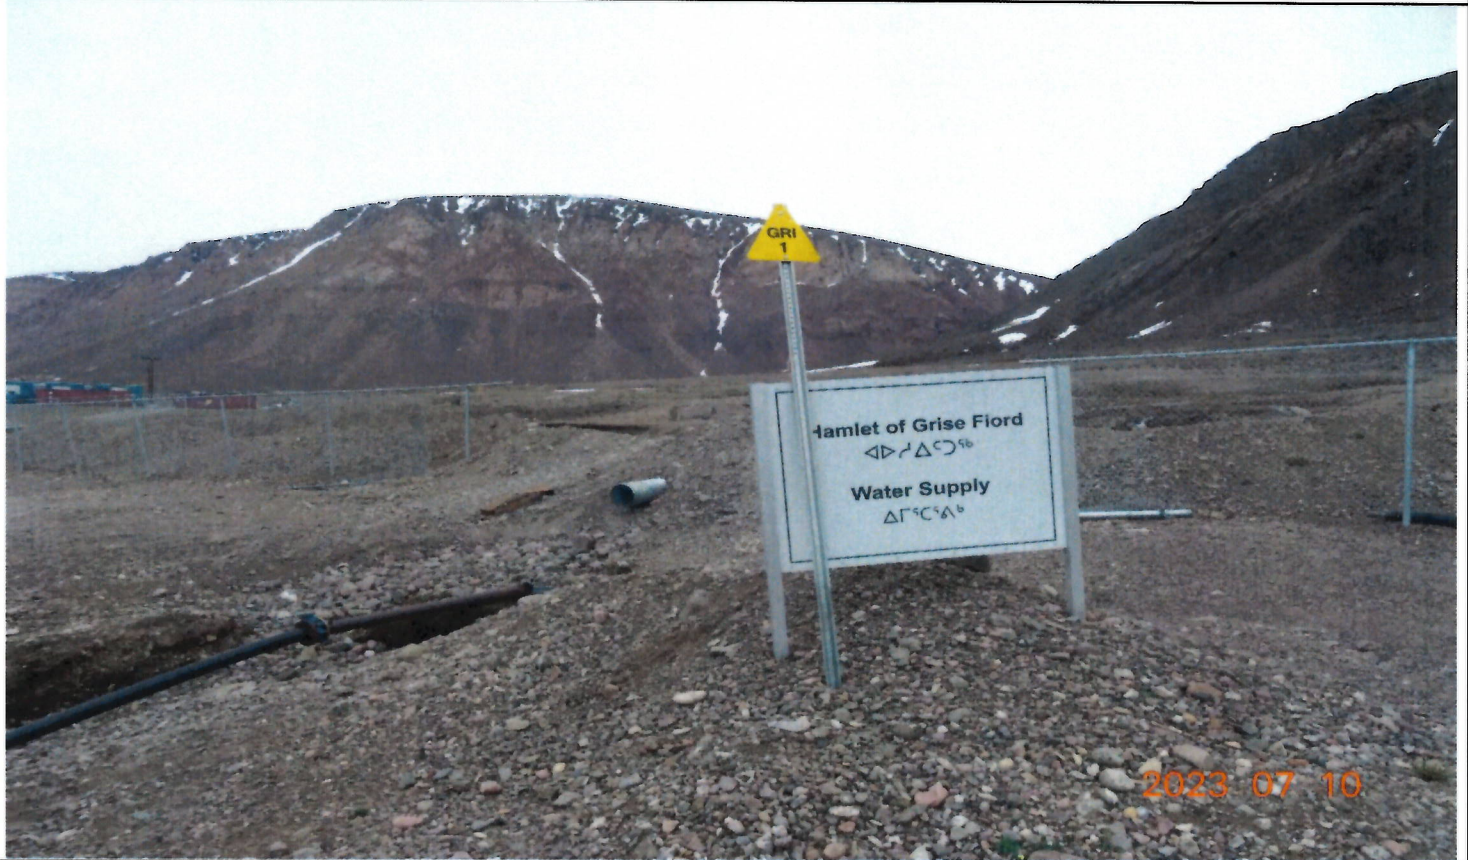
Photo 3

2. At the time of the inspection a yellow triangle sign was observed titled GRI-1. The monitoring station is listed in the water licence(photo 3).
3. The secondary water source at airport river was observed with a water pump and hose (photo 2). The hose from the water pump deposited the water in the water reservoir.

Description: Sign Reads Hamlet of Grise Fiord, Water Supply . Monitoring station GRI1 observed.

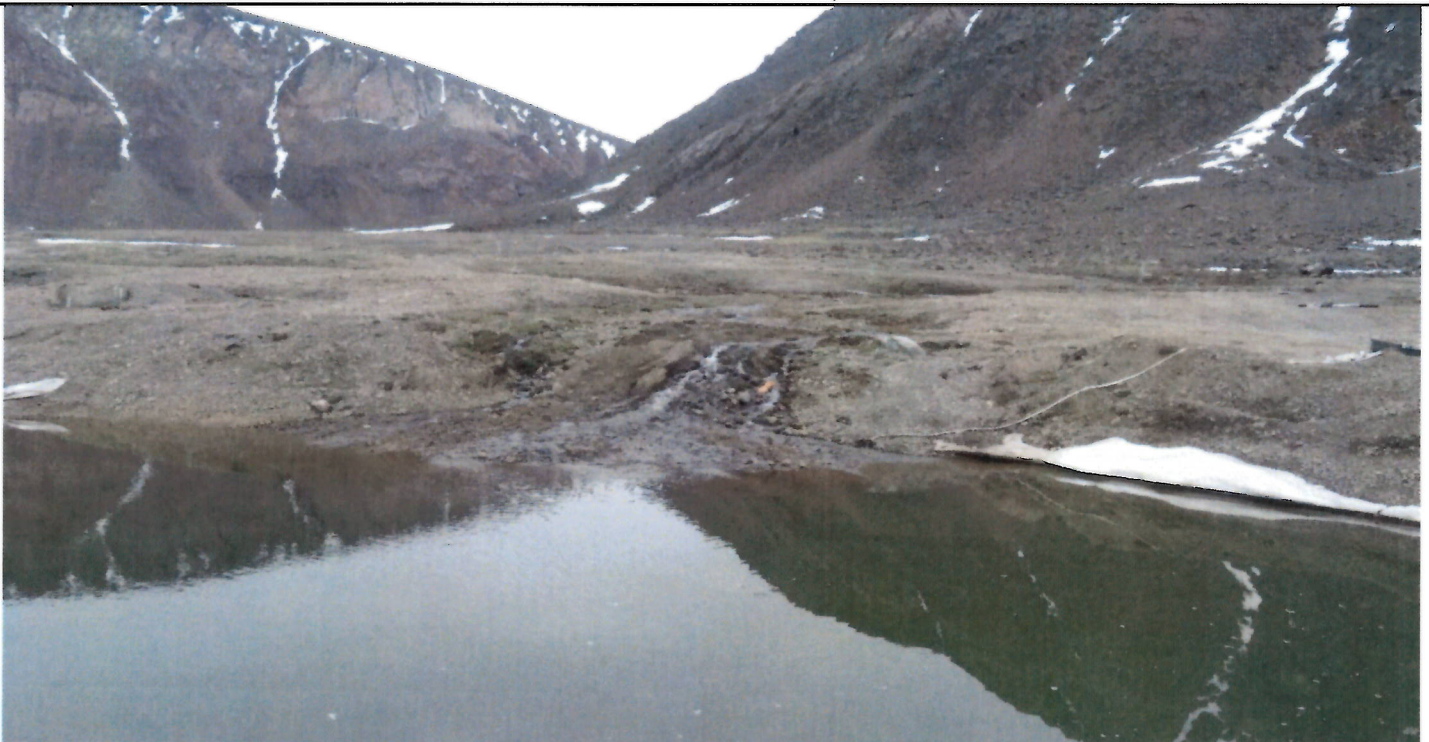
Photo 4

1. Water withdrawal is conducted from a glacier run-off stream that meanders down to the Hamlet of Grise Fiord from the mountain above Grise Fiord. A pond with walls that extend up approximately a metre and a half catches water run-off, and pools up. Fencing was being erected around the ponds at the time of the inspection. No sign of fish mesh screen (photo 1,3,4).

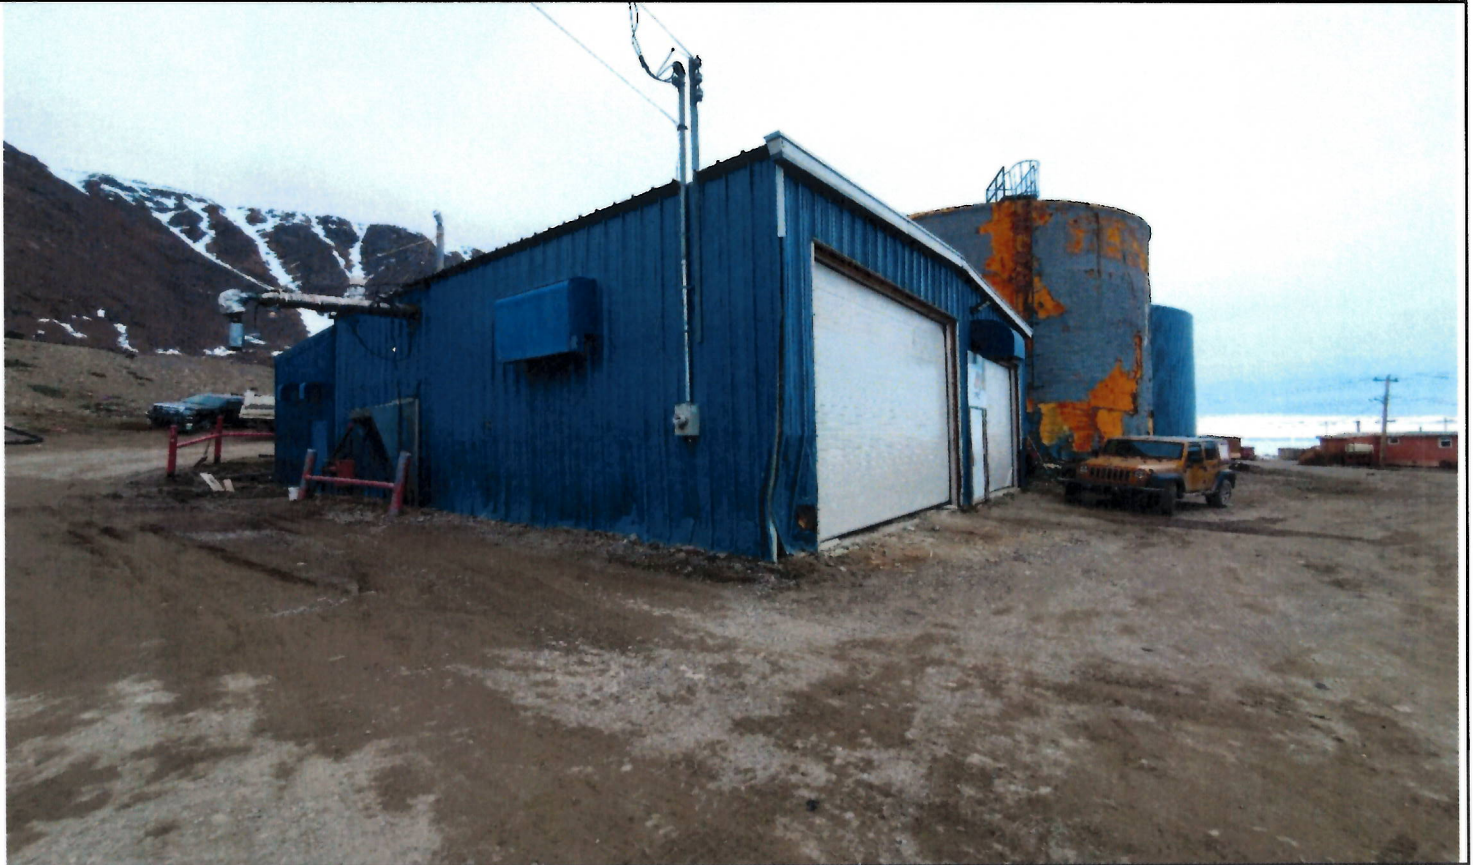
Photo 5

6. The Water Treatment Plant, and its inner pipes (photo 5 &6).
7. No working flow meter in the water treatment plant, truck was not available for observation of water meter readings.

Description: 3x Water Storage Tanks. 1 of 3 Water Storage Tanks damaged, and decommissioned. Truck refill station.

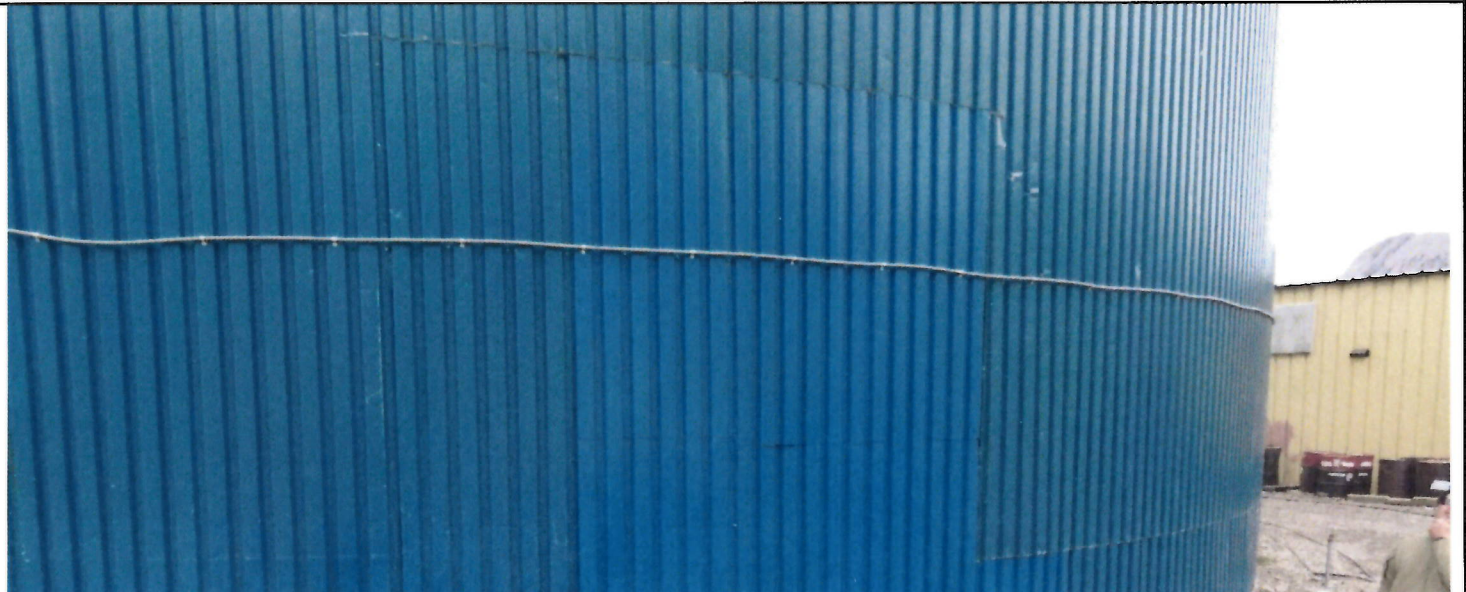
Photo 8

8. Water Storage Tank damaged in 2018 was repaired in 2023. Equipment outside of tank (photo 8).
9. A bridge crossing was inspected within the community. No signs of erosion on the banks or sedimentation were observed in the fresh water. Buildup of sand was observed on the bridge. This buildup has the potential to spill over into the fresh water. A containment wall should be fixed onto the bridge, and maintained to prevent sedimentation into the river (photo 17).

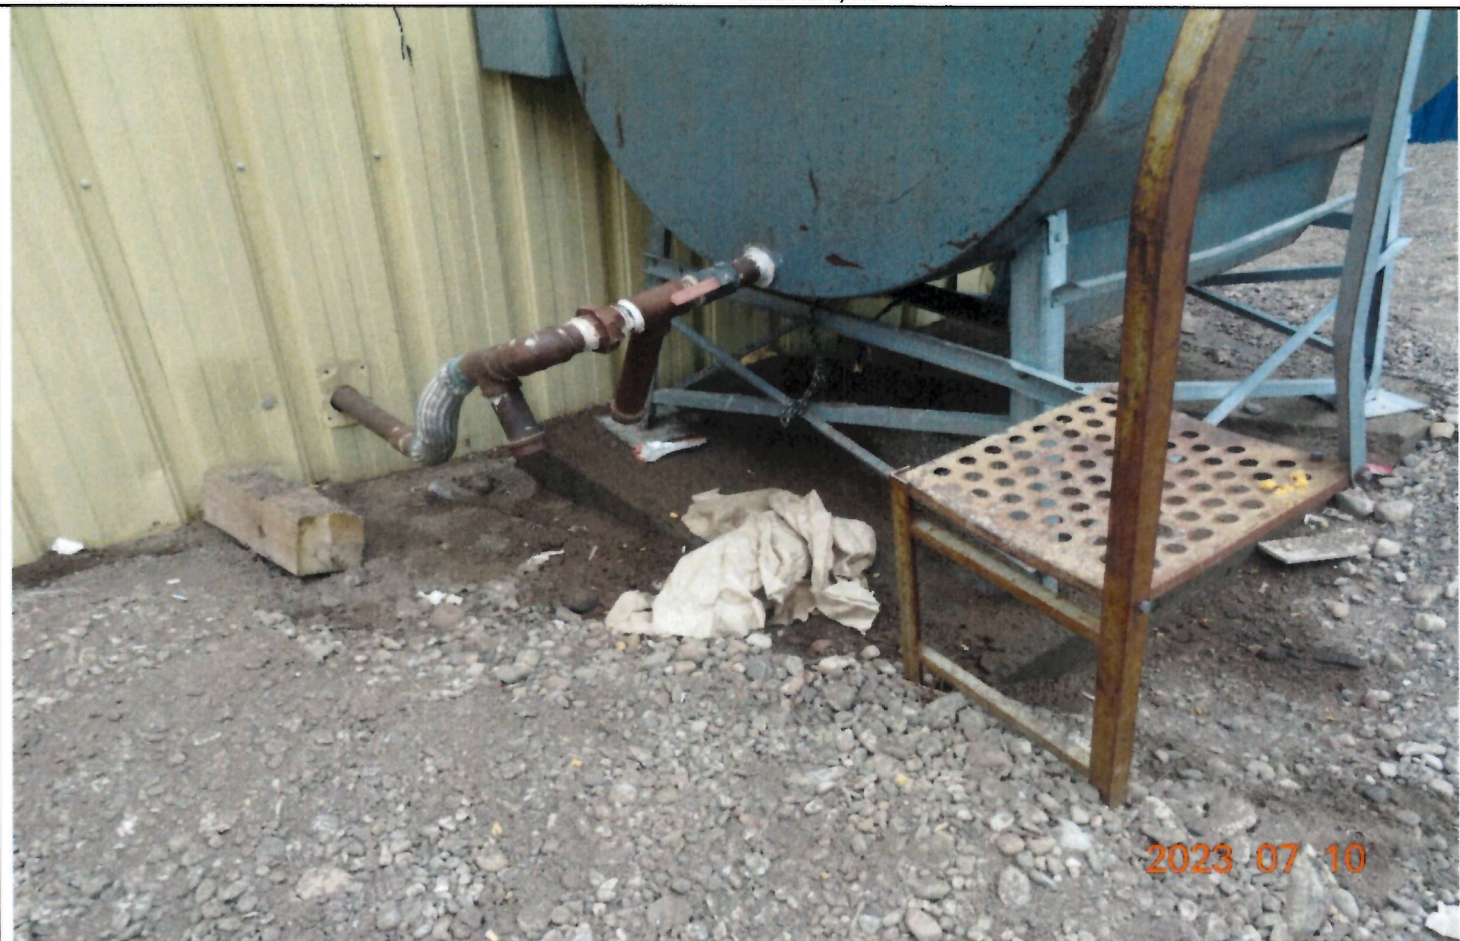
Photo 9

21. Spill observed in 2022, not reported and covered in gravel(photo 9).

Description: Spill observed in 2021, covered with gravel.

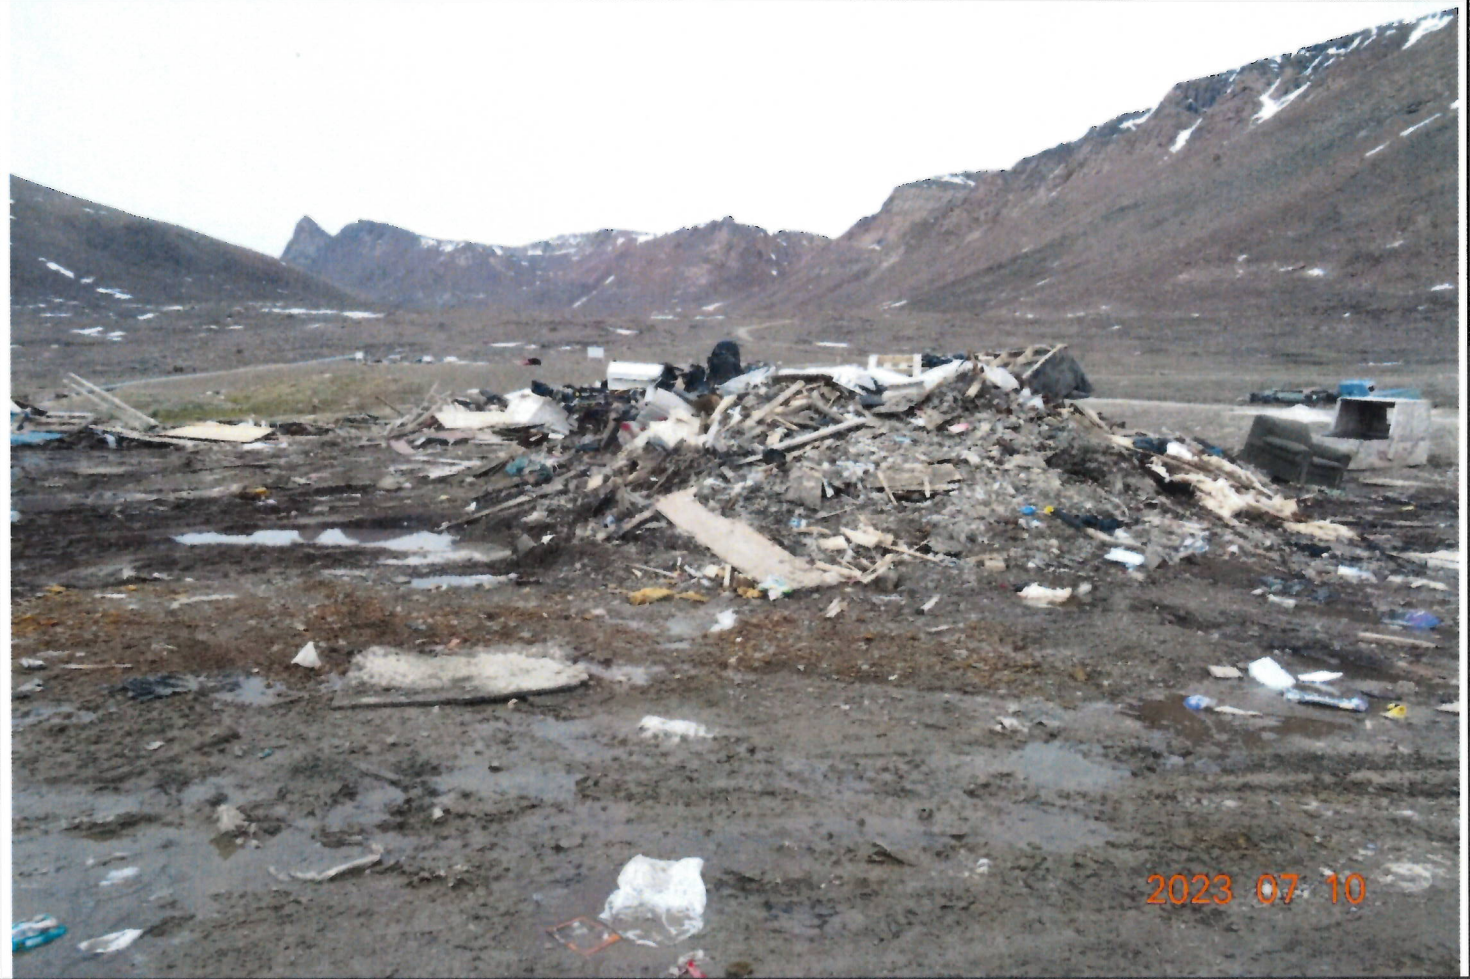
Photo 12

Description: Pile of bulk wood, in the Bulk Woods Section of the Solid Waste Facility

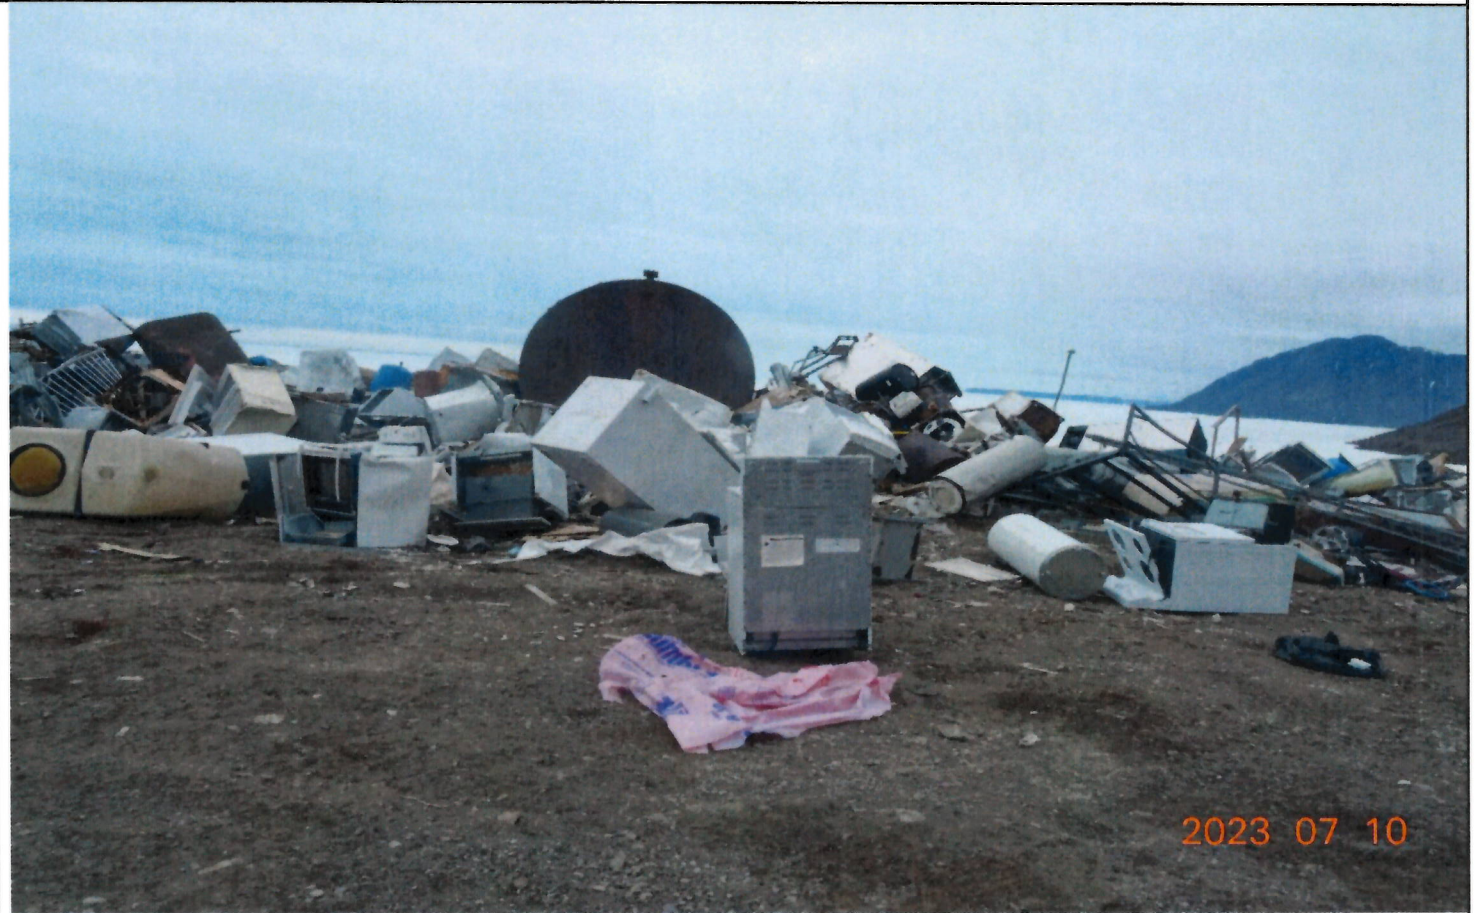
Photo 13

Description: Bulk Metal waste. White waste includes freezers, fridges, washers and dryers. Segregated from other wastes.

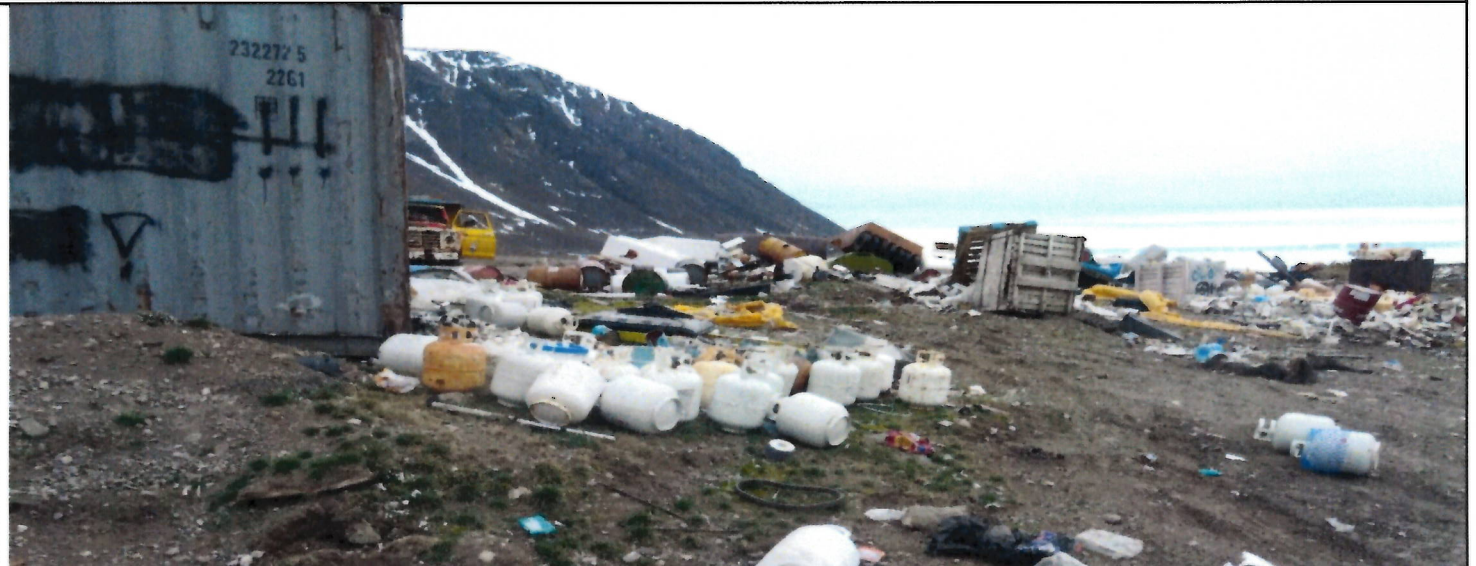
Photo 14

15. The Solid Waste Facility was loosely segregated into Woods, Metals, Hazardous Wastes and Burnable Wastes (photo 14).
16. The burnable waste is open pit burned, pushed off the end of that section then capped with soil. No fencing around the burnable waste.
17. The bulk metals contain white waste, and metal from construction. Hazardous Waste was observed at this site (photo 13).
18. Wood waste was segregated, probably for the purpose of allowing the community help themselves to the wood wastes (photo 11).
19. The Hazardous Waste sea can is mixed with the bulk metal waste. Lots of hazardous waste observed within the bulk metals (photo 14,15,16).
20. A yellow triangle sign titled GRI-2 was observed, which indicated a monitoring site. No Samples were taken on this inspection.

- Separate bulk metals, bulk wood, domestic waste, and hazardous waste to be in line with National Standards for the management of Solid Waste Facilities.
- Divert surface water run off away from Solid Waste Facility to mitigate the amount of wastes migrating to the receiving marine environment.
- Email joseph.monteith@rcaanc-cirnac.gc.ca notifying the inspector the intent to decant the sewage lagoon.
- Send WRO Monteith sample results ahead of a decant of the sewage lagoon.
- Maintain a 1 metre freeboard at the sewage lagoon.
- Verify whether there is Fish Mesh Screen on the intake hose at Airport River secondary water source, and the water source with the green hose.

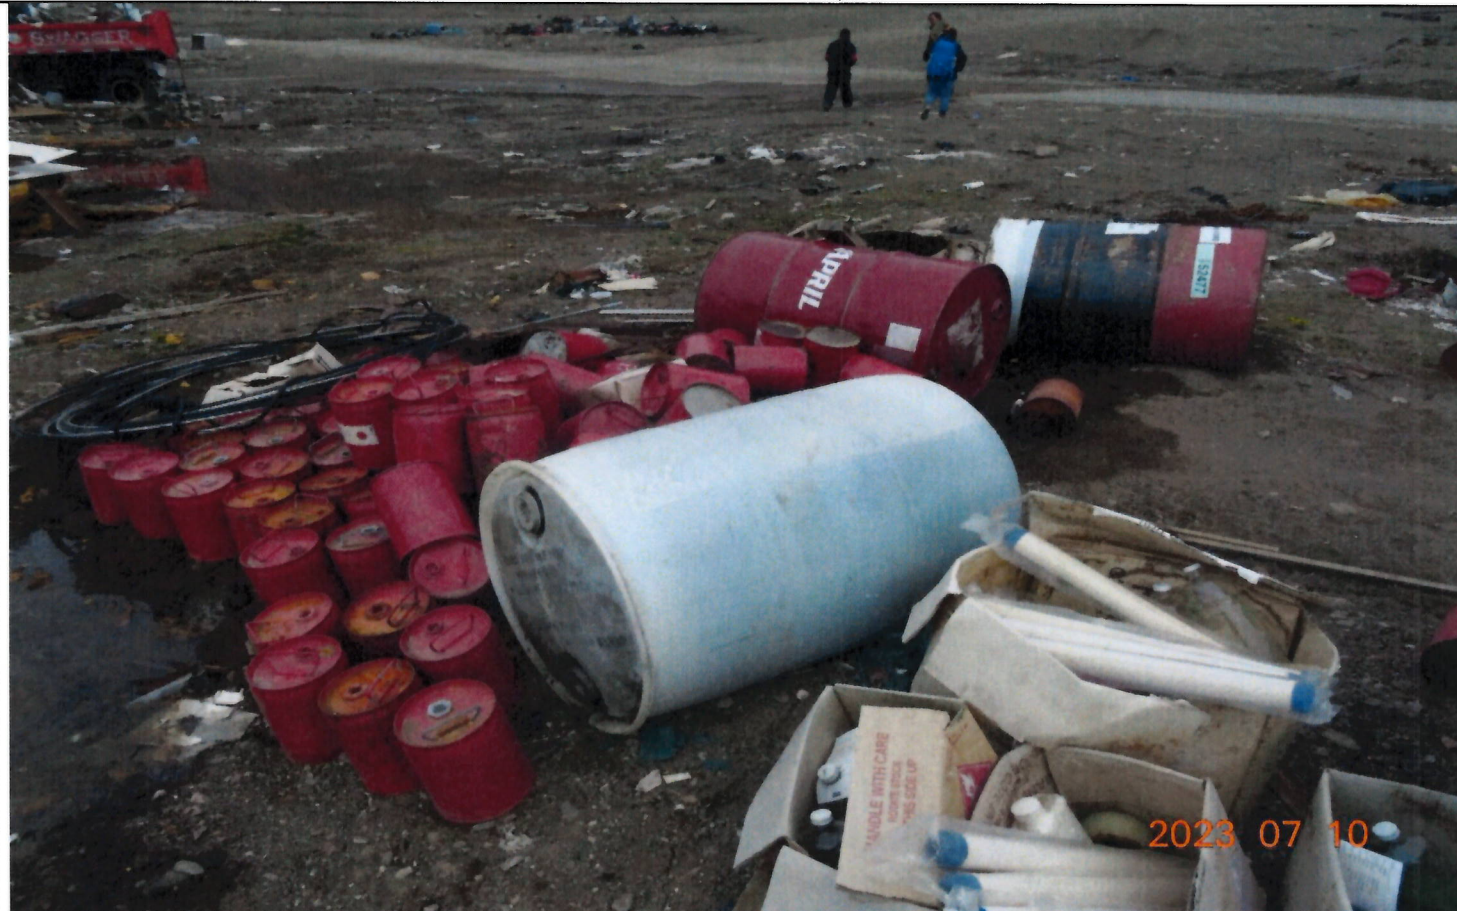
Photo 15

Description: empty fuel test containers. Signs of spills from larger drums.

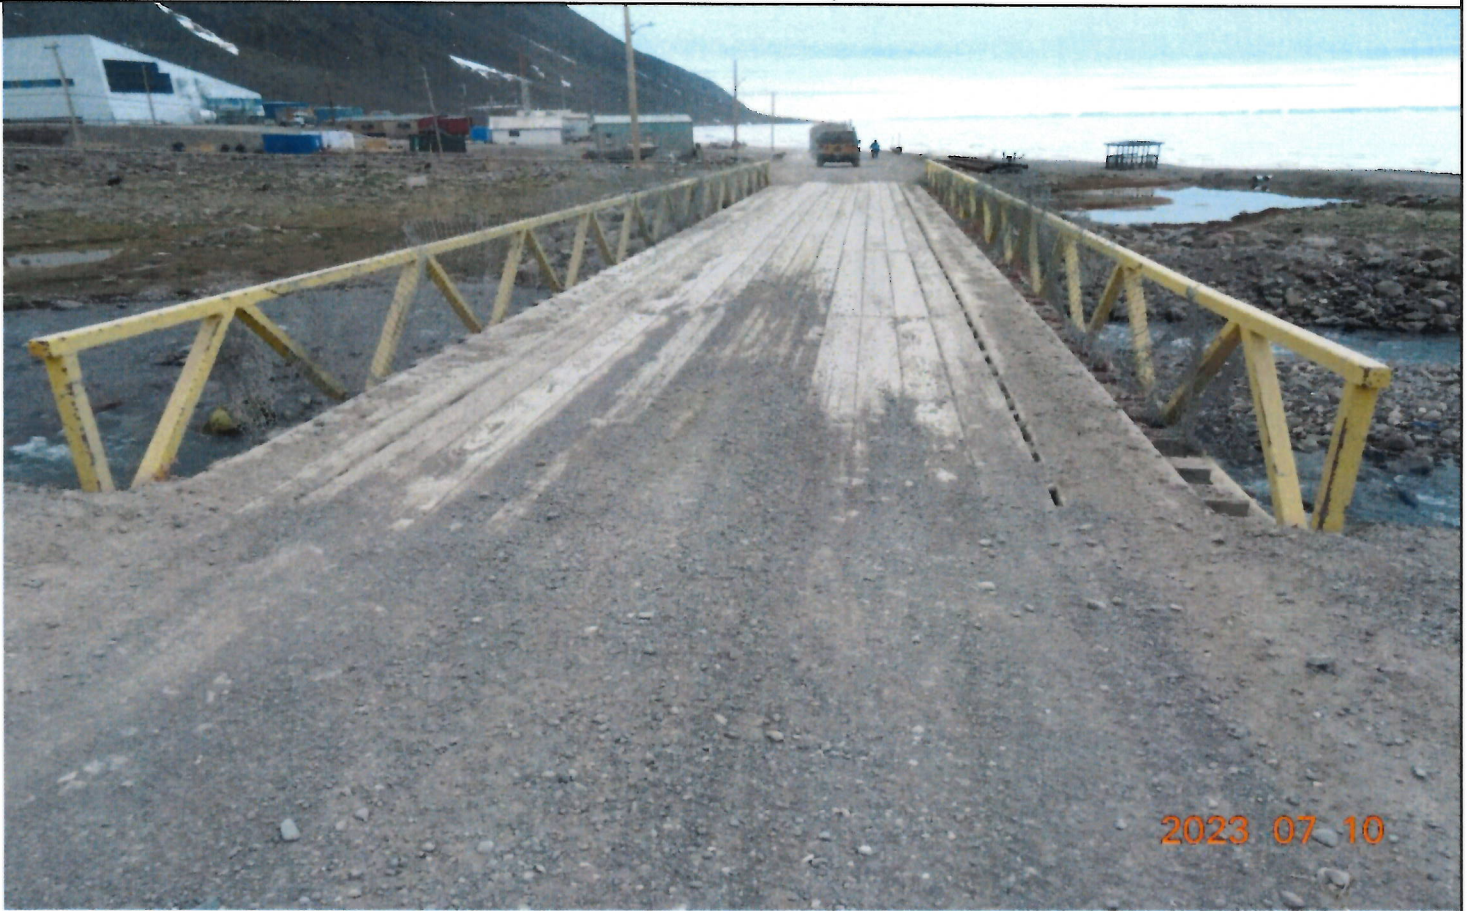
Photo 17

Description: Soil build up on bridge. No walls on bridge to prevent soil from falling into fresh water.
