INAC, Nunavut District Office
P.O. Box 100
Iqaluit, NU
X0A 0H0

July 20-21, 2001 Municipal Water Use Inspection - Report

MUNICIPAL WATER USE INSPECTION FORM

Licensee: Hamlet of Grise Fiord

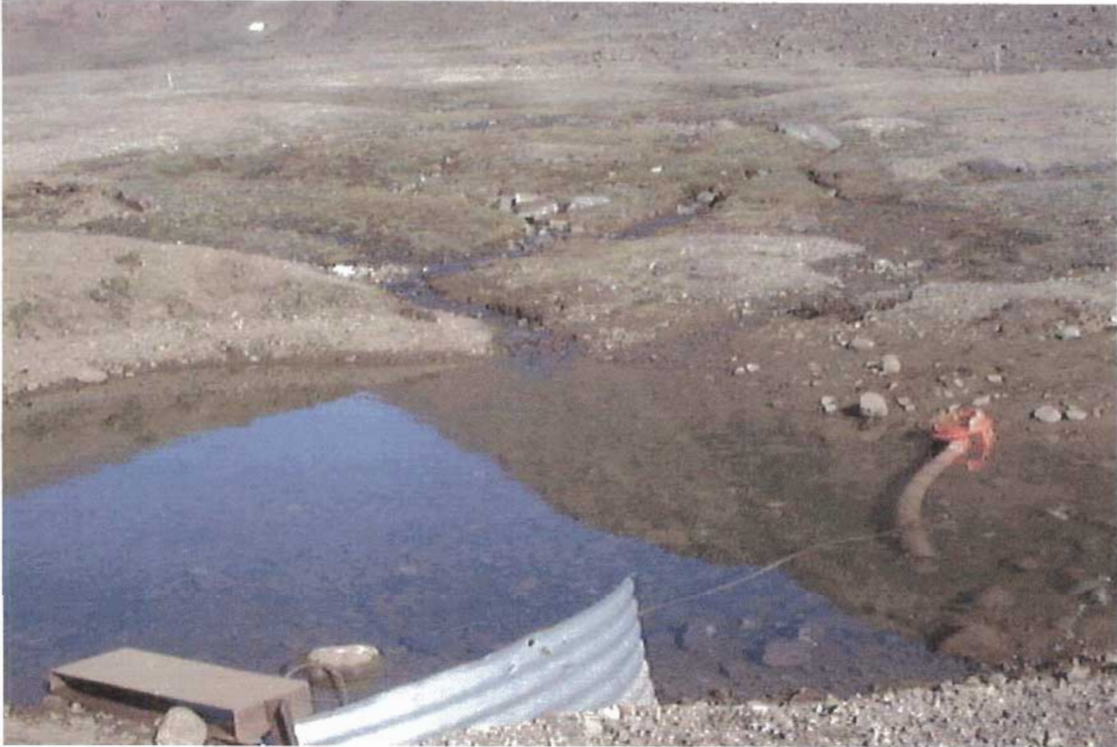
figure 1. Catchment basin for seasonal glacier-fed runoff; 2001/07/20.

Comments: Improvements to the catchment basin planned for late summer, once the runoff stream will have dried up: dig to enlarge the pit, line, then cover. Aging water storage tank undersized for the community's needs; additional one still not erected. The required work, if at all undertaken by a this party this summer, will likely come too late in the year to allow for the testing/filling of the additional storage tank.

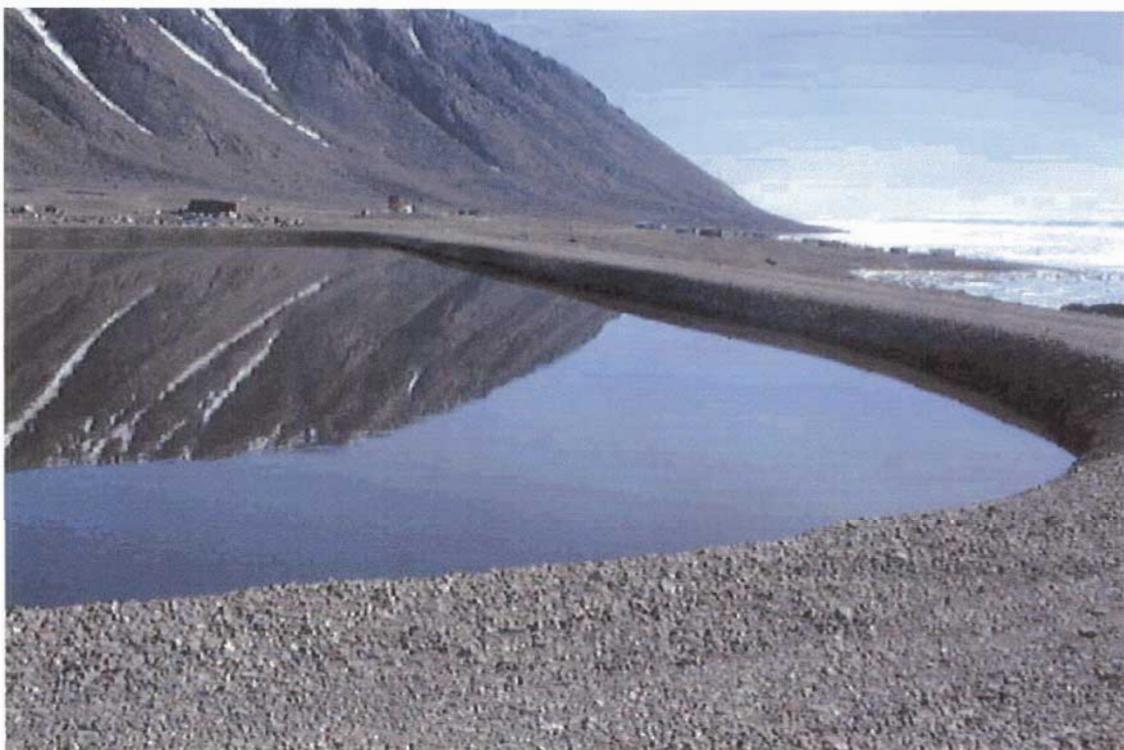
- **Sewage disposal:** At the time of the inspection, the annual decant of the sewage disposal facility was to begin shortly since limited freeboard remained (figure 2). In this regards, it was mentioned that it may be advisable to restrict the flow of discharge by using a decanting line of smaller diameter, thus spreading the effluent release over a longer period of time in order to maximize aerobic decomposition and secondary biological treatment. It must also be noted that veins of seepage were noticeable along the downslope berm of the facility (figure 3), even if the extent of the seepage was minimal and did not permit sampling. In related matters, the Inspector acknowledges the partial reclamation of both the old sewage lagoon cell and the honeybag pit.

figure 2. Limited freeboard at the sewage disposal facility; 2001/07/20.

Comments: The imminent decant of the sewage lagoon has been postponed; no discharge sample could be collected. Very little freeboard remains. Decant structure located in an impractical area, therefore annual decant is carried on via pump and line over the downslope berm; the use of a smaller diameter line was suggested in order to spread the discharge over time and maximize effluent treatment. Several veins of seepage noted along the toe of the downslope berm. Honeybuckets no longer relied upon; old lagoon cell has been filled with scrap metal, and the backfilling of the cell and the honeybag pit is planned. Wood, hazardous materials and bulky metal wastes are segregated from the combustible household wastes at the unfenced solid waste disposal facility. Waste oil is adequately disposed of at the Hamlet garage (furnace). Approximately 150 drums which cannot be burned due to their 'unknown' contents are stored and monitored at the dump; plans to ship out on sealift backhauls.

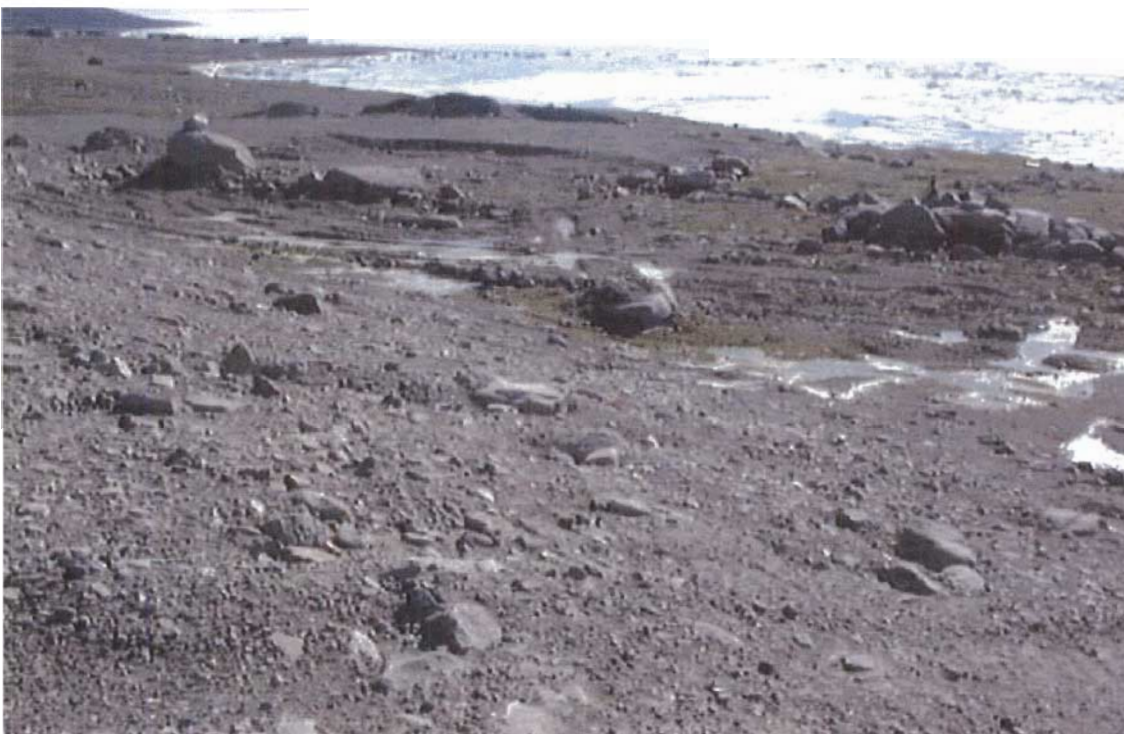
figure 3. Veins of seepage from the sewage disposal facility; 2001/07/20.

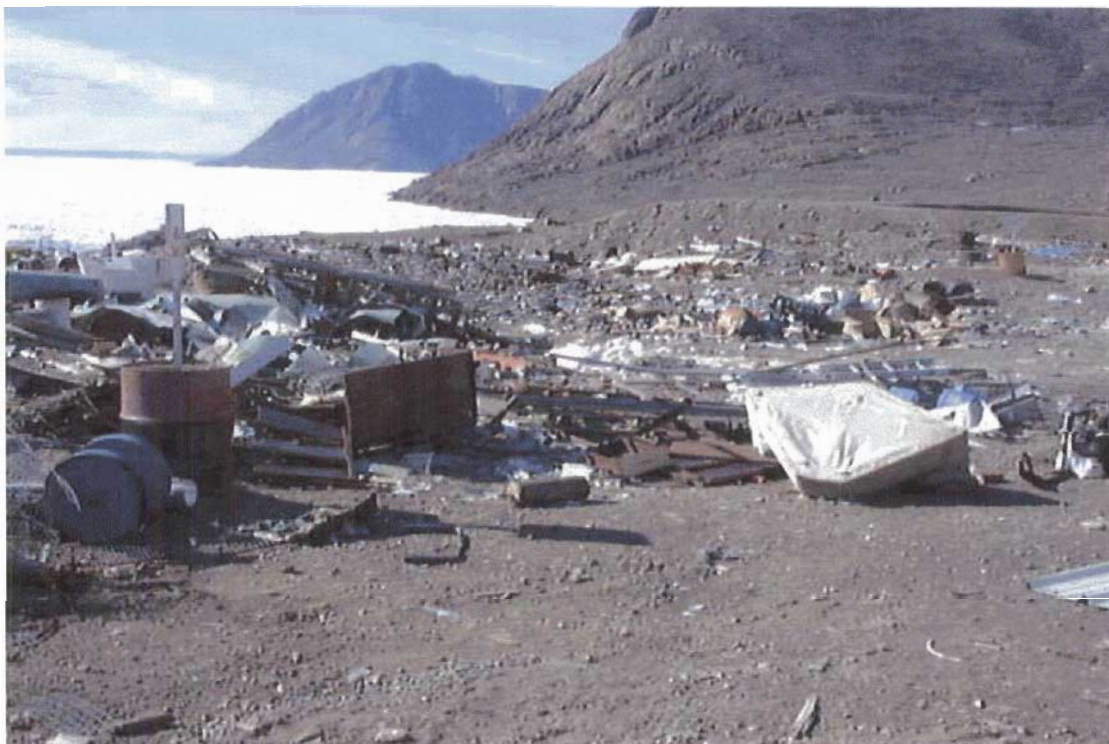
- **Solid waste disposal:** A considerable amount of segregation is undertaken at the solid waste disposal facility, as wood, hazardous materials, and bulky metal wastes are separated from the combustible household wastes. Further, it was mentioned that the Hamlet was diligently attempting to find southern end-users for its stockpiled scrap metal (figure 4). Regardless, a path of runoff from the solid waste disposal facility was observed during the inspection. As such, the attached analytical results relating to a leachate sample taken 30 metres downslope from the toe of the dump (figure 5) indicate that ammonia (3.62 mg/L vs 2.2 mg/L), cadmium (0.6 µg/L vs 0.017 µg/L), and iron (857 µg/L vs 300 µg/L) exceed the *Canadian Water Quality Guidelines for the Protection of Freshwater Aquatic Life*. Nevertheless, the Microtox sample, which constitutes a reliable toxicity indicator (IC₅₀), did not attribute toxicity to the leachate.

figure 4. Bulky metal wastes section of the solid waste disposal facility; 2001/07/20.

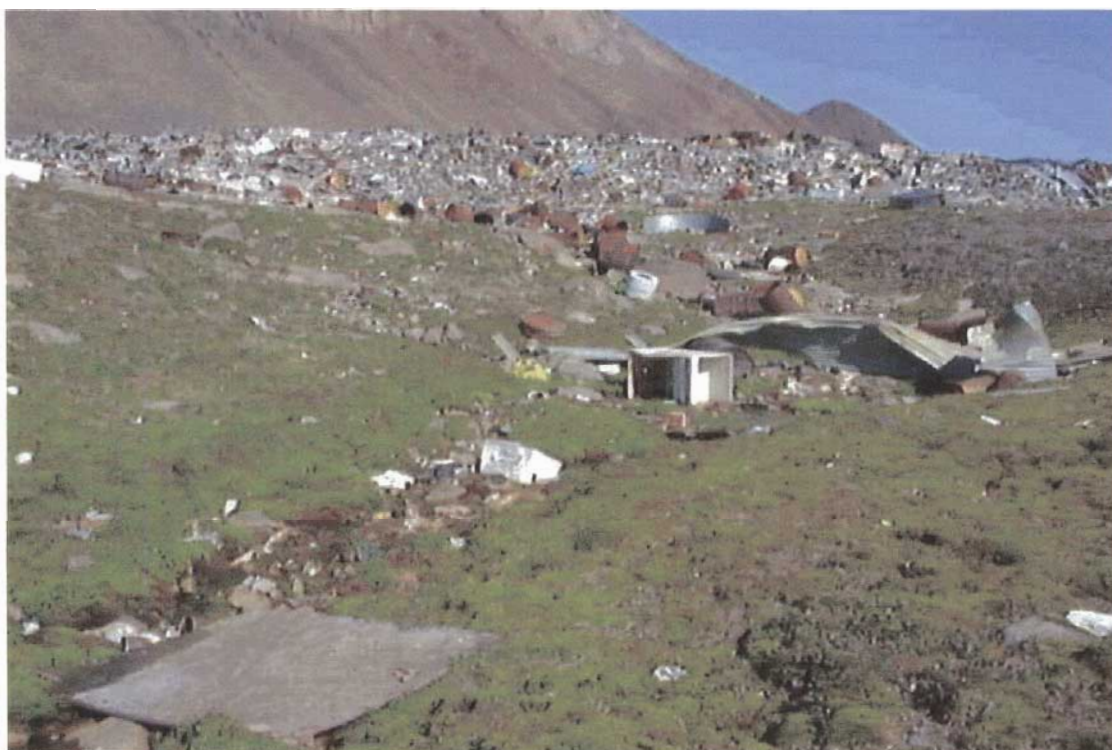
figure 5. Path of leachate from the toe of the solid waste disposal facility; 2001/07/20.

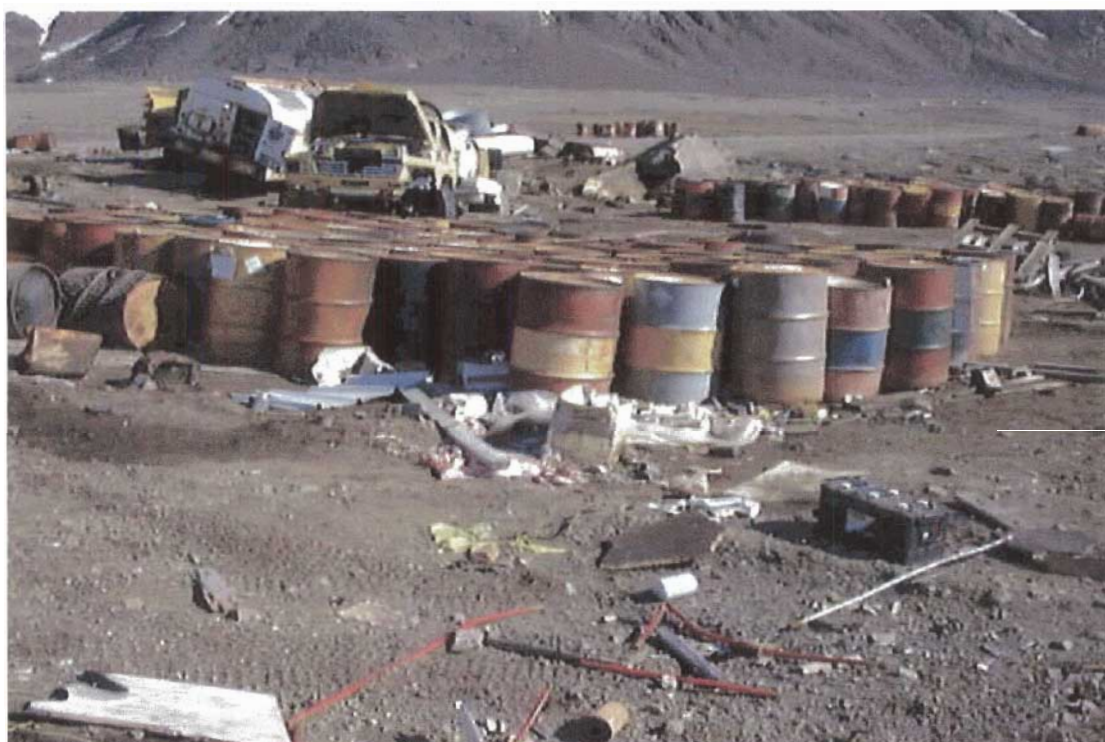
Also of note are the numerous drums of 'unknown' contents stored alongside the solid waste disposal facility (figure 6). Since these cannot be disposed of at the Hamlet's waste oil furnace due to their unidentified nature, the Inspector acknowledges that the hamlet plans to see to their eventual placement on a sealift backhaul. Lastly, it was recognized that when the Hamlet's resources allow such undertakings, the erection of a perimeter fence around the solid waste disposal facility and the securing of a sealift container for the storage of hazardous materials would both significantly reduce the likelihood of waste being deposited into waters.

figure 6. Storage area for drums of 'unknown' contents; 2001/07/20.
