## **Additional Geotechnical Investigation**

**Project Name**  
Proposed Sewage Lagoon Upgrades  
Hall Beach, Nunavut

**Project Number**  
OTT-00220382-A0

**Date Submitted**  
September 29, 2014

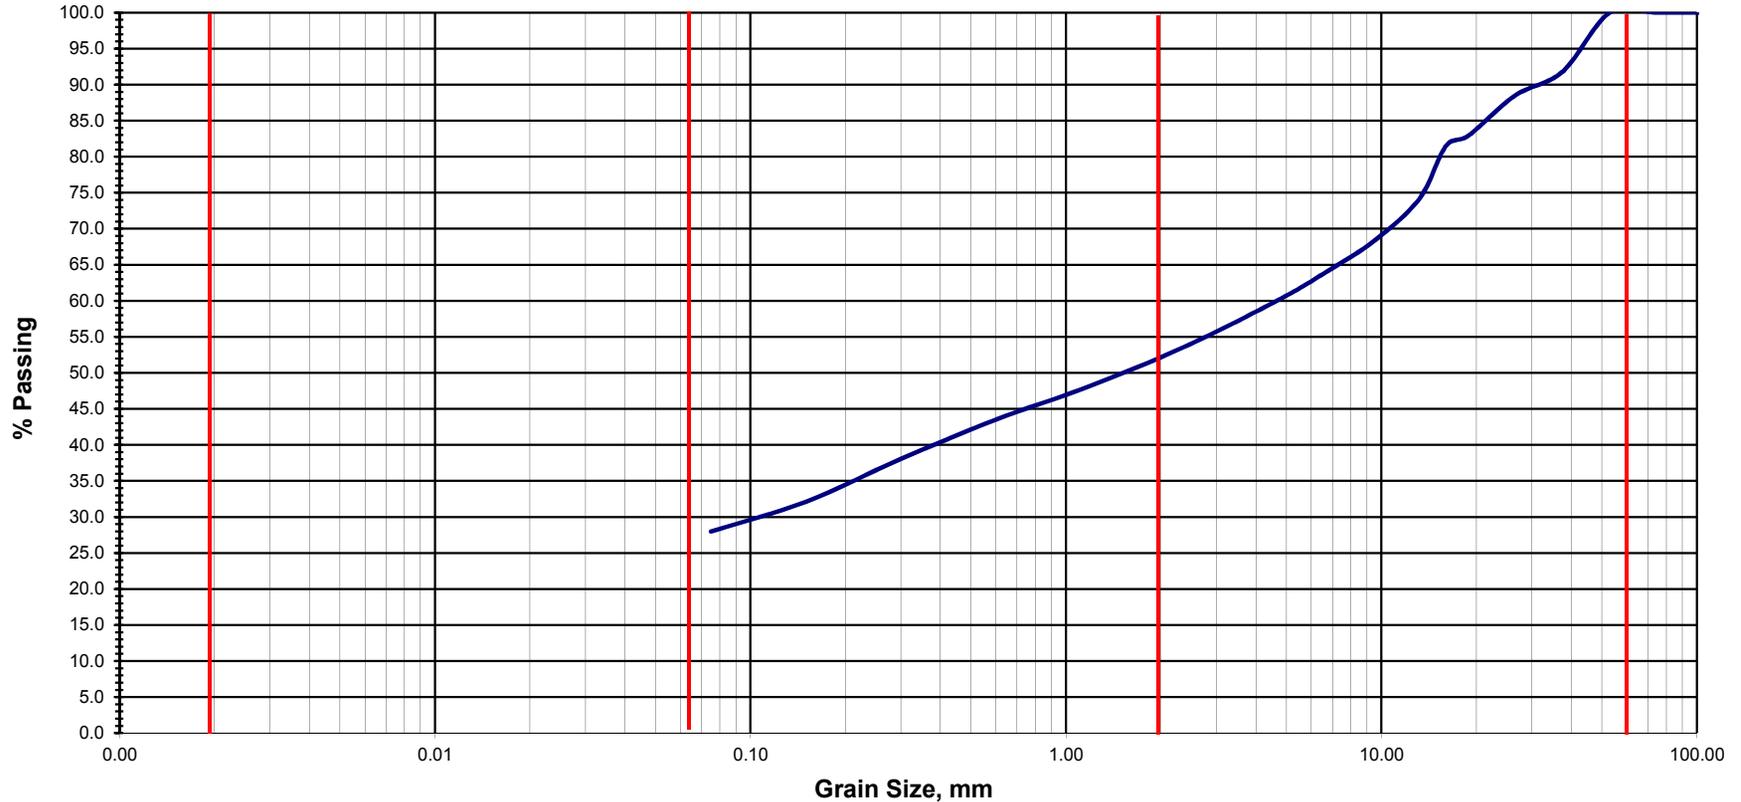
Exp Project No.:	OTT-00215839-A0	Project Name :	Geotechnical Investigation, Proposed Sewage Lagoon Expansion			
Client :	Government of Nunavut	Project Location :	Hall Beach, NU			
Date Sampled :	November 14, 2013	BOREHOLE	1	SAMPLE run 3	Depth (m) :	0.3-0.6
Sample Description :	<b>silty sandy GRAVEL</b>				Figure :	<b>28</b>

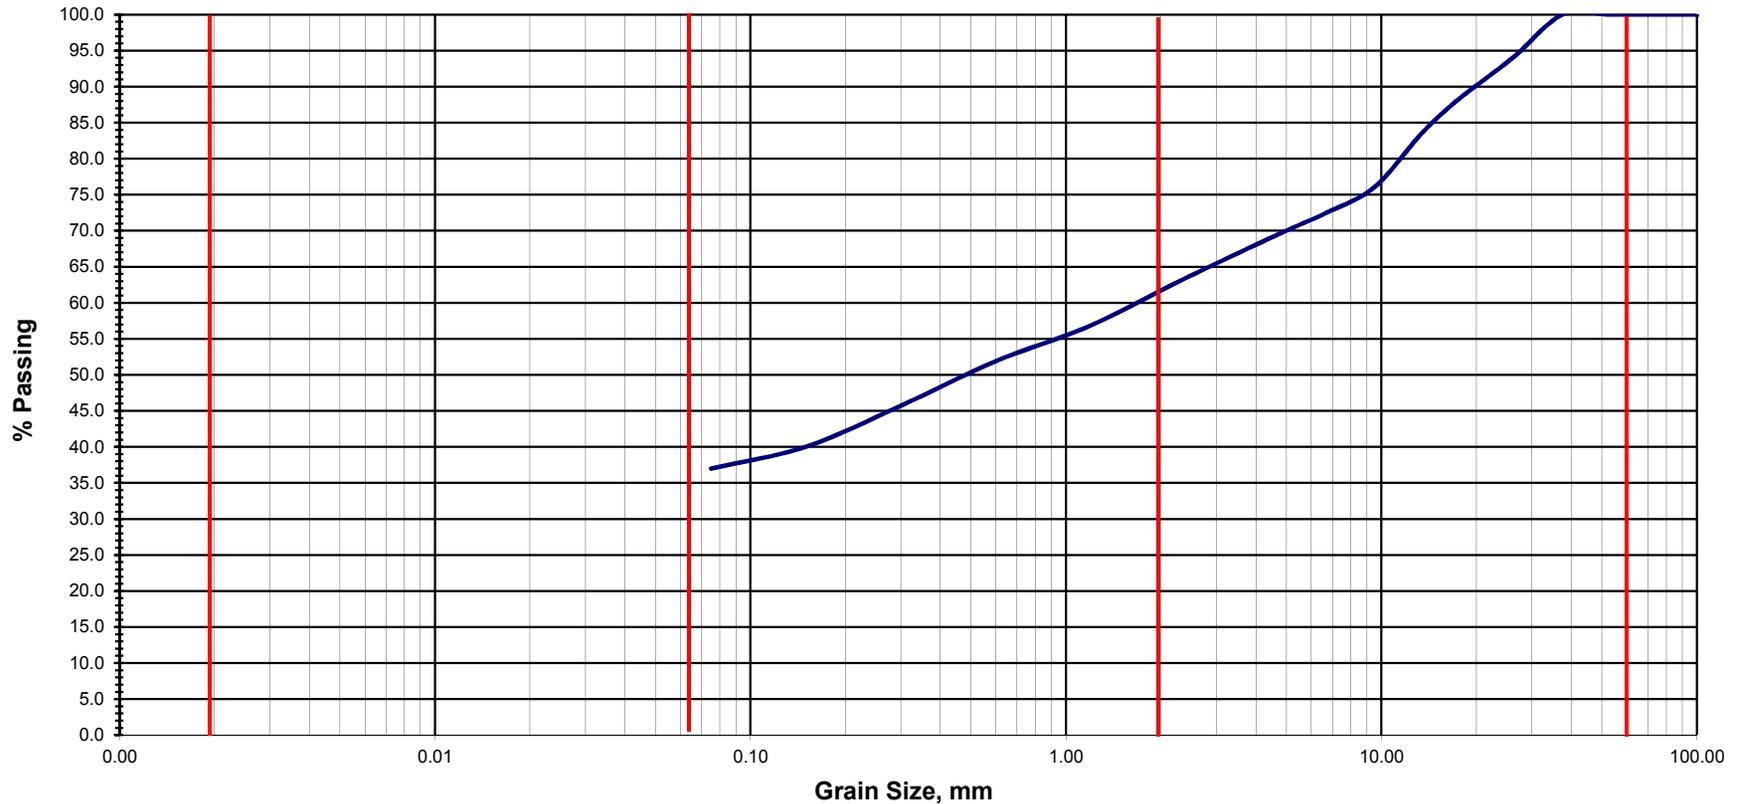
Exp Project No.:	OTT-00215839-A0	Project Name :	Geotechnical Investigation, Proposed Sewage Lagoon Expansion
Client :	Government of Nunavut	Project Location :	Hall Beach, NU
Date Sampled :	November 15, 2013	BOREHOLE	1
		SAMPLE	run 6
Sample Description :	<b>sandy GRAVEL and CLAY</b>		Depth (m) : 1.5-2.4
		Figure :	29

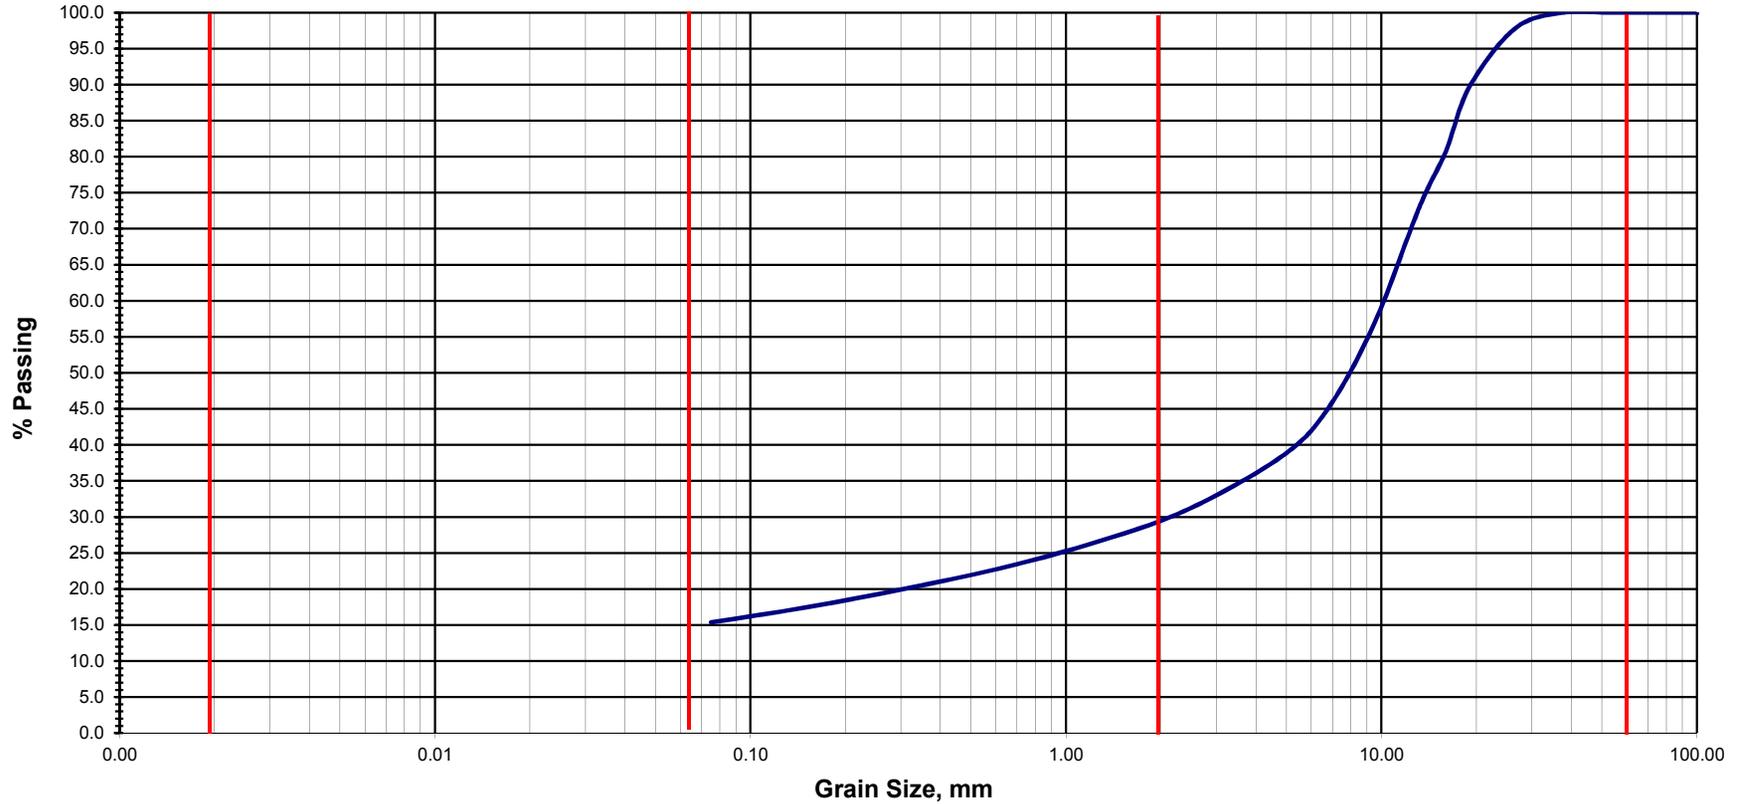
Exp Project No.:	OTT-00215839-A0	Project Name :	Geotechnical Investigation, Proposed Sewage Lagoon Expansion			
Client :	Government of Nunavut	Project Location :	Hall Beach, NU			
Date Sampled :	November 19, 2013	BOREHOLE	2	SAMPLE run 3	Depth (m) :	0.7-1.2
Sample Description :	<b>GRAVEL, some silt, some sand</b>				Figure :	17

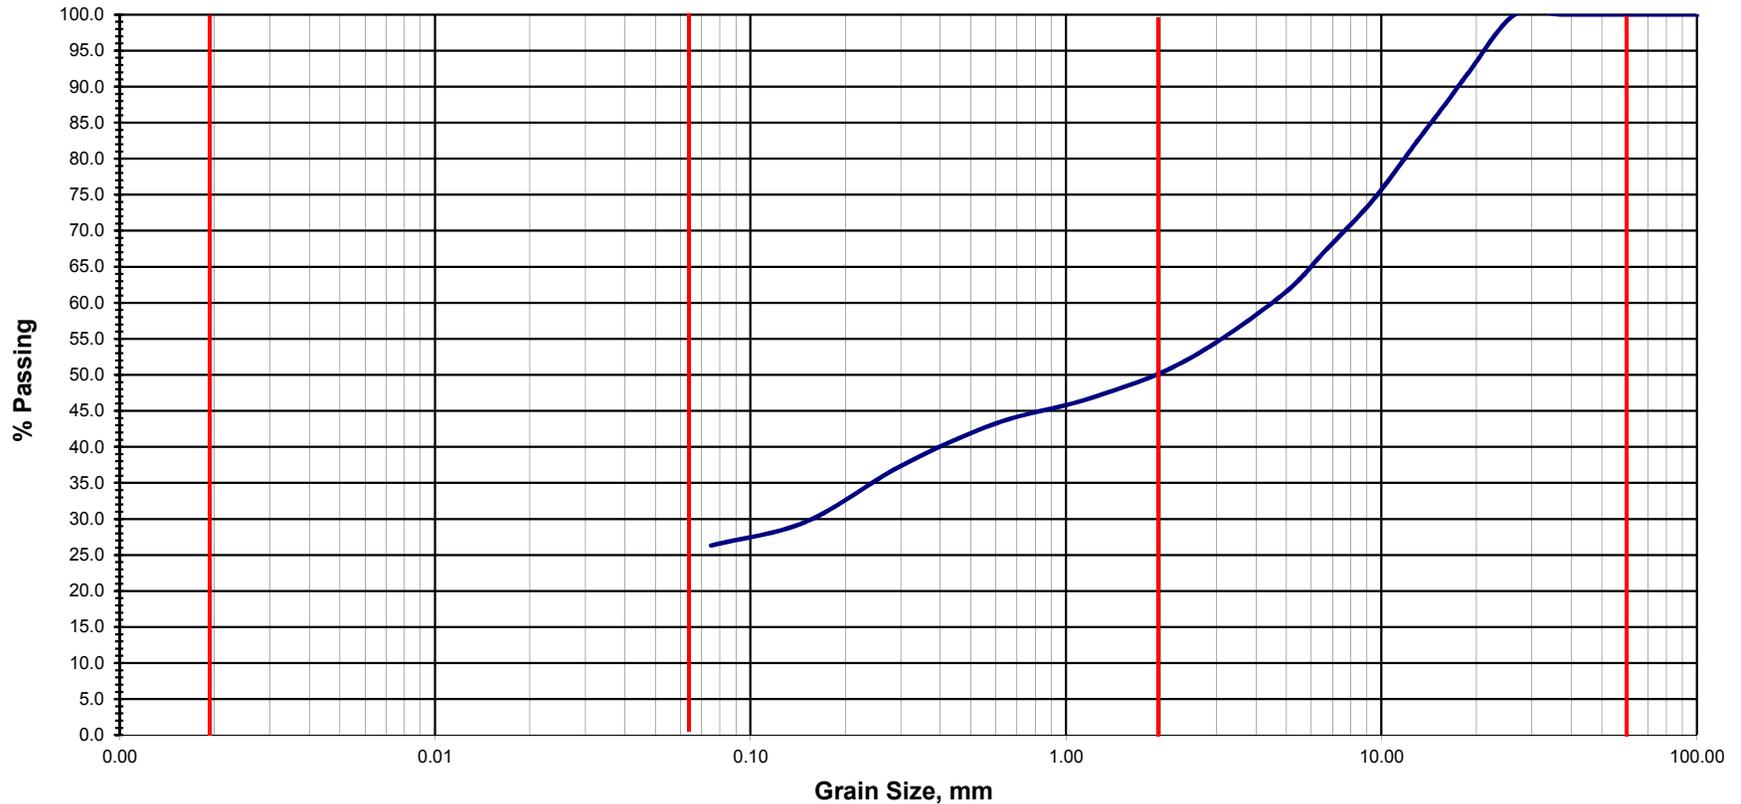
Exp Project No.:	OTT-00215839-A0	Project Name :	Geotechnical Investigation, Proposed Sewage Lagoon Expansion
Client :	Government of Nunavut	Project Location :	Hall Beach, NU
Date Sampled :	November 19, 2013	BOREHOLE	2
		SAMPLE	run 5
Sample Description :	<b>silty sandy GRAVEL</b>		Depth (m) : 2.0-2.4
		Figure :	30

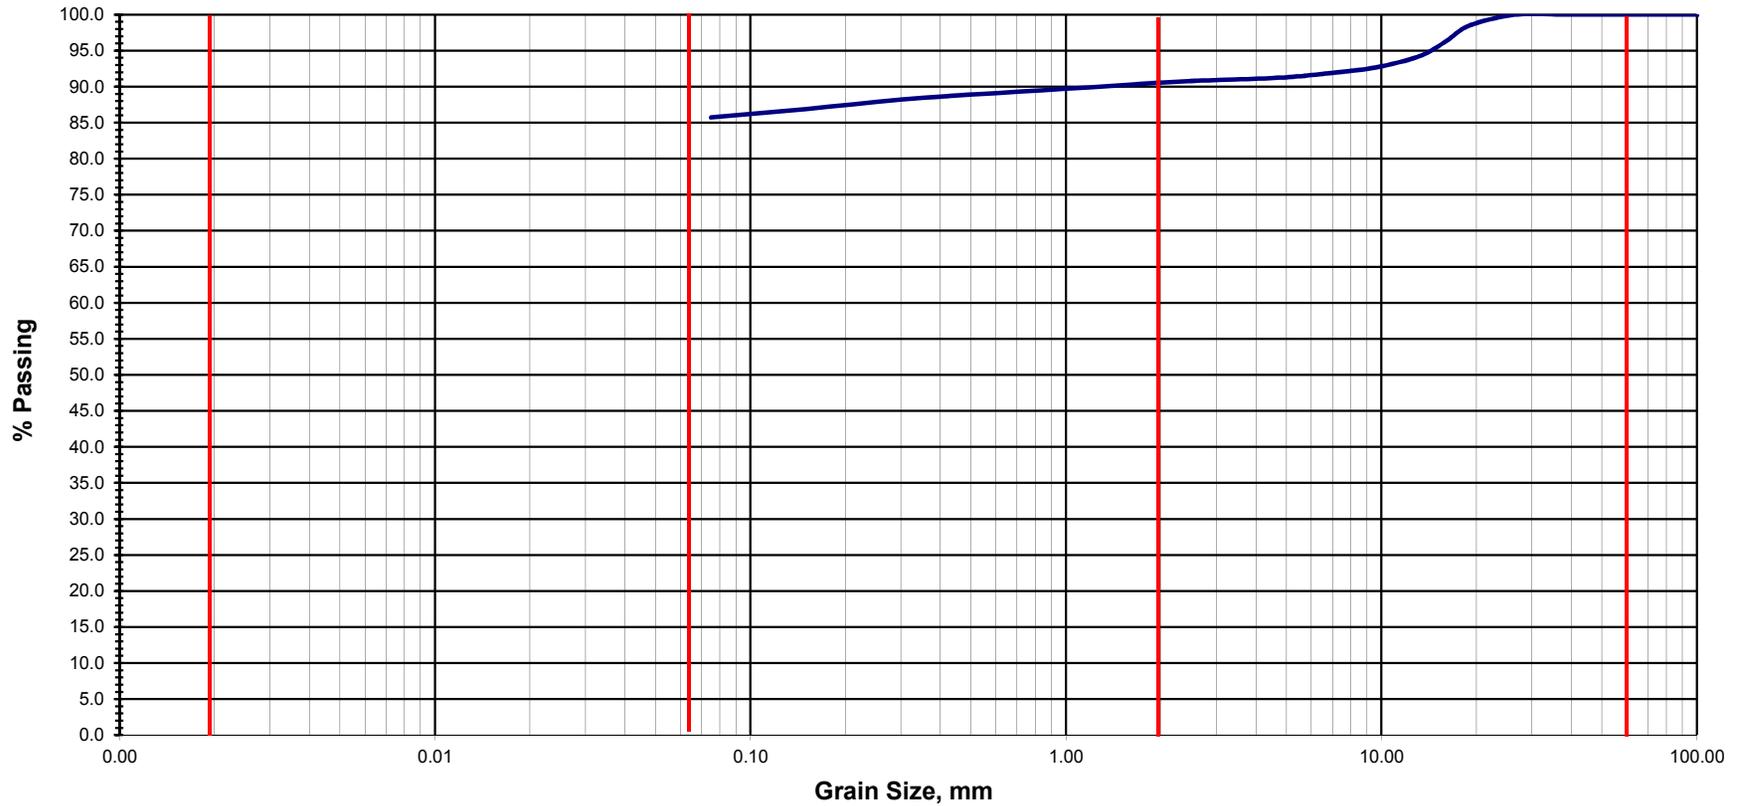
Exp Project No.:	OTT-00215839-A0	Project Name :	Geotechnical Investigation, Proposed Sewage Lagoon Expansion						
Client :	Government of Nunavut	Project Location :	Hall Beach, NU						
Date Sampled :	November 19, 2013	BOREHOLE	2	SAMPLE	run 6	Depth (m) :	2.4-3.7		
Sample Description :	CLAY, some gravel, some sand						Figure :	31

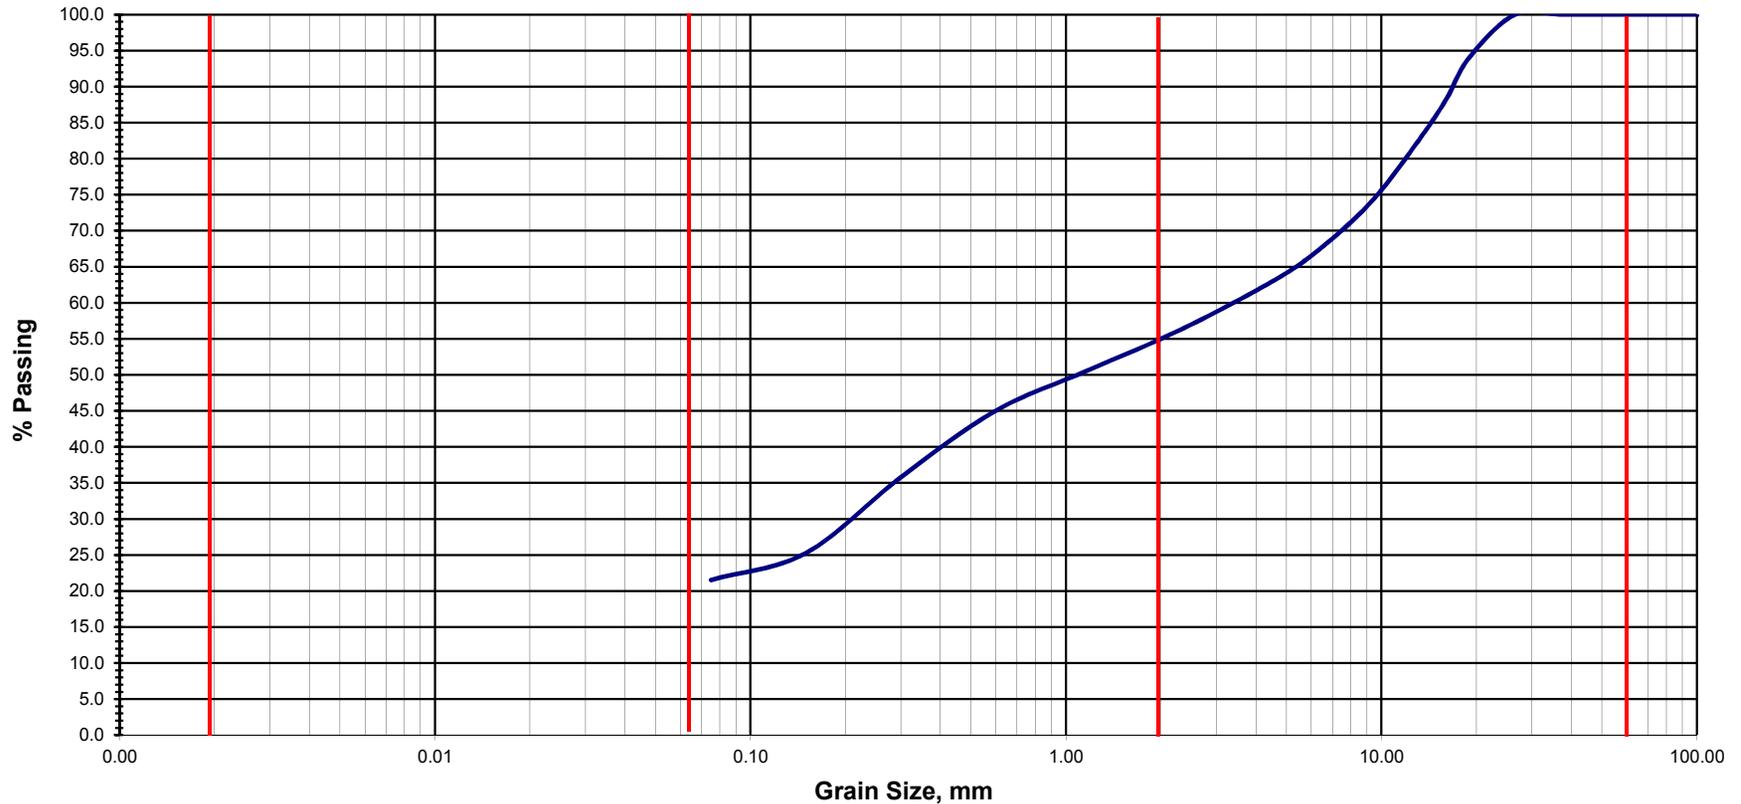
Exp Project No.:	OTT-00215839-A0	Project Name :	Geotechnical Investigation, Proposed Sewage Lagoon Expansion			
Client :	Government of Nunavut	Project Location :	Hall Beach, NU			
Date Sampled :	November 20, 2013	BOREHOLE	3	SAMPLE run 3	Depth (m) :	0.6-1.2
Sample Description :	<b>silty GRAVEL and SAND</b>				Figure :	32

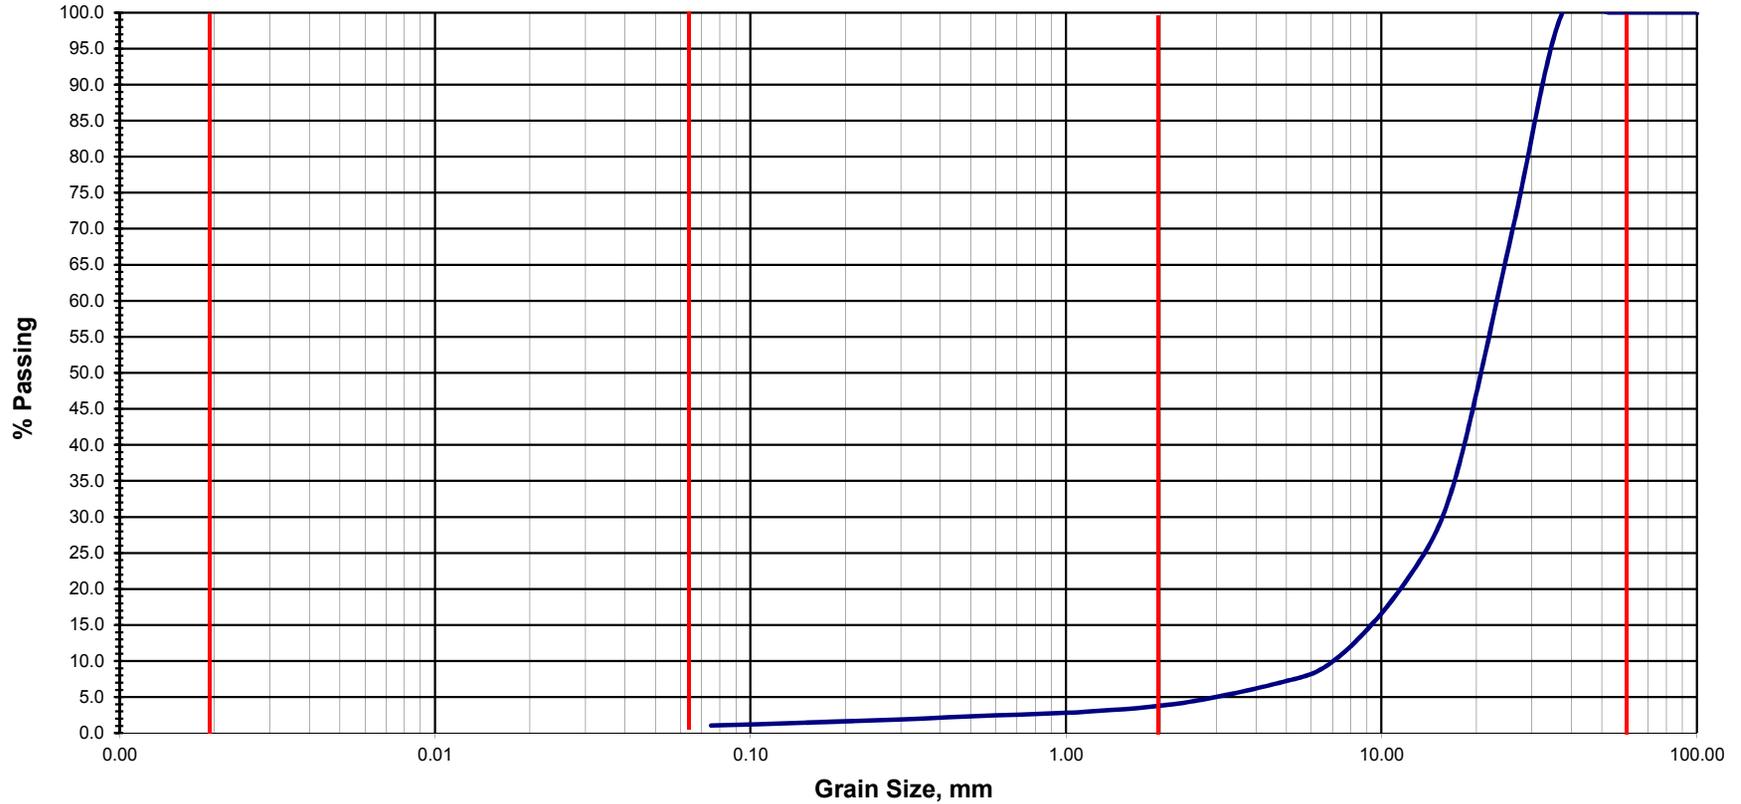
Exp Project No.:	OTT-00215839-A0	Project Name :	Geotechnical Investigation, Proposed Sewage Lagoon Expansion			
Client :	Government of Nunavut	Project Location :	Hall Beach, NU			
Date Sampled :	November 14, 2013	BOREHOLE	TP1	SAMPLE G2	Depth (m) :	0.3-0.5
Sample Description :	<b>GRAVEL, trace sand, trace silt</b>				Figure :	33

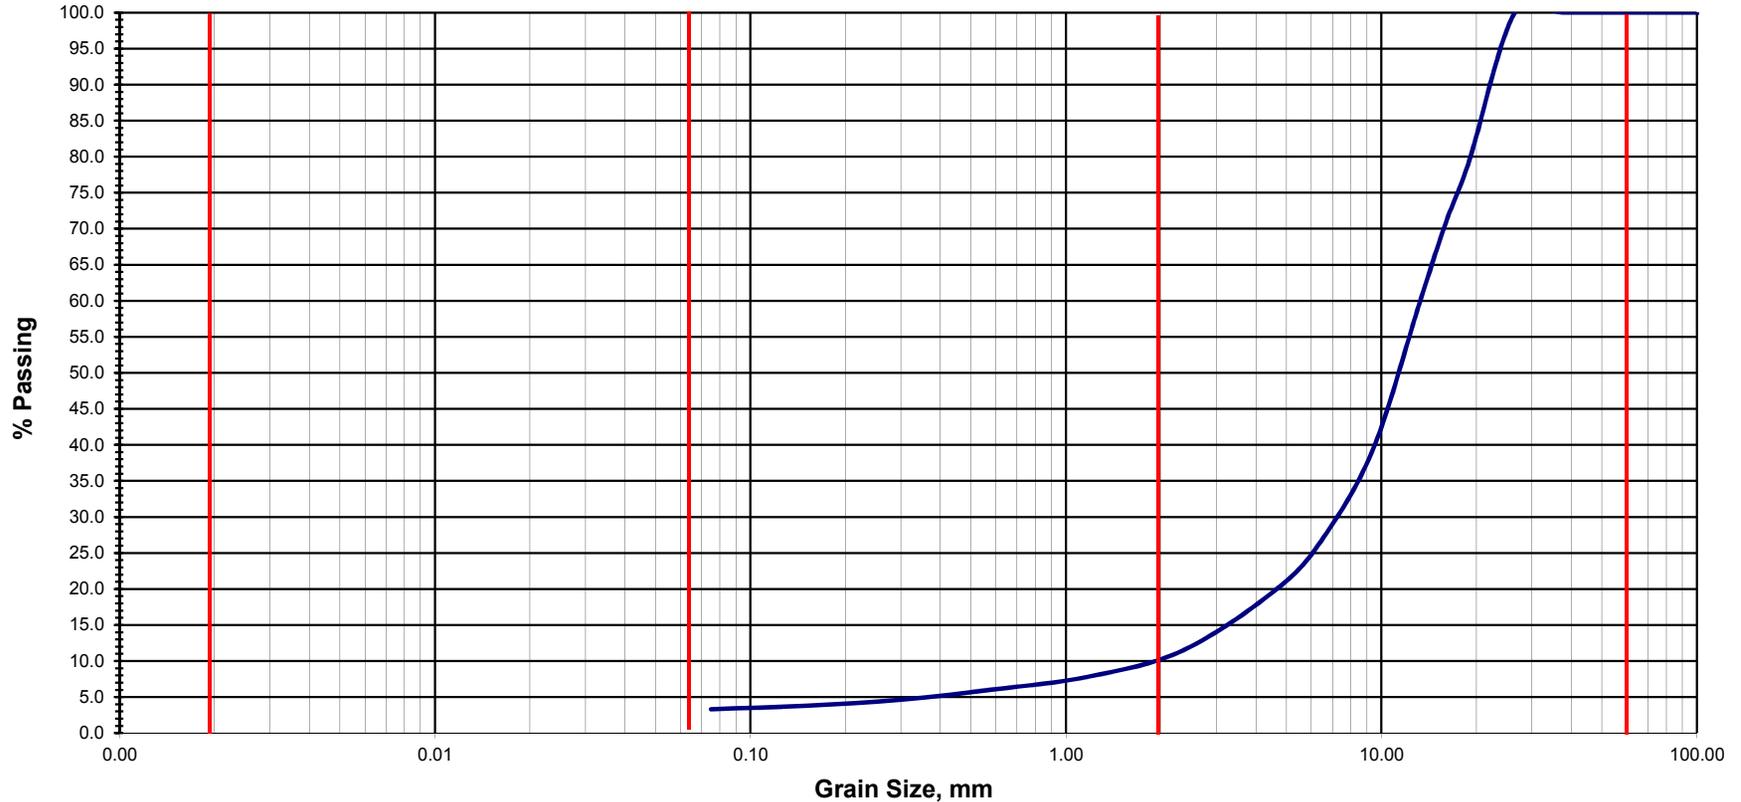
Exp Project No.:	OTT-00215839-A0	Project Name :	Geotechnical Investigation, Proposed Sewage Lagoon Expansion
Client :	Government of Nunavut	Project Location :	Hall Beach, NU
Date Sampled :	November 15, 2013	BOREHOLE	TP5
		SAMPLE	G1
Sample Description :	<b>GRAVEL, trace sand, trace silt</b>		Depth (m) : 0-0.4
			Figure : 34

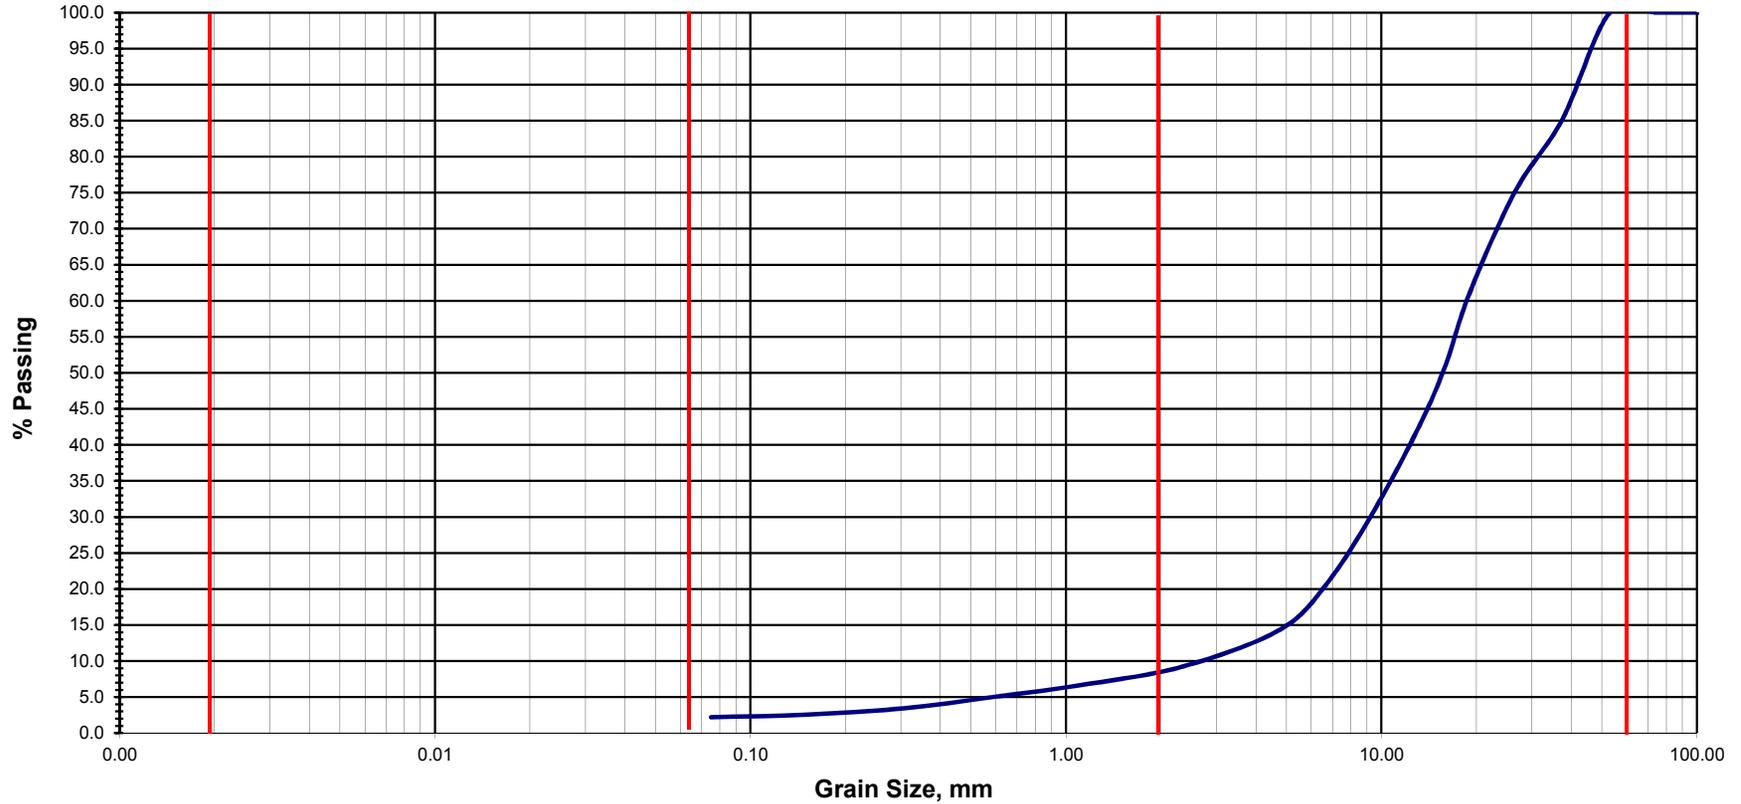
Exp Project No.:	OTT-00215839-A0	Project Name :	Geotechnical Investigation, Proposed Sewage Lagoon Expansion						
Client :	Government of Nunavut	Project Location :	Hall Beach, NU						
Date Sampled :	November 15, 2013	BOREHOLE	TP5	SAMPLE	G2	Depth (m) :	0.3-0.5		
Sample Description :	<b>GRAVEL, trace sand, trace silt</b>						Figure :	35

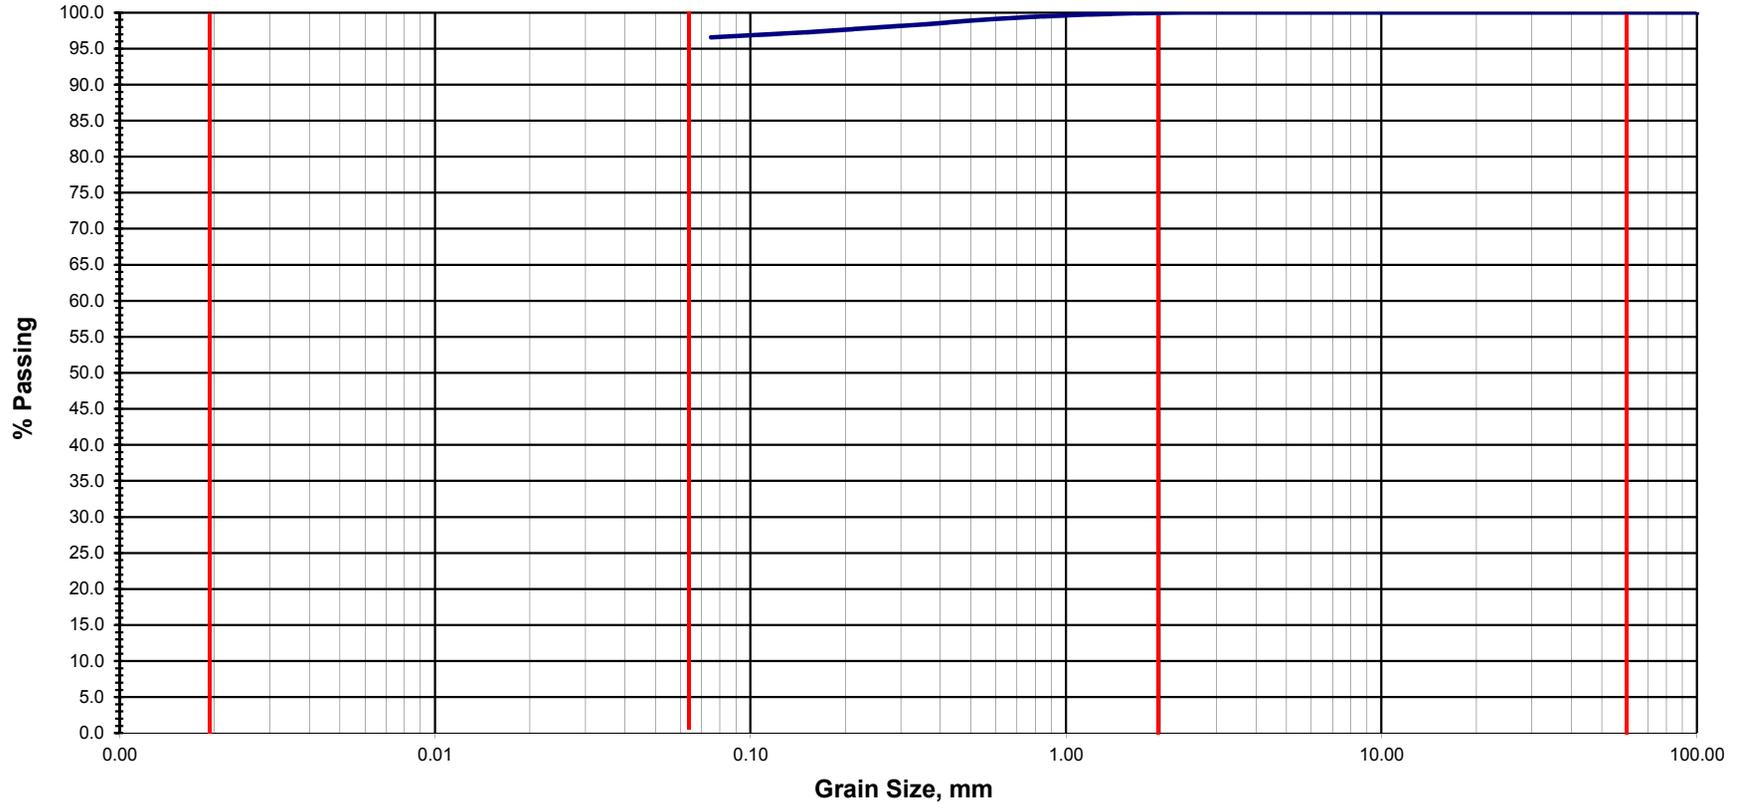
Exp Project No.:	OTT-00215839-A0	Project Name :	Geotechnical Investigation, Proposed Sewage Lagoon Expansion						
Client :	Government of Nunavut	Project Location :	Hall Beach, NU						
Date Sampled :	November 15, 2013	BOREHOLE	TP7	SAMPLE	G3	Depth (m) :	0.4-0.7		
Sample Description :	CLAY, trace sand						Figure :	36

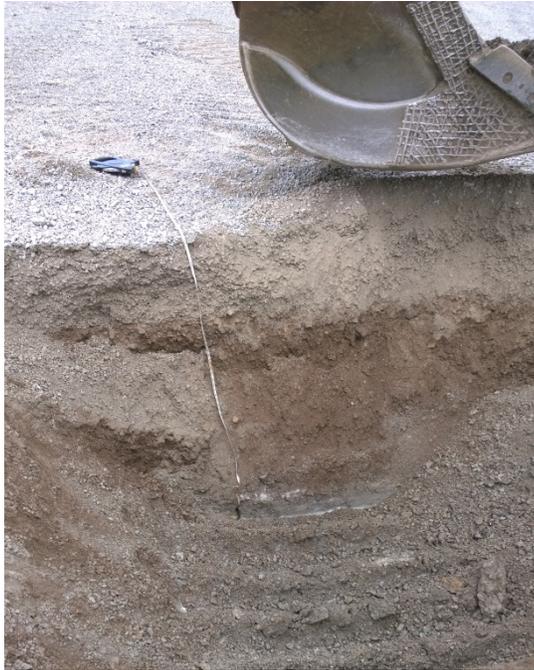
**Photo 1: August 25, 2014 – TP10**

Based on the test pits excavated along the outside toe of the existing south berm (TP10, TP11, TP12 and TP21), the layer of debris is present directly adjacent to and beneath portions of the existing outside slope. It is noted that the test pits excavated along the existing slope were extended to just beneath the toe and the full extent of the debris present beneath the berm will also need to be delineated at the time of construction. However, based on the test pits excavated throughout the existing base of Cell 1 (TP01 to TP09, TP13 and TP14) the layer of debris does not appear to extend inside the existing lagoon.

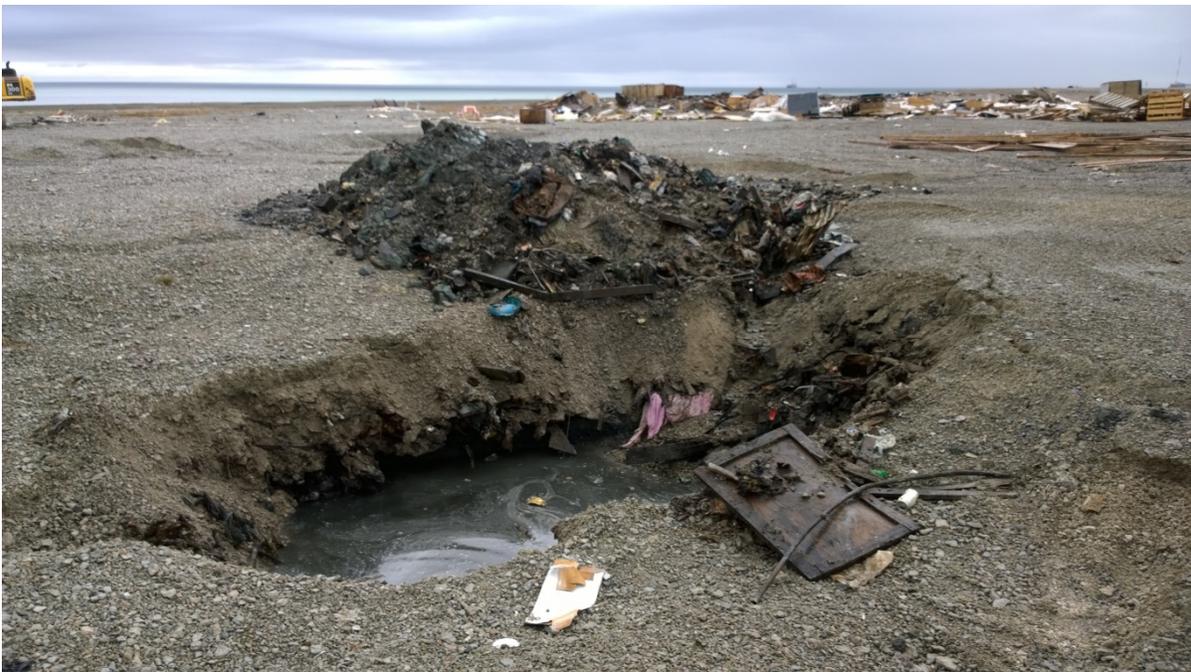
**Photo 2: August 25, 2014 – TP11**

A layer of light grey silty sandy gravel to gravel with some silt, and sand fill/till was encountered at the surface in all three boreholes and all twenty-three test pits. In test pits TP11 and TP16 the surficial gravel layer was observed to be intermixed with debris just beneath the surface. In test pits TP12, TP18 and TP23 the surficial gravel layer was observed to be 0.5 m to 0.8 m thick and underlain by debris.

A layer of debris (pieces of metal, wood, plastic, glass, etc.) intermixed with organic materials and brown to black silty sandy gravel was observed in test pits TP11, TP12, TP16, TP18 and TP23. Test pits TP12, TP16, TP18 and TP23 were terminated due to practical refusal within the debris layer at total depths of 1.6 m, 1.0 m, 1.1 m and 1.4 m, respectively. The only test pit that could continue through the full thickness of the debris layer was TP11, where the debris layer was observed to be 1.0 m thick and underlain by silty sandy gravel similar to that noted above.

The layer of debris was observed to contain sharp pieces of metal, wood, etc. that would represent considerable risk to the integrity of the liner system if left in place. Furthermore, it is apparent that voids present throughout the debris layer have resulted in the washing out of fines from the silty sandy gravel fill materials used to construct the existing south berm and that this has resulted in the observed leakage of Cell 1 over the years. Therefore, it is recommended that the debris be removed down to approved soils throughout the expansion footprint and replaced with embankment fill as outlined herein.
