July 12, 2001 Municipal Water Use Inspection - Report

MUNICIPAL WATER USE INSPECTION FORM

Date: 2001/07/12 Licensee Rep. (Name/Title): Brian Martin / SAO
Licensee: Municipality of Hall Beach Licence No.: unlicensed

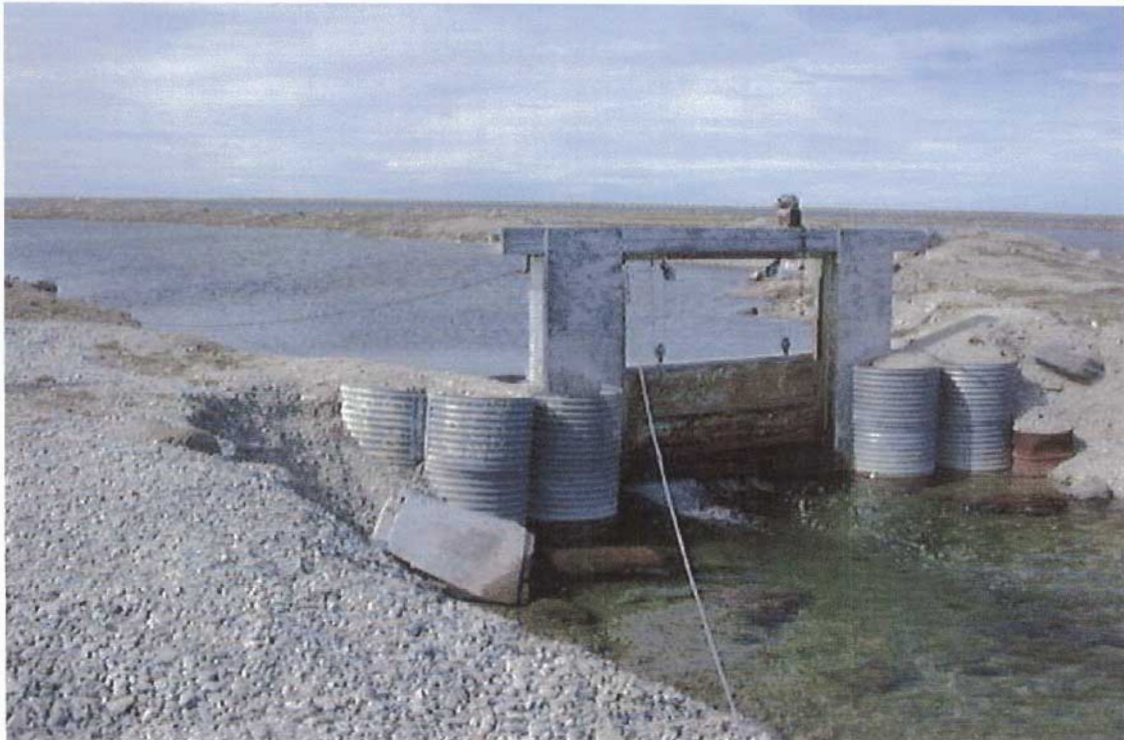
- **Water supply:** No concerns were noted in regards to the truckfill station at the newly-built reservoir, or to the quality of the municipal water supply. As such, the attached analytical results relating to a sample collected from the decant station at Water Lake (figure 1) indicate that the raw water meets the *Guidelines for Canadian Drinking Water Quality*, save for a faint exception: a field pH value of 8.8, which rests slightly above the 8.5 aesthetic objective. However, the state of secondary water impoundment structures proved far from ideal and will need to be seen to. Indeed, the western berm of the 'outer' lake, immediately downstream of the decant station, has been breached (figure 2). Further, excessive spring runoff has also created a sizeable breach in the northern berm of the 'inner' lake, which lies between the 'outer' lake and the water reservoir (figure 3). In consequence, it will likely prove impossible to recharge the water reservoir (figure 4) this year. As the reservoir probably does not contain more than two years worth of water supply, the Inspector trusts that Community Government and Transportation (CG&T) will respond to the municipality's requests for suggestions and/or assistance on how to best deal with the matter.

figure 1. Decant station at outlet of Water Lake; 2001/07/12.

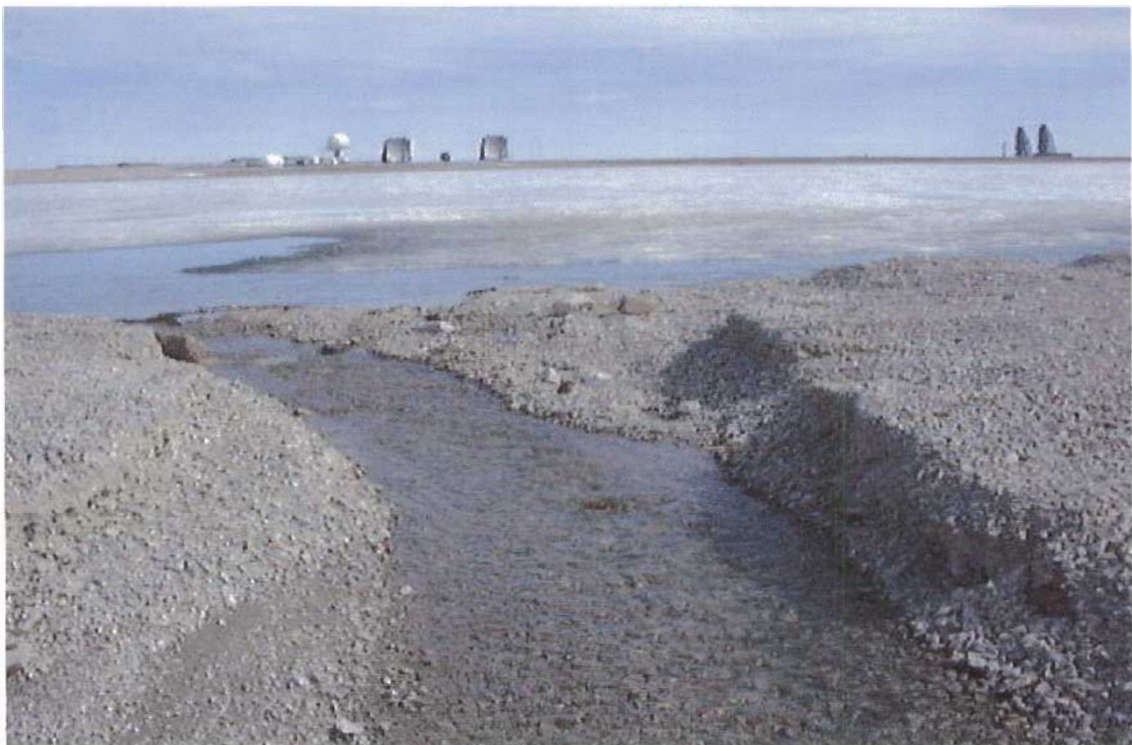
Comments: No concerns noted in regards to the truckfill station at the recently-built reservoir. Abundant spring runoff brought on breaches of secondary water impoundment structures; may be impossible to recharge the water reservoir this year. Chlorination in use. Filtration system no longer operated since malfunction; outside resources required to correct the problem.

figure 2. Breached berm along western face of the 'outer' lake; 2001/07/12.

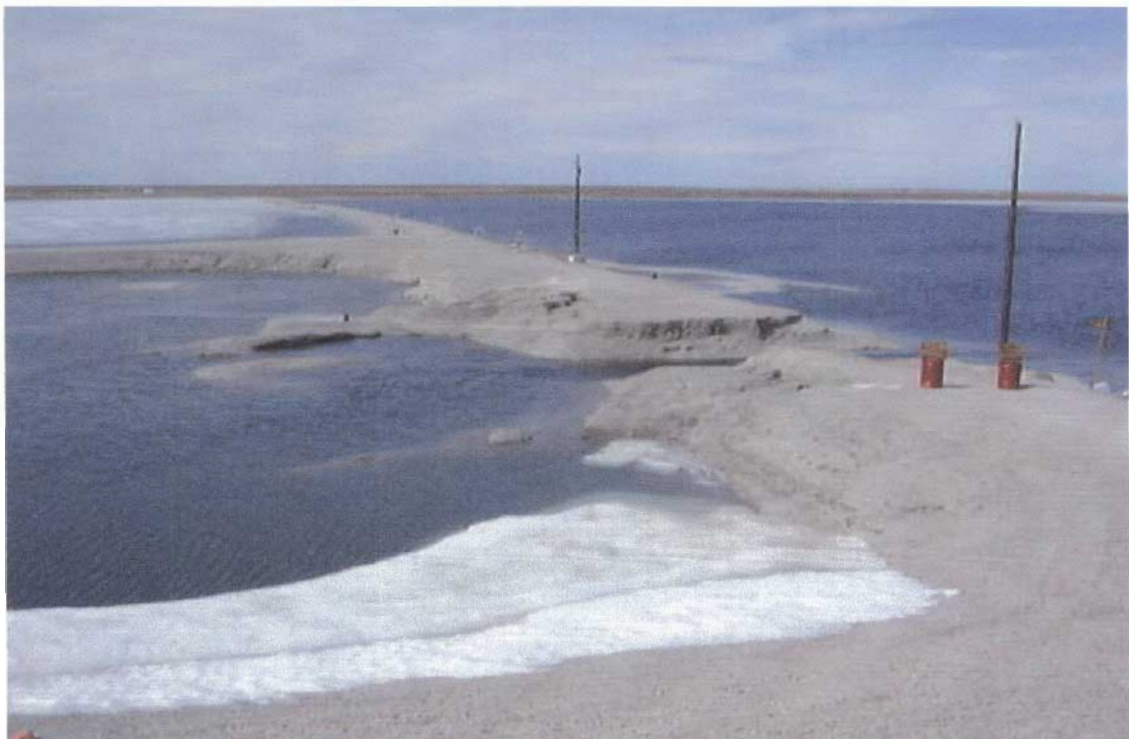
figure 3. Breached berm along the northern face of the 'inner' lake; 2001/07/12.

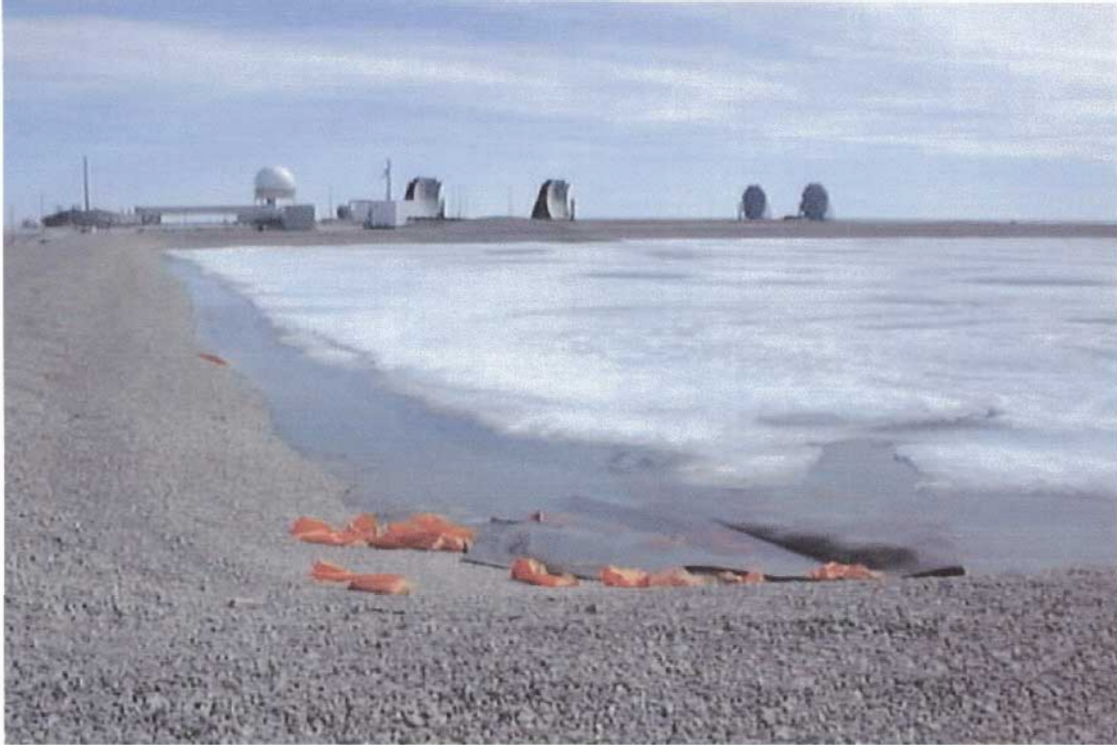
figure 4. Water reservoir, with truckfill station in background; 2001/07/12.

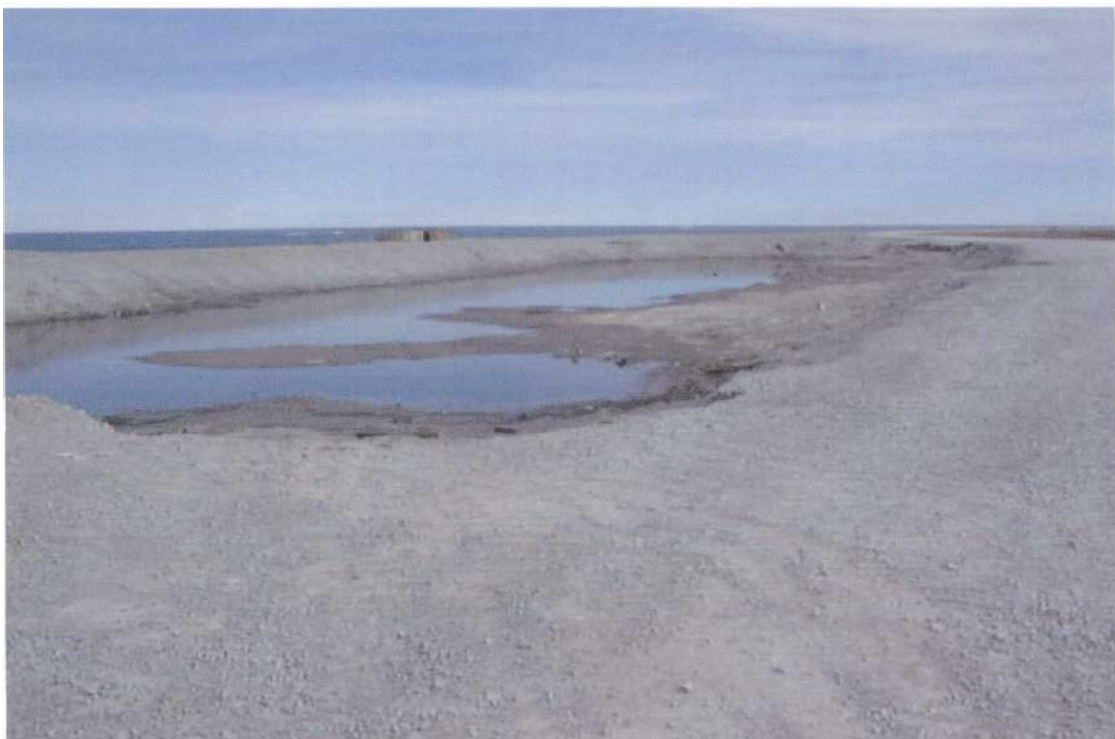
- **Sewage disposal:** The state of the sewage disposal facility also poses some concerns. Both sewage lagoon cells, in particular cell 2 (figure 5), are essentially dried out. In addition, as the contents of sewage lagoon cell 1 (figure 6) was noticeably seeping along the toe of the outer berm, minimal retention time appeared to be provided to the effluent prior to discharge to receiving waters (figure 7).

Comments: Sewage lagoon cells almost completely dried out; retention time apparently minimal. Abundant seepage noted; effluent flow bypasses drainage ditch. Partly-fenced solid waste disposal facility appears well managed; wastepile burnt regularly, covered on annual basis. Bulky metal wastes are segregated; old site along the shoreline and active site near the solid waste disposal facility. No particular storage/disposal area for hazardous materials; batteries and waste oil drums present in various areas. Significant volume of runoff flows along the toe of the solid waste disposal facility.

figure 6. Sewage lagoon cell 1; 2001/07/12.

The attached analytical results relating to a sample taken five metres from the outer berm reveal that levels of ammonia (61.7 mg/L vs 2.2 mg/L) and phenols (40 µg/L vs 4.0 µg/L) exceed the *Canadian Water Quality Guidelines for the Protection of Freshwater Aquatic Life*. Moreover, the Microtox sample, which constitutes a reliable toxicity indicator (IC₅₀), shows that half of light-producing bacteria were inhibited by a sample concentration of 47.6%, whereas 50% and over is considered non-toxic. This being said, it was mentioned during the inspection that engineer(s) were due to assess the status of the sewage disposal site this summer, and possibly contemplate alternative facilities.

Samples Collected Hamlet: none
INAC: raw water, sewage discharge, dump leachate
Signs Posted SNP: not applicable Warning: none
Records & Reporting: none required
Geotechnical Inspection: none required; may be warranted due to excessive seepage from the lagoon cells

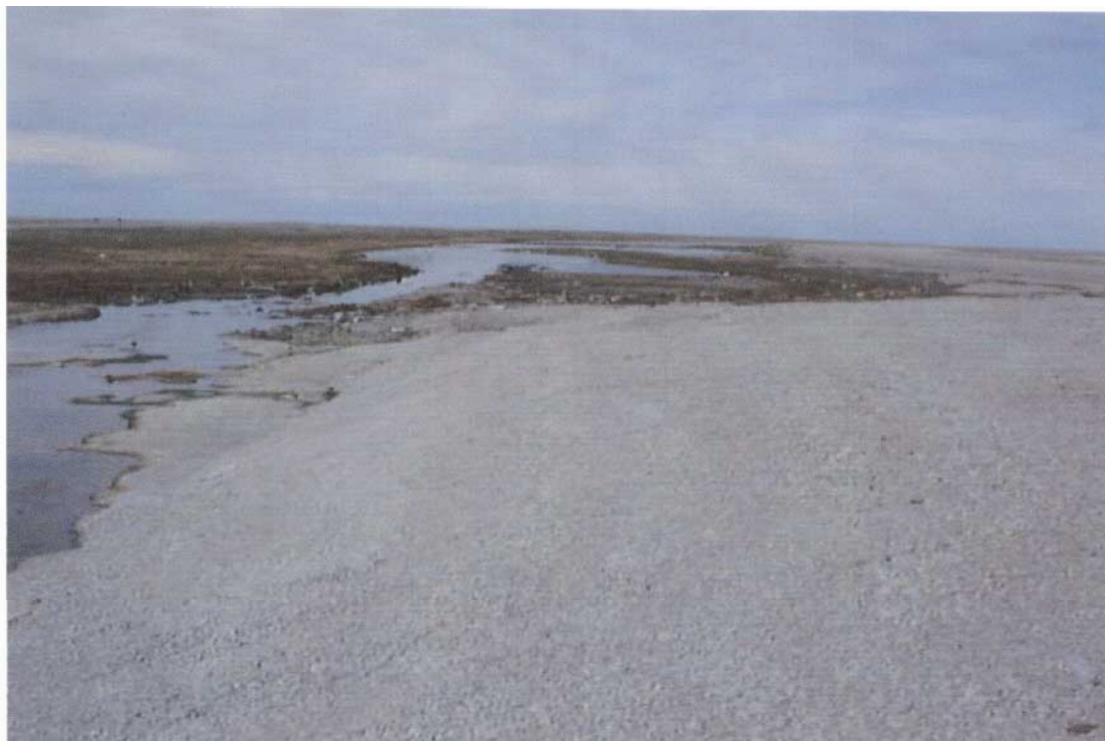
figure 7. Path of effluent discharge from the sewage disposal facility; 2001/07/12.

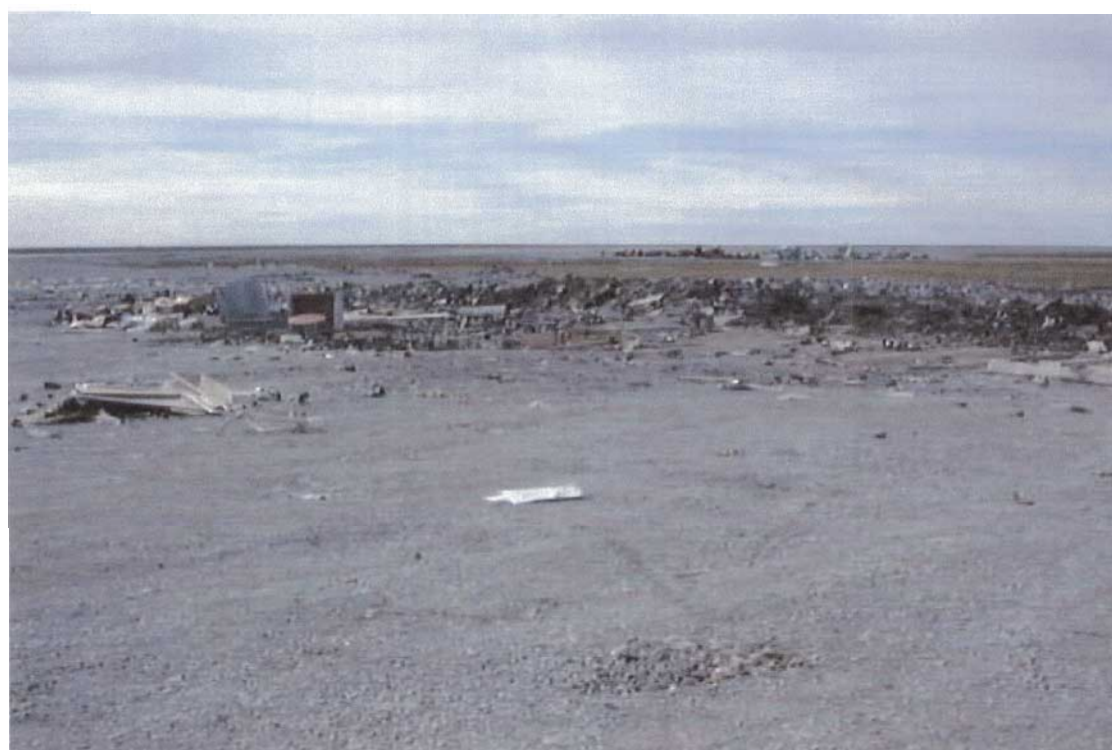
- **Solid waste disposal:** Although combustible waste appears well burned/compacted and periodically covered (figure 8), the completion of the partial perimeter fence would greatly minimize the extent of windblown wastes in the vicinity of the solid waste disposal facility. In regards to waste segregation, assigning a sealift container to the storage of batteries and other hazardous materials would lessen the chance of contaminants being accidentally deposited into water. Lastly, the significant volume of runoff flowing along the toe of the solid waste disposal facility potentially implies leachate considerations. Nonetheless, the Microtox sample collected downstream of the toe of the dump (figure 9) did not attribute toxicity to the effluent, and concentrations of only copper (30 µg/L vs 4.0 µg/L) and iron (1.06 mg/L vs 0.3 mg/L) exceeded the *Canadian Water Quality Guidelines for the Protection of Freshwater Aquatic Life*.

figure 8. Solid waste disposal facility, with bulky wastes in background; 2001/07/12.

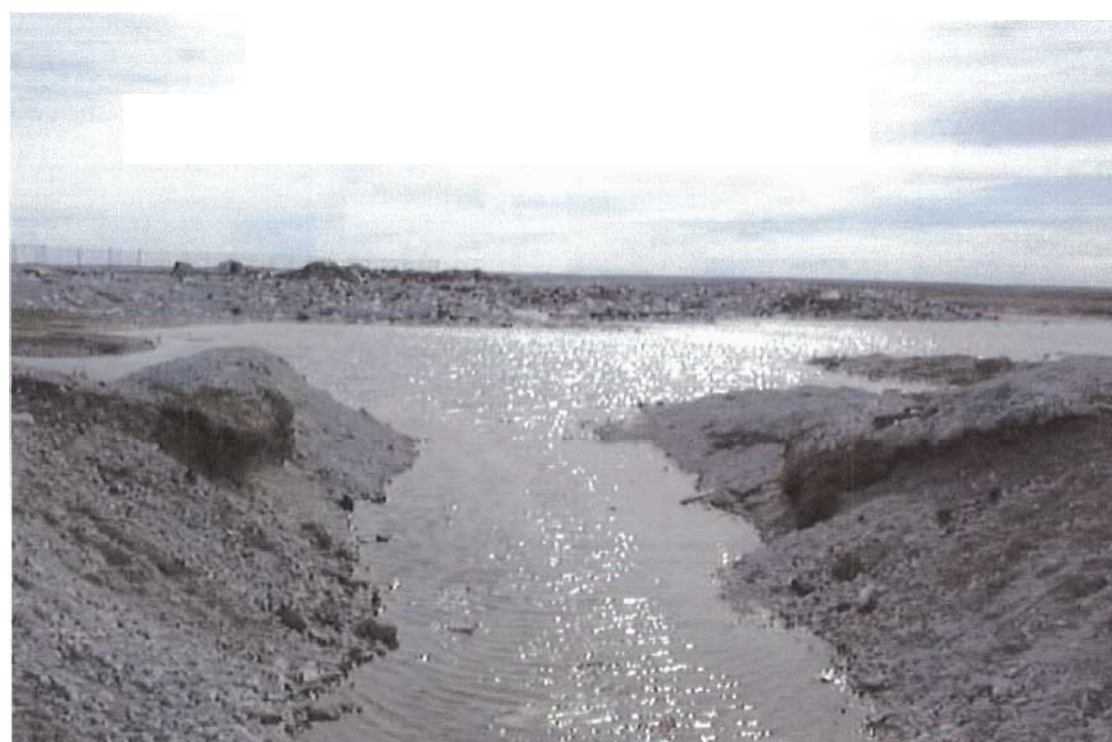
figure 9. Runoff flowing along the toe of the solid waste disposal site; 2001/07/12.
