### **DIAND Inspection Reports**

*Ferguson Simek Clark*  
*Hall Beach Water Licence Application*  
*Project No. 2002-1000-052*

July 12, 2001 Municipal Water Use Inspection - Report

## MUNICIPAL WATER USE INSPECTION FORM

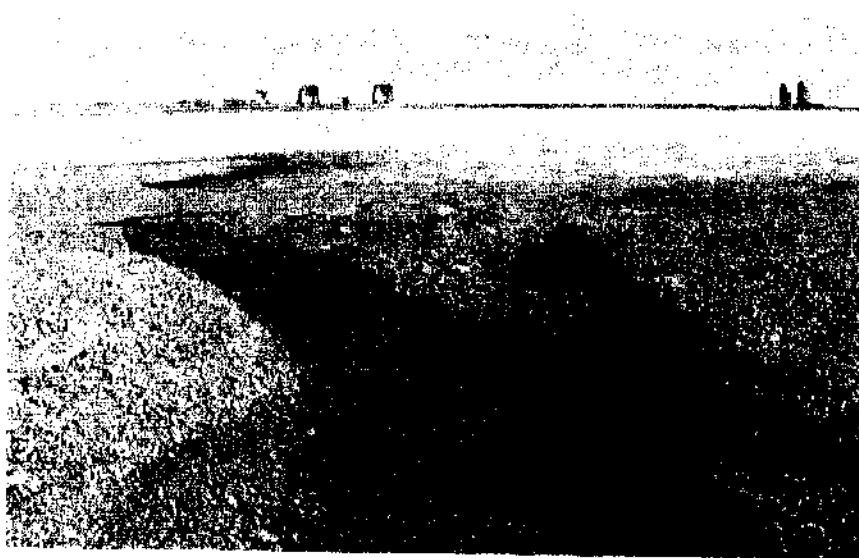
figure 2. Breached berm along western face of the 'ouner' lake; 2001/07/12.

Comments: No concerns noted in regards to the truckfill station at the recently-built reservoir. Abundant spring runoff brought on breaches of secondary water impoundment structures; may be impossible to recharge the water reservoir this year. Chlorination in use. Filtration system no longer operated since malfunction; outside resources required to correct the problem.

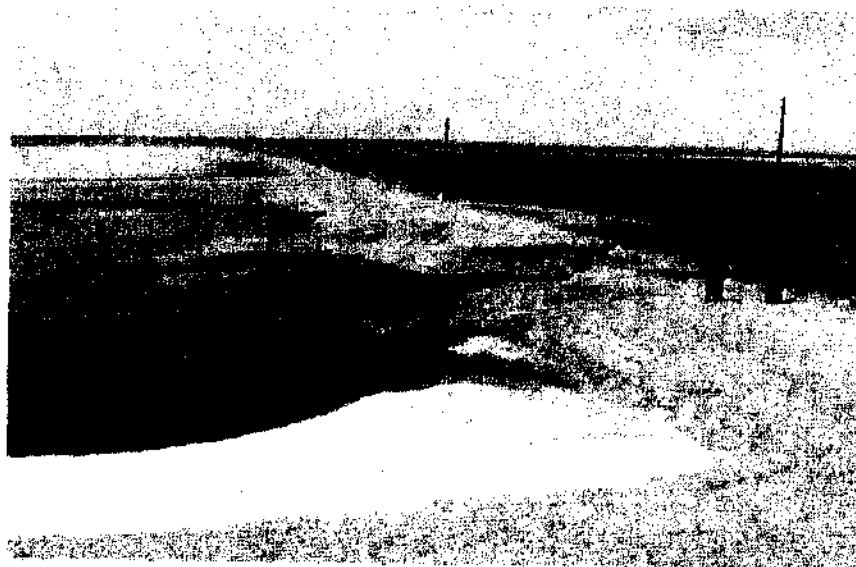
figure 3. Breached berm along the northern face of the 'inner' lake; 2001/07/12.

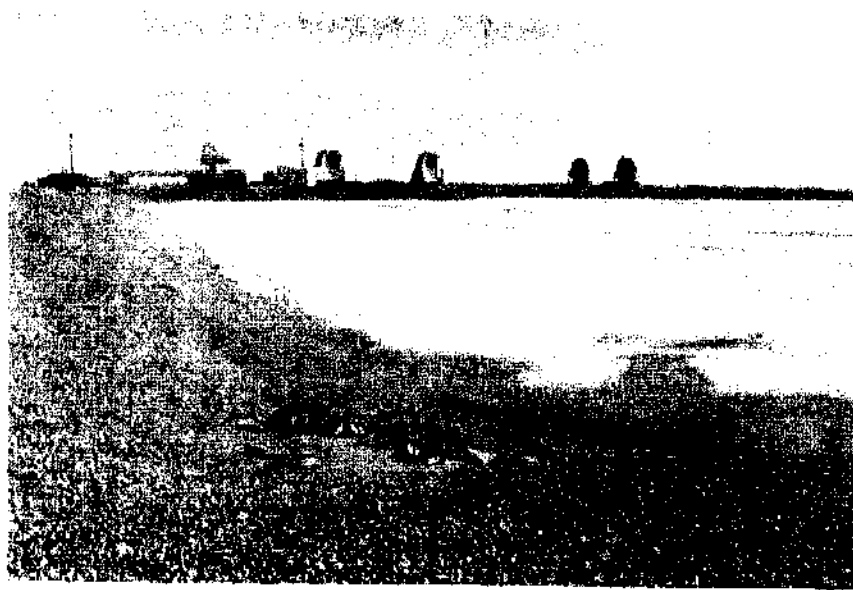
figure 4. Water reservoir, with truckfill station in background: 2001/07/12.

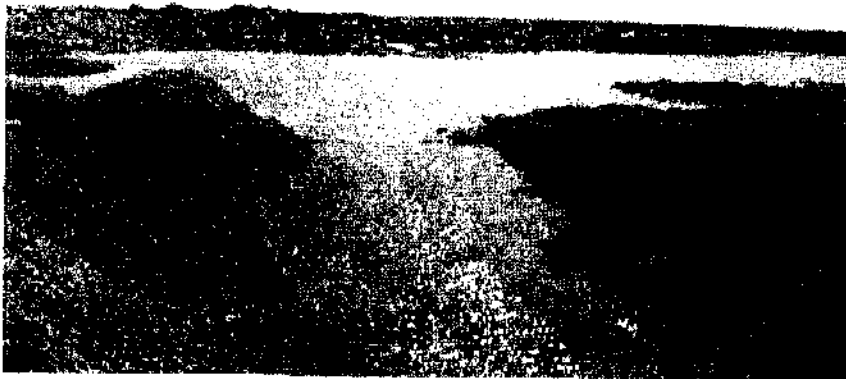
Comments: Sewage lagoon cells almost completely dried out; retention time apparently minimal. Abundant seepage noted; effluent flow bypasses drainage ditch. Partly-fenced solid waste disposal facility appears well managed; wastepile burnt regularly, covered on annual basis. Bulky metal wastes are segregated, old site along the shoreline and active site near the solid waste disposal facility. No particular storage/disposal area for hazardous materials; batteries and waste oil drums present in various areas. Significant volume of runoff flows along the toe of the solid waste disposal facility.

figure 9. Runoff flowing along the toe of the solid waste disposal site: 2001/07/12.
