**Sub: Conditions applying to Operation and Maintenance,  
Hamlet of Hall Beach, Water License no. 3MB-HAL0810**

## Action Plan on the remedial works of Hall Beach Sewage Lagoon, Cell -1

**Prepared by: Bhabesh Roy, M.A.Sc., P.Eng.  
MPE, Baffin Region, GN-CGS.**

Hall Beach Sewage Lagoon-Cell 1, field Inspection Report

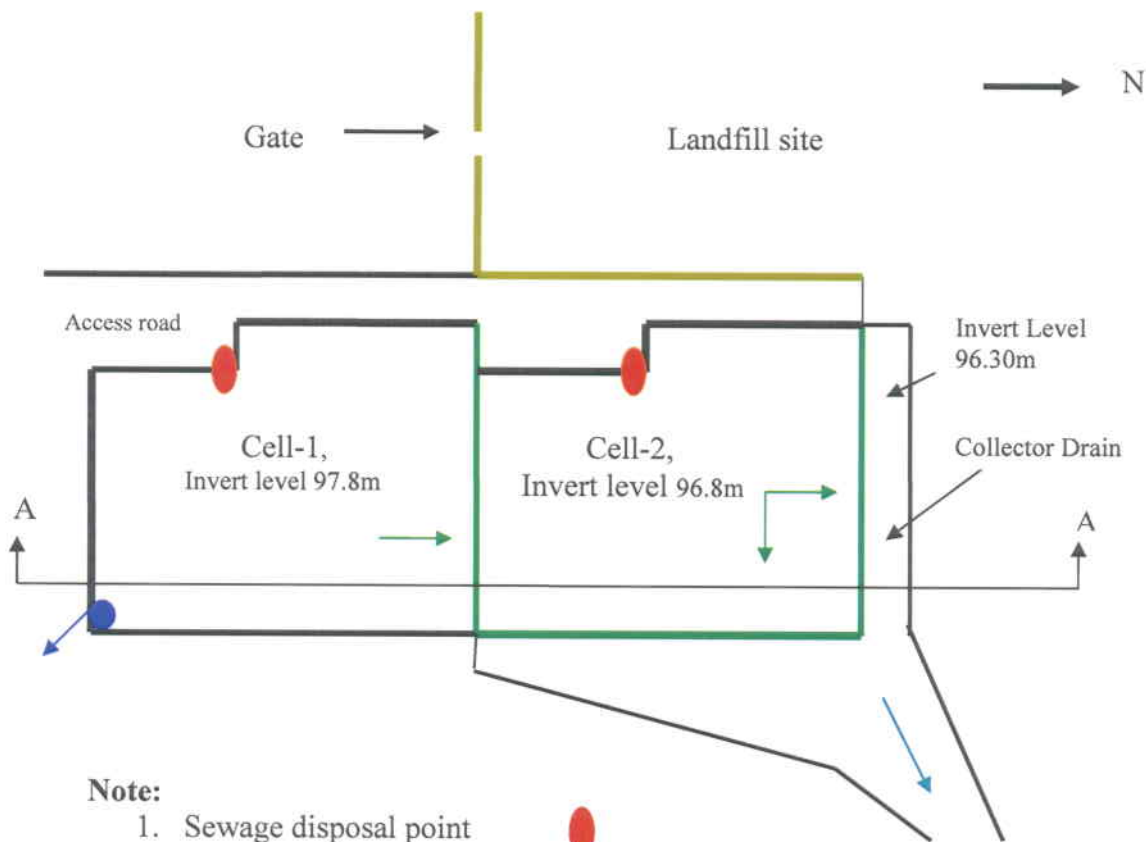
**Introduction:** Hall Beach is a small community of Baffin Region, Nunavut, with only 700 populations and located within a zone of continuous permafrost. This is the unique community located on sand and gravel raised beaches with flat and gently rolling terrain with numerous lakes and ponds. This community like many others in Baffin Region provides trucked sewage services for the community's residents, businesses and institutions. Currently the wastewater of this community is being treated by two cells aerated Lagoons located more than 1km to the North of this community at  $68^{\circ}48.3'N$  and  $81^{\circ}15.79'W$ . The Land fill site is located almost perpendicular to these lagoons just opposite side of the access road as shown below.

1. Sewage disposal point
2. Exfiltration Berm
3. Containment Berm
4. Landfill site fencing
5. Leakage (developed)
6. Effluent flow

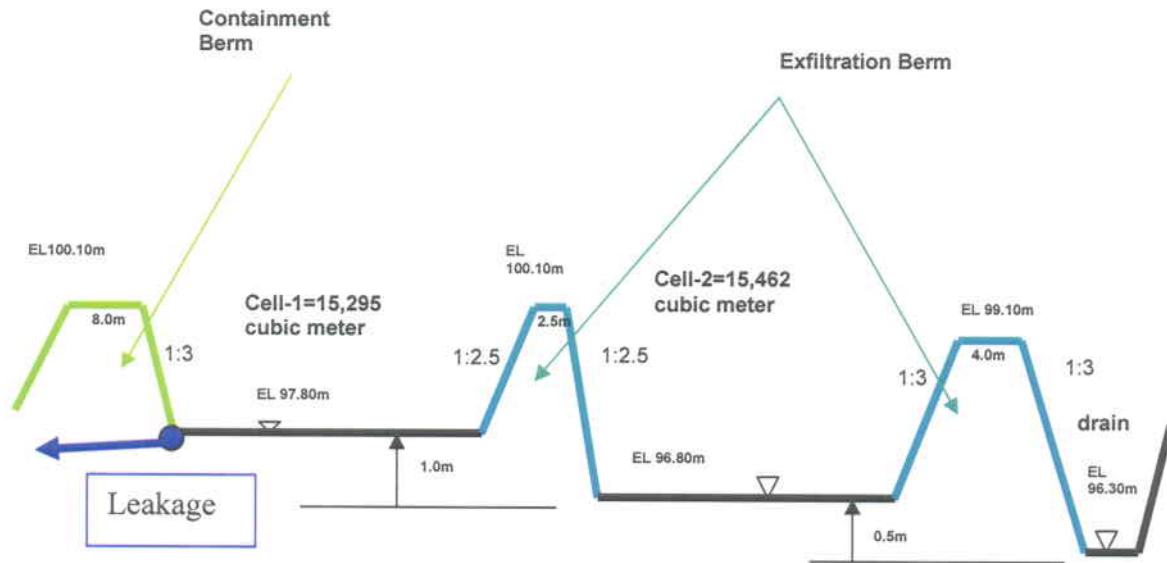
## Hall Beach Sewage Lagoons

### Section: A - A

1. The Common berm of cell 1 and 2 is exfiltration berm and it allows seepage from cell 1 to cell 2.
2. The E-W berm of cell 2 is also exfiltration berm and allows seepage from cell 2 to the collector drain.
3. The N-W berm of cell 2 is also an exfiltration berm and allows seepage to the Wetlands from cell 2.
4. The bed level of cell 2 is 1m below from the bed level of cell 1.
5. The invert level of the drain is 0.5m below from the bed level of cell 2.

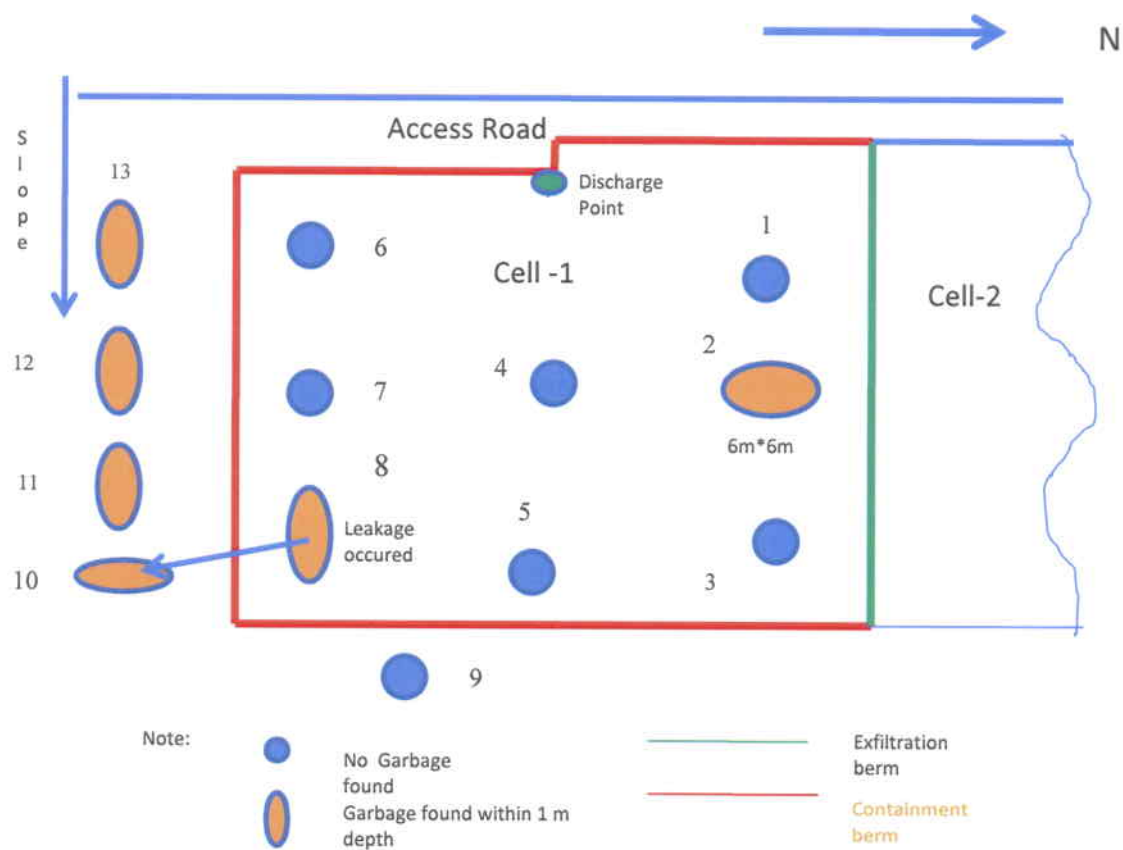
For further investigation, Bhabesh again visited the site on August 20 and worked there with Kudlik construction ltd until August 21. A massive investigation was conducted by digging 8 holes inside of cell 1 with an excavator to find out the extent of garbage under this lagoon bed and five holes outside of cell 1 to know the surroundings. It has been observed that these two holes (2 and 8) inside cell 1 only contains garbage but they are not connected each other. This confirms that the corner hole which drained out entire liquid from cell 1. No other garbage spot was identified inside the cell 1. But the corner hole (8) has shown garbage also under the E-W containment berm of cell 1.

Outside of this containment berm of cell 1, along E-W direction, a big garbage area has been identified. It appears that this containment berm might be built on the garbage area. Since no geotechnical report is available, it is also difficult to ascertain the extent of the garbage area under this berm. No garbage was found in hole (9) outside of the N-S berm of cell 1. The field assessment sketch is attached.

1. Remove all the garbages from both the holes (2 and 8) of cell 1.
2. Dump the garbage contaminated soil in the designated area of the landfill site.
3. Backfill in layers with fresh gravel imported from the Hamlet stockpile with 95% compaction.
4. Back fill all the holes (1, 3,4,5,6 and 7) inside of the cell 1 and hole 9 out side of cell 1 with the existing excavated materials in layers with 95% compaction.
5. Remove the garbage collected from outside holes (10, 11, 12 and 13).
6. Dump the contaminated soil in the same designated area of the landfill site.
7. Backfill in layers with fresh gravel with 90% compaction.

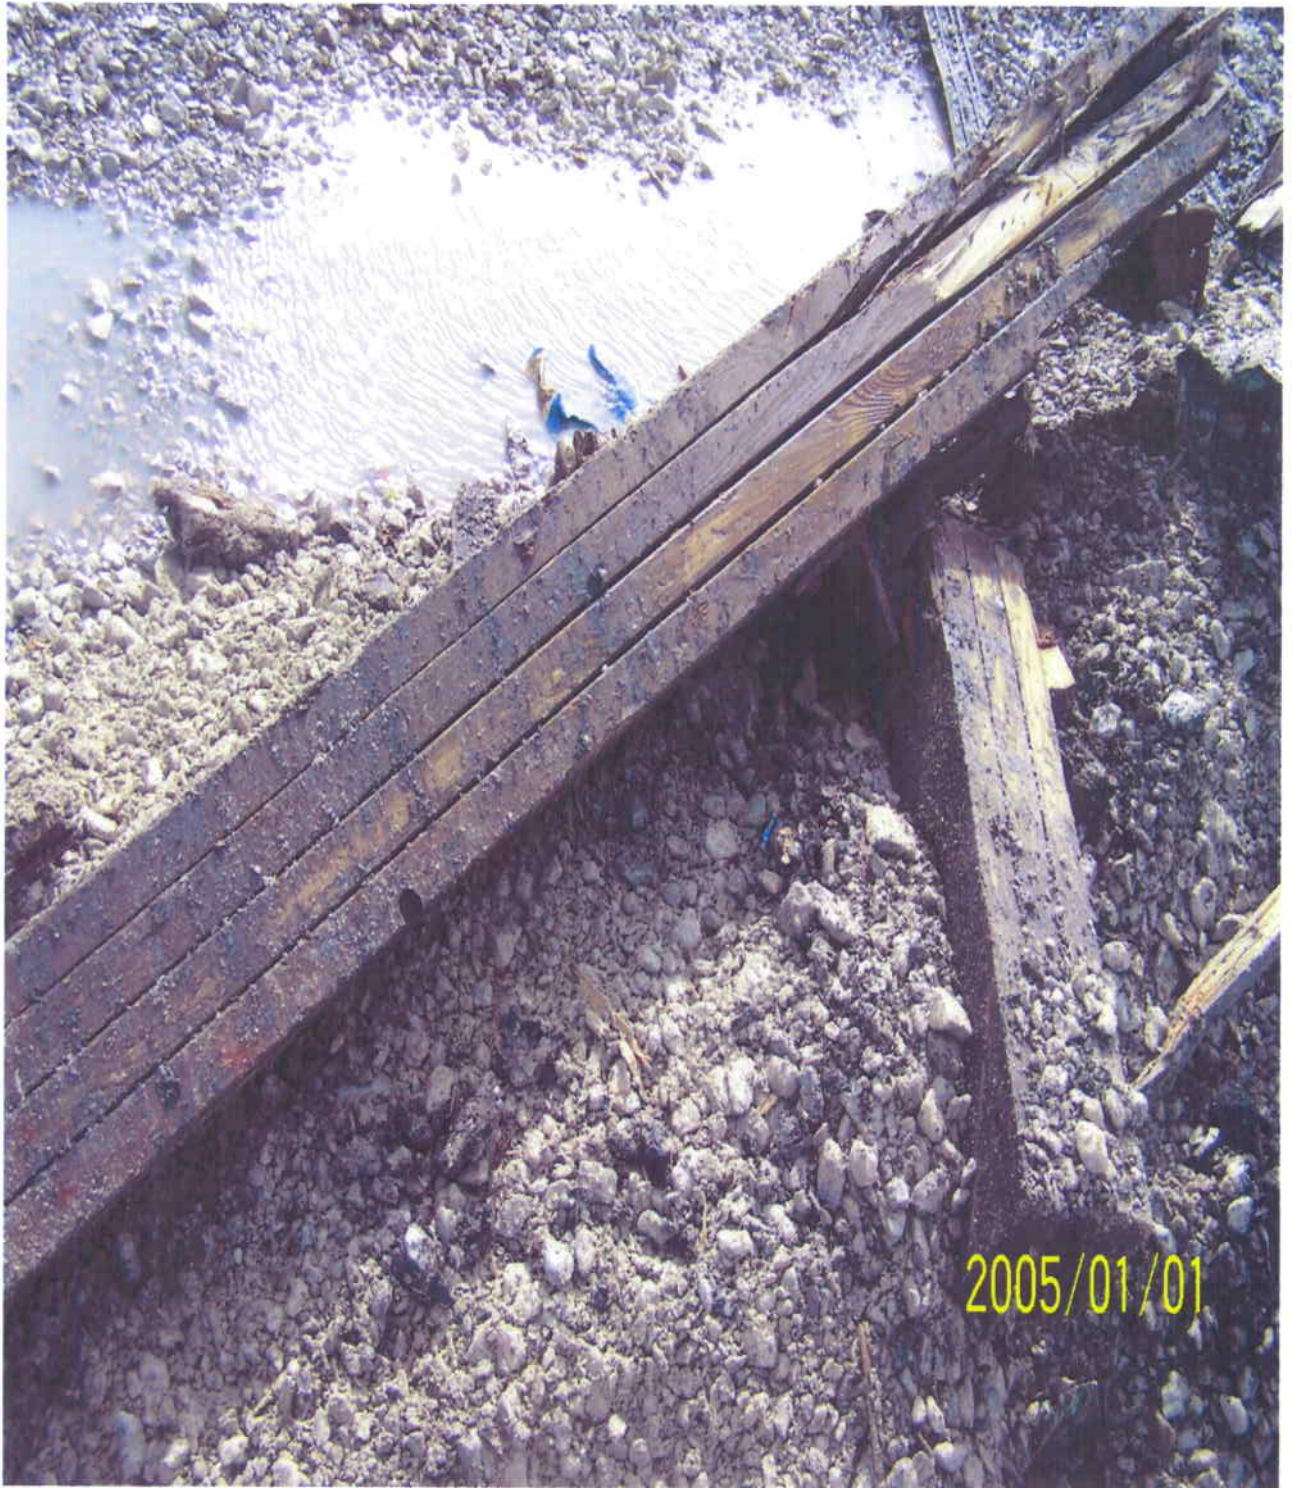
**Garbage Found in Hole 2,  
Photo taken on August 20, 2008**

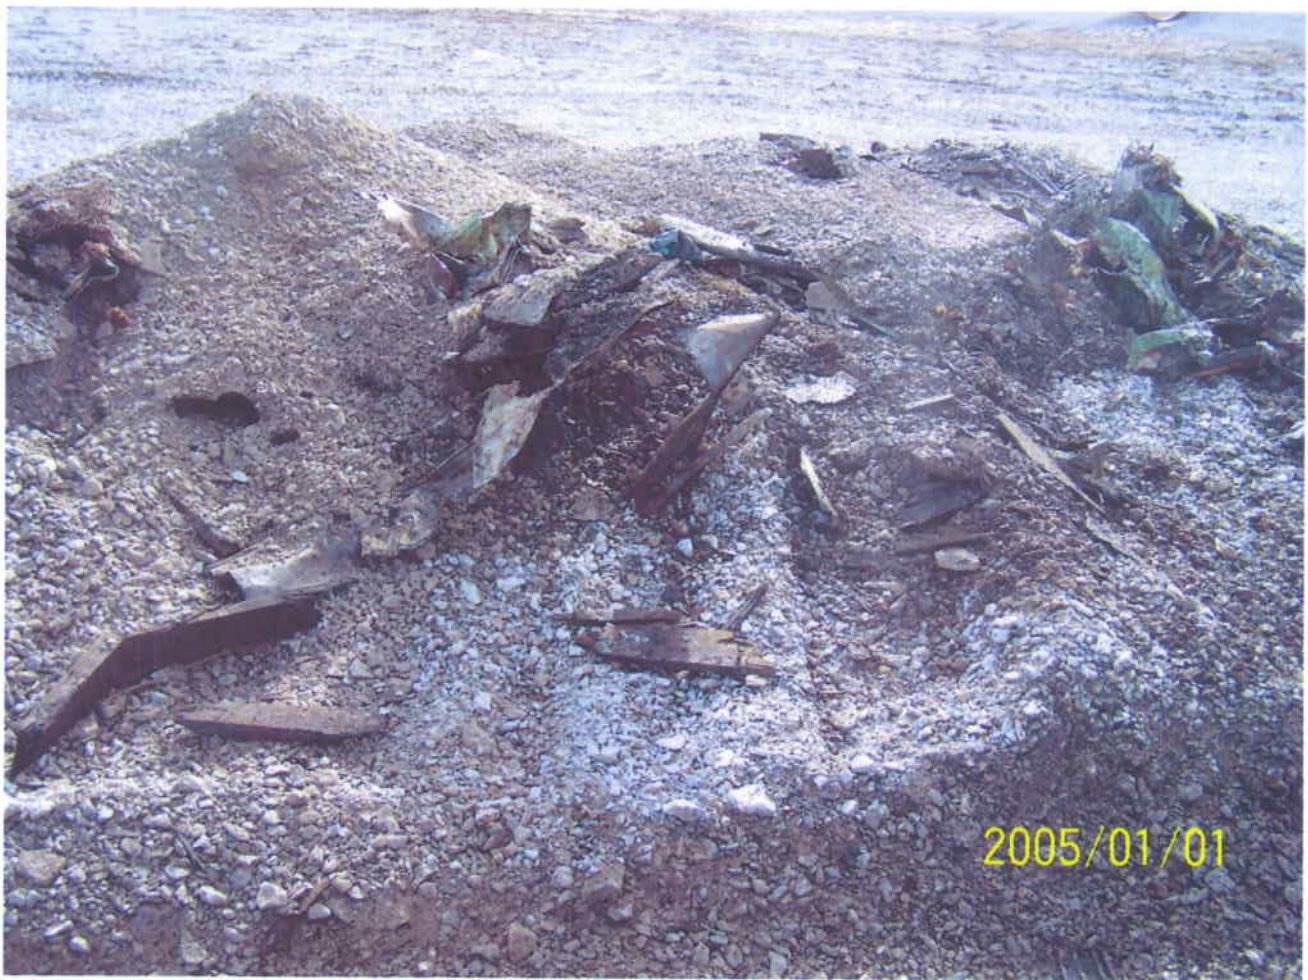
**Garbage Found in Hole 2,  
Photo taken on August 20, 2008**

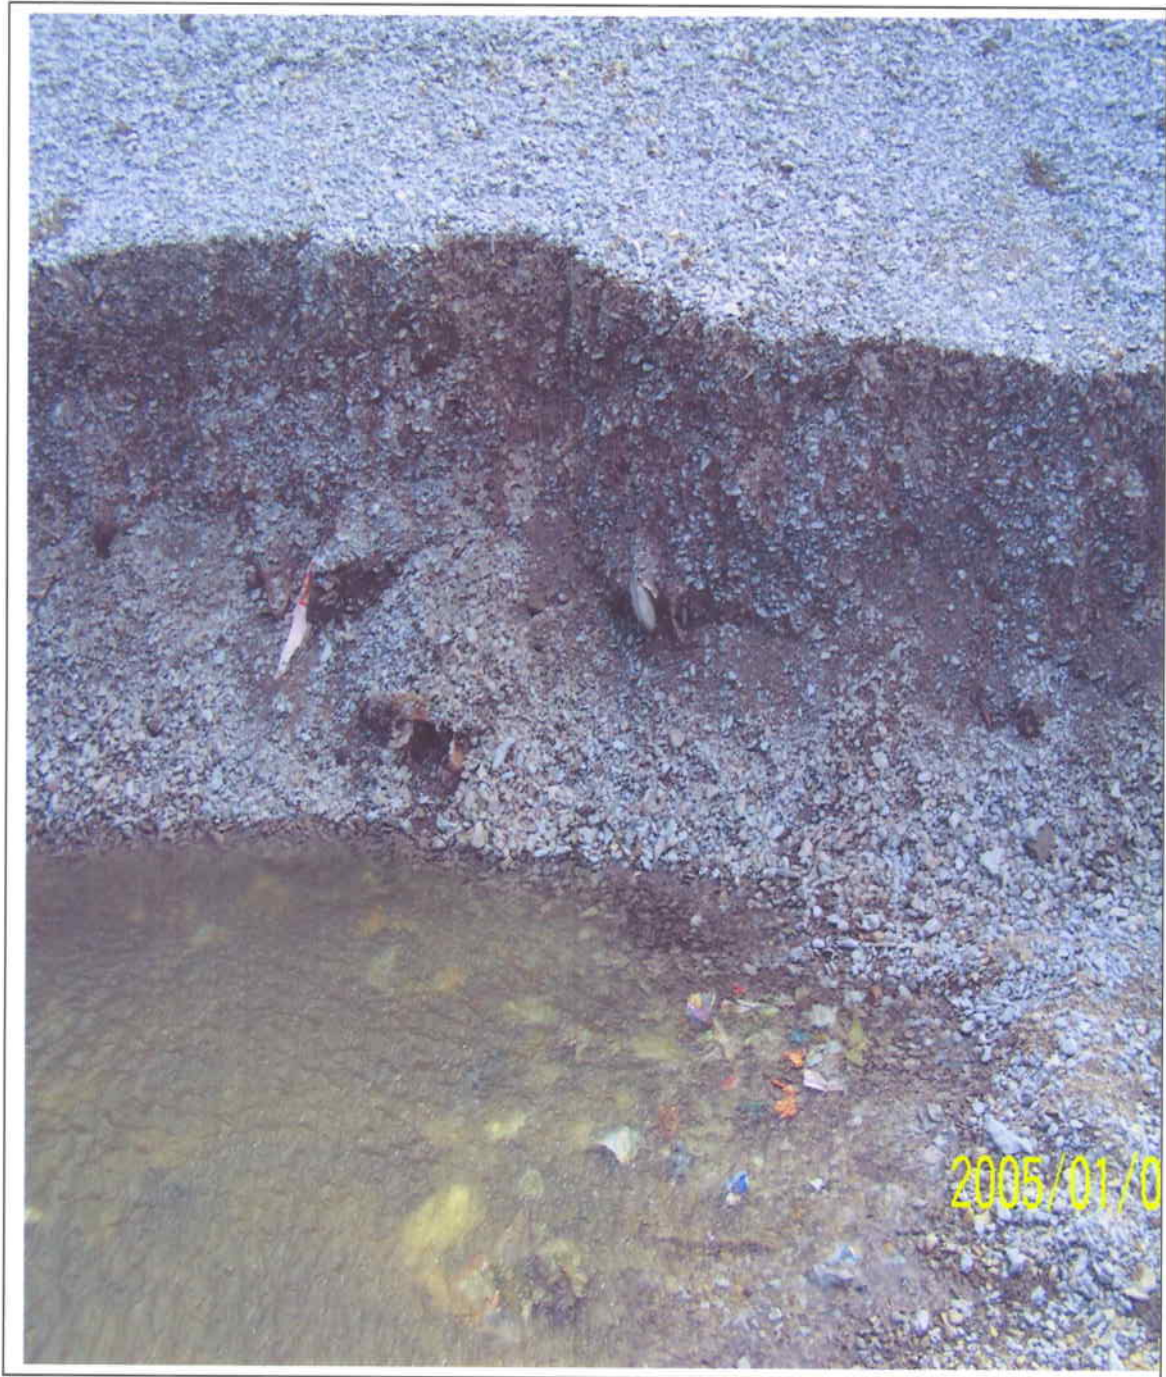
**Garbage shown inside the berm, hole 8,  
Photo taken on August 26, 2008**

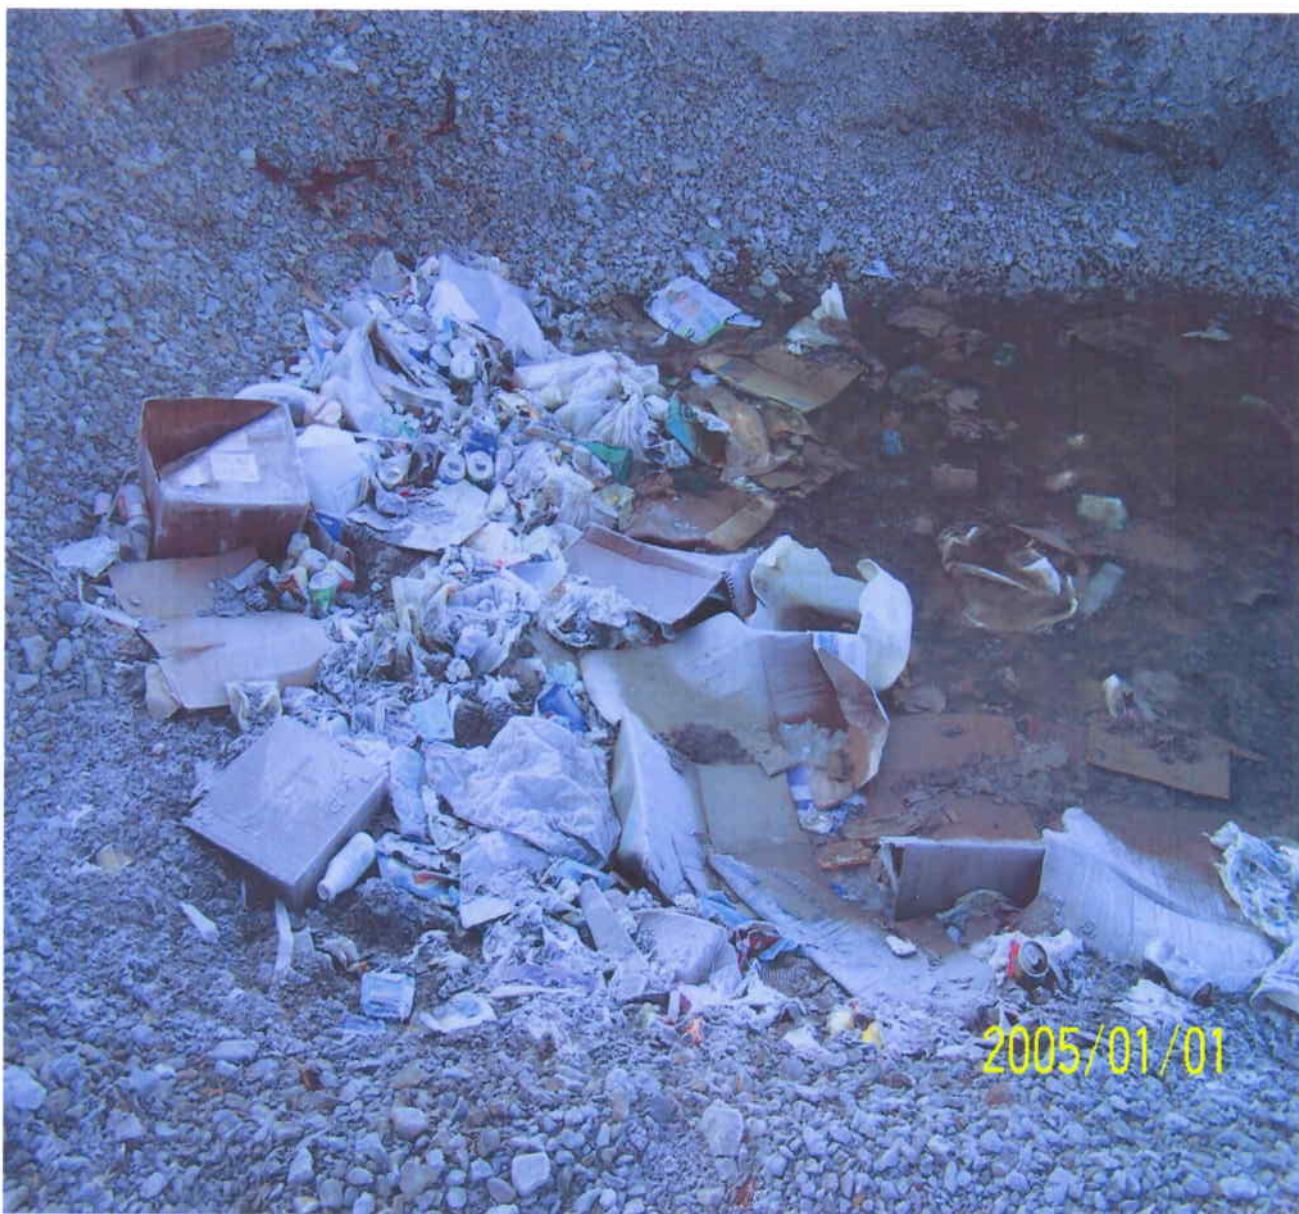
**Hole no.8, shows garbage still collecting,  
Photo taken on August 26, 2008**

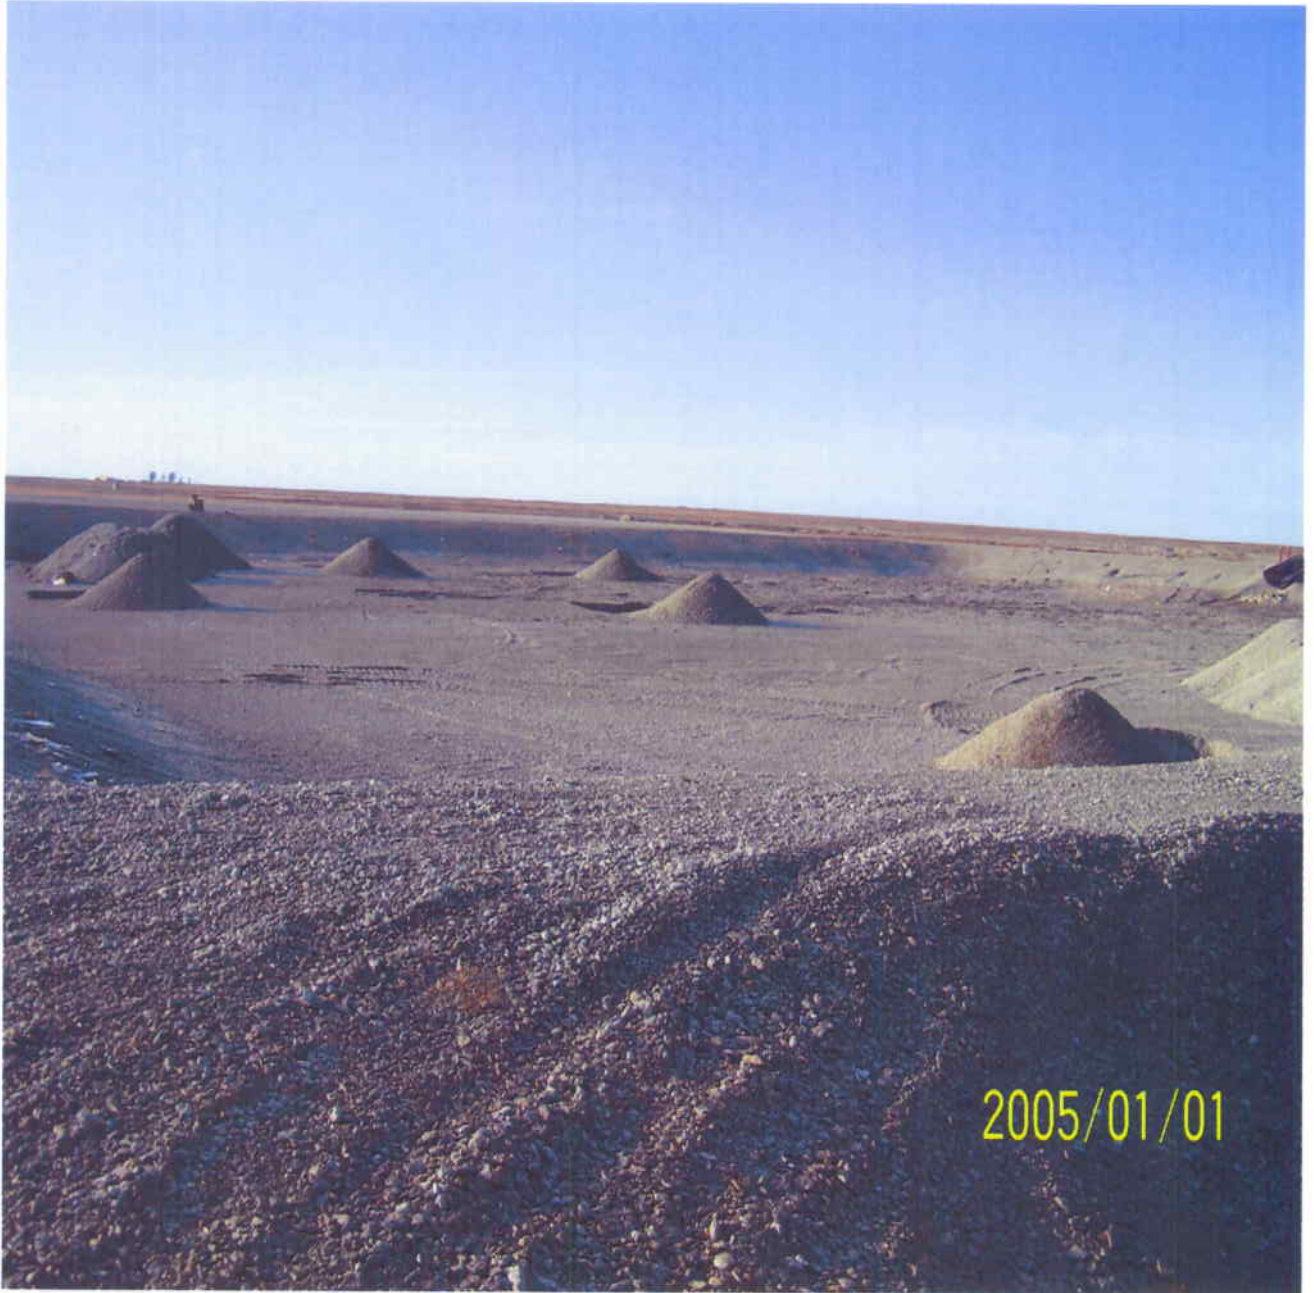
**Digging holes in Progress inside the Cell 1,  
Photo taken on August 20, 2008**

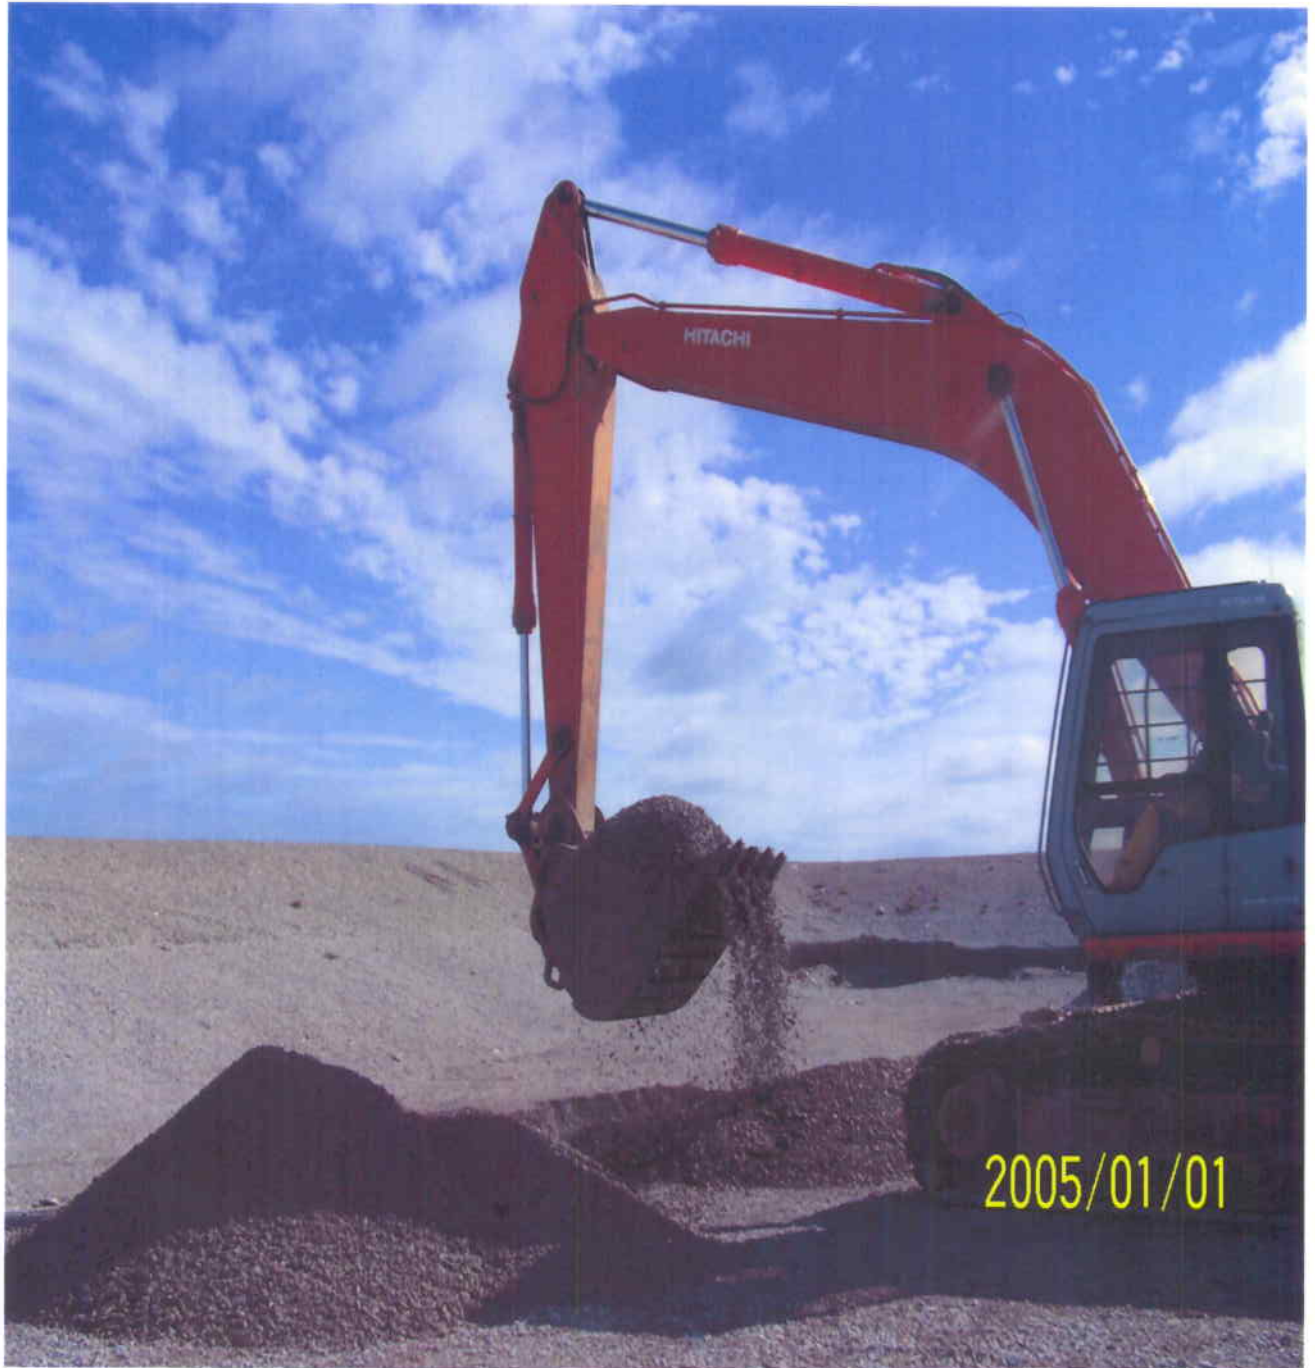
**Kudlik Excavator digging holes in Sewage Lagoon cell 1,  
Photo taken on August 20,2008**

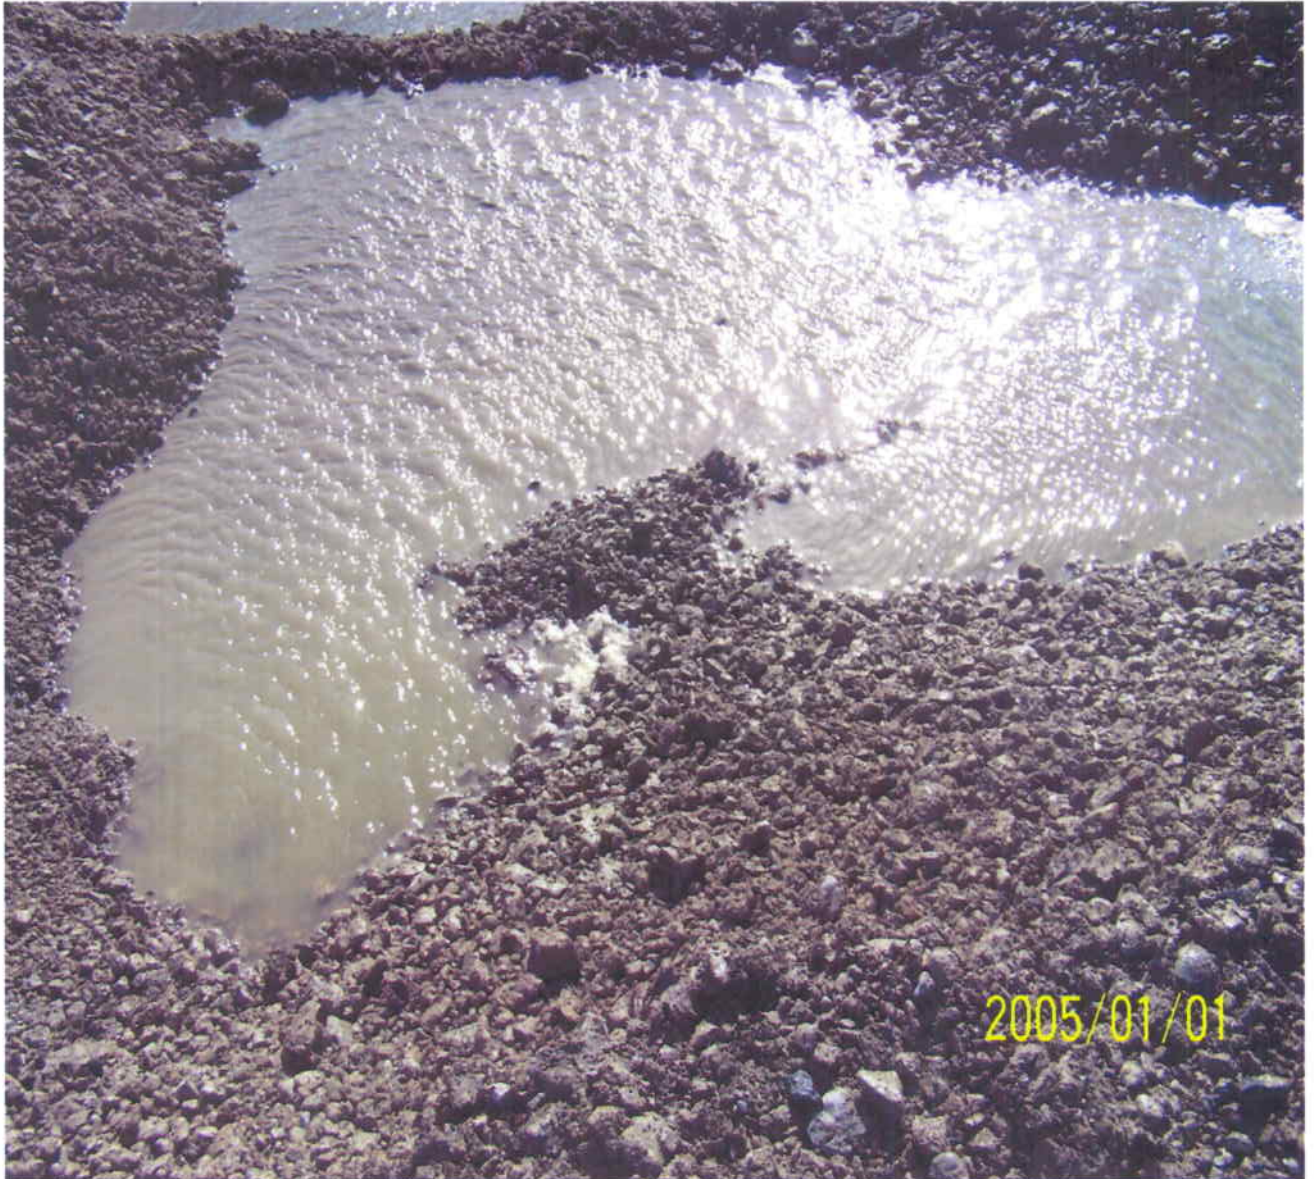
**Clean bottom, no Garbage inside cell 1,  
Photo taken on August 26, 2008**

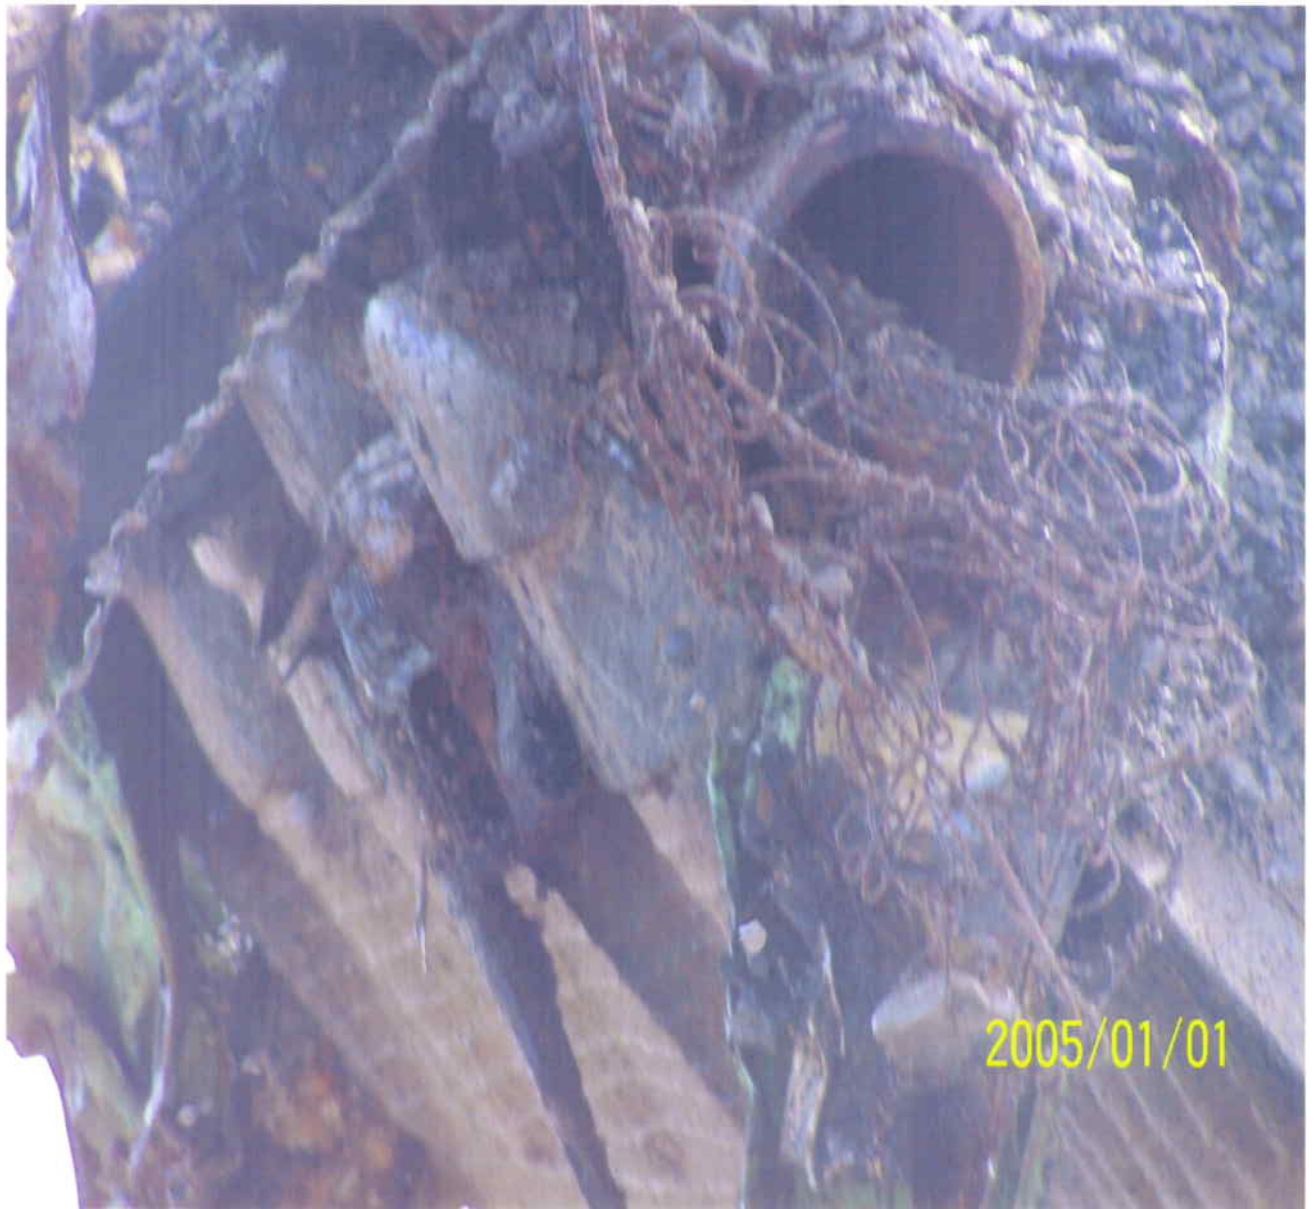
**Garbage found outside of the E-W berm of lagoon Cell 1,  
Photo taken August 20, 2008**

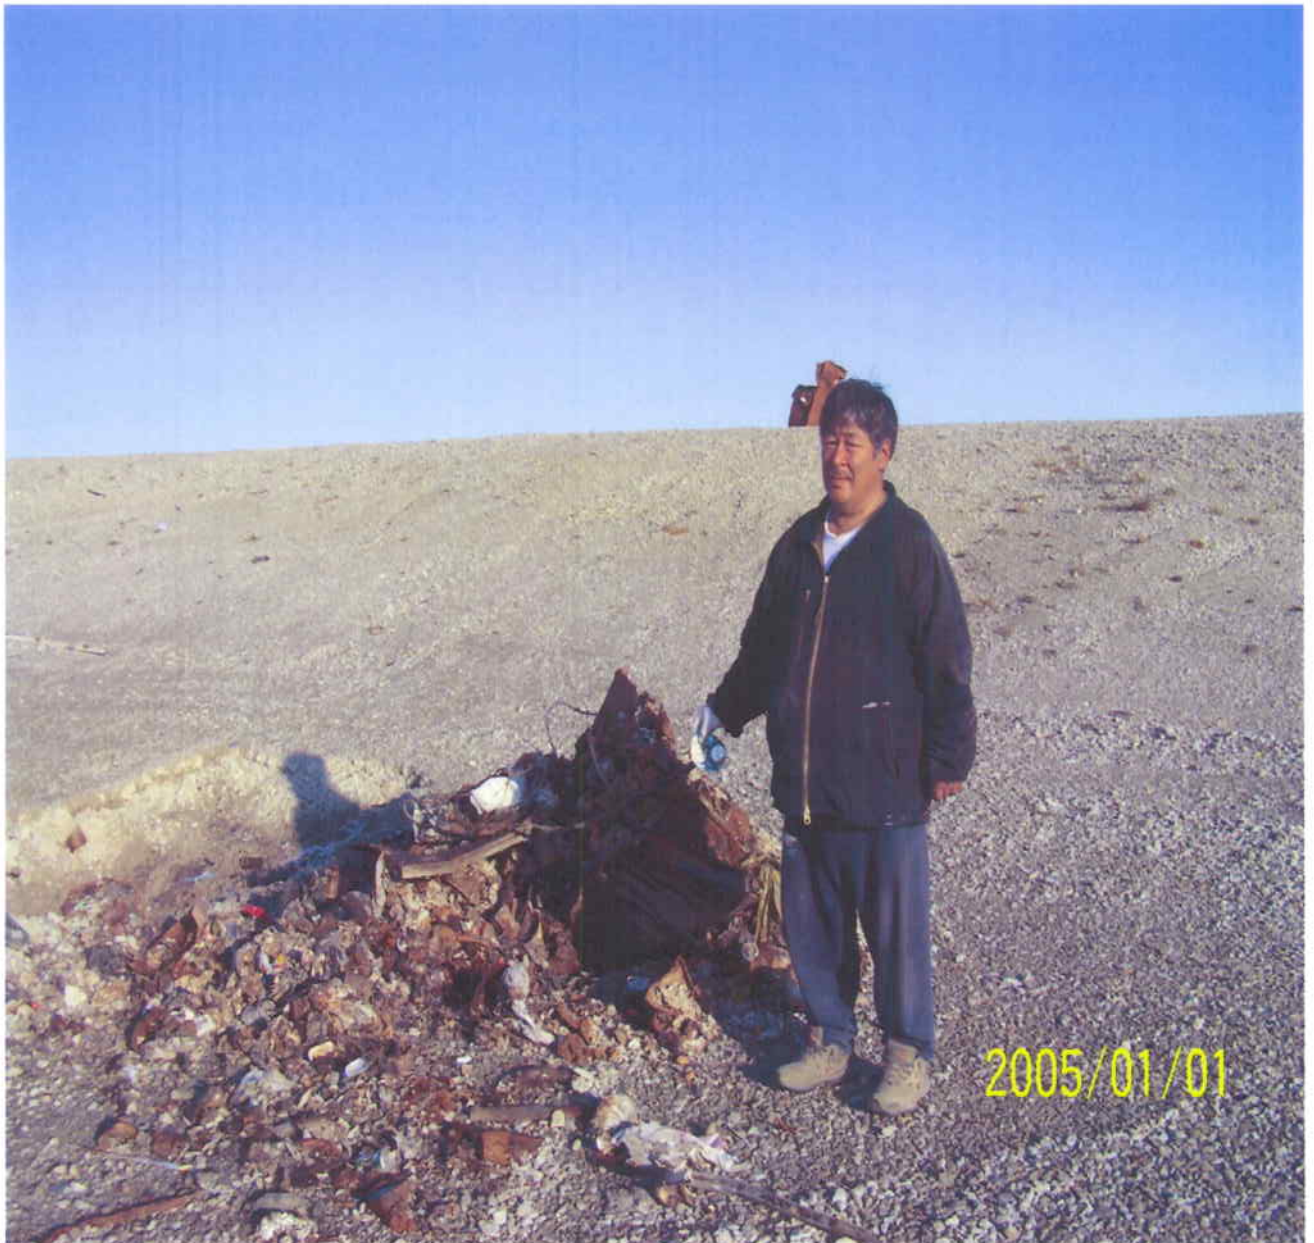
**Garbage found outside of the E-W berm of lagoon Cell 1  
(A cane showed 1986)  
Photo taken on August 20, 2008**

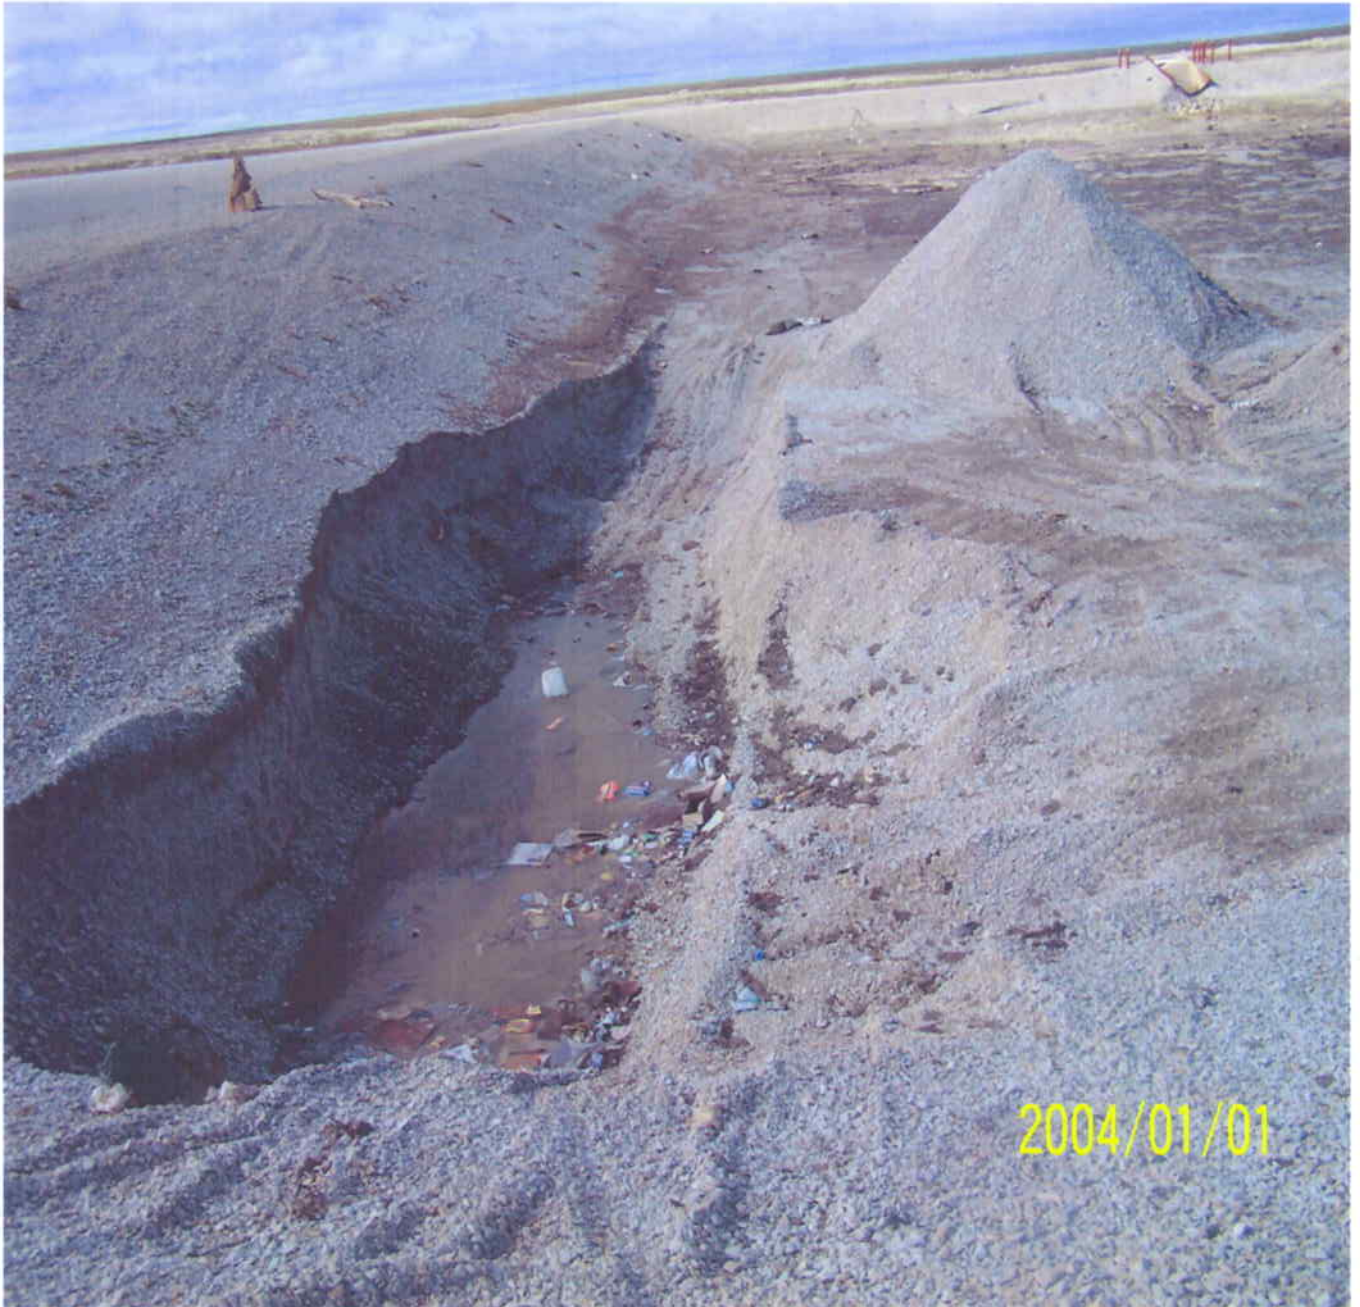
**Excavated along the E-W berm where leakage occurred of Lagoon cell 1**  
**Photo taken in July 25, 2008**

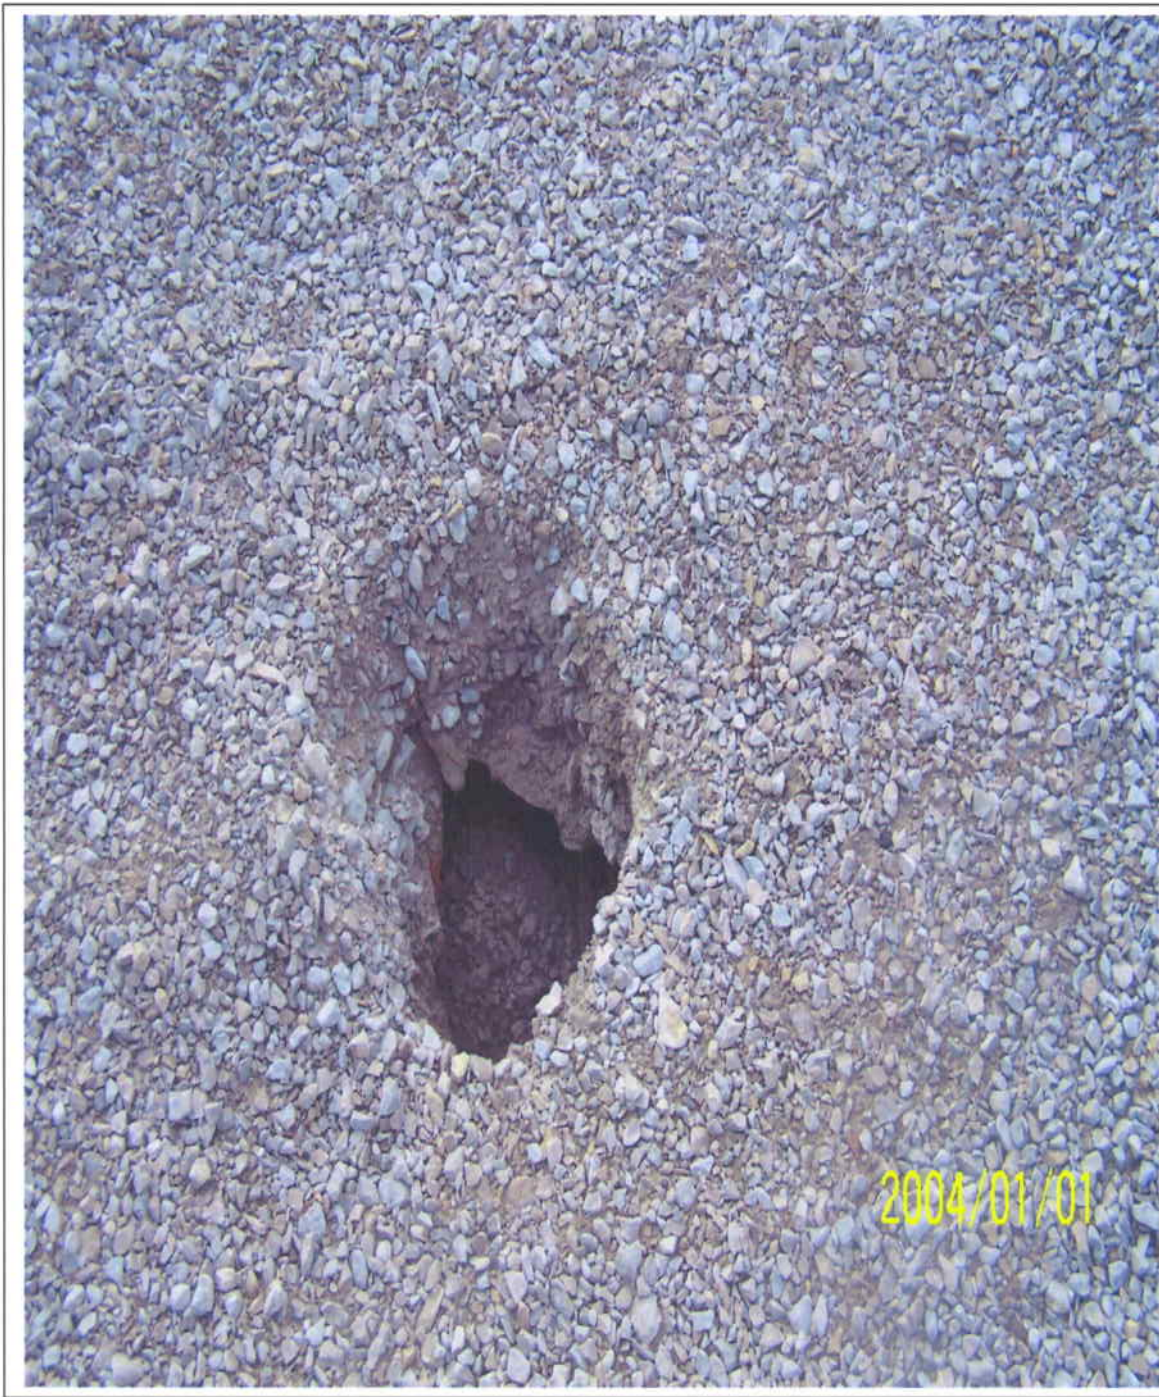
These facilities were built in 2002. Since then these have been functioning well. On July 01, 2008, SAO of the Hamlet of Hall Beach was informed by her foreman that water level of cell 1 was dropping down rapidly. SAO examined next day and found the cell 1 was almost empty. The liquid was seeping speedily from the S-E corner of cell 1 under the containment berm. Hamlet informed GN-CGS and GN-DOE as well. But they did not report to the spill emergency line.

**Hole developed outside of the E-W containment berm of Lagoon cell 1,  
Which drained out cell 1.  
Photo taken, July 25, 2008.**
