**Sub: Conditions applying to Operation and Maintenance,  
Hamlet of Hall Beach, Water License no. 3MB-HAL0810**

## Action Plan on the remedial works of Hall Beach Sewage Lagoon, Cell -1

**Prepared by: Bhabesh Roy, M.A.Sc., P.Eng.  
MPE, Baffin Region, GN-CGS.**

Hall Beach Sewage Lagoon-Cell 1, field Inspection Report

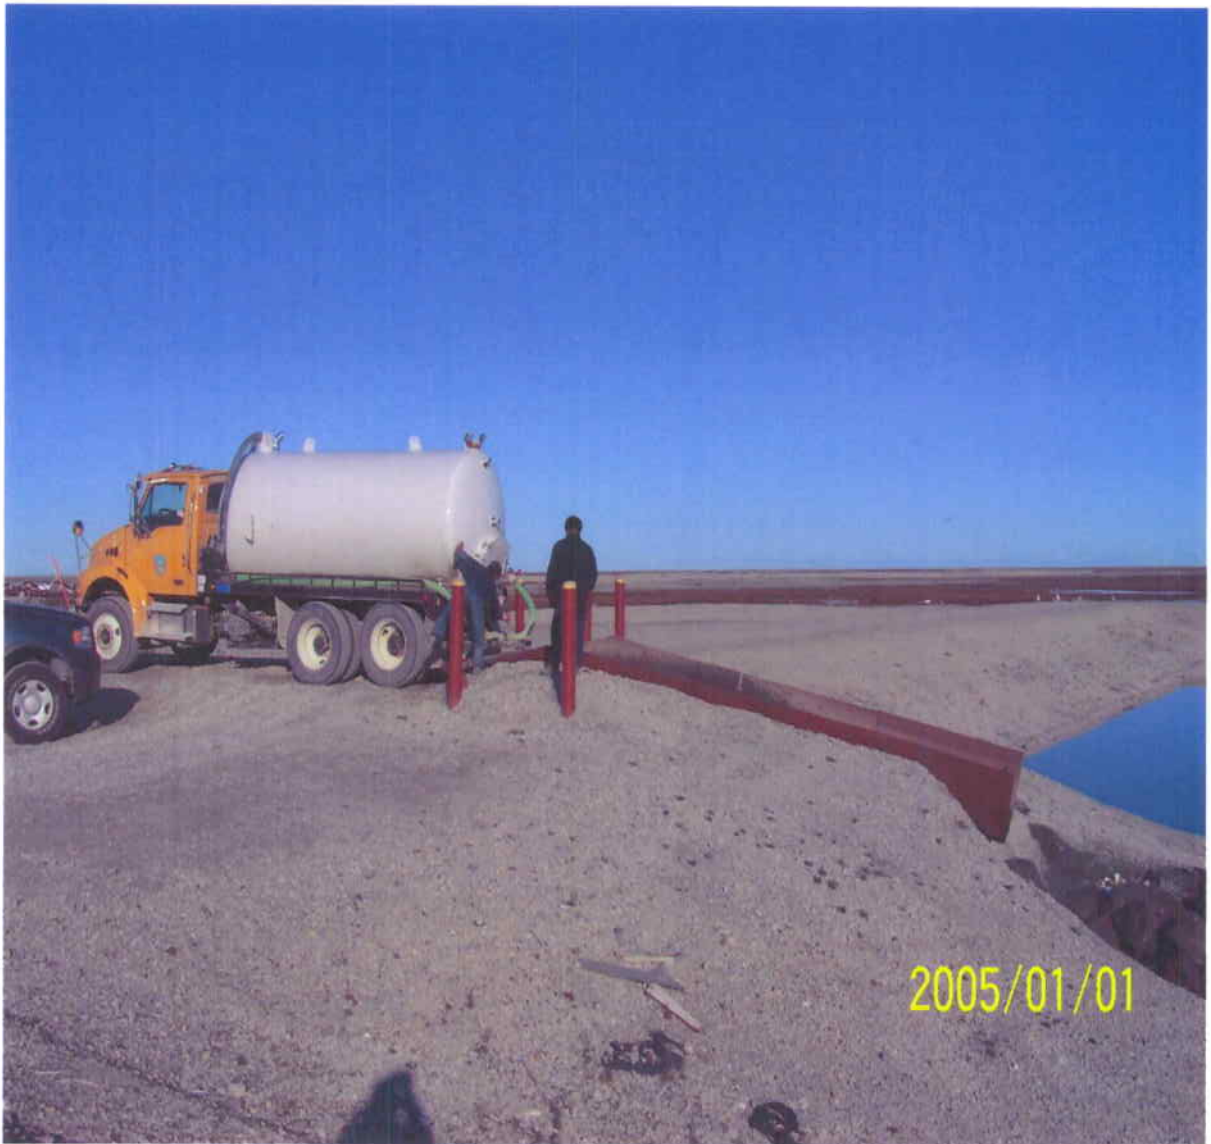
**Raw sample is being collected from the Wastewater Truck prior to decanting the Sewage Lagoon cell 2, Photo taken on august 27, 2008.**

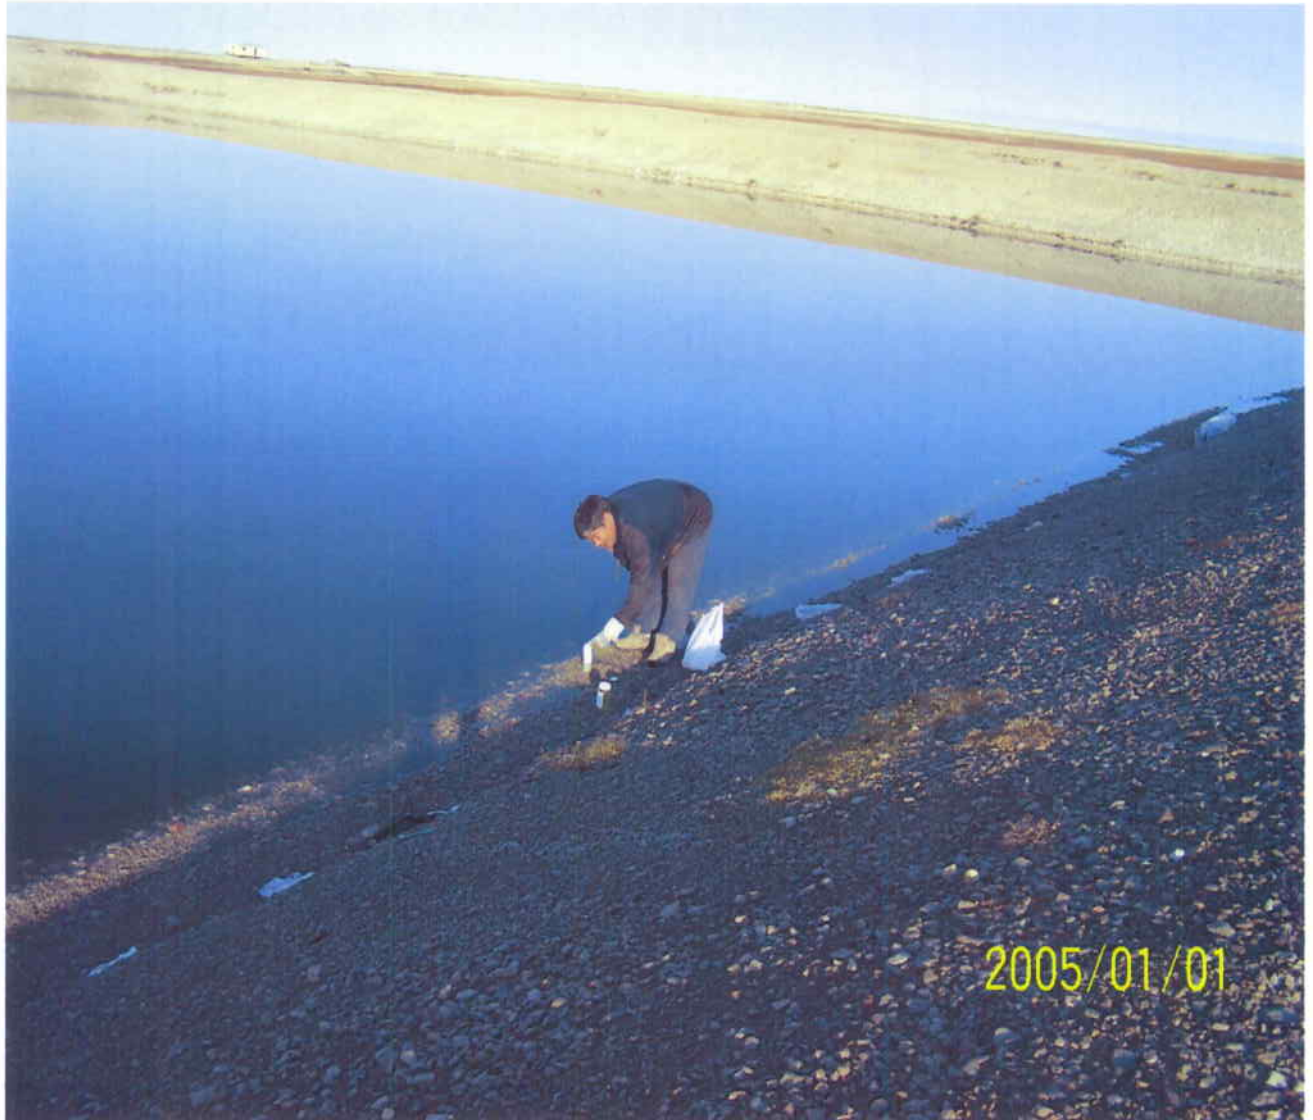
**Sample of Sewage Lagoon cell-2 is being collected prior to decanting ,  
Photo taken on August 27, 2008**

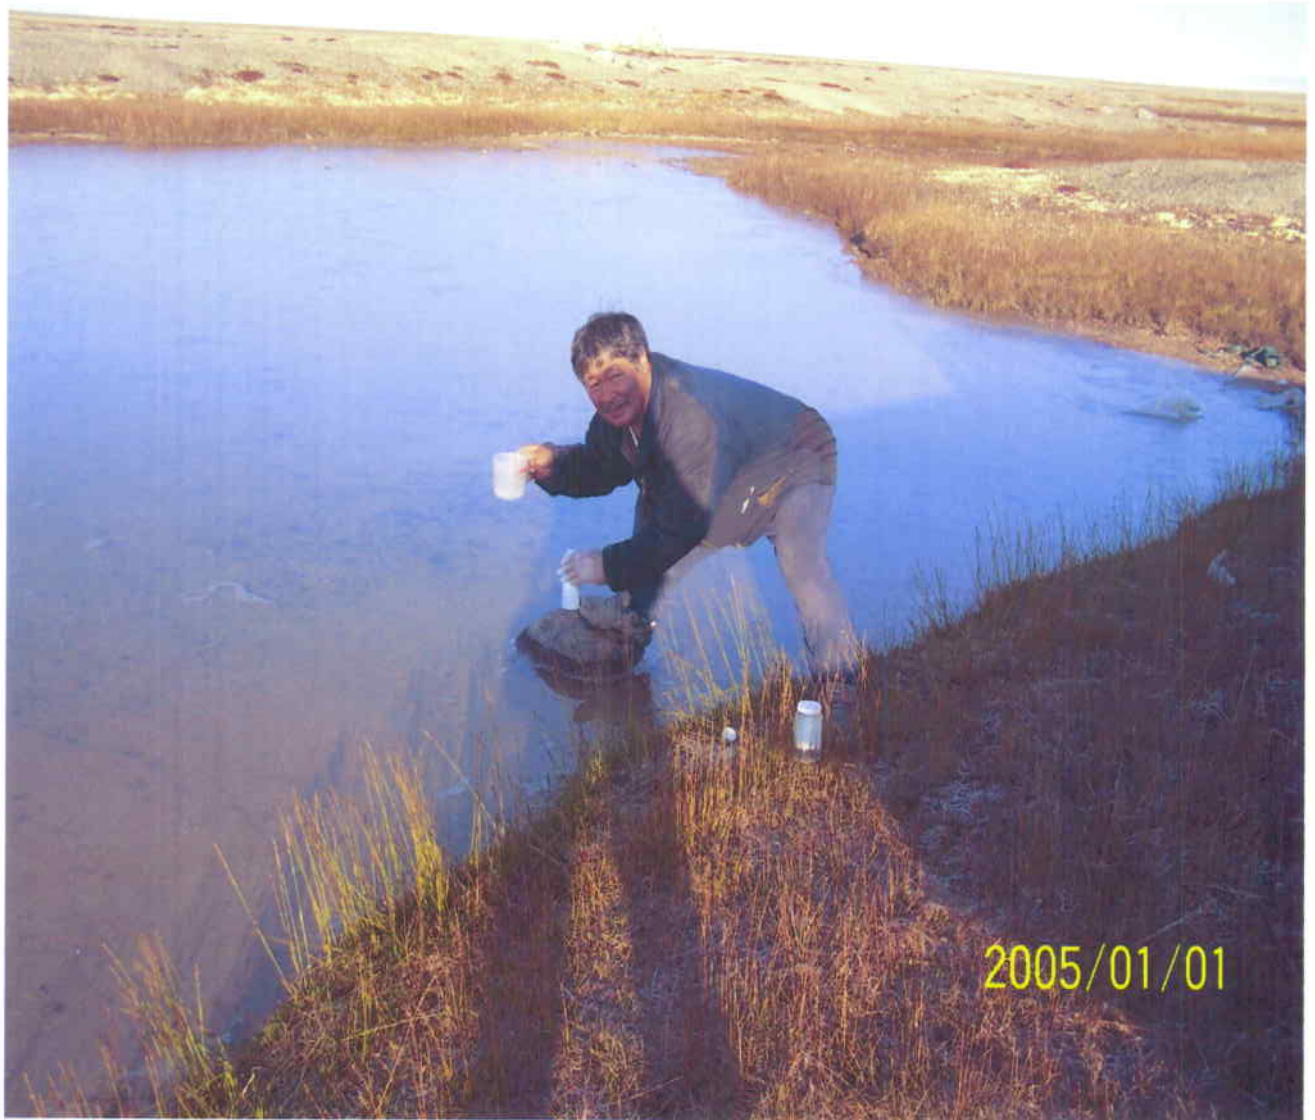
**Sample is being taken from the wetland prior to decanting the sewage lagoon cell 2, Photo taken on August 27, 2008**

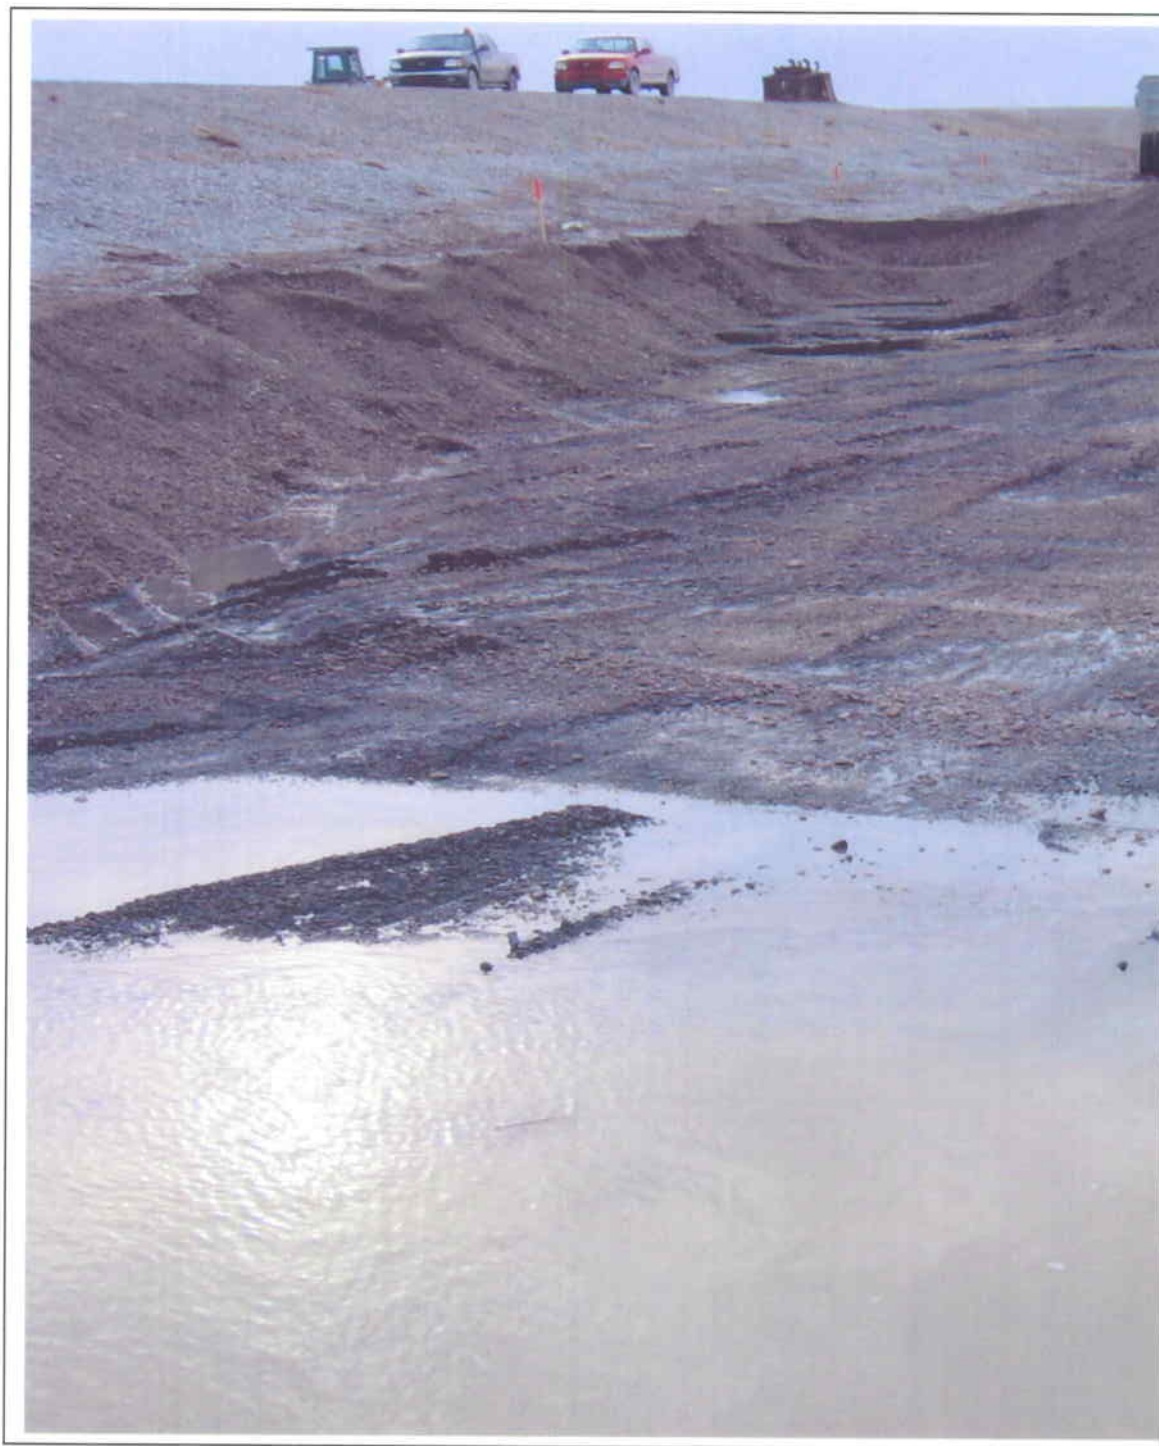
Excavating along the Southern Berm of Cell 1

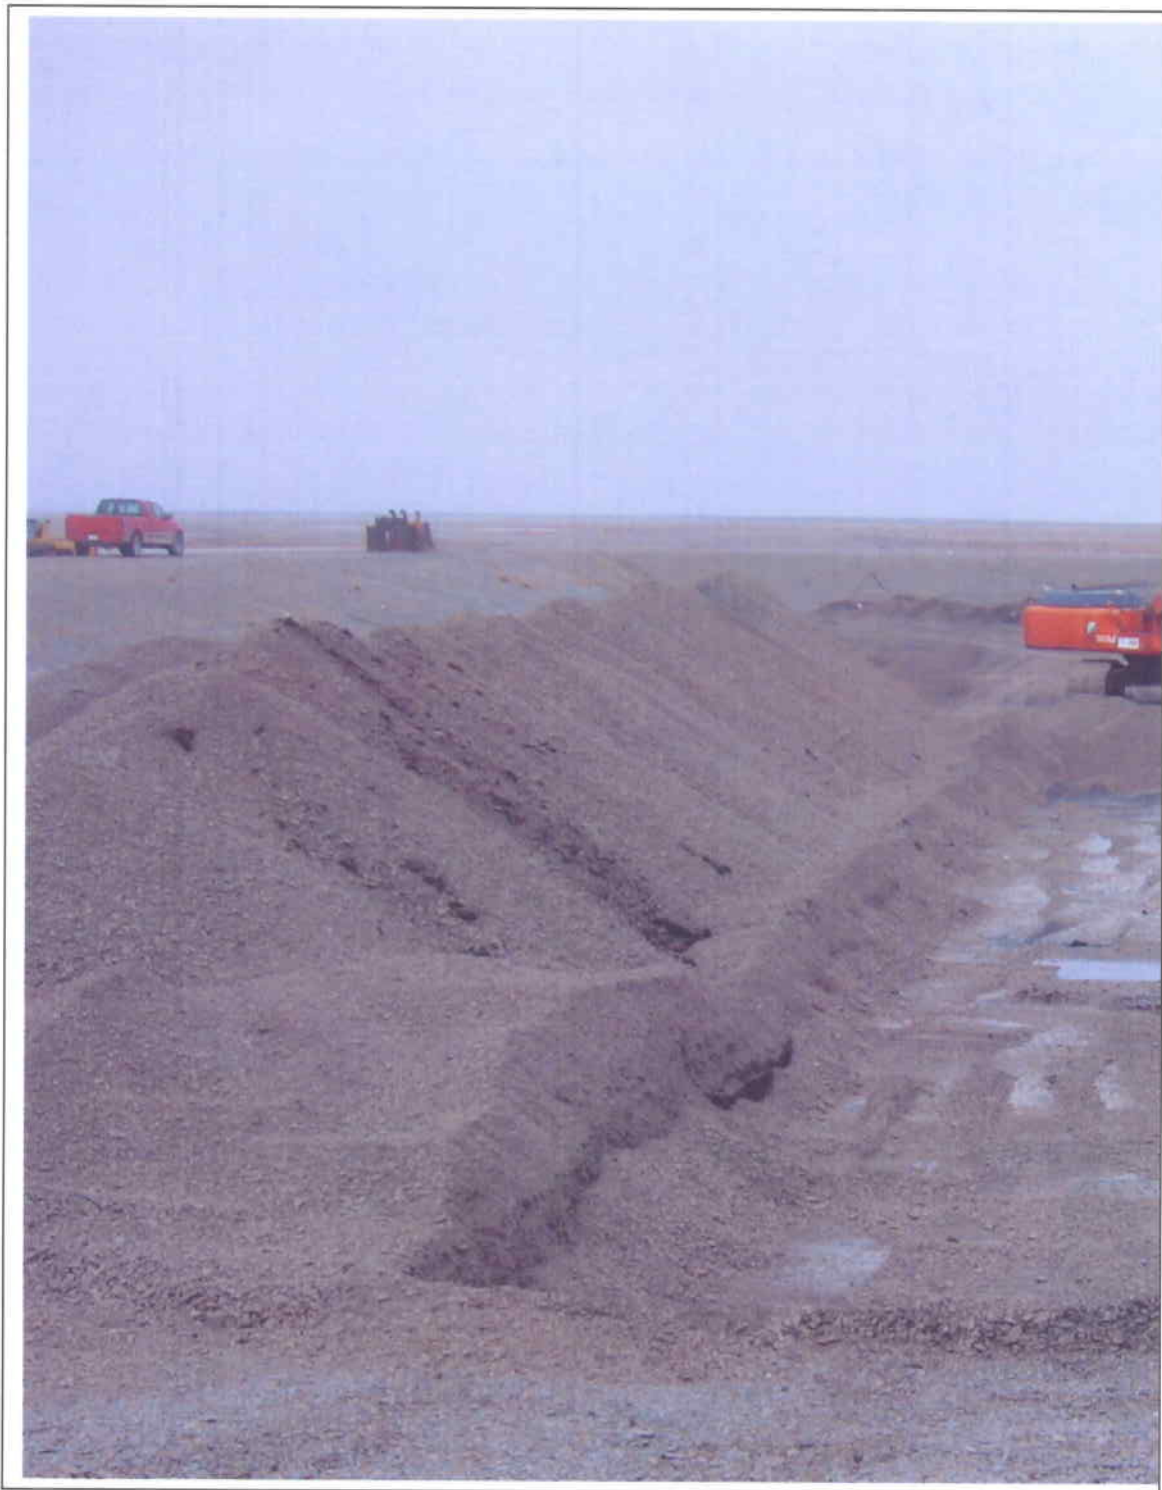
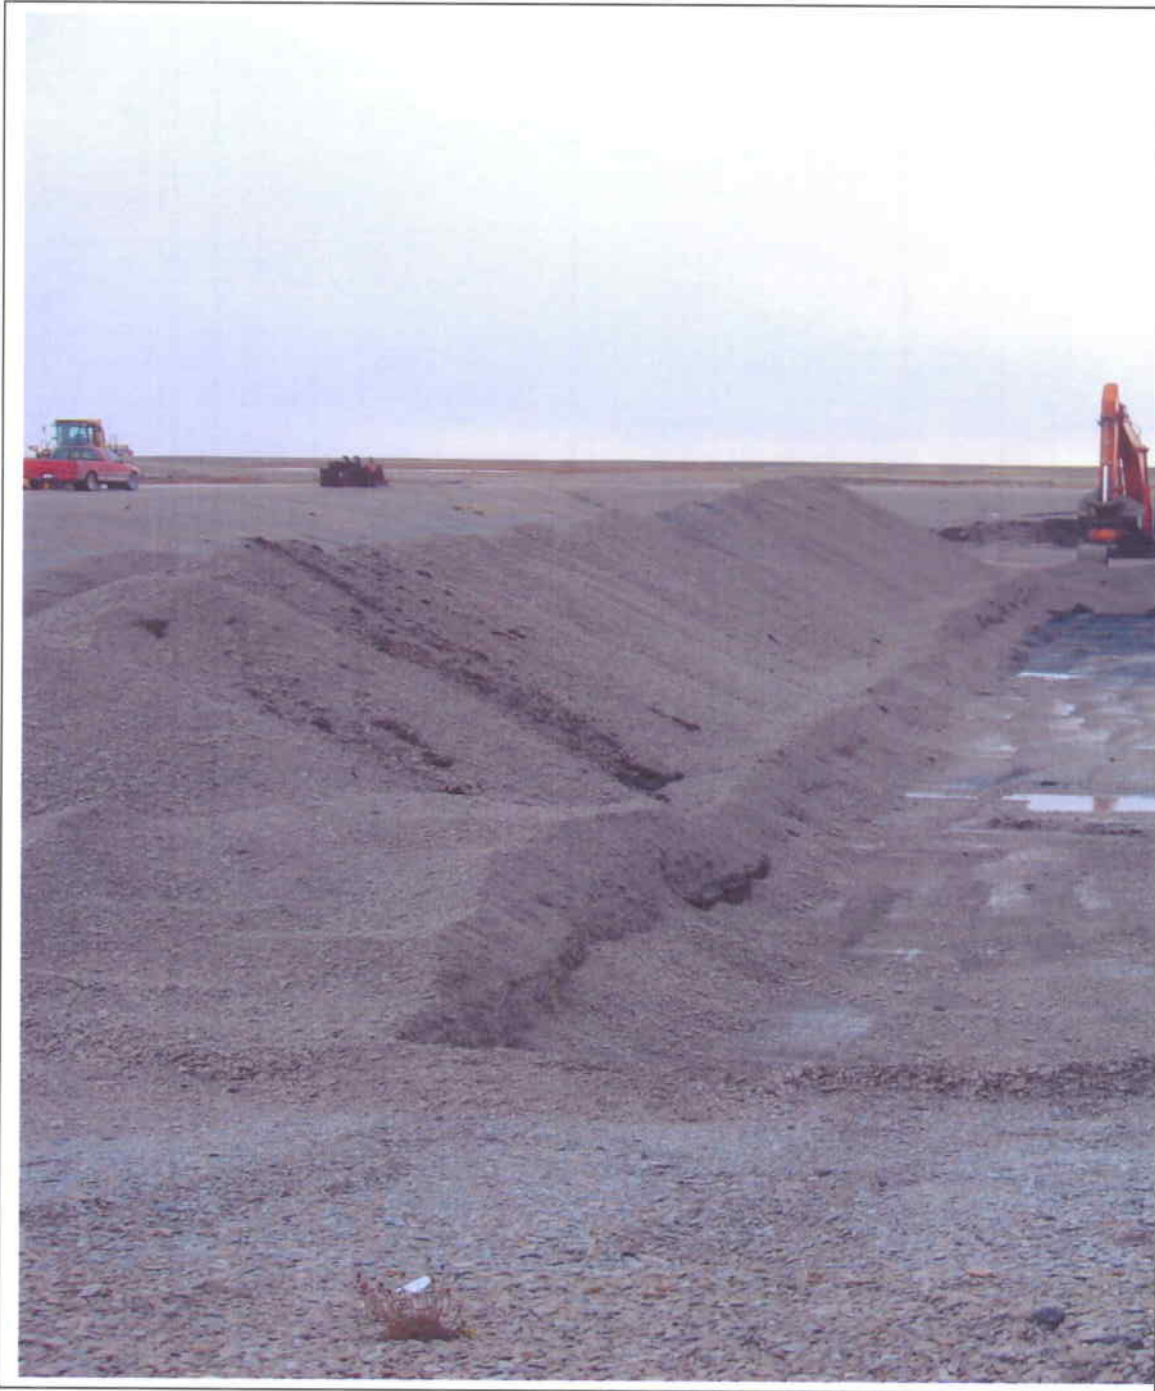
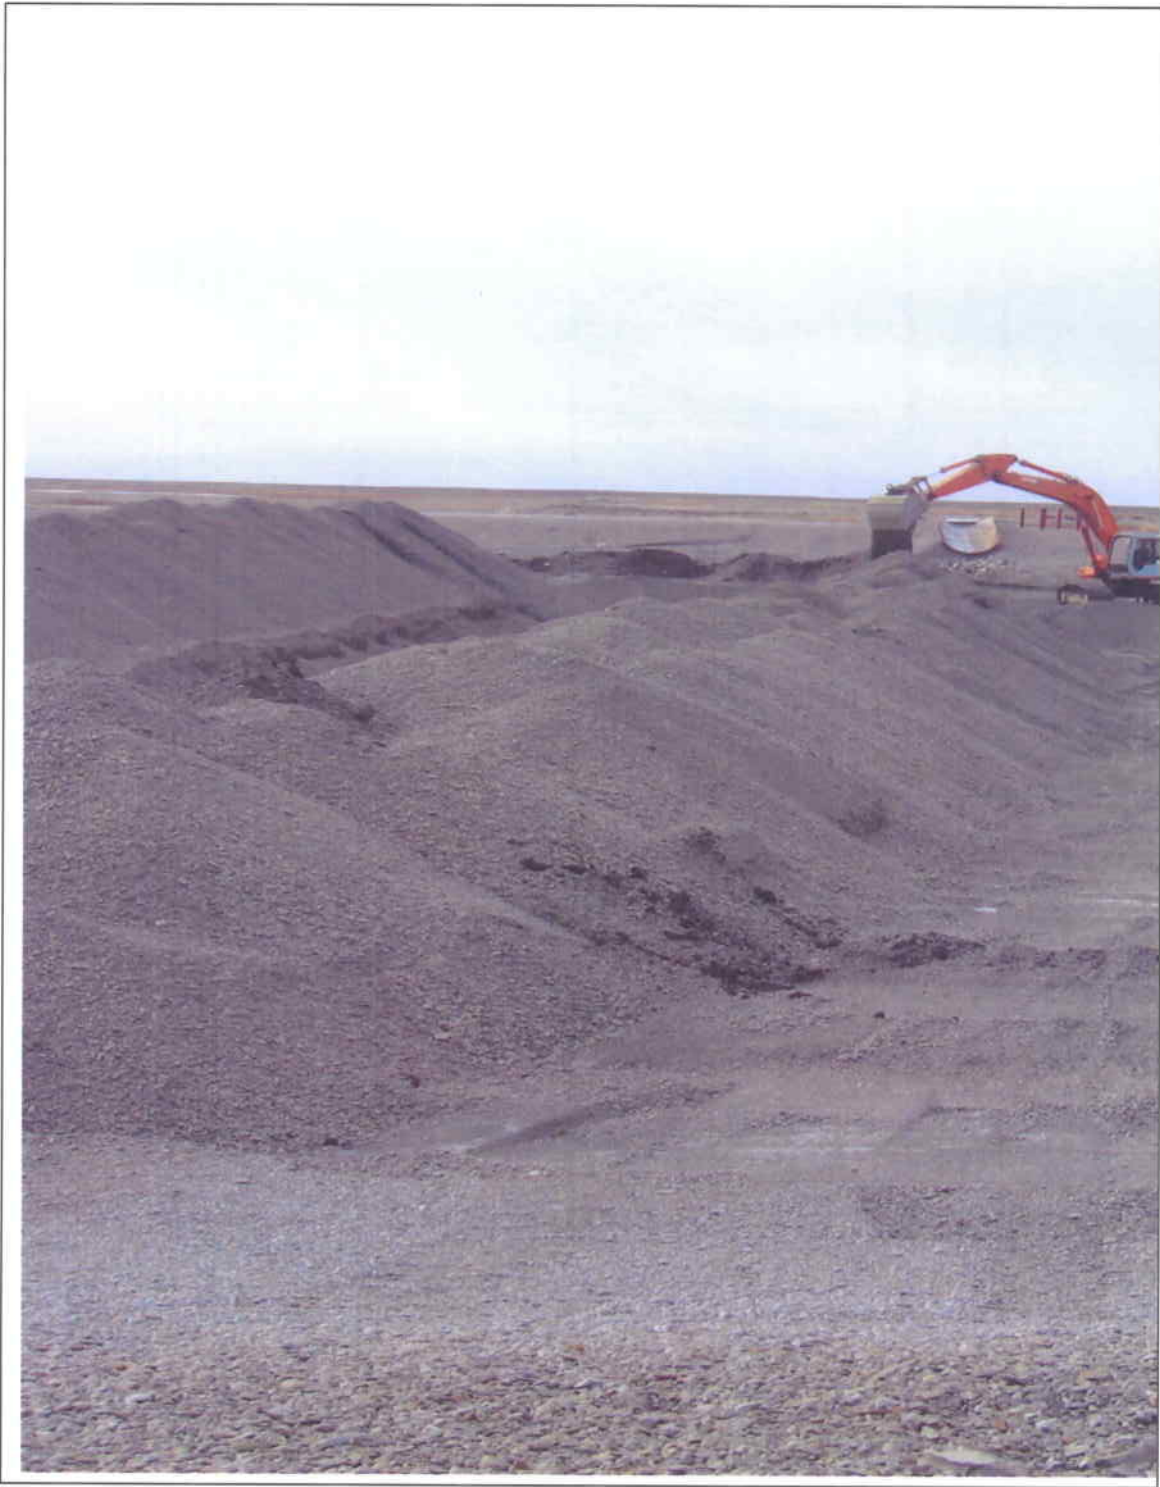
Excavating the floor along the Southern Berm of Cell 1

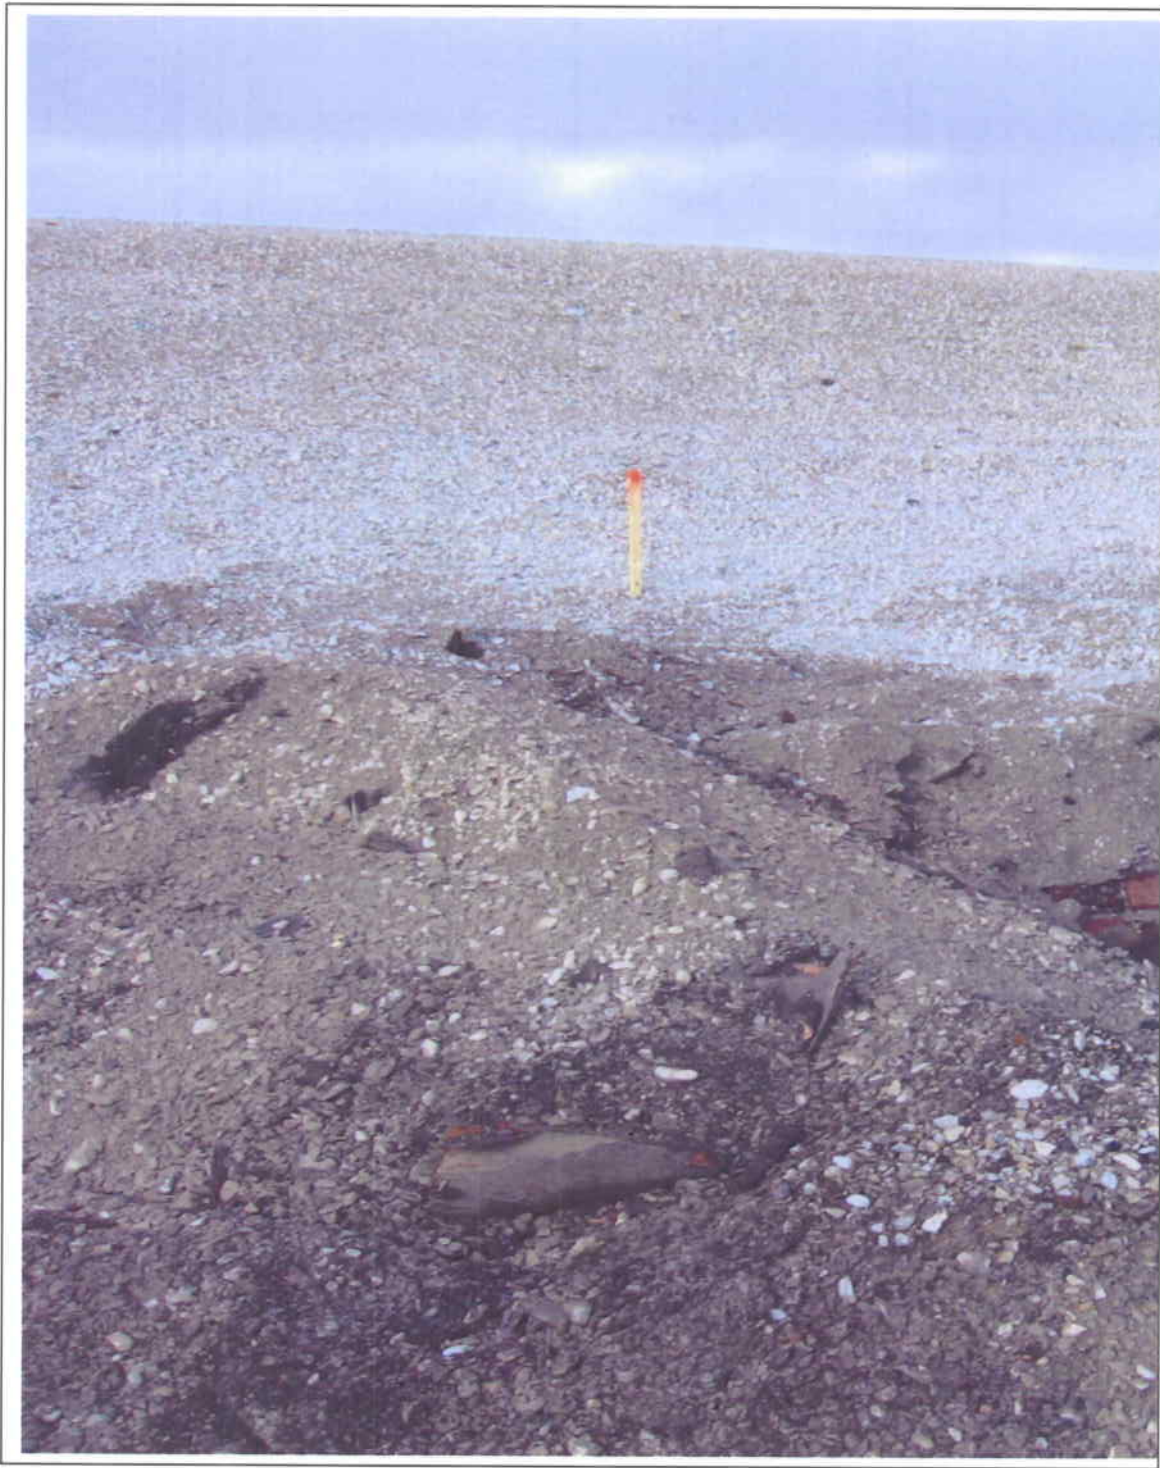
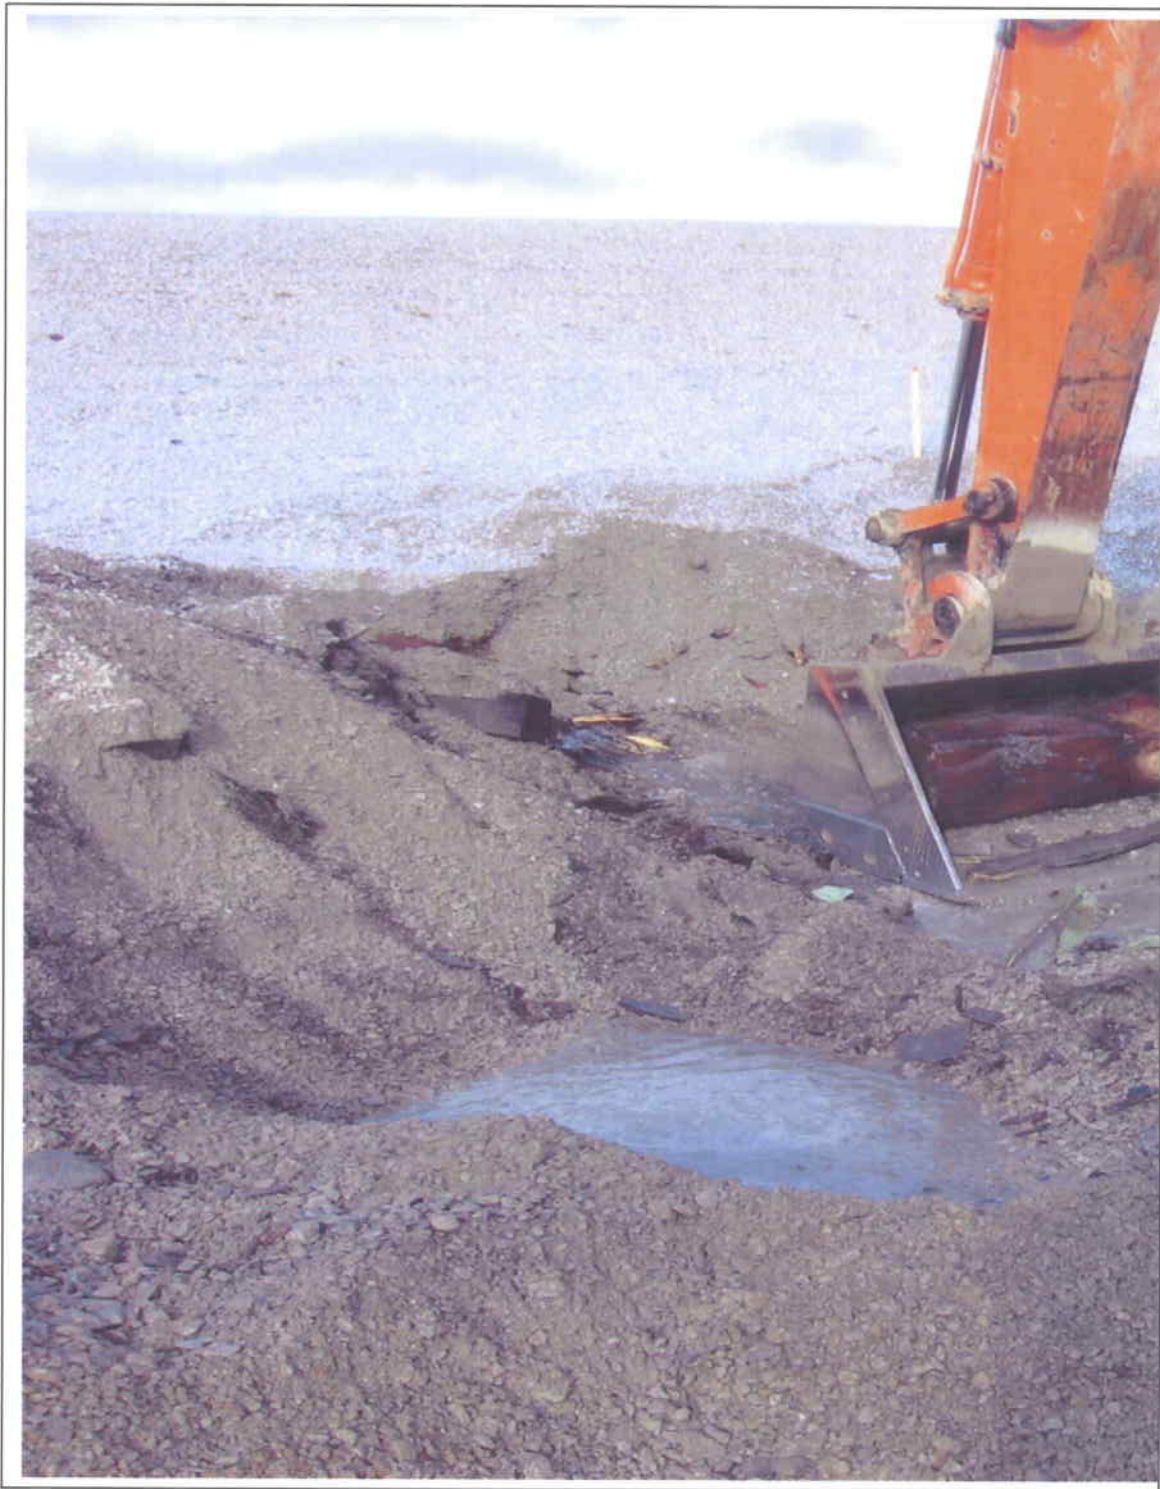
Removing Garbage from the middle of cell 1

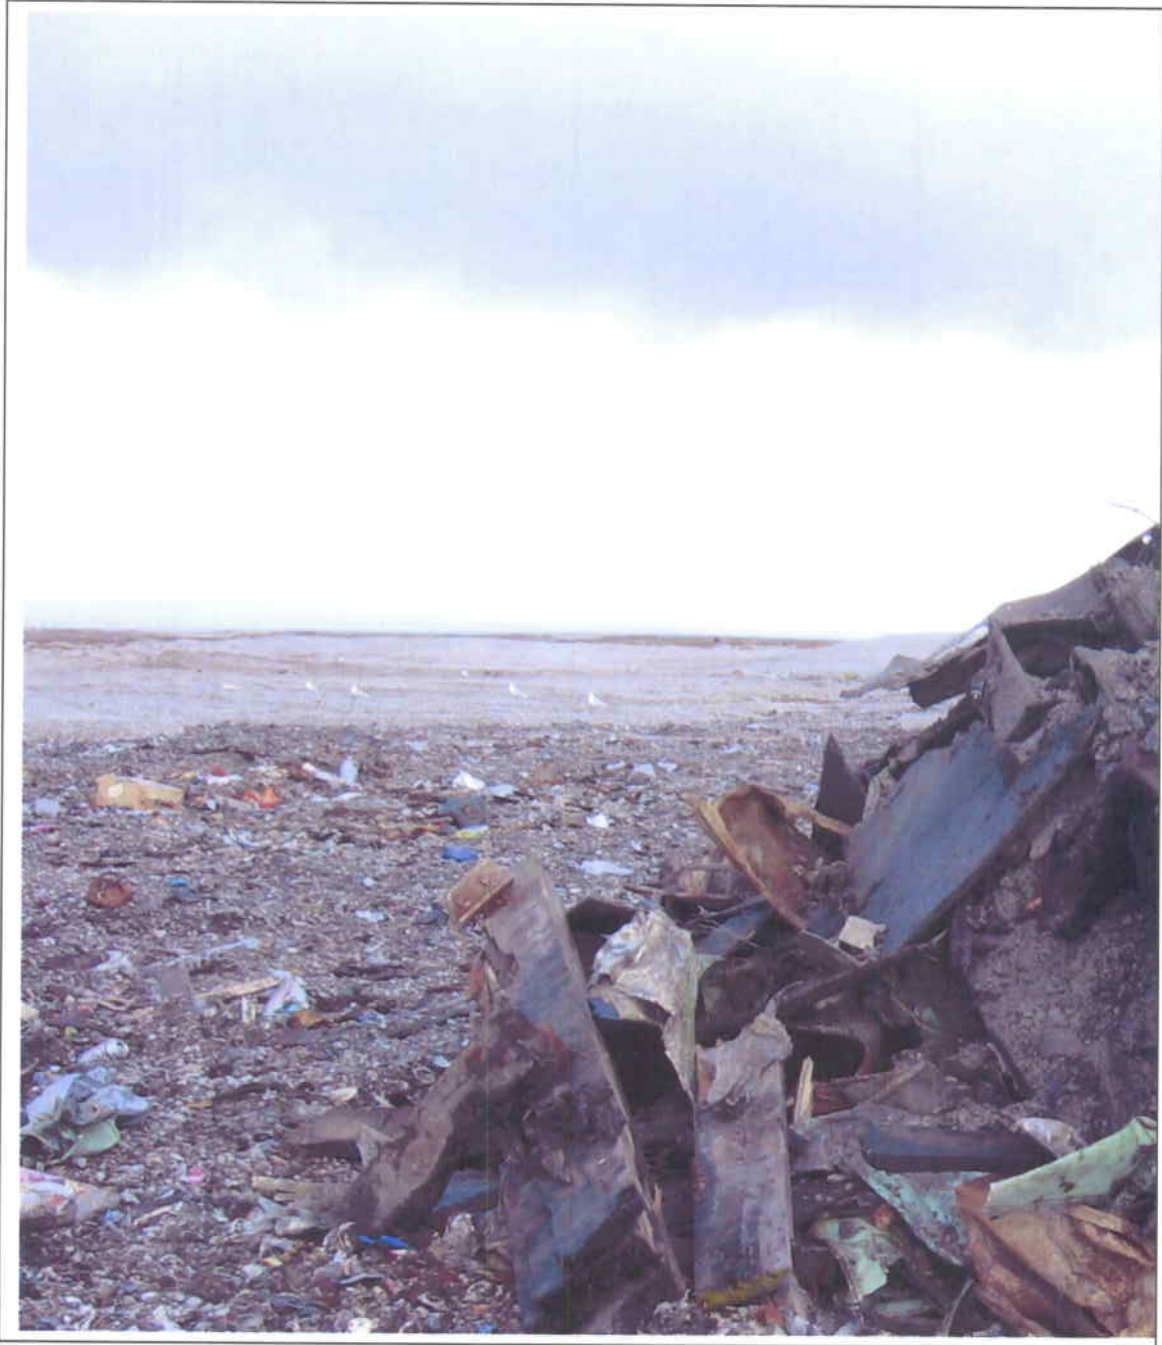
Dumping excavated garbage in the Landfill Site
