# Memo

**To:** Paul Harper, Fisheries and Oceans Canada  
**From:** Bryan Gale, Dillon Consulting Limited  
**cc:** Paul Clow, Government of Nunavut  
**Date:** August 22, 2022  
**Subject:** Kimmirut New Sewage Lagoon – Fish Habitat Assessment  
**Our File:** File #20-2790

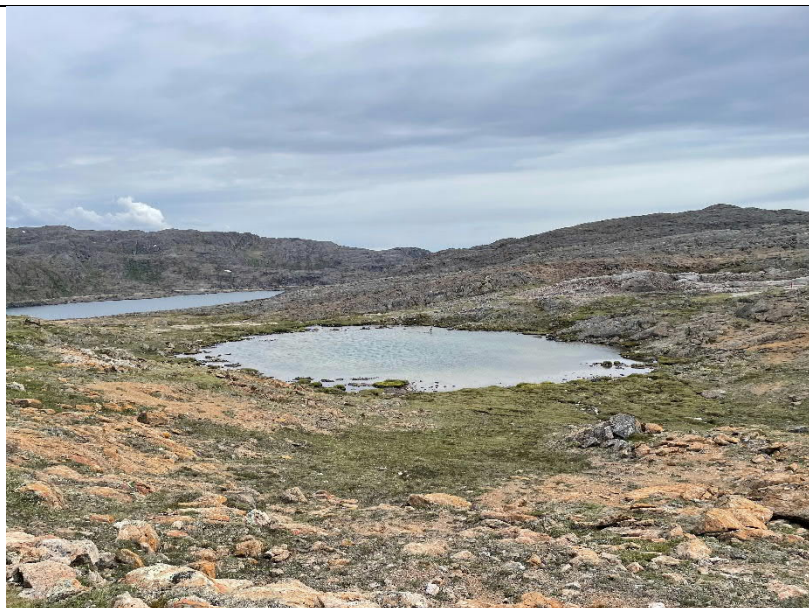
The pond is situated at the bottom of a small valley, with surrounding slopes comprised of bedrock and large boulders, with sparse ground-cover vegetation (Photos 1, 2). Water within the pond primarily consists of surface water runoff and melt within the valley, which is concentrated into a small inlet, entering the pond at on the west bank (Photos 3, 4). The inlet has a defined channel, though the channel was dry at the time of the assessment and is not anticipated to provide fish habitat nor does it connect to any other waterbodies upstream of the pond.

Photo 1: Facing southeast. The unnamed pond and surrounding valley. July 12, 2022.

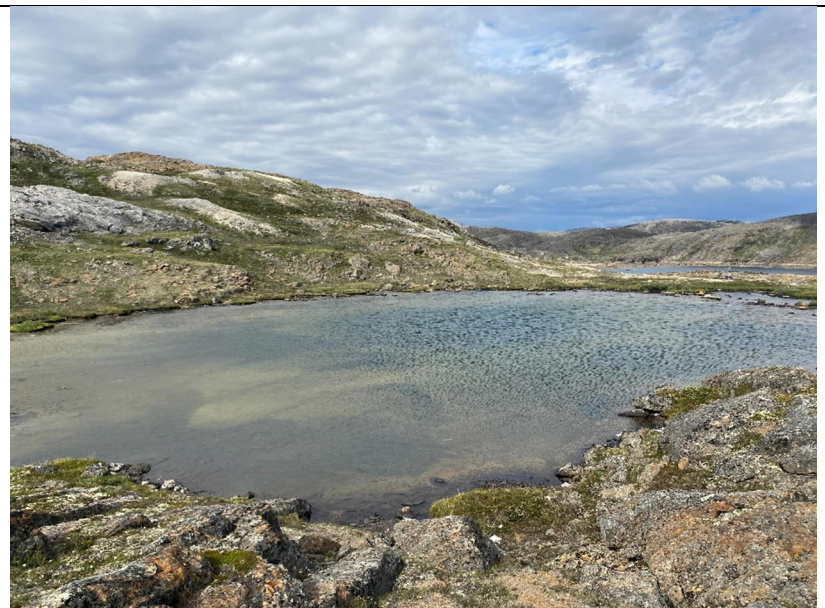
Photo 2: Facing northwest. Close-up of pond depth, riparian zone. July 12, 2022.

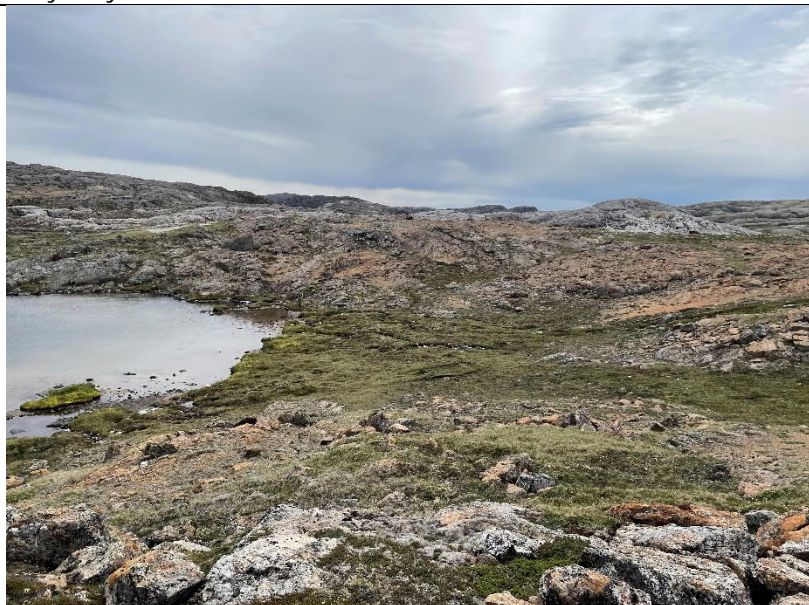
Photo 3: Facing south. Dry inlet channel. July 12, 2022.

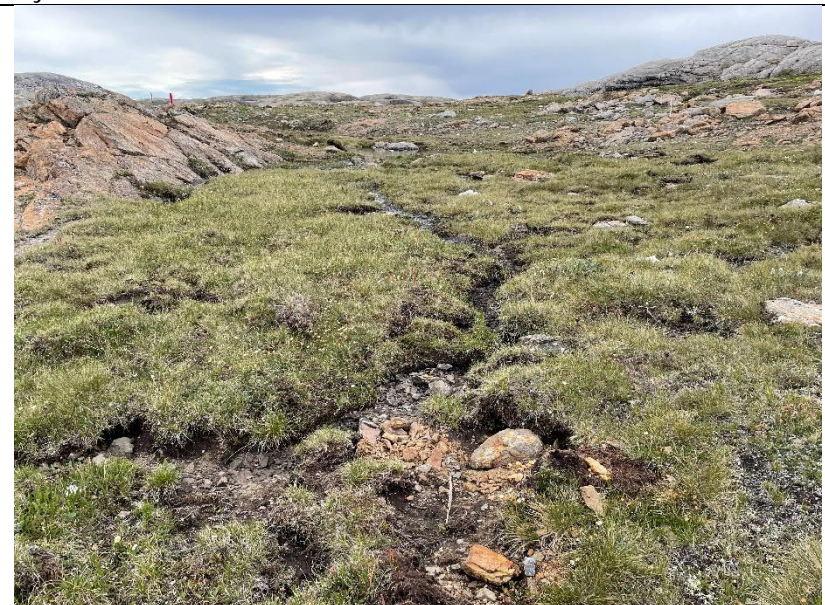
Photo 4: Facing west. Dry inlet channel. July 12, 2022.

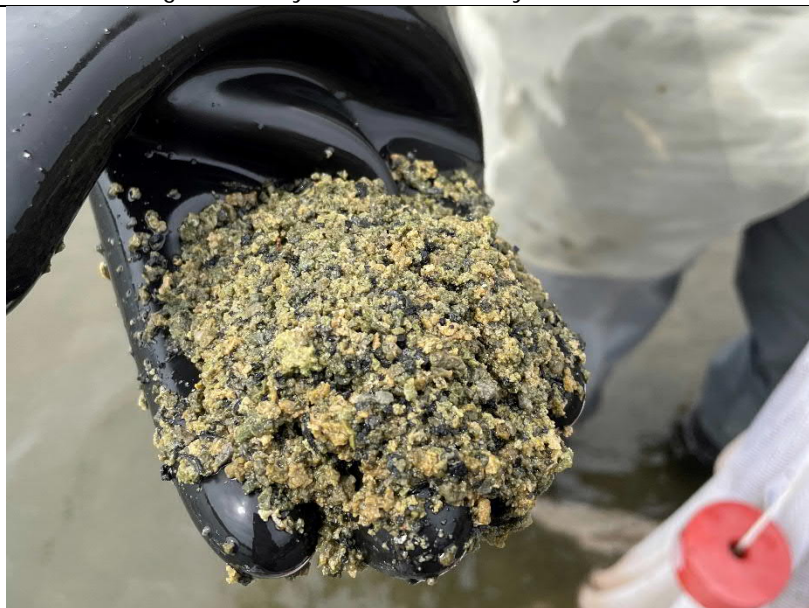
substrate consisted primarily of organics, with an approximately 4-inch thick uniform layer of soft, unconsolidated organic material, likely consisting of partially decomposed biomass (Photo 5). Disturbing the biomass layer (e.g., walking) resulted in the mobilization of an opaque black plume of material, with gas bubbling to the pond surface (Photo 6). A strong sulfur odor was also associated with the black plume, likely methane indicating anaerobic decomposition occurring within the biomass layer. Suitable fish habitat within the pond was limited, with very little functional cover, structure or complexity in habitat. The majority of the pond consists of uniform organic substrate with sparse boulders that have potential to provide limited cover for small-bodied fish. No in-water vegetation was present and riparian vegetation consisted of low-lying shrubs, grasses, moss, and lichen. Ravens were observed flying above the valley, and no other wildlife or birds were observed within the pond or the surrounding valley. Animal bones were located throughout the riparian zone and surrounding valley, with bones from species ranging in size from small (e.g., juvenile seal) to large (e.g., caribou) observed (Photos 7, 8).

Photo 5: Substrate of the unnamed pond. July 12, 2022.

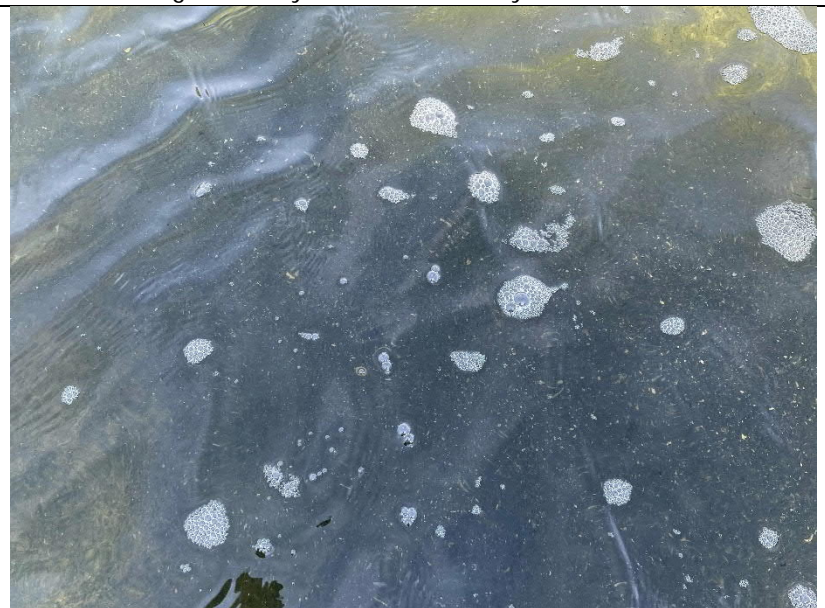
Photo 6: Black plume and gas bubbles with strong sulphur odor. July 12, 2022.

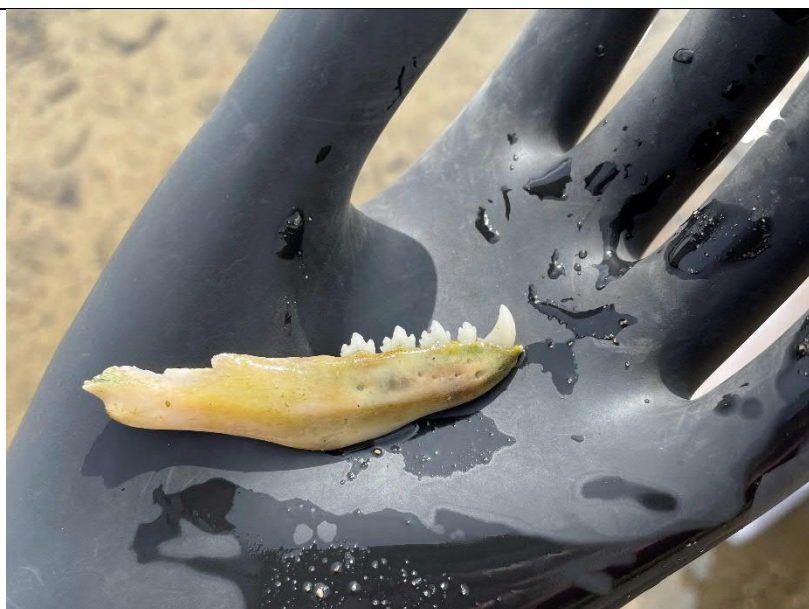
Photo 7: Partial mandible of a small mammal, potentially a juvenile harbour seal (*Phoca vitulina*) based on morphology. July 12, 2022.

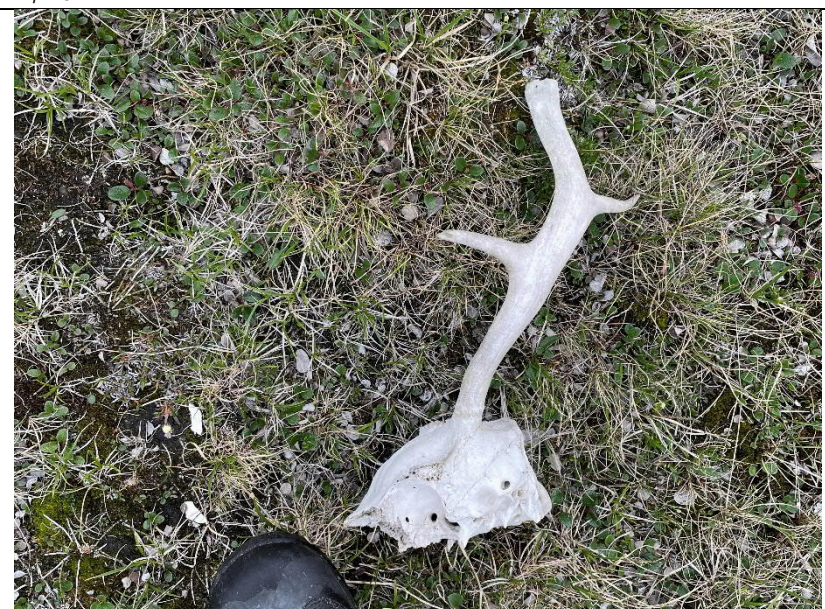
Photo 8: Partial caribou (*Rangifer tarandus groenlandicus*) skull and antlers. July 12, 2022.

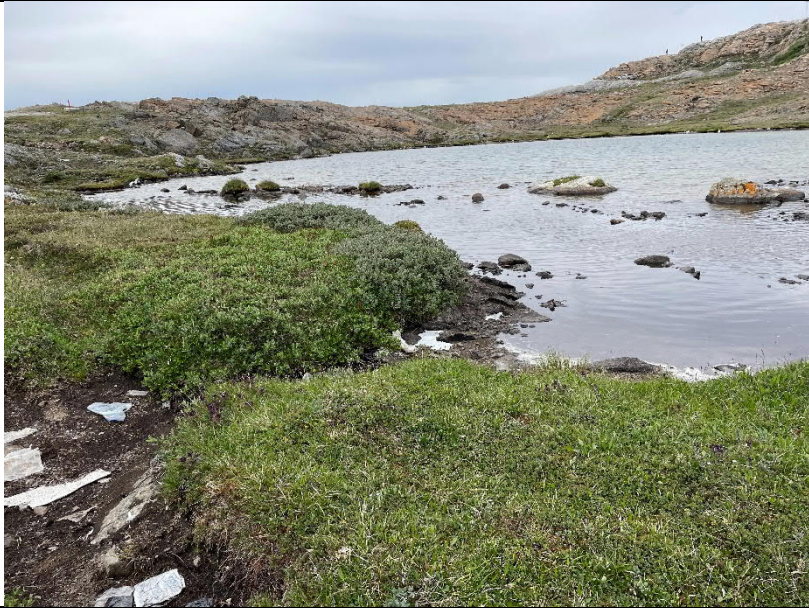
A defined outlet channel is present at the eastern bank of the pond, flowing in a northeast direction, with a bankfull width of approximately 0.3 m. (Photos 9, 10). The outlet channel was dry at the pond outlet, with surface flow starting approximately 30 m downstream of the pond (i.e., from subsurface flows). Approximately 350 m downstream of the pond, the channel outlets into the existing effluent flowpath, which is characterized by an extremely productive riparian zone and is full of other anthropogenic debris (Photo 11). While the outlet channel is defined, flow is broken up by long (approximately 50-100 m) sections, where surface flow is not present. As such, the outlet channel is not anticipated to provide suitable fish habitat, and connectivity between the pond and the effluent flowpath likely only occurs during periods of high flow.

Photo 9: Facing west. Dry portion of the outlet channel. July 12, 2022.

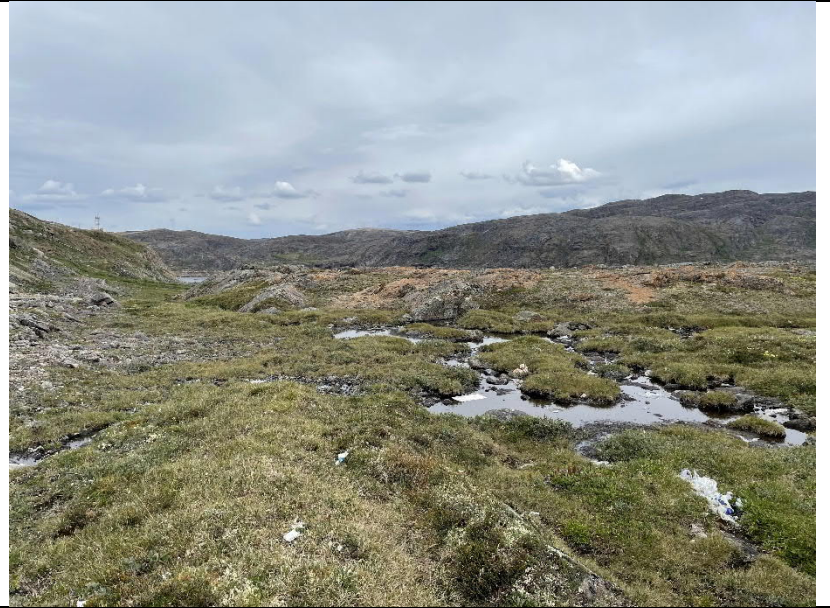
Photo 10: Facing northeast. Wetted portion of the outlet channel. July 12, 2022.

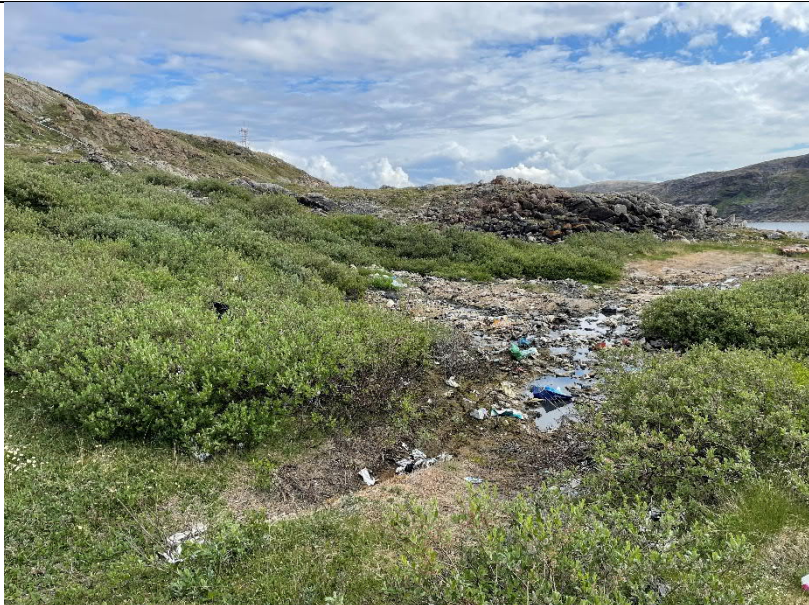
The effluent flowpath has continuous flow, very high riparian productivity for Baffin Island (i.e., due to high nutrient load), and was full of anthropogenic debris. Due to health and safety concerns, habitat characteristics of the effluent flowpath were not collected during the field assessment.

Photo 11: Facing north. Effluent flowpath and debris from landfill. July 13, 2022.

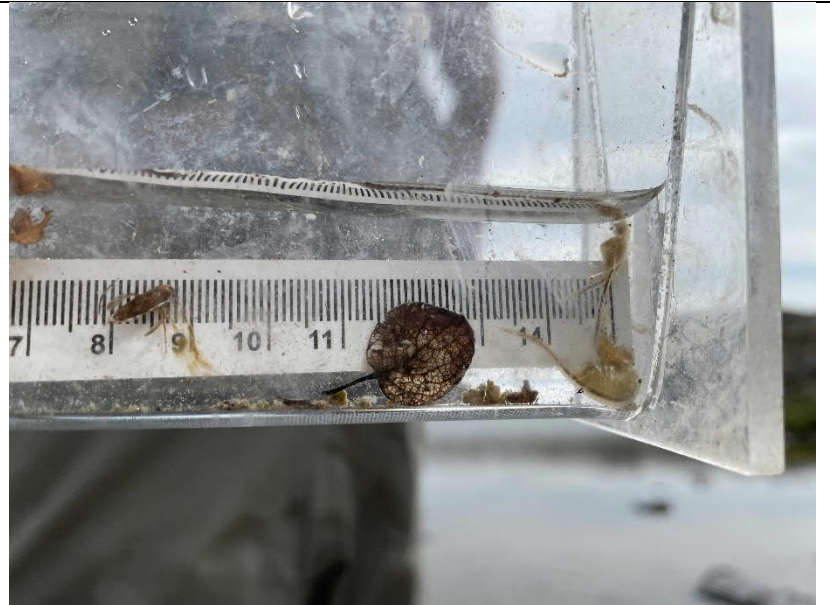
Using a seine net (3/16" mesh x 4' deep x 10' length), two biologists conducted 10 passes along the shoreline of the pond. Invertebrates were captured, including caddisfly (*Trichoptera* spp.) larvae, brine shrimp (*Branchiopoda* spp.) and diving beetles (*Dytiscidae* spp.) (Photo 12). No fish were captured or observed.

Photo 12: Invertebrates captured via seine netting. July 12, 2022.
