Water Licence Inspection - June 27, 1997

MUNICIPAL WATER USE INSPECTION FORM

Kimmirut - June 27, 1997

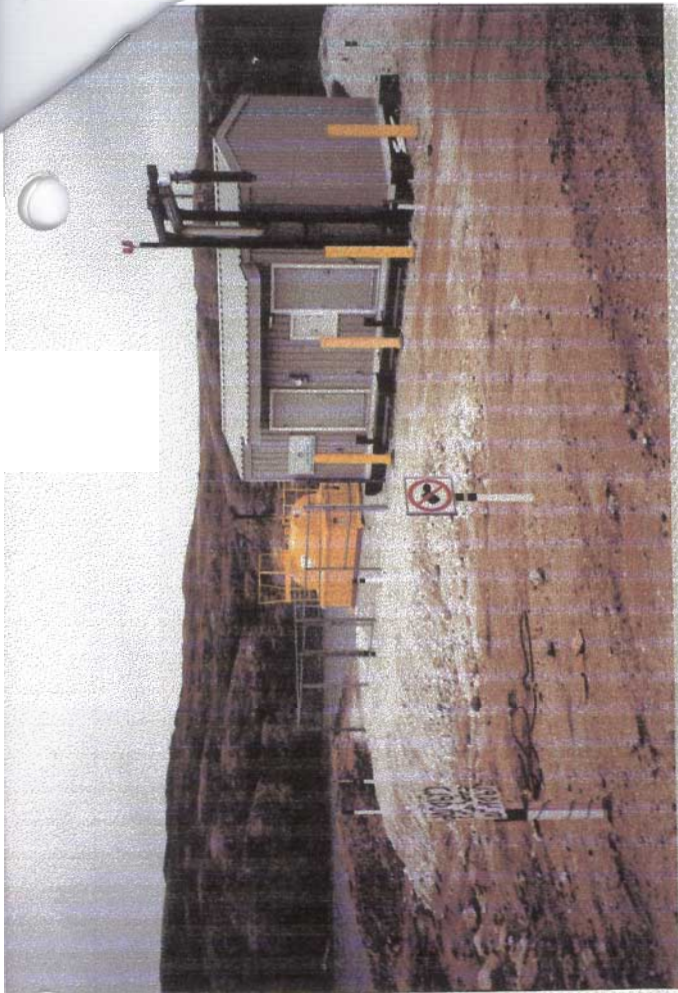
1. Truckfill station.
2. Flowmeter at truckfill station.
3. View of dump and sewage disposal area (indicated by arrows).
4. Sewage effluent discharge to ocean. Greenery denotes route.
- 5-6. 2 views of dump.
- 7-8. Drums of waste oil above dump. Note stained area in photo #8.

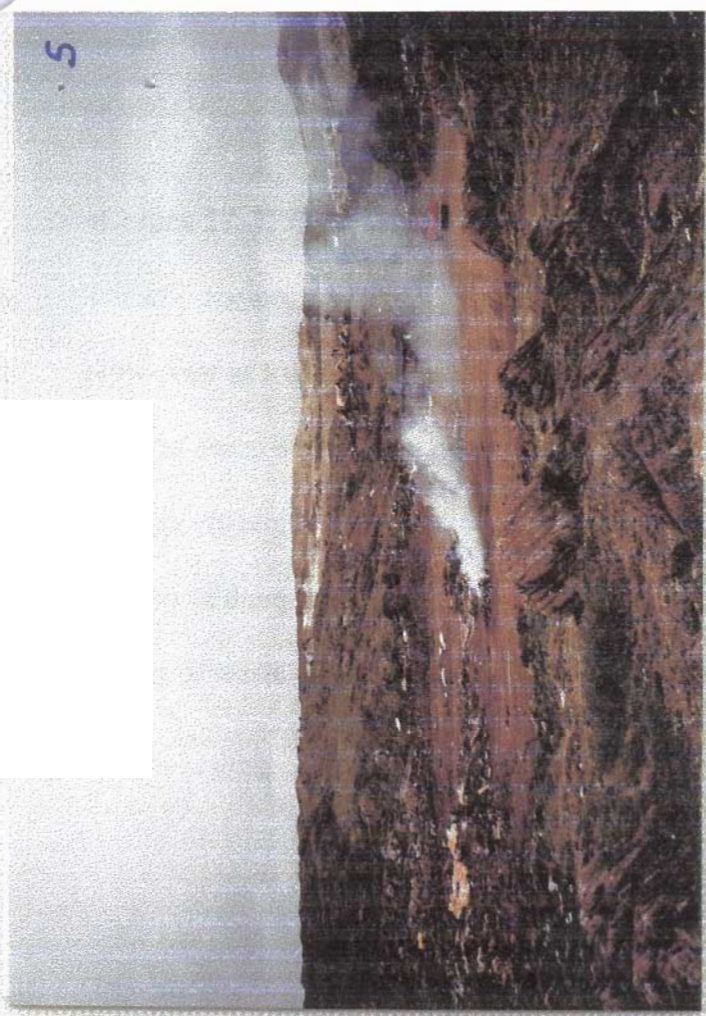
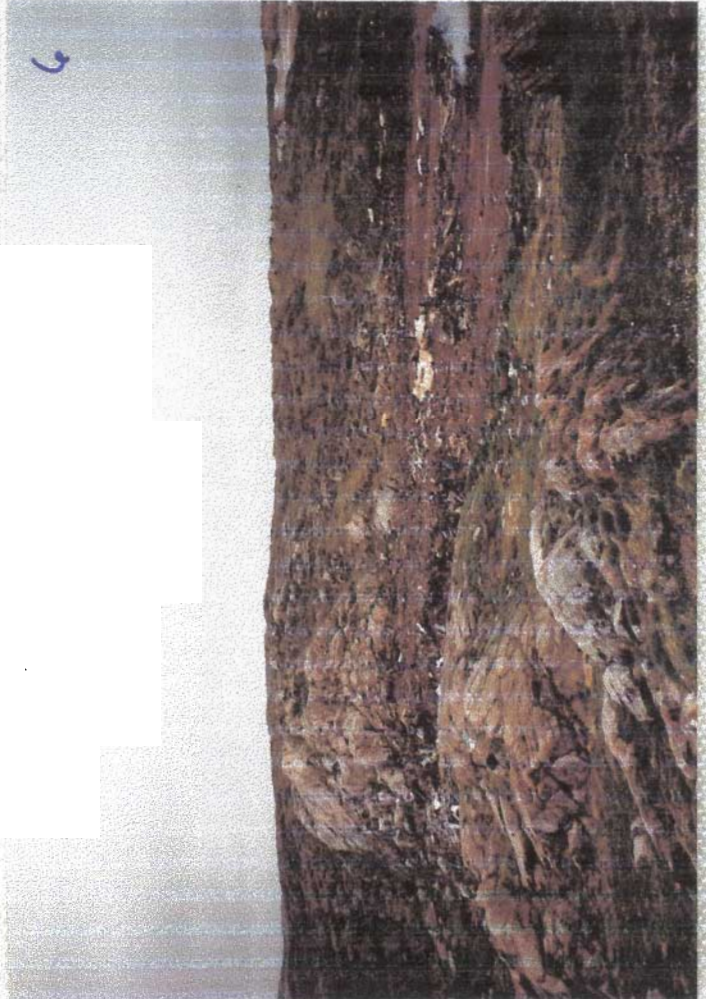
Non-Compliance of Act or Licence: Licensee has failed to submit their 1995+1996
Annual Reports; Have not yet posted SNP station signs; Have not collected
any water samples per SNP requirements; have not submitted a sewage facility upgrade plan.
Note 1: No action has been taken to improve waste oil disposal
area, which shows heavy staining
